# **Phase I Environmental Site Assessment**

230 and 232 Lisgar Street  
Ottawa, Ontario

Prepared for 230 Lisgar Street Inc.

Report: PE5905-1  
November 11, 2022

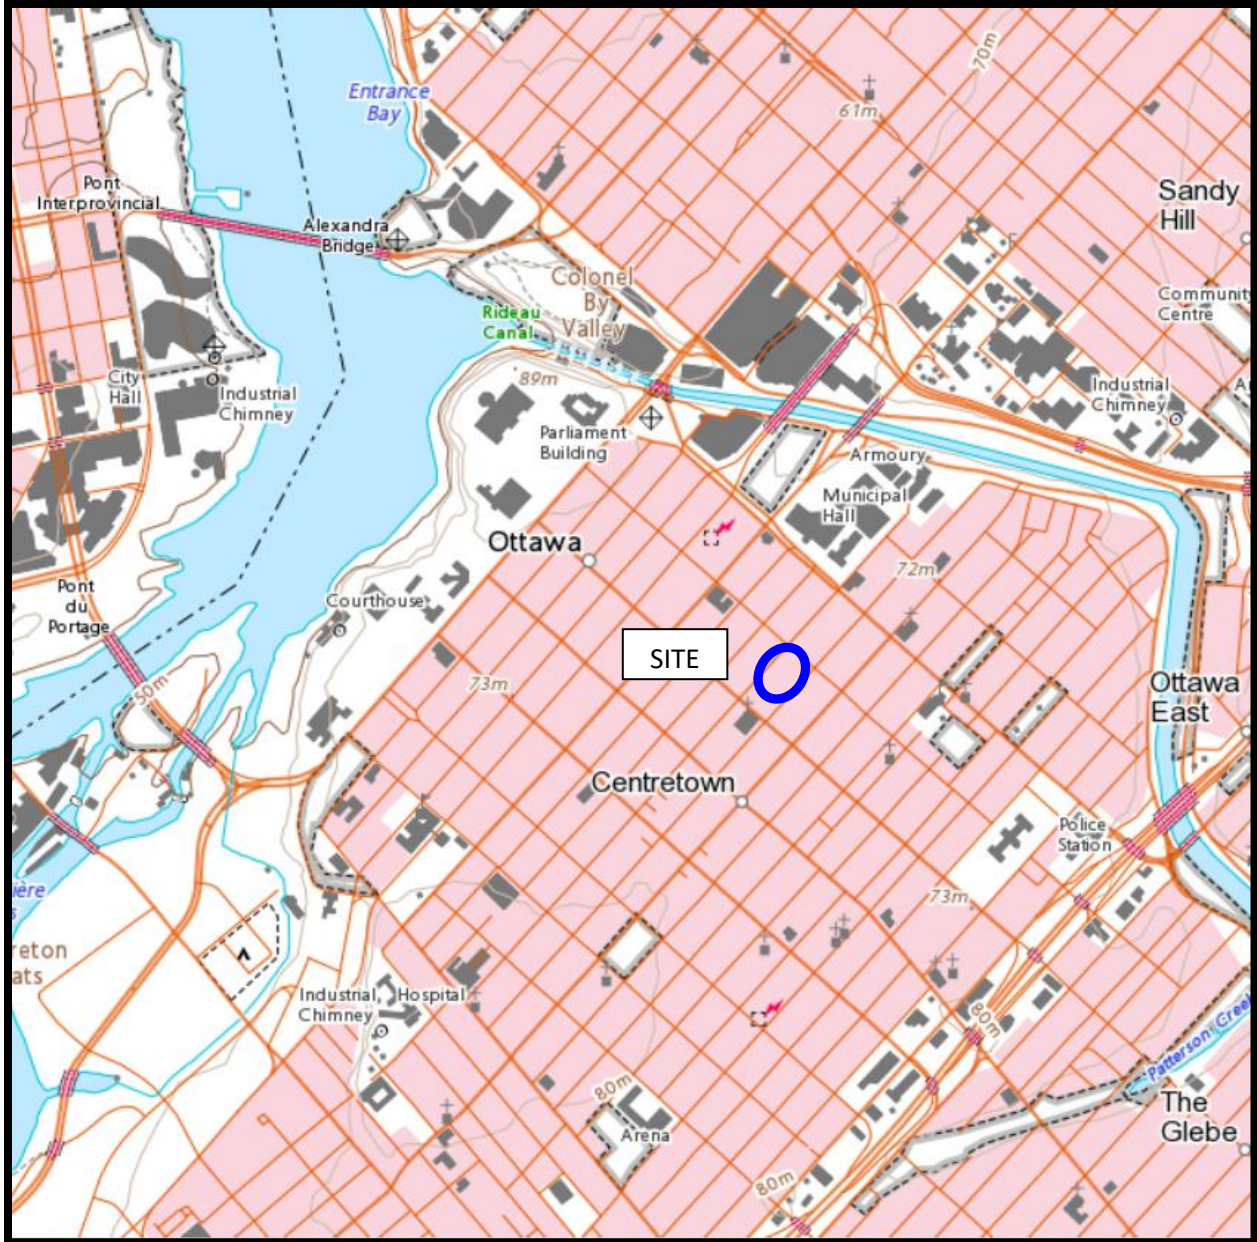
FIGURE 2  
TOPOGRAPHIC MAP

Topographic maps were obtained from Natural Resources Canada – The Atlas of Canada website and from the City of Ottawa website. Based on the topographic map, the Phase I Property is situated at approximately 72 masl. Regionally, the topographic maps indicate a downward slope in a northwesterly direction. An illustration of the referenced topographic map is presented on Figure 2 – Topographic Map, appended to this report.

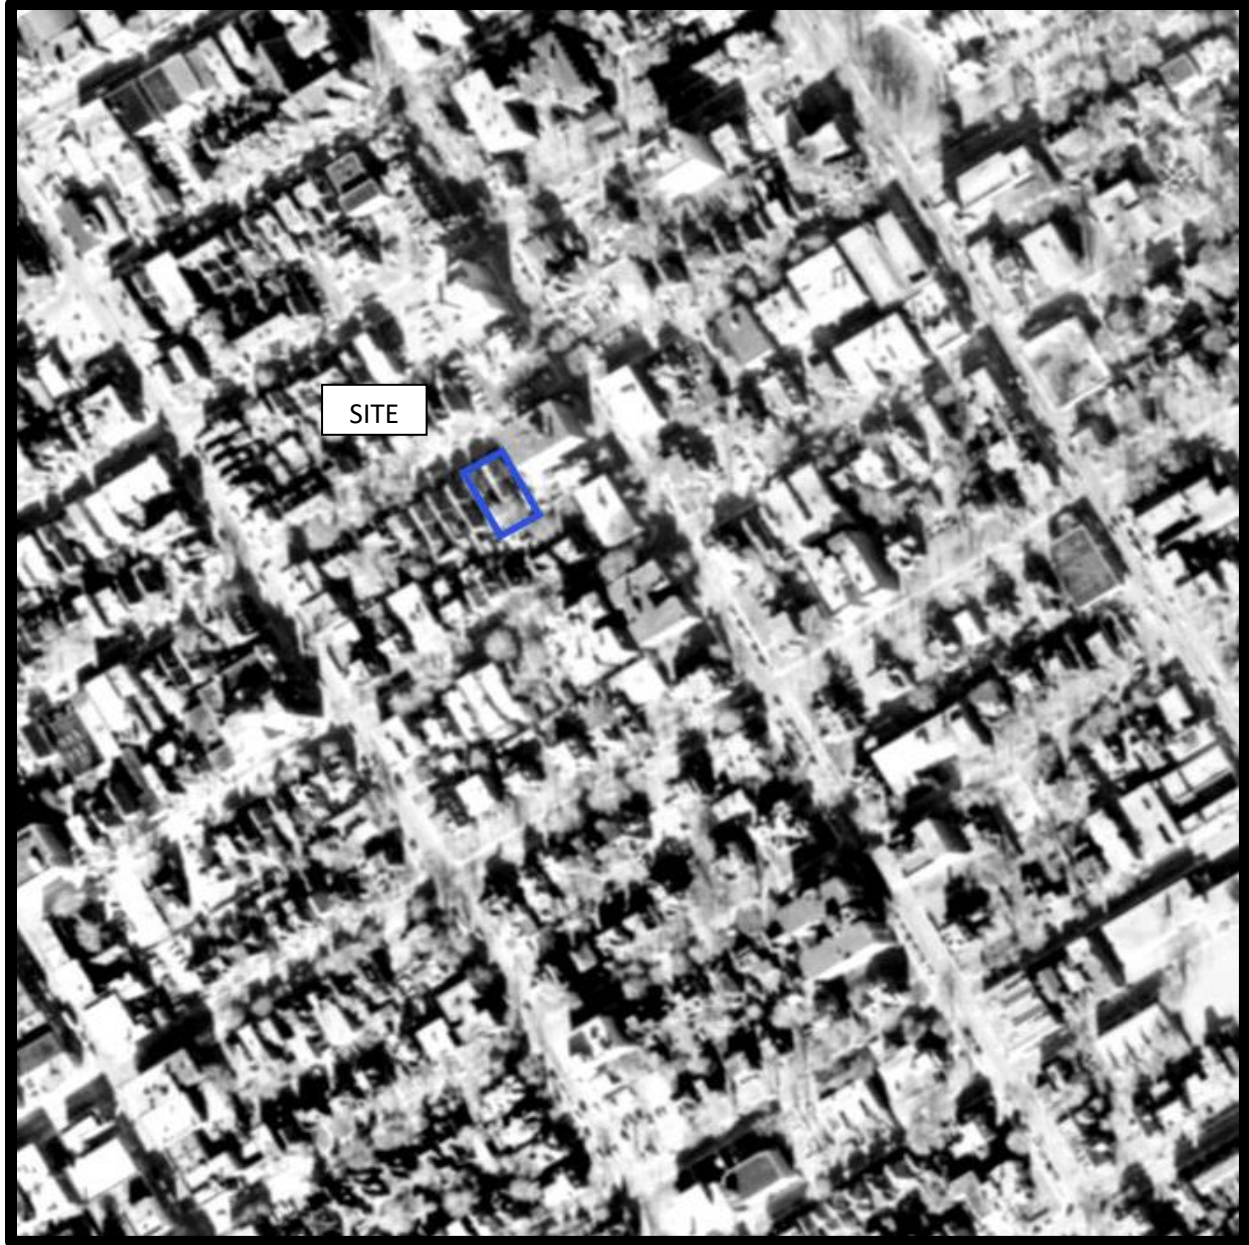
AERIAL PHOTOGRAPH  
1958

1958	No significant changes are apparent on the Phase I Property or properties within the Phase I Study Area.
1965	The Phase I Property and surrounding lands appear unchanged from the previous image.
1976	The Phase I Property and surrounding lands to the east, west and south appear unchanged at this time. Lands further to the north appear to have been redeveloped with the present-day commercial office building.
1991	No significant changes are apparent on the Phase I Property or properties within the Phase I Study Area.
2005	The Phase I Property and surrounding lands appear unchanged from the previous image.
2011	The Phase I Property and surrounding lands to the north, east, west and south appear unchanged at this time, with the exception of a former parking lot situated on the northeast corner of the Metcalfe and Nepean Street intersection, which now appears to be under construction.
2021	The Phase I Property and the surrounding lands appear unchanged from the previous image, with the exception that the property that was formerly under construction, is now occupied by a residential high-rise building.

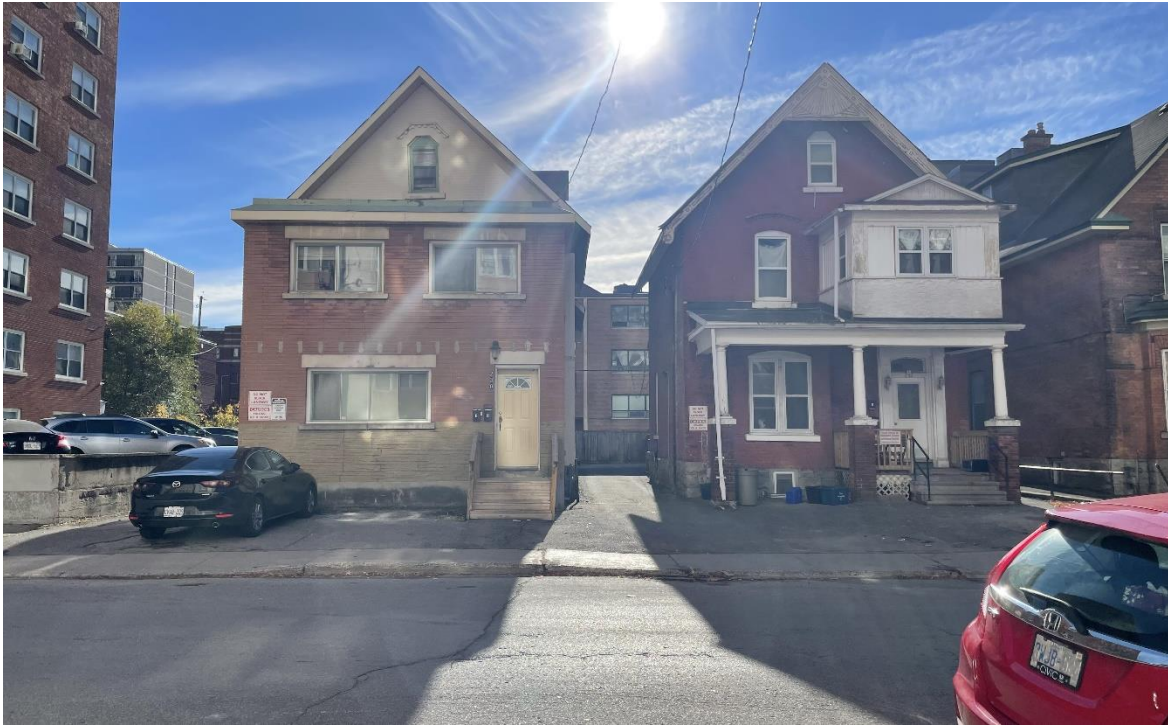
Photograph 1: View of the northern side of the Phase I Property, fronting Lisgar Street.

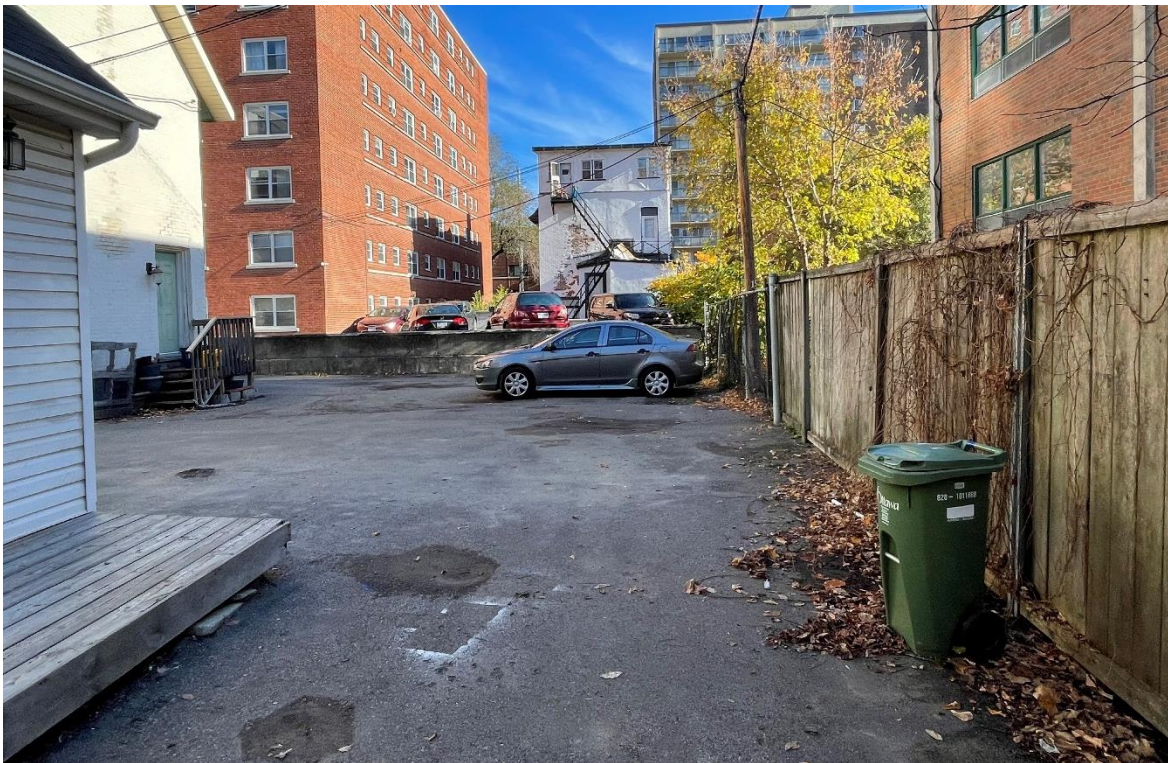
Photograph 2: View of the southern side of the of the Phase I Property, looking north.

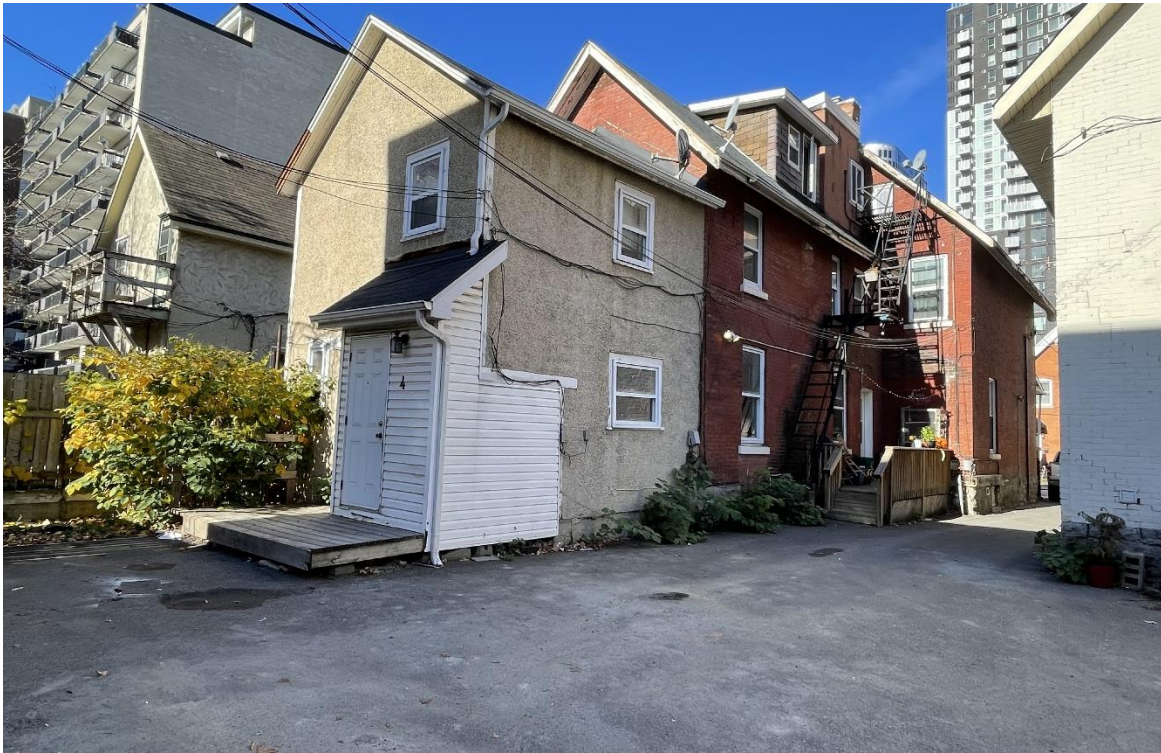
232 Lisgar Street is occupied by a 2-storey, multi-tenant residence with a basement level. The present-day residence was constructed circa 1888 with a limestone foundation with large areas covered in exterior parging. The exterior façade of the building is finished in brick, while the rear extension is finished in a mixed aggregate stucco and vinyl siding with a sloped shingle style roof.

Photograph 3: View of the 232 Lisgar Street, looking northwest.

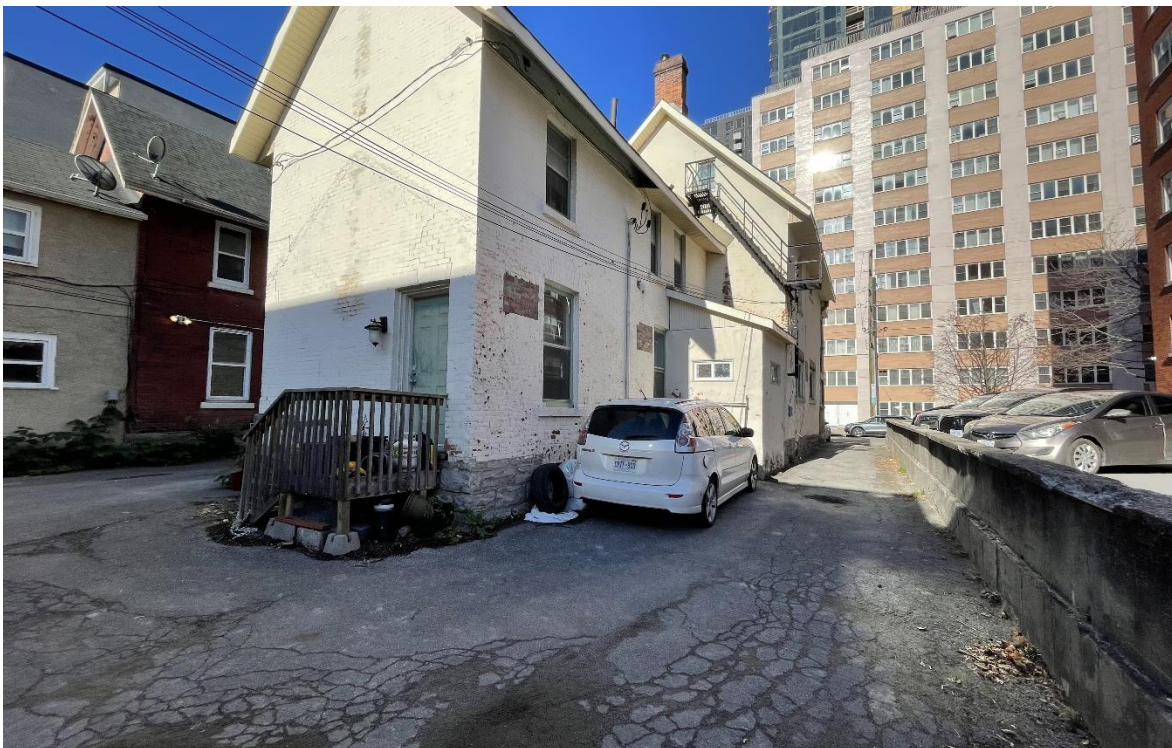
230 Lisgar Street is occupied by a 2-storey, multi-tenant residence with a basement level. The present-day residence was constructed circa 1888 with a limestone foundation with large areas covered in exterior parging. The exterior façade of the building is finished in brick with a sloped shingle style roof.

Photograph 4: View of the 230 Lisgar Street, looking northwest
