REPORT

Geotechnical Investigation Access Property Developments

864 Lady Ellen Place, Ottawa, ON

December 15, 2022

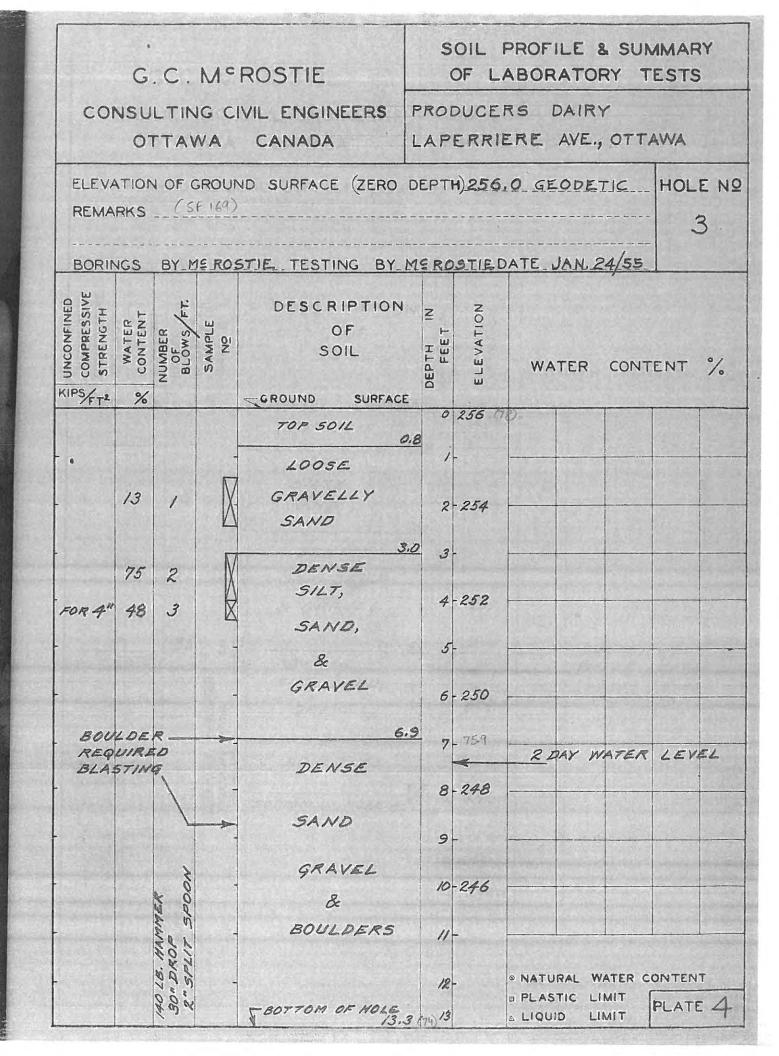
G	. C .	M°	ROSTIE			PROFILE & SU ABORATORY	
CON				VIL ENGINEERS CANADA			ERE AVE., C	TTAWA
REMA	RKS	CSF	169)	ND SURFACE (ZERO				HOLE
BORIN	IGS	BY_M	19 ROS	TIE_TESTING BY_	MS RC	STIE D	ATE JAN 25/5	5_
COMPRESSIVE STRENGTH	WATER CONTENT	NUMBER OF BLOWS	SAMPLE Ng	DESCRIPTION OF SOIL	DEPTH IN FEET	ELEVATION	WATER CON	itent %
-	/0			TOP SOIL	A DECEMBER OF THE OWNER OWNER OWNER OWNER OWNER OWNER	2.54.1		
		3	/ [SILTY SAND	2	- 252.1		
		72	2	DENSE SILT, SAND & GRAVEL	3	-250.1		
•		85	3	DENSE	0 5	-	OVERNI. WATER	LEVEL
			REQUIRED ANCE	SILT, SAND, GRAVEL, &	6	248.1	INATER FEB, B	155
			JETTING I TO ADVA CASING	BOULDERS	7	246.1		
		NOON	3~0	BOTTOM OF HOLE -	9	-		
		Y a L			10	-244.1		
		LE. HAMM. INCH DROI INCH SPLI			11		• NATURAL WATER	CONTENT
		30 11			12		PLASTIC LIMIT	PLATE

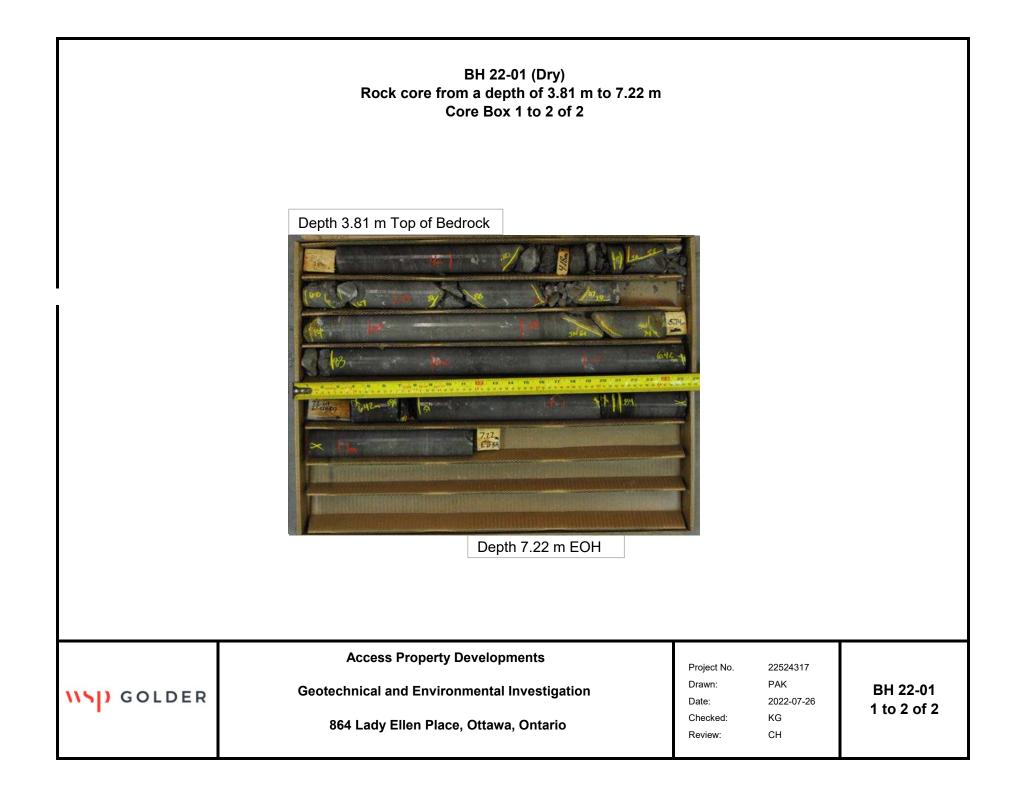
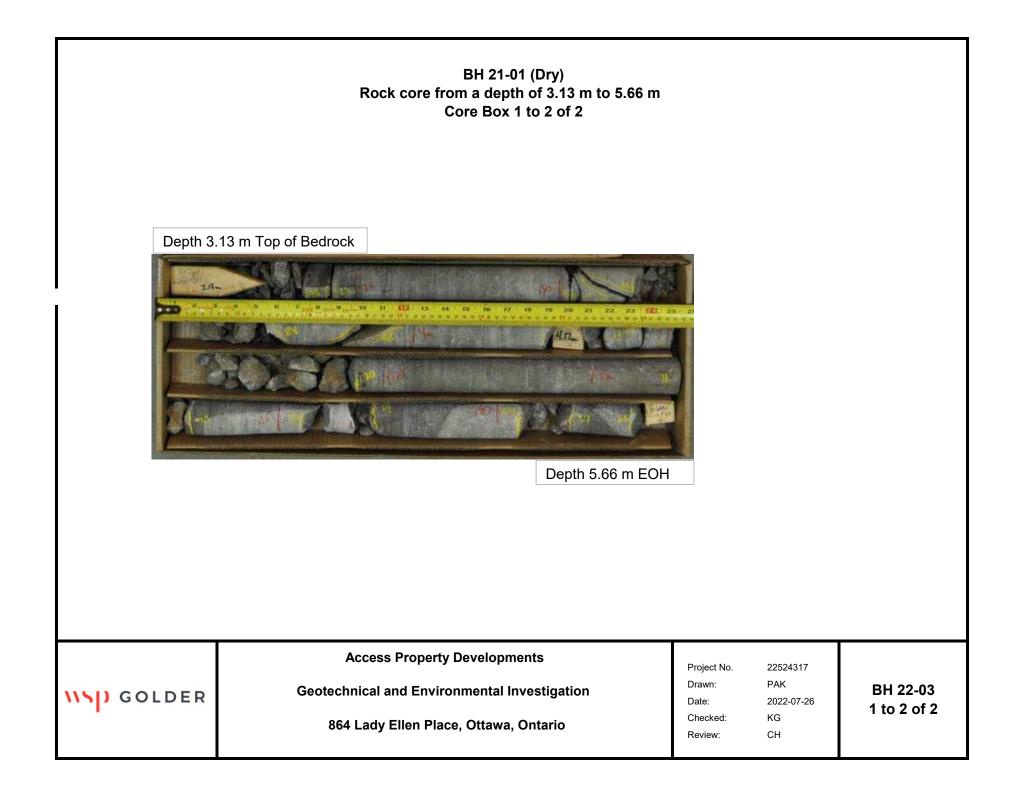
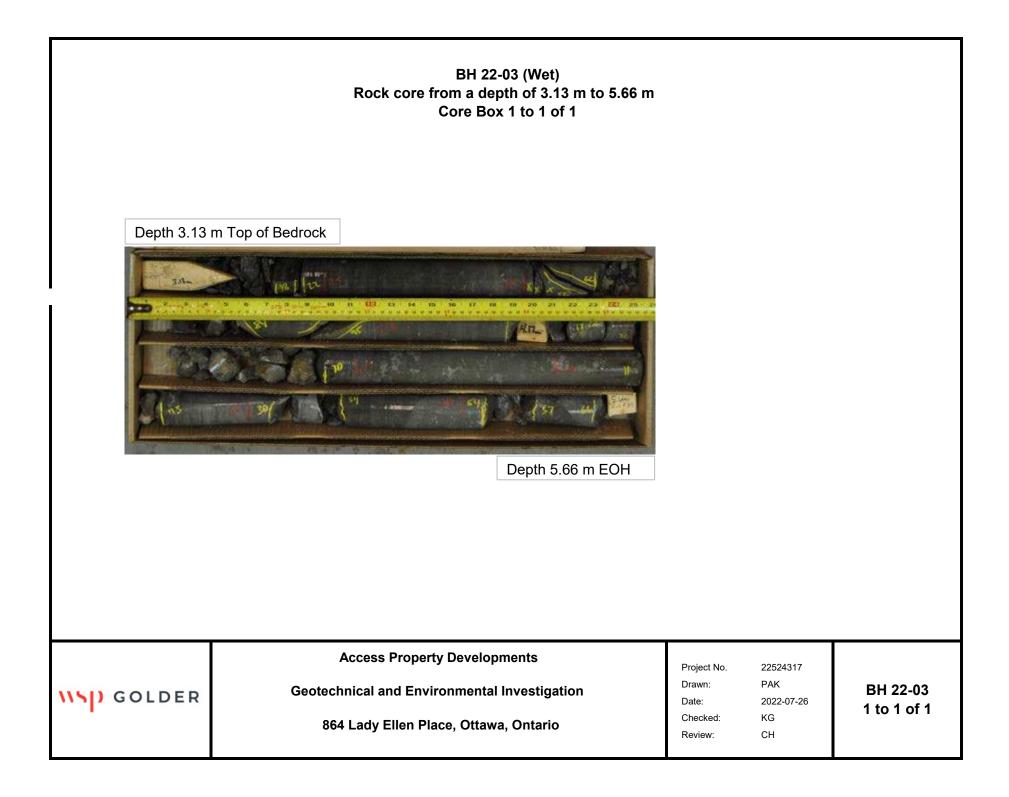
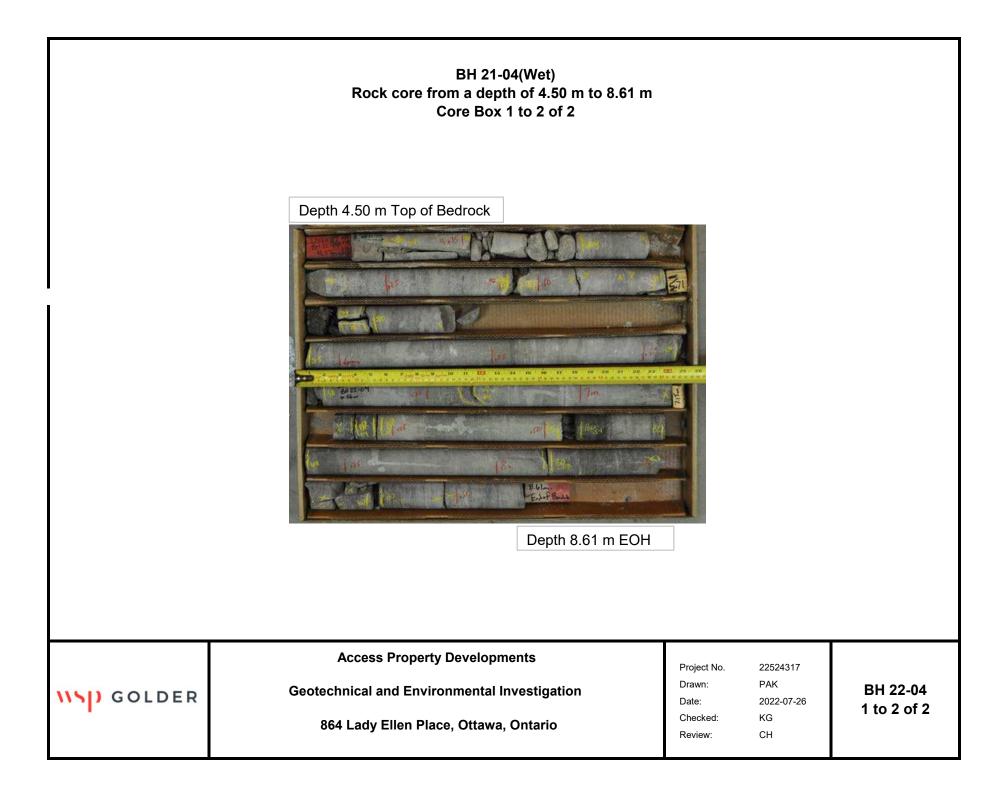
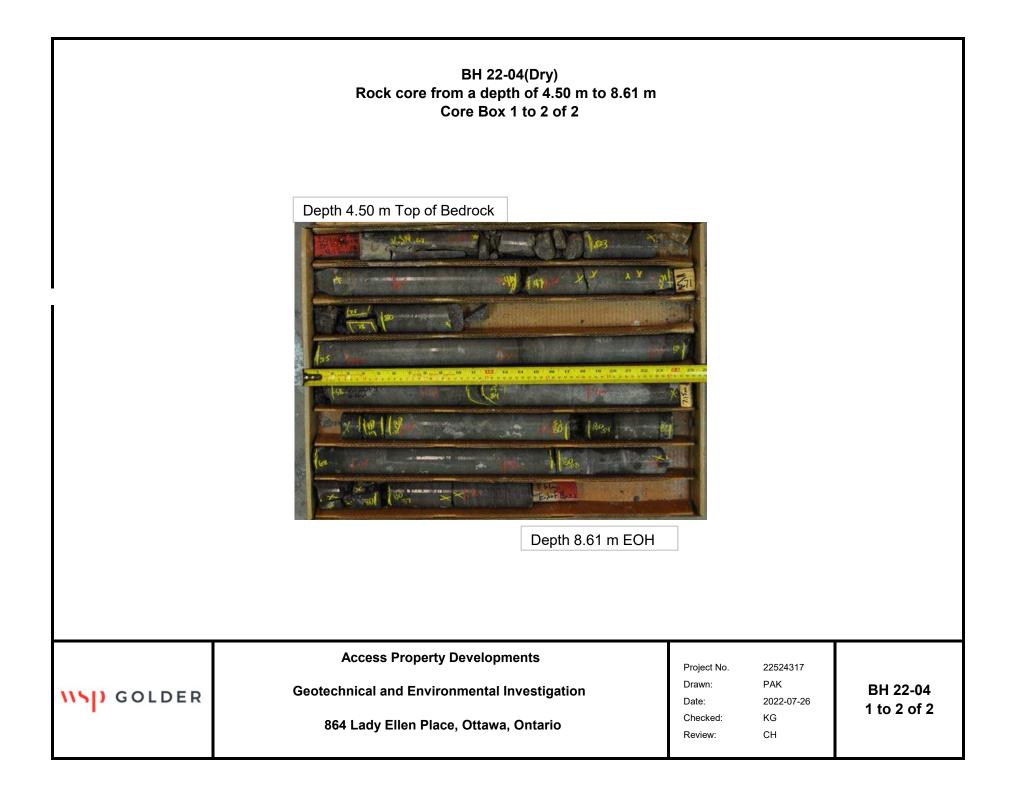
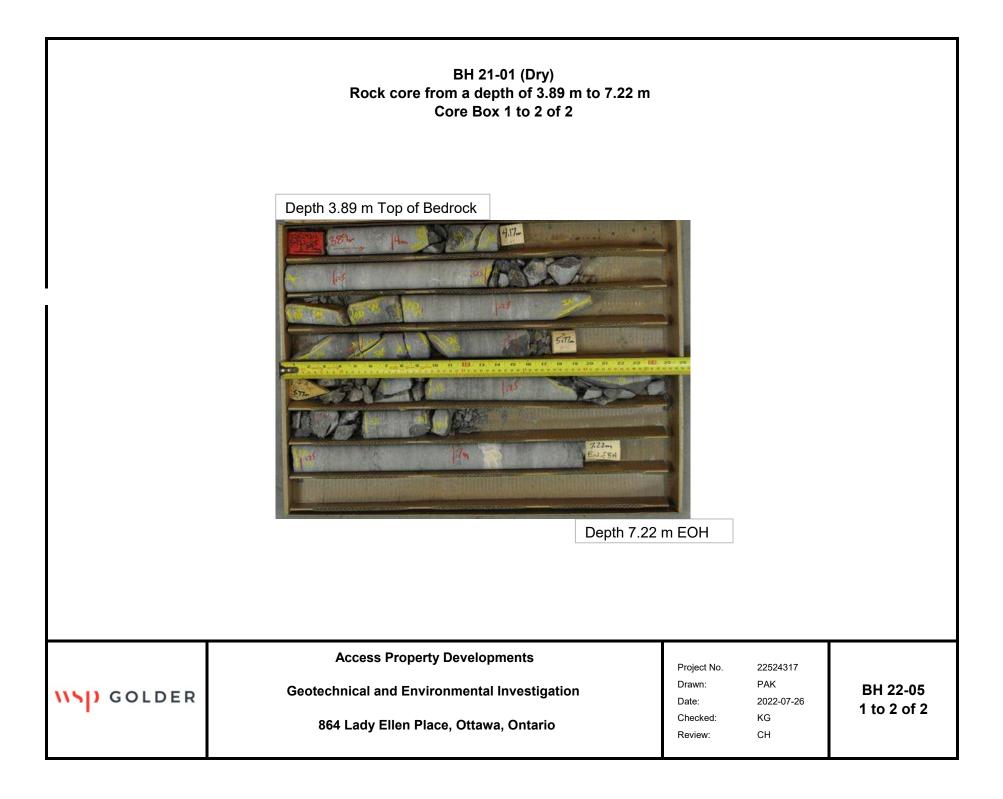
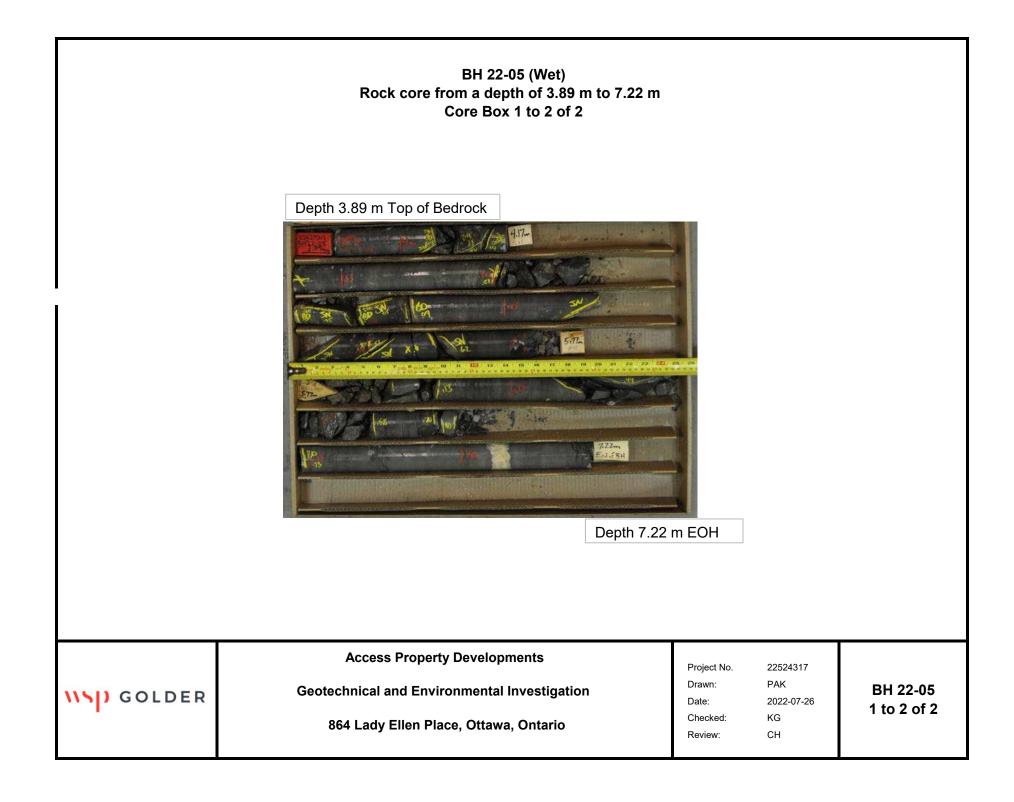
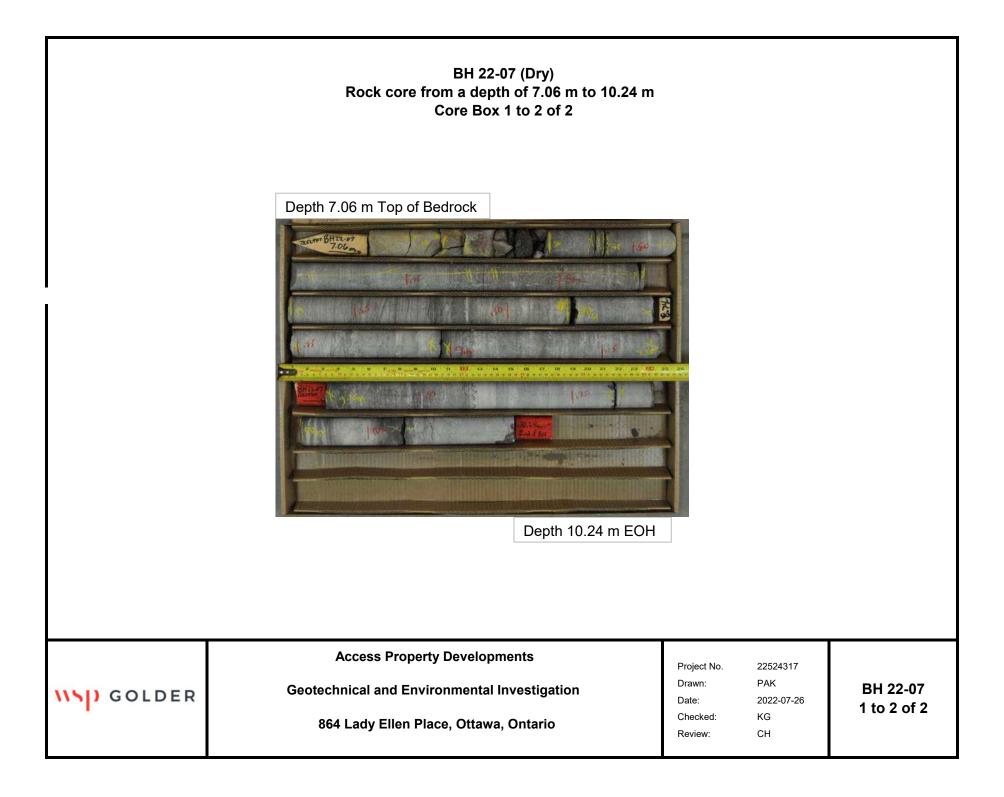
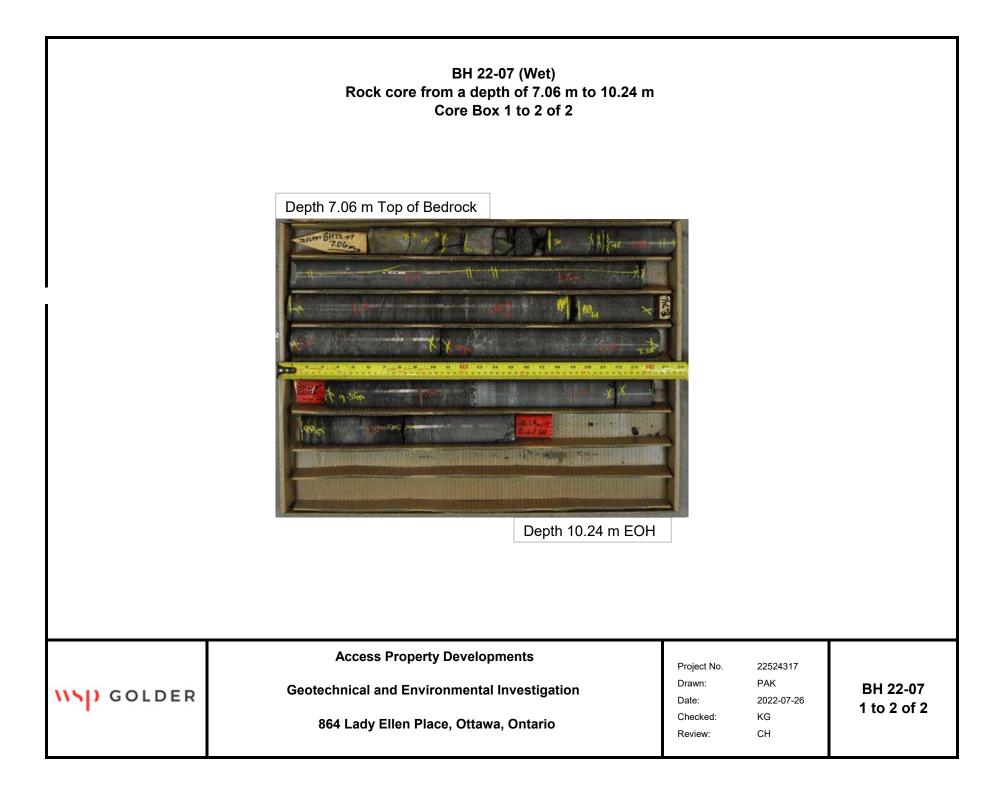
Core Photographs

BH 22-01 (Dry) Rock core from a depth of 3.81 m to 7.22 m Core Box 1 to 2 of 2		
	Depth 3.81 m Top of Bedrock Image: State of State o		
<mark>\\\S</mark>]) GOLDER	Access Property Developments Geotechnical and Environmental Investigation 864 Lady Ellen Place, Ottawa, Ontario	Project No.22524317Drawn:PAKDate:2022-07-26Checked:KGReview:CH	BH 22-01 1 to 2 of 2

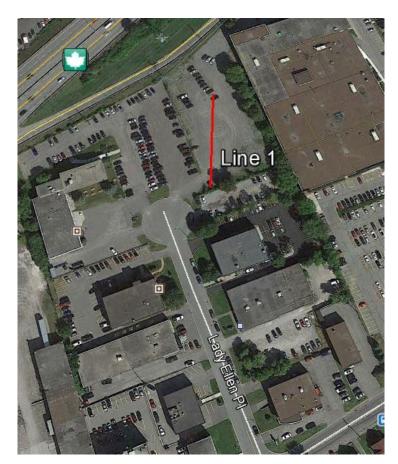
Figure 1: MASW Location Site Map (MASW Line in red)

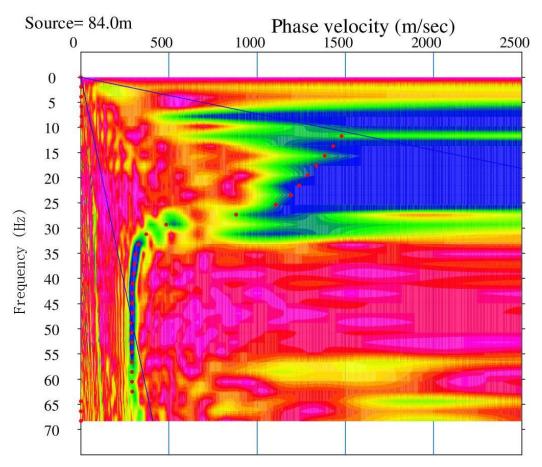
Processing of the MASW data was completed using the SeisImager/SW software package (Geometrics Inc.). The calculated phase velocities for a seismic shot point were combined and the dispersion curve generated by choosing the minimum phase velocity calculated for each frequency component as shown on Figure 3. Shear wave velocity profiles were generated through inverse modelling to best fit the calculated dispersion curves. The active survey provided a dispersion curve with a suitable frequency range (11 to 60 Hz). The minimum measured surface wave frequency with sufficient signal-to-noise ratio to accurately measure phase velocity

Figure 3: Active MASW Dispersion Curve Picks (red dots) along the MASW line

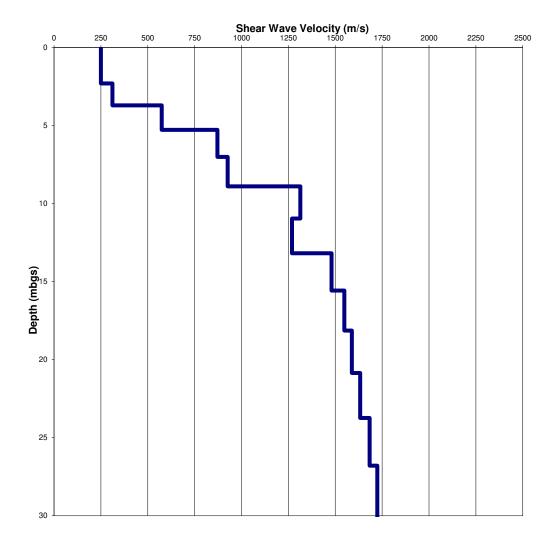
Figure 4: MASW Modelled Shear-Wave Velocity Depth profile along the MASW Line

To calculate the average shear-wave velocity as required by the NBCC 2015, the results were modelled to 30 metres below ground surface. The average shear-wave velocity along the MASW line was found to be 877 m/s (Table 1). The NBCC 2015 requires special site specific evaluation if certain soil types are encountered on the site, so the site classification stated here should be reviewed, and modified if necessary, according to borehole stratigraphy, standard penetration resistance results, and undrained shear strength measurements, if available for this site.

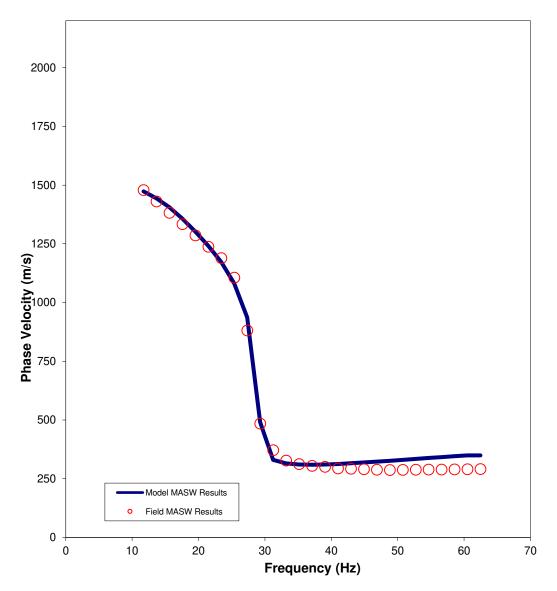
Figure 5: Comparison of Field (red dots) vs. Modelled Data (blue line) along the MASW Line
