Phase II – Environmental Site Assessment

2006, 2020, & 2026 Scott Street and
314 & 318 Athlone Avenue
Ottawa, Ontario

Morley Hoppner Group

Report: PE5303-2R

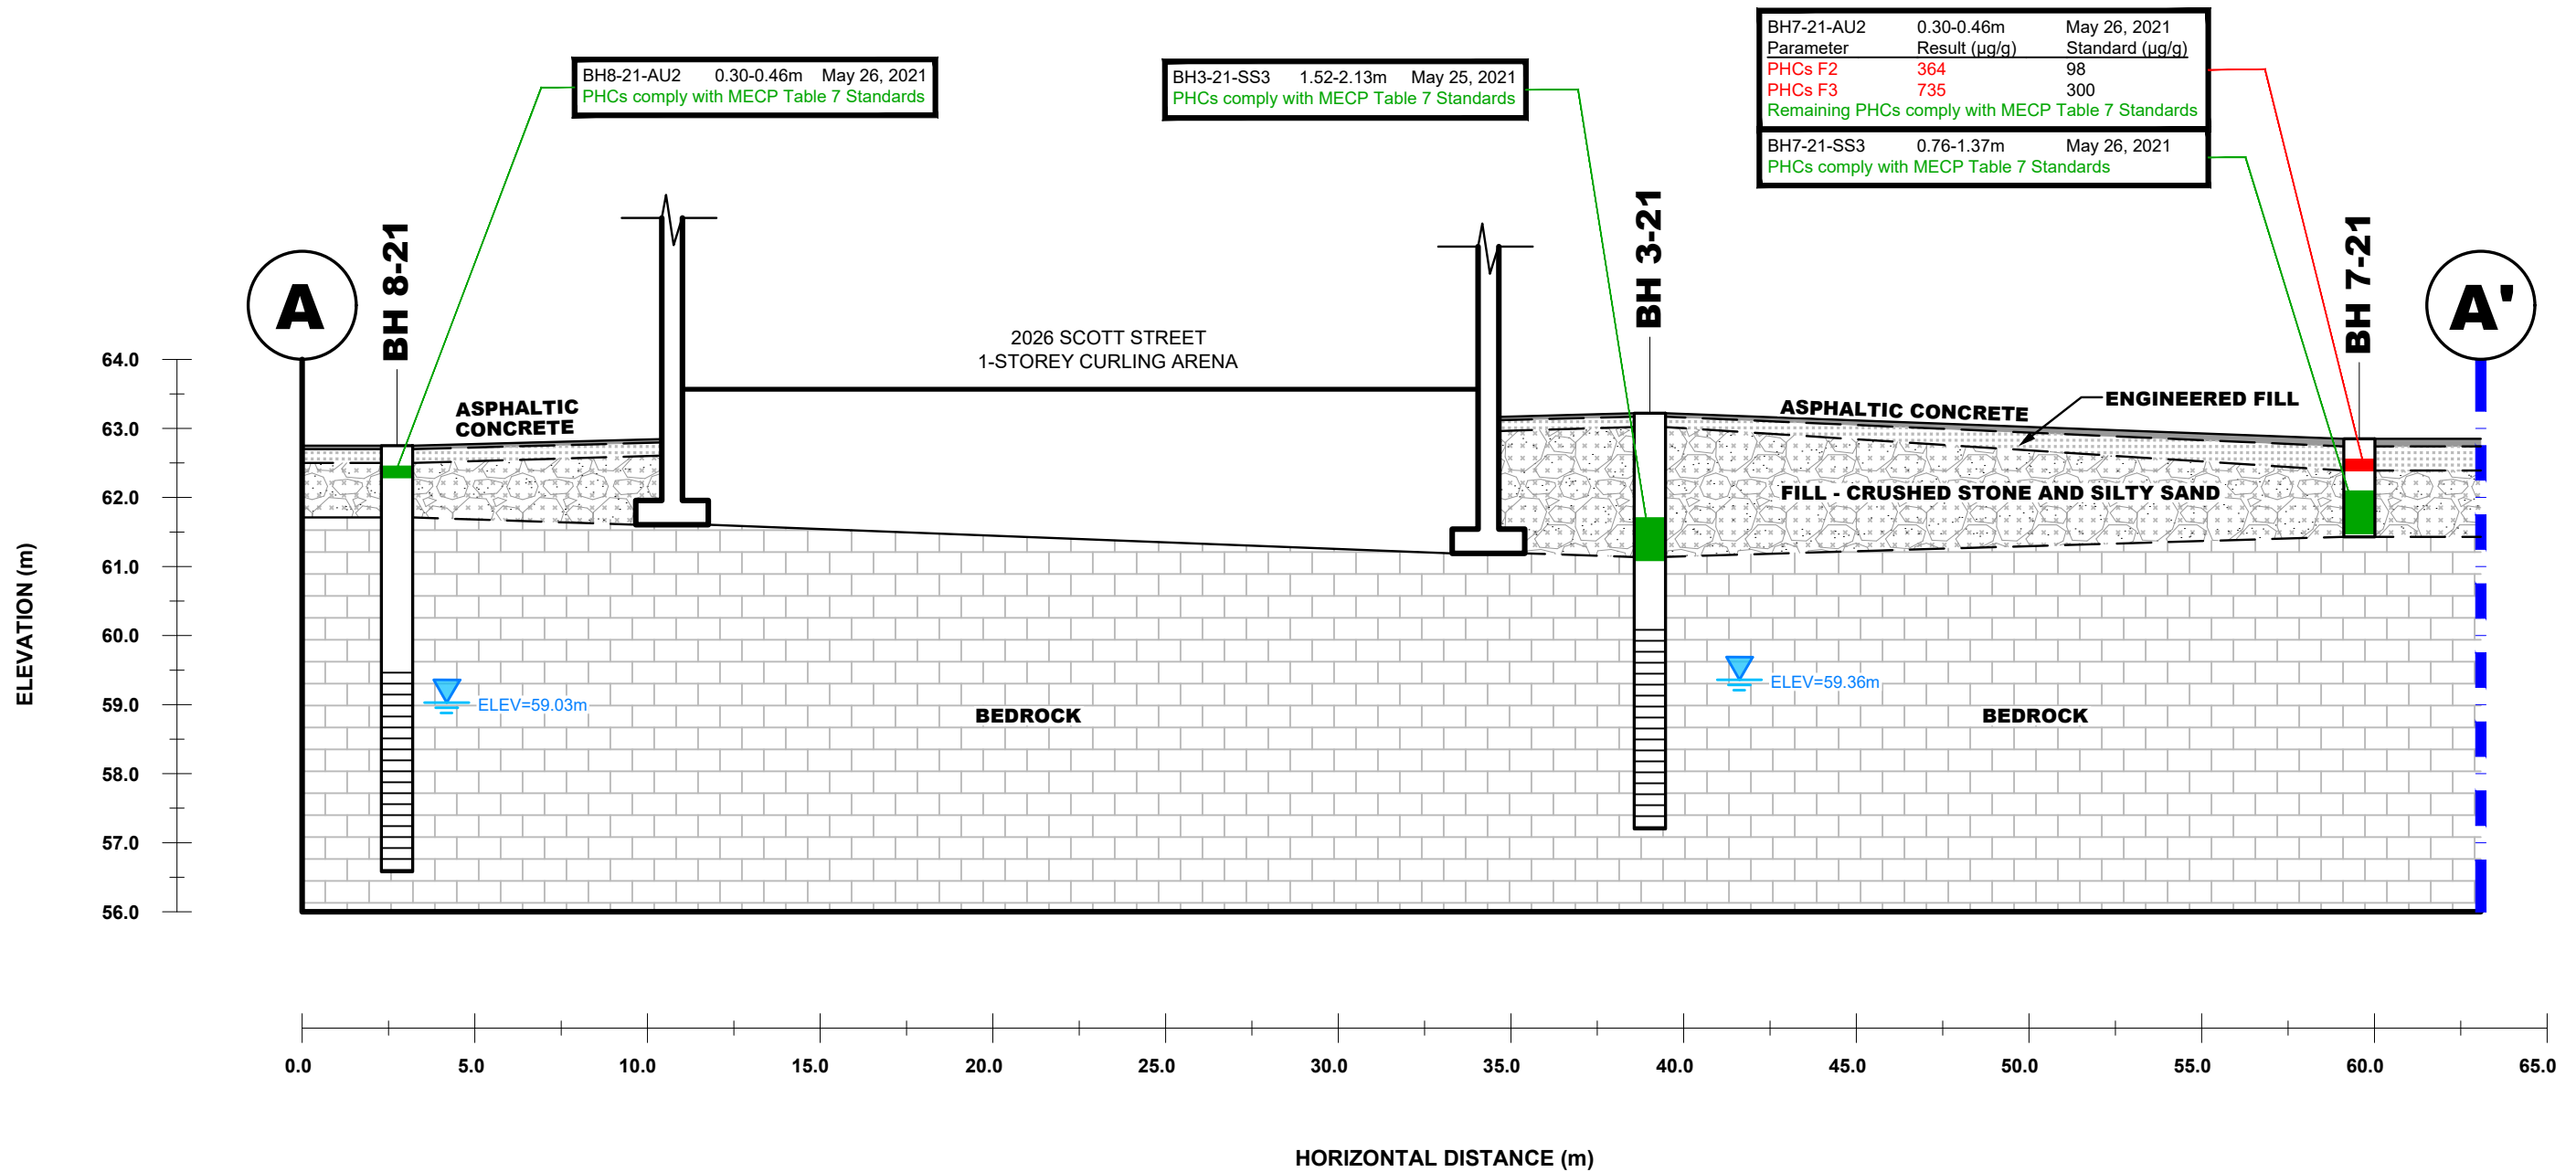
Drawing PE5303-4A – Cross Section A-A' – Soil (PHCs)

BH8-21-AU2 0.30-0.46m May 26, 2021
PHCs comply with MECP Table 7 Standards

BH3-21-SS3 1.52-2.13m May 25, 2021
PHCs comply with MECP Table 7 Standards

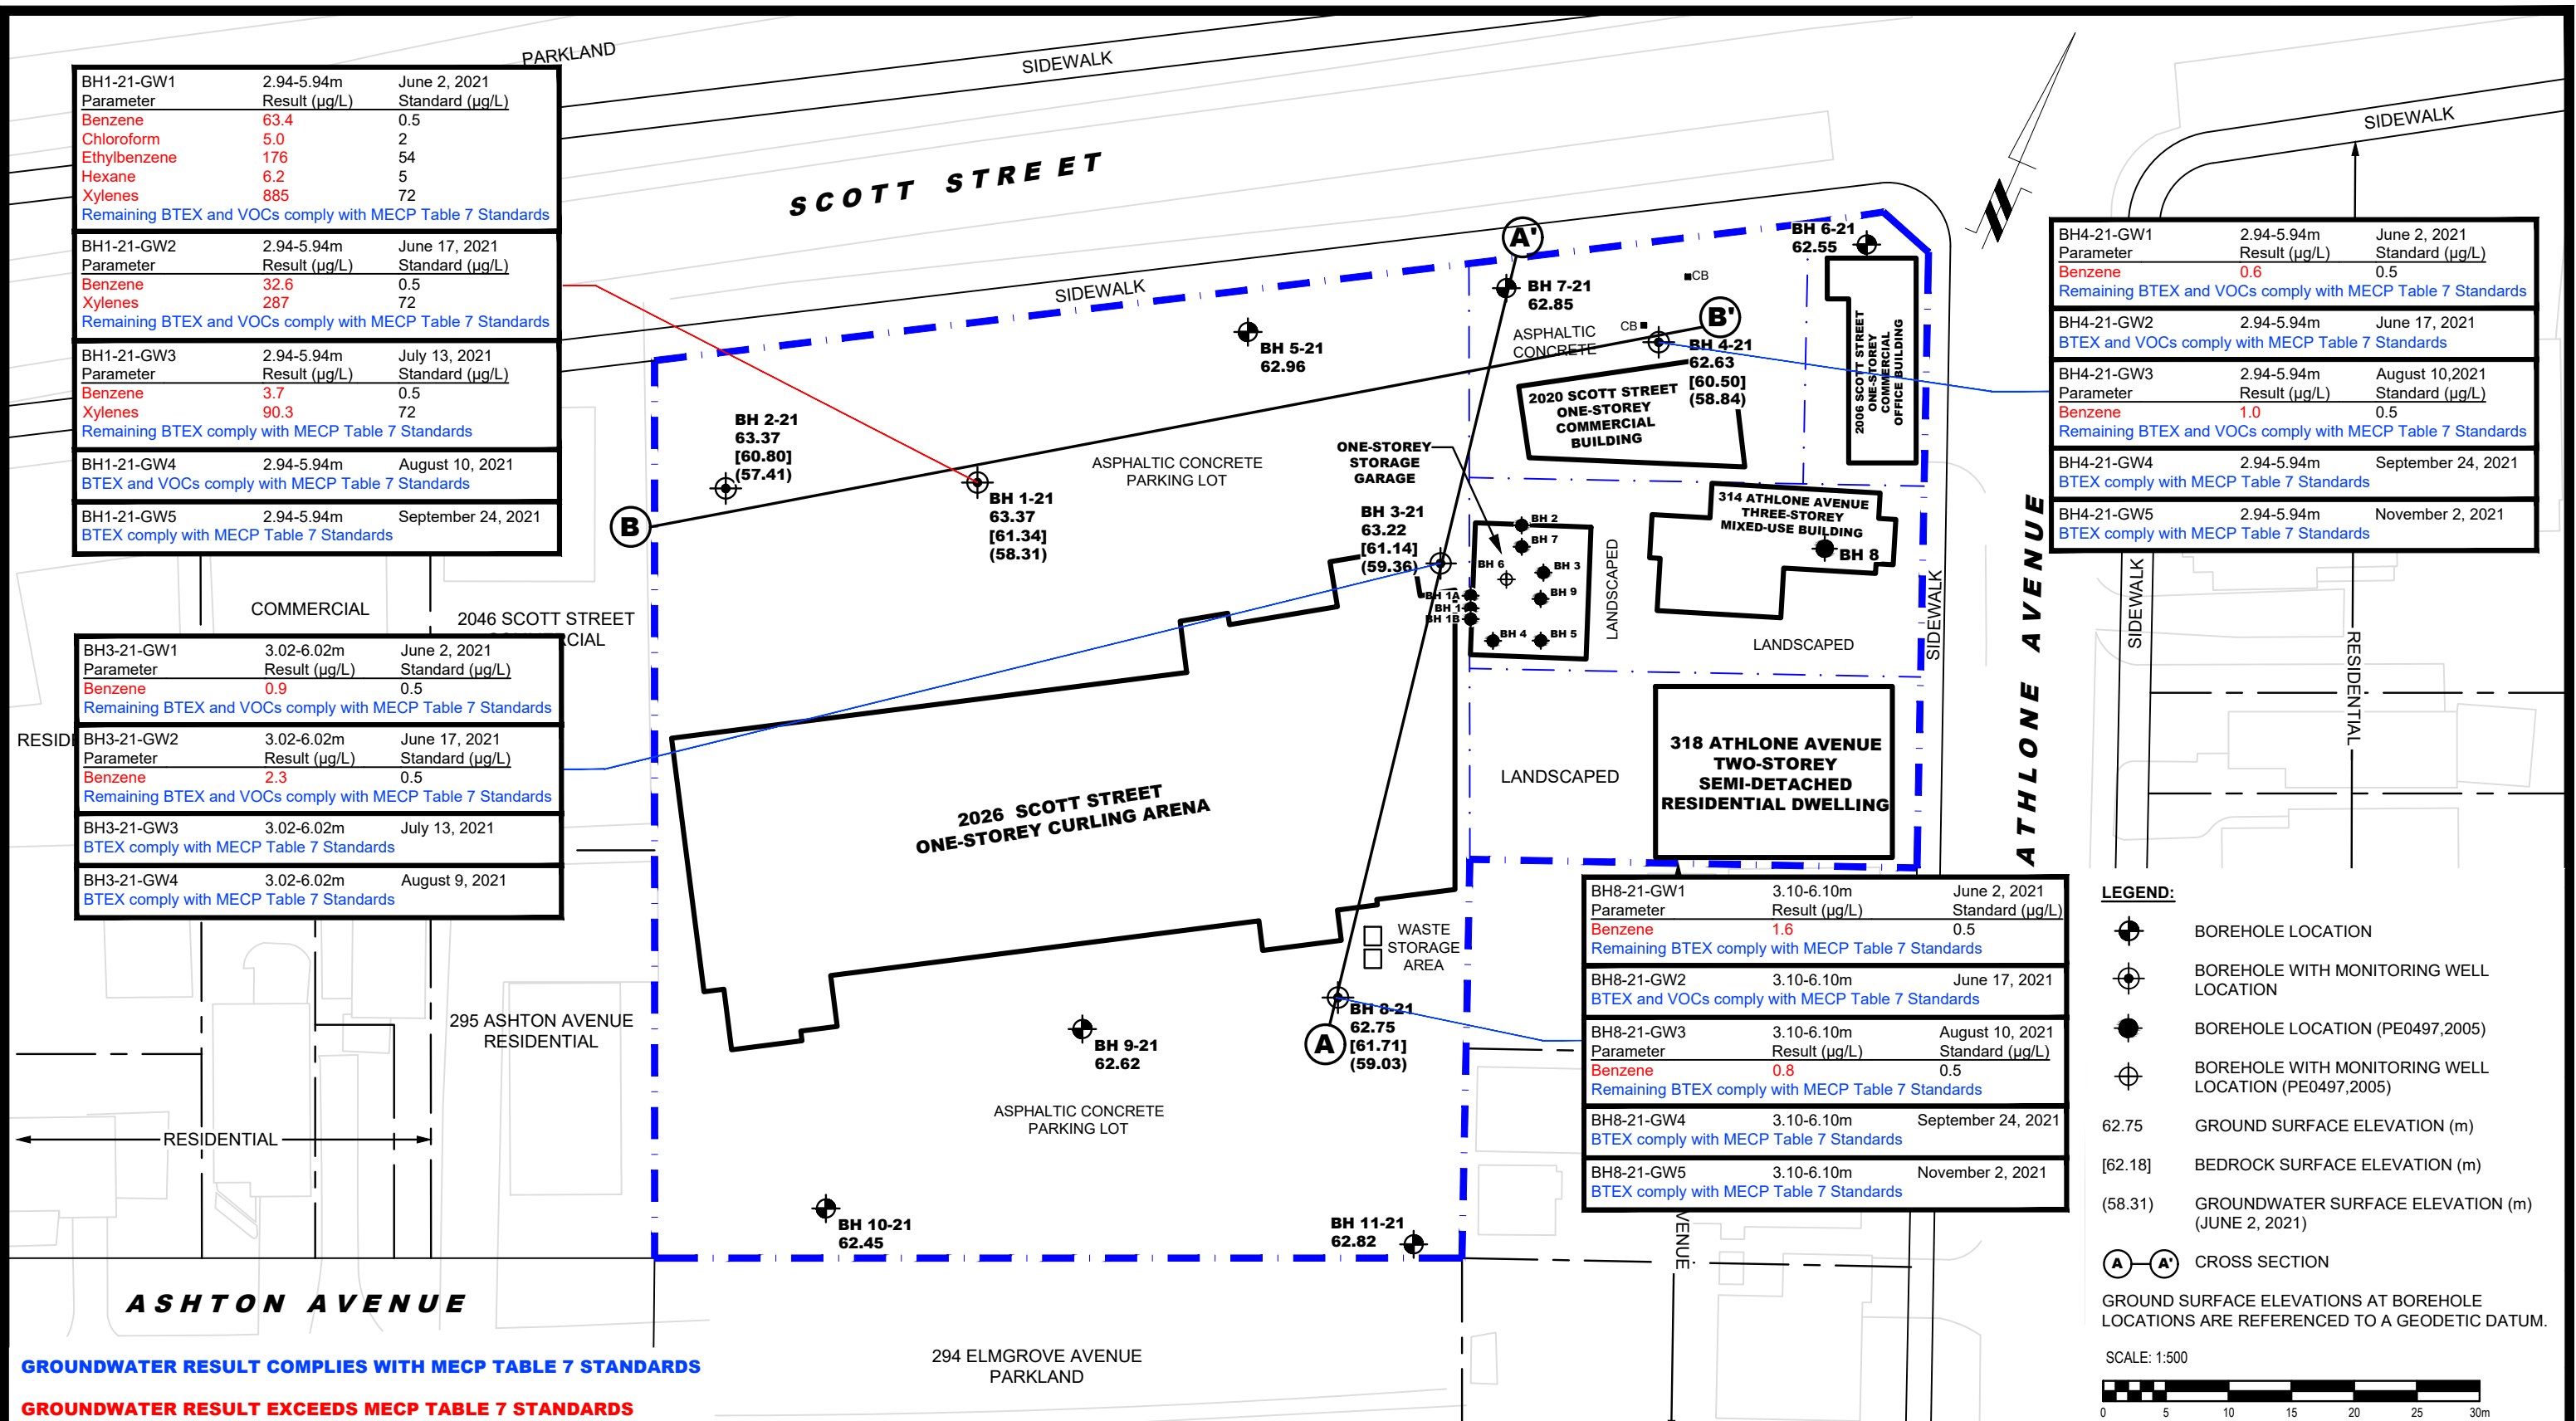
Drawing PE5303-6 – Analytical Testing Plan – Groundwater (BTEX & VOCs)

BH1-21-GW1	2.94-5.94m	June 2, 2021
Parameter	Result (µg/L)	Standard (µg/L)
Benzene	63.4	0.5
Chloroform	5.0	2
Ethylbenzene	176	54
Hexane	6.2	5
Xylenes	885	72
Remaining BTEX and VOCs comply with MECP Table 7 Standards		
BH1-21-GW2	2.94-5.94m	June 17, 2021
Parameter	Result (µg/L)	Standard (µg/L)
Benzene	32.6	0.5
Xylenes	287	72
Remaining BTEX and VOCs comply with MECP Table 7 Standards		
BH1-21-GW3	2.94-5.94m	July 13, 2021
Parameter	Result (µg/L)	Standard (µg/L)
Benzene	3.7	0.5
Xylenes	90.3	72
Remaining BTEX comply with MECP Table 7 Standards		
BH1-21-GW4	2.94-5.94m	August 10, 2021
BTEX and VOCs comply with MECP Table 7 Standards		
BH1-21-GW5	2.94-5.94m	September 24, 2021
BTEX comply with MECP Table 7 Standards

BH3-21-GW1	3.02-6.02m	June 2, 2021
Parameter	Result (µg/L)	Standard (µg/L)
Benzene	0.9	0.5
Remaining BTEX and VOCs comply with MECP Table 7 Standards		
BH3-21-GW2	3.02-6.02m	June 17, 2021
Parameter	Result (µg/L)	Standard (µg/L)
Benzene	2.3	0.5
Remaining BTEX and VOCs comply with MECP Table 7 Standards		
BH3-21-GW3	3.02-6.02m	July 13, 2021
BTEX comply with MECP Table 7 Standards		
BH3-21-GW4	3.02-6.02m	August 9, 2021
BTEX comply with MECP Table 7 Standards

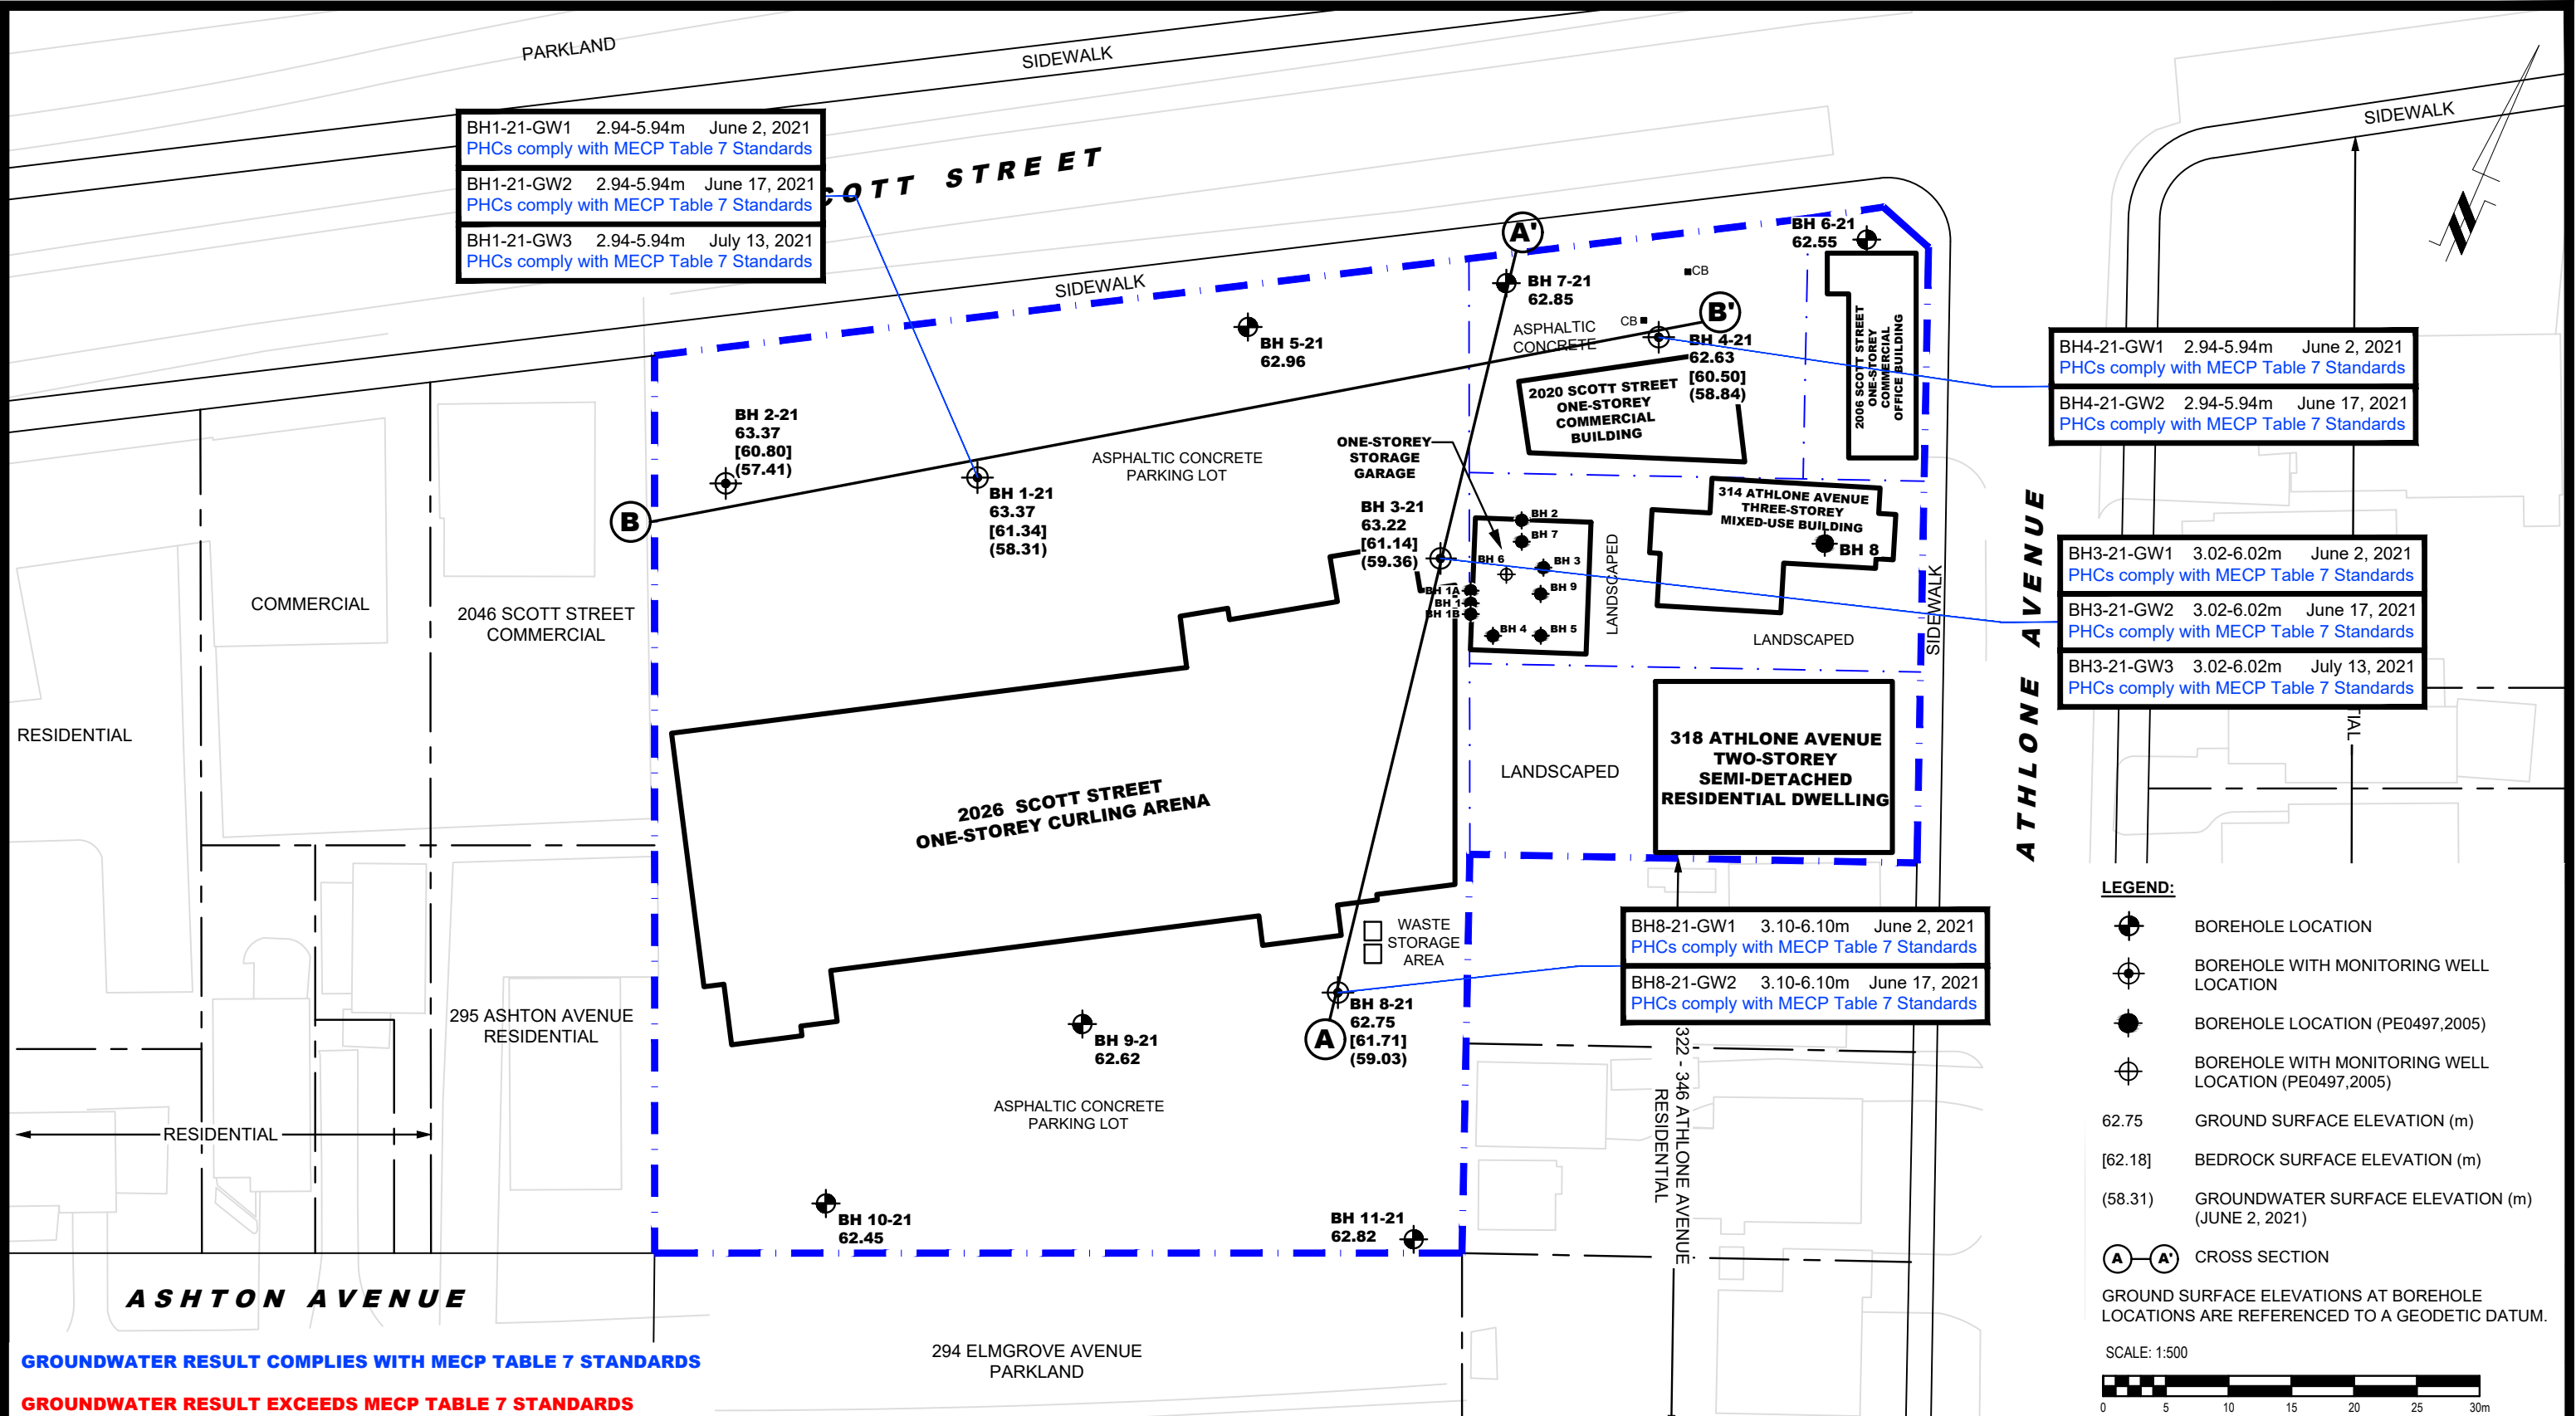
Drawing PE5303-7 – Analytical Testing Plan – Groundwater (PHCs)

BH1-21-GW1 2.94-5.94m June 2, 2021
 PHCs comply with MECP Table 7 Standards

BH1-21-GW2 2.94-5.94m June 17, 2021
 PHCs comply with MECP Table 7 Standards

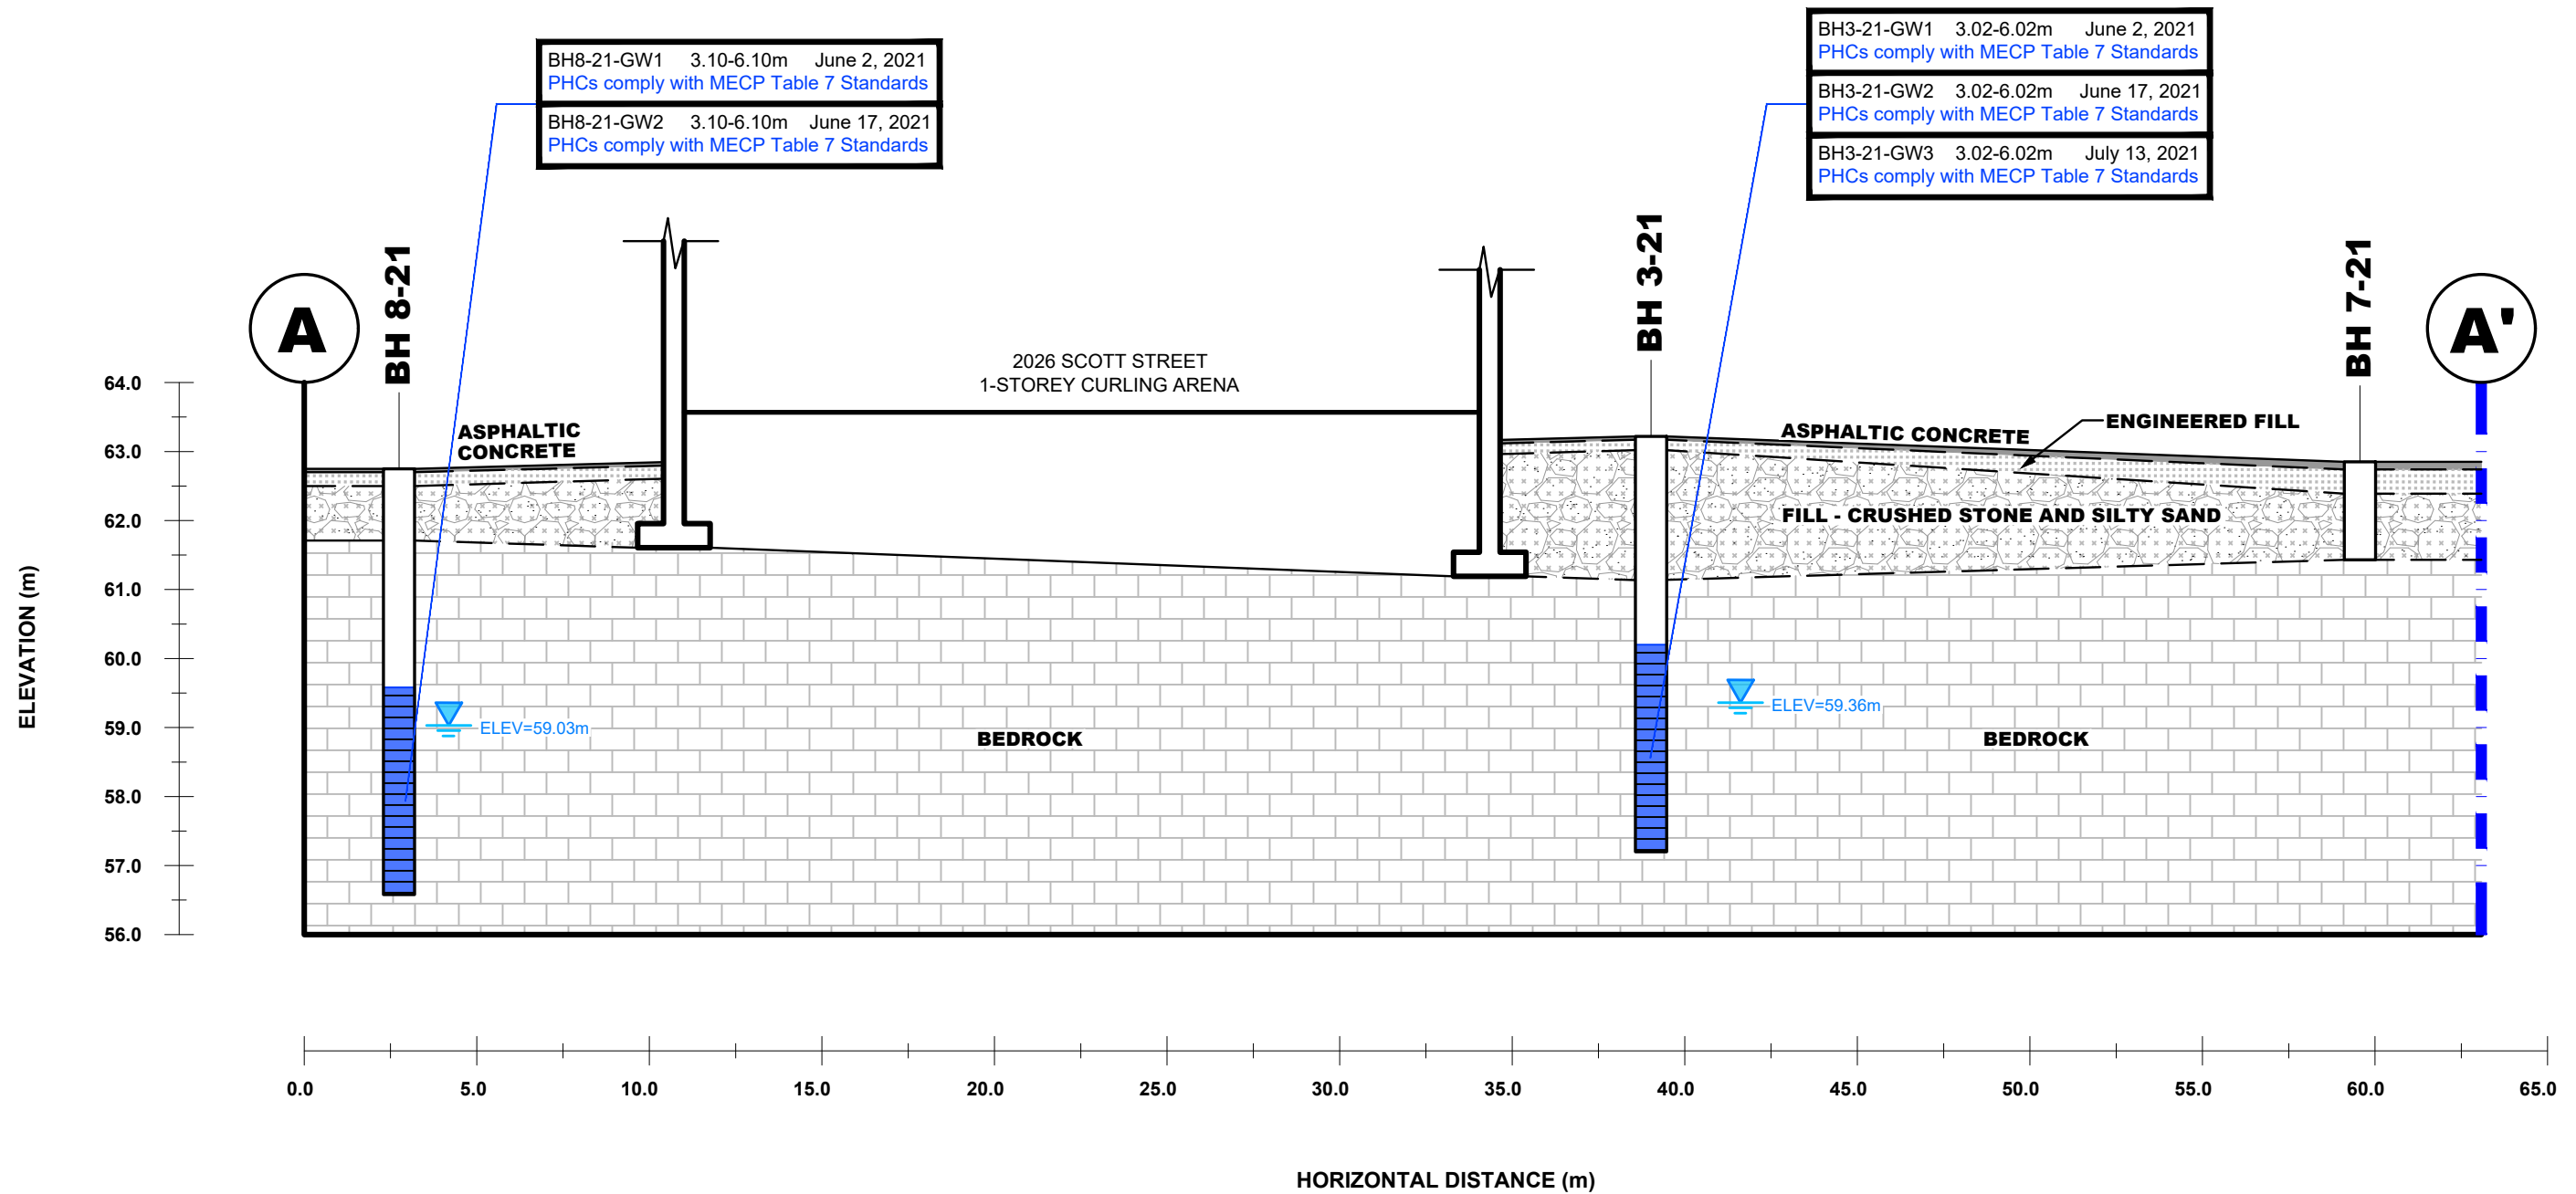
Title: **CROSS SECTION A-A' - GROUNDWATER (PHCs)**

BH8-21-GW1 3.10-6.10m June 2, 2021
PHCs comply with MECP Table 7 Standards

BH8-21-GW2 3.10-6.10m June 17, 2021
PHCs comply with MECP Table 7 Standards
