224 Preston Street, Ottawa
Environmental Site Assessment Phase I

Project # E-03-21

September 2021

Updated July 2022

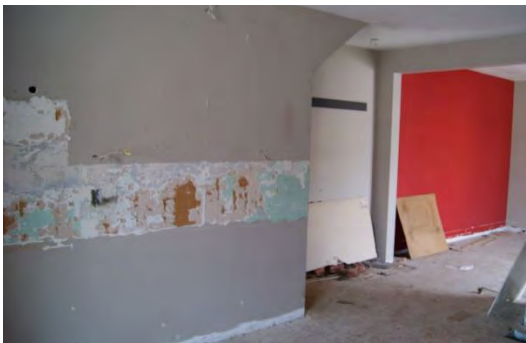
Main floor

No stains on surface around the building as well inside the building were found. The building is not maintained so the interior is deteriorated and it was not safe to walk through some parts.
