# Supplemental Phase II Environmental Site Assessment

1531 St. Laurent Boulevard, Ottawa, ON

**Katasa Groupe + Développement**  
Final Report  
02105693.001

February 2022

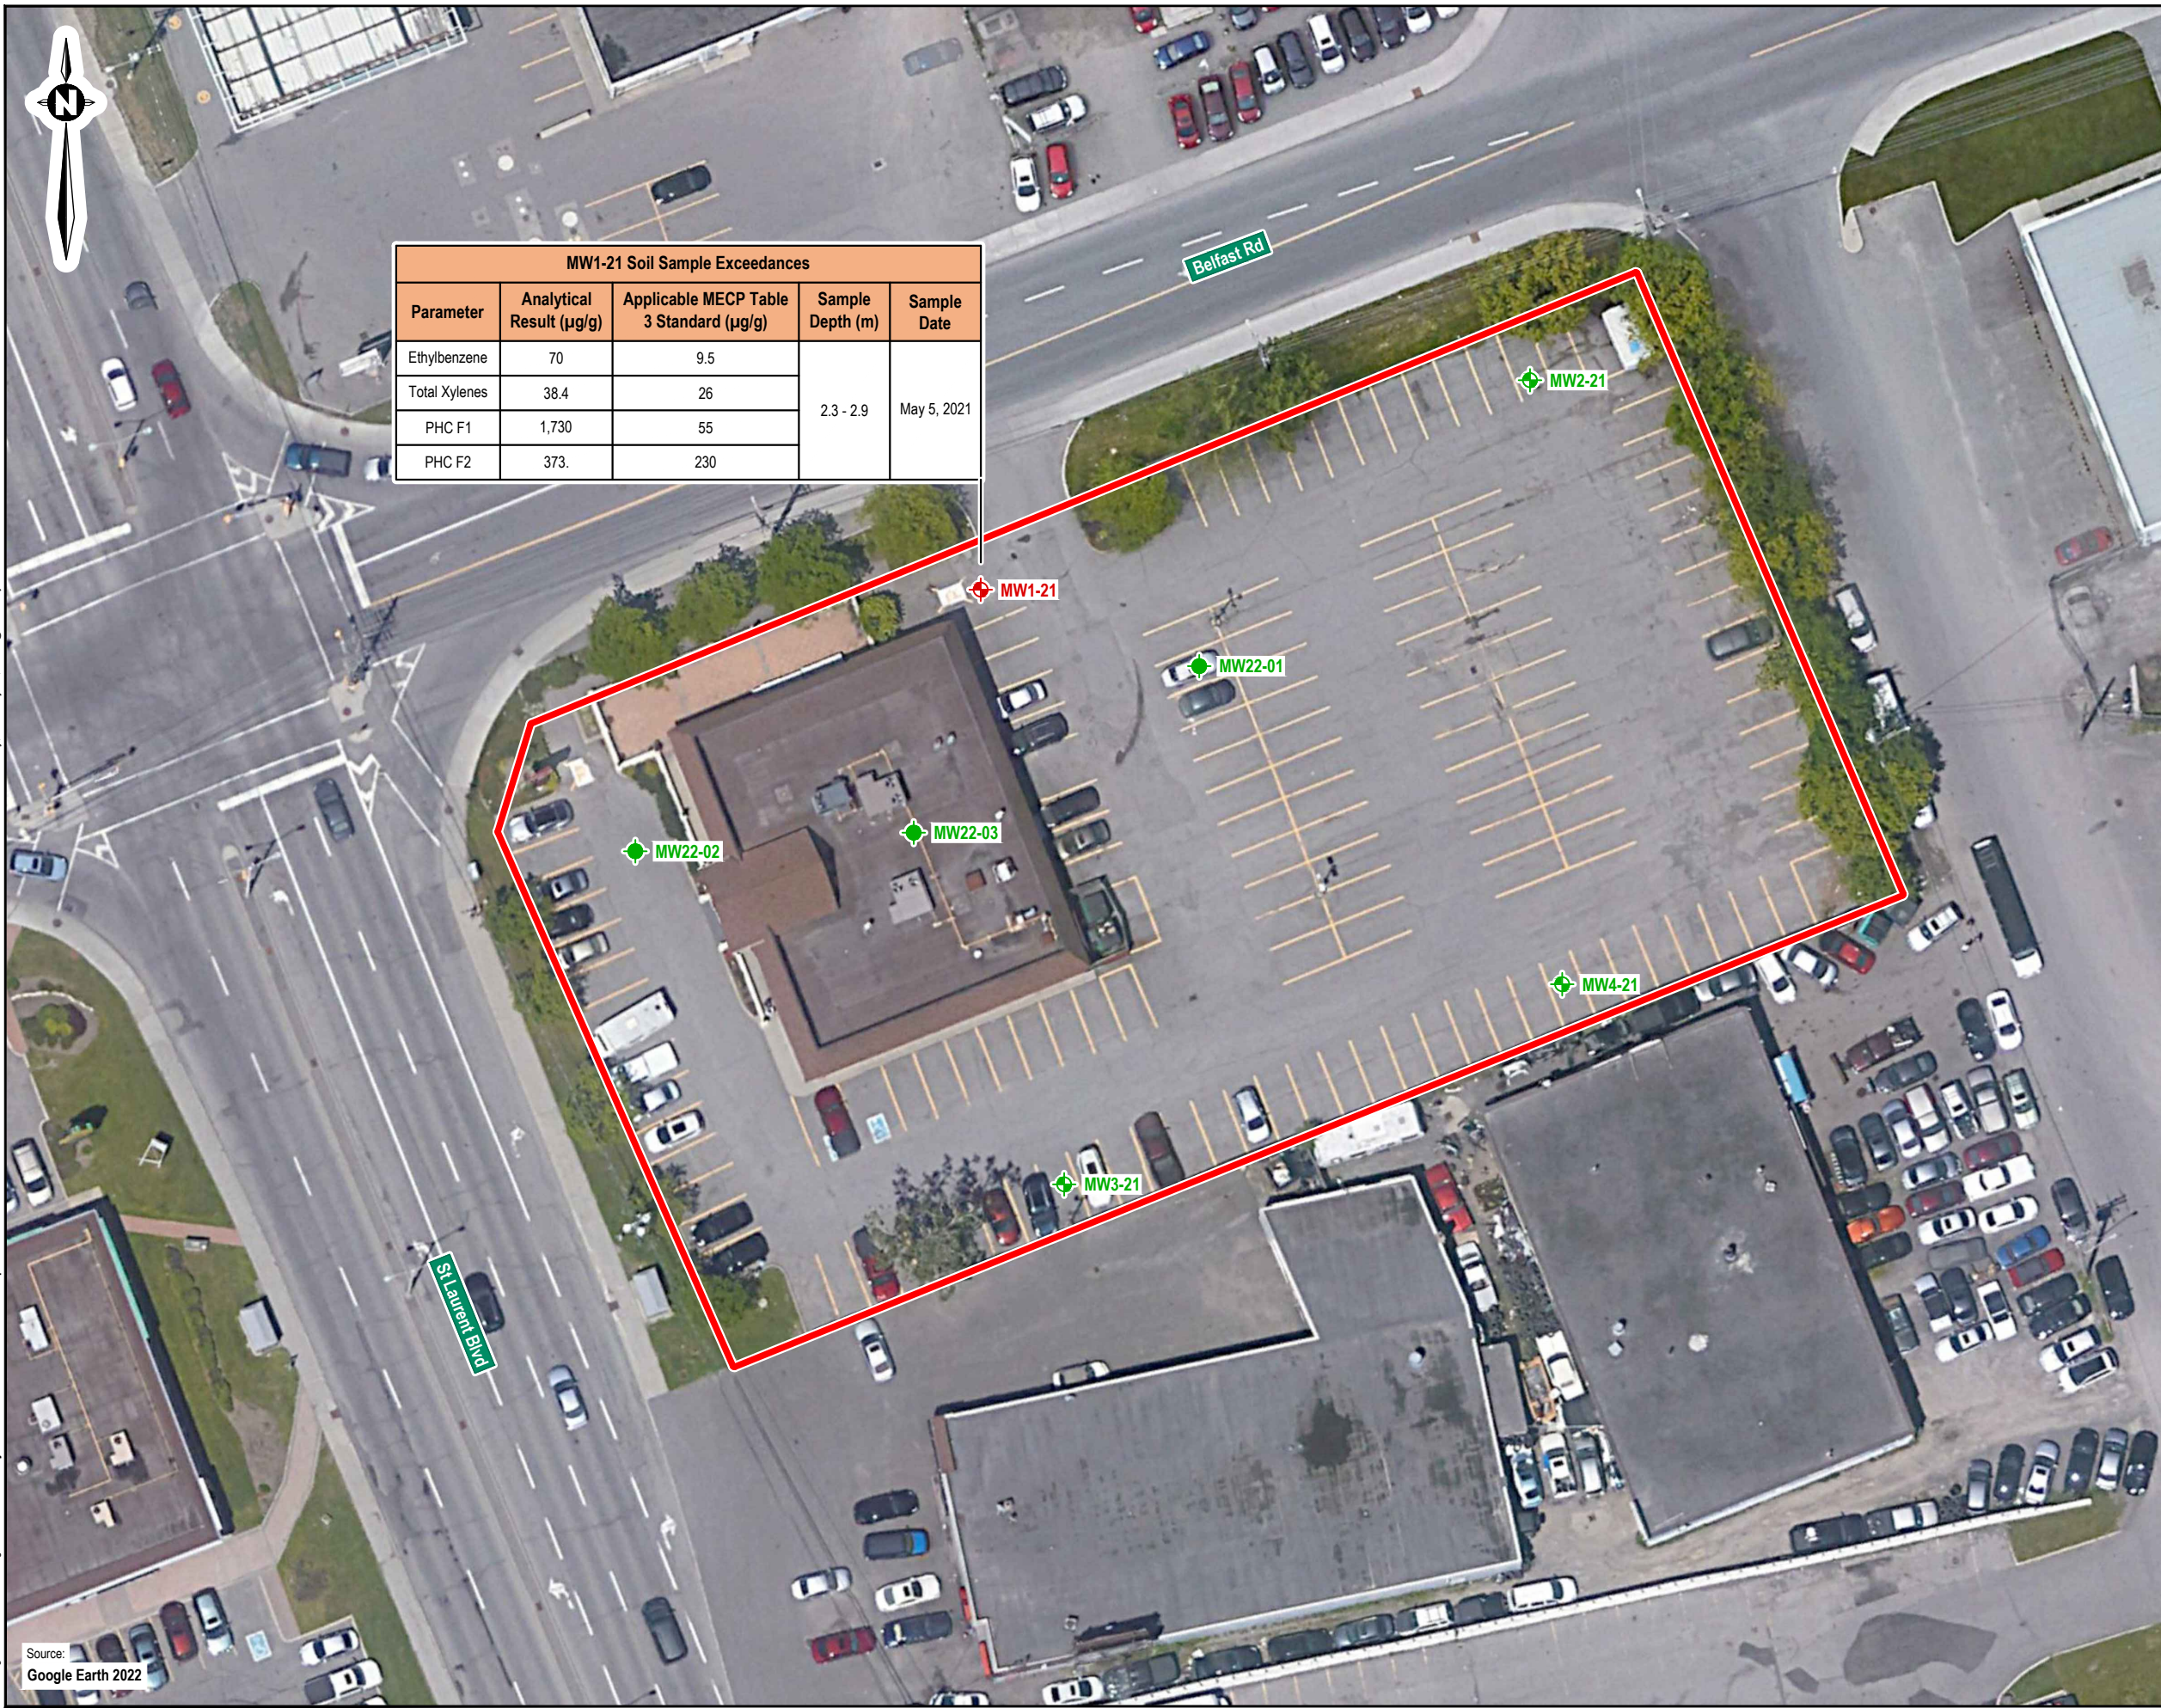
- Legend**
- ▬ Approximate site limits
  - ⊕ Borehole / MW (DST, 2021) Meets Applicable MECP Table 3 Standards (Commercial / Industrial Property Use)
  - ⊕ Borehole / MW (DST, 2021) Exceeds Applicable MECP Table 3 Standards (Commercial / Industrial Property Use)
  - ⊕ Borehole / MW (Englobe, 2022) Meets Applicable MECP Table 3 Standards (Commercial / Industrial Property Use)
