Phase II Environmental Site Assessment

2506 Innes Road
Ottawa, Ontario

Prepared for Concorde Properties

Report: PE6214-3
September 24, 2024

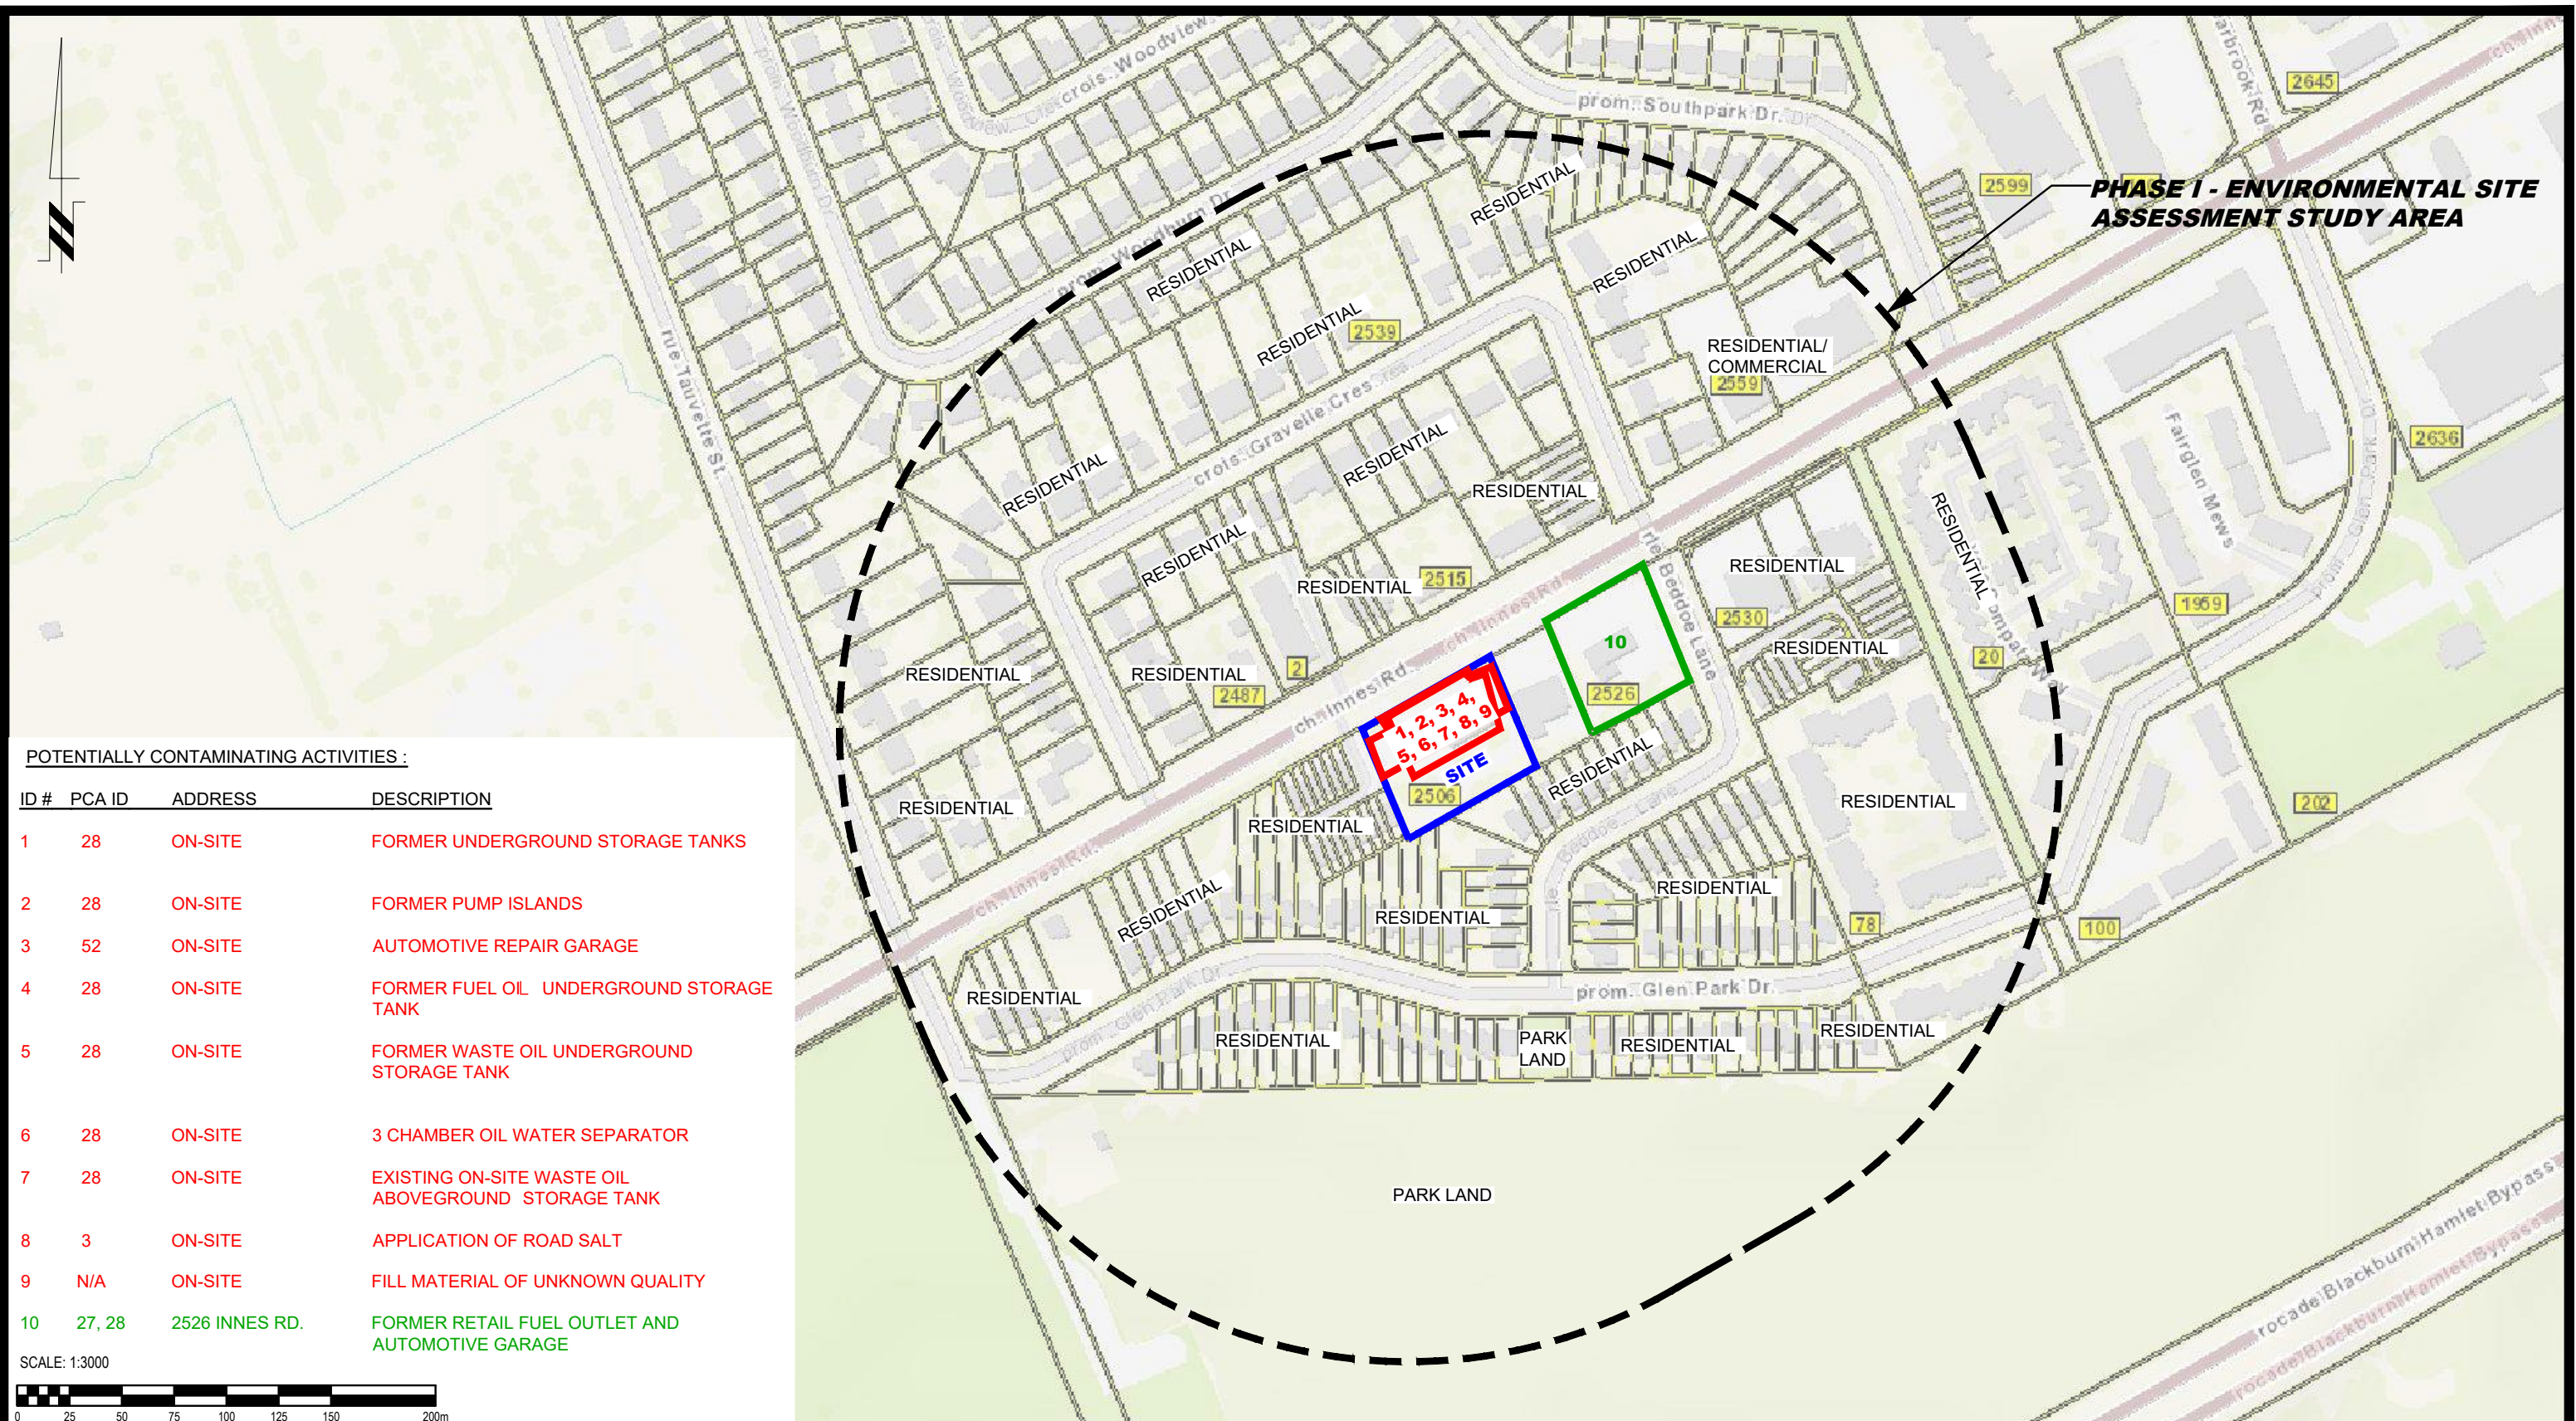
PHASE I - ENVIRONMENTAL SITE ASSESSMENT STUDY AREA

POTENTIALLY CONTAMINATING ACTIVITIES :

ID #	PCA ID	ADDRESS	DESCRIPTION
1	28	ON-SITE	FORMER UNDERGROUND STORAGE TANKS
2	28	ON-SITE	FORMER PUMP ISLANDS
3	52	ON-SITE	AUTOMOTIVE REPAIR GARAGE
4	28	ON-SITE	FORMER FUEL OIL UNDERGROUND STORAGE TANK
5	28	ON-SITE	FORMER WASTE OIL UNDERGROUND STORAGE TANK
6	28	ON-SITE	3 CHAMBER OIL WATER SEPARATOR
7	28	ON-SITE	EXISTING ON-SITE WASTE OIL ABOVEGROUND STORAGE TANK
8	3	ON-SITE	APPLICATION OF ROAD SALT
9	N/A	ON-SITE	FILL MATERIAL OF UNKNOWN QUALITY
10	27, 28	2526 INNES RD.	FORMER RETAIL FUEL OUTLET AND AUTOMOTIVE GARAGE
