September 20, 2022
Project No.: 1954004.06

Re: Landslide hazards affecting 3459 and 3479 St. Joseph Boulevard

1.0 INTRODUCTION

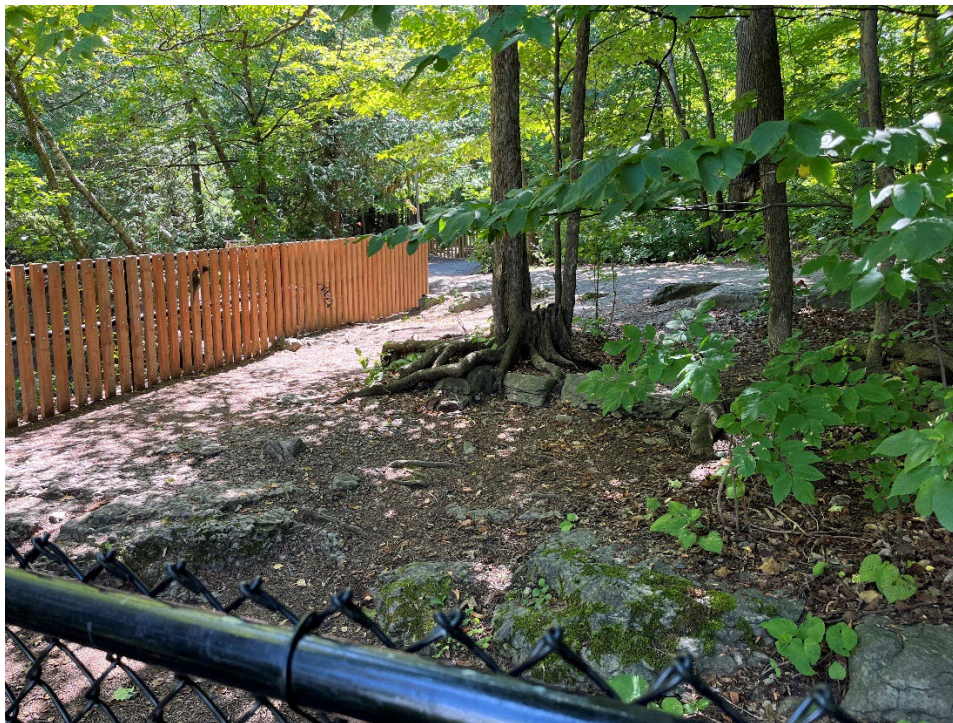
Photo 2. Bedrock at the ground surface above the slope crest west of Princess Louise waterfall at an approximate elevation of 83 m (see Figure 02). Photo taken by BGC 2022-08-15.

BGC conducted a ground traverse along the escarpment slope south of St. Joseph Boulevard, starting at the location of Princess Louise waterfall (see Figure 02 and Photo 1), and progressing west beyond the point where the escarpment curves to the southwest. BGC observed horizontally bedded limestone bedrock in several locations along the crest of the slope; these observation locations are shown on Figure 02. BGC observed the top of bedrock at approximately 83 m elevation near Princess Louise waterfall (Photo 2) and 80 m near the western end of the traverse at a culvert outlet discharging onto rock (Photo 3). Observations made along the traverse suggest that top of bedrock is at or above elevations with slope angle > 30 degrees, suggesting a minimum elevation of top of bedrock of 80 m along the length of the traverse. Ground elevations along the upland south of the escarpment slope crest range from 85 to 87 m, suggesting a maximum thickness of 7 m of overburden above bedrock, ranging from 0 m at the east end near the waterfall.

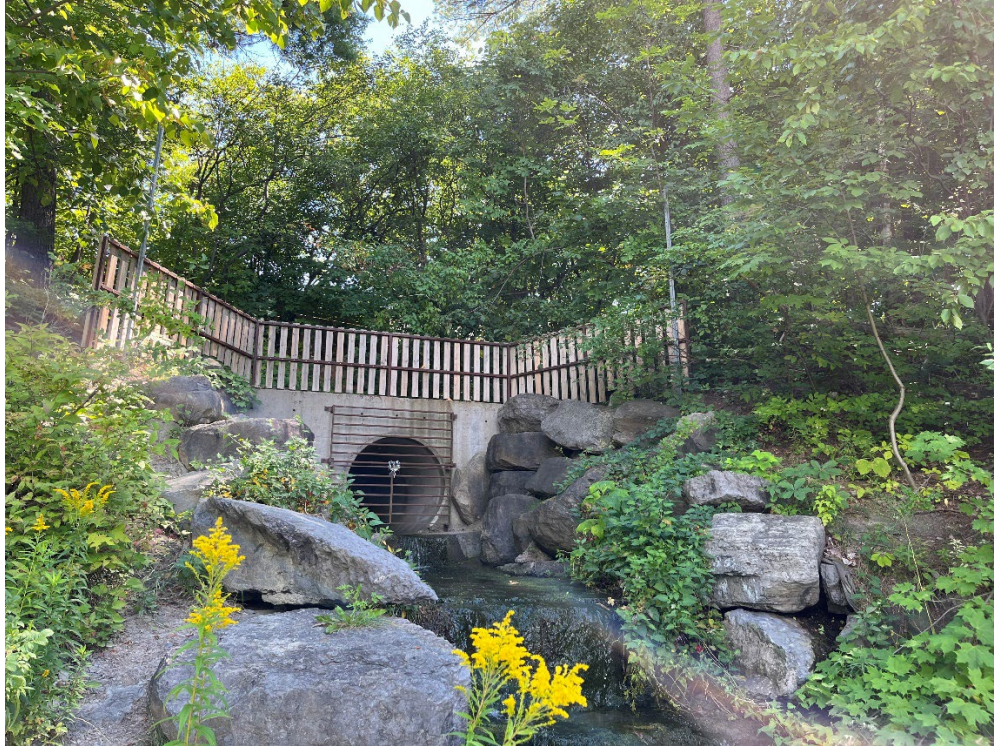
Photo 3. Culvert outlet with discharge onto bedrock at an approximate elevation of 80 m (see Figure 02). Photo taken by BGC 2022-08-15.
