PHASE ONE ENVIRONMENTAL SITE ASSESSMENT UPDATE

LANSDOWNE PARK – PROPOSED EVENT CENTRE LANDS

PROJECT NO.: CA0037195.1094

DATE: AUGUST 26, 2024

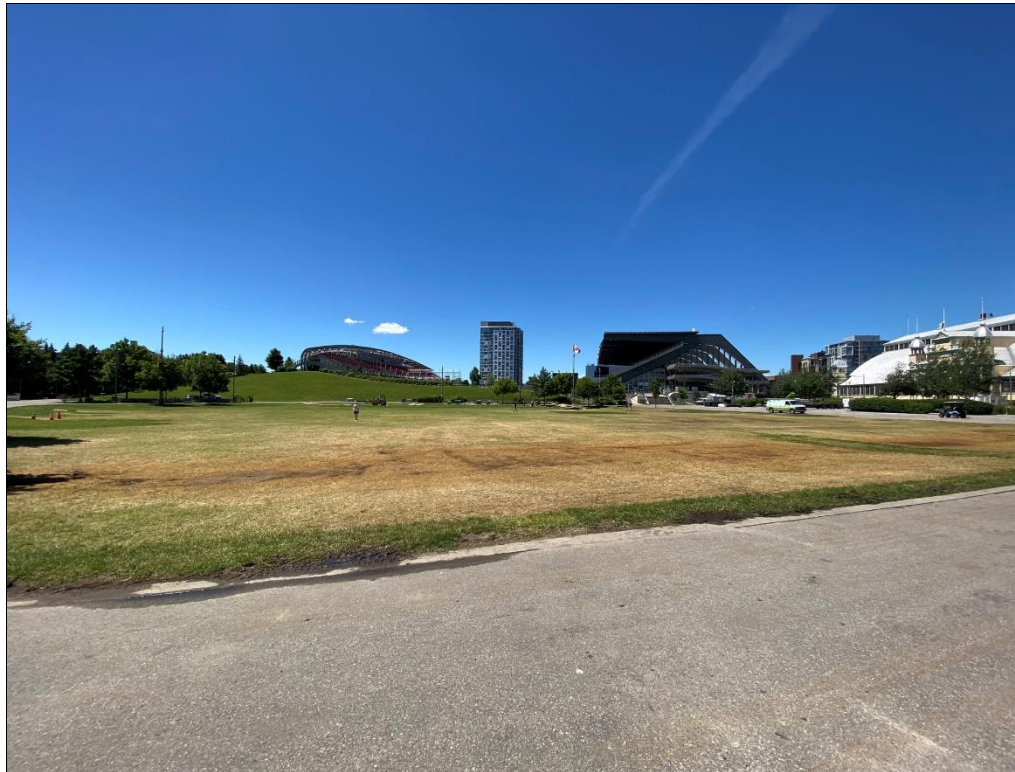
Photo 1:
General view of the Site: Great Lawn, Great Porch, East and South Berms, TD Place.
Date: 06/28/24
Direction: Southwest

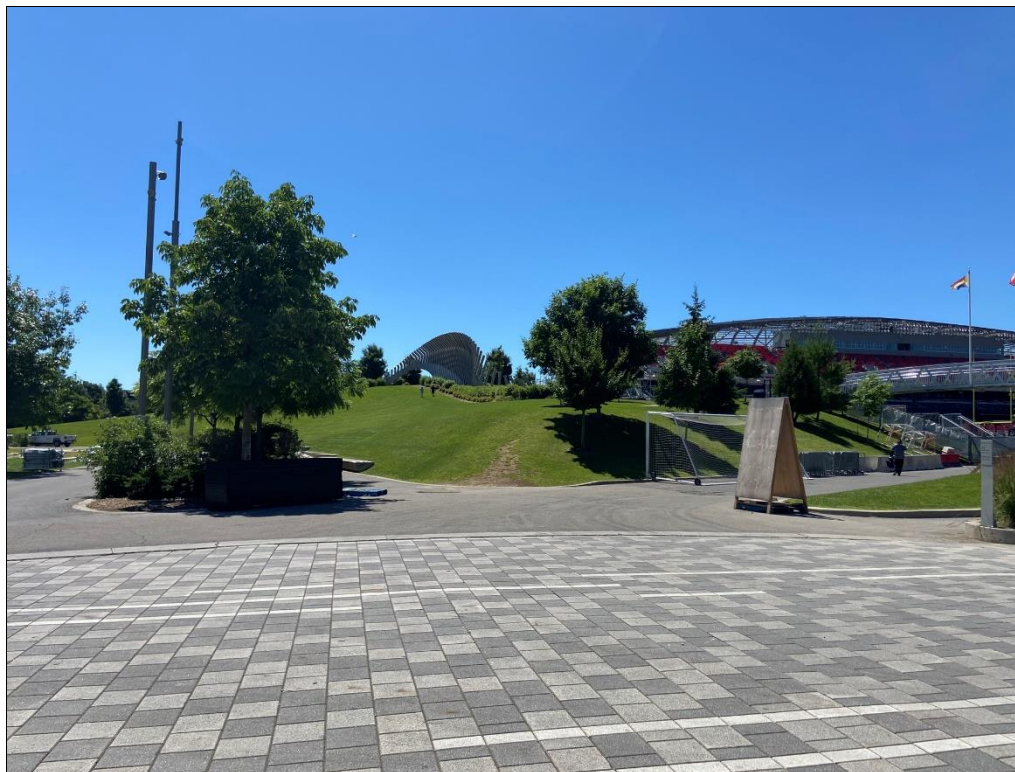
Photo 6:
General view of the northern elevation of the East Berm.
Date: 06/28/24
Direction: South

Soil used to construct the cores of the East and South Berms (APEC 1) was excavated from Zone A of Lansdowne Park and was tested during placement and is known to contain COC which exceed applicable Site Condition Standards (SCS) established under *Ontario Regulation 153/04 – Records of Site Conditions*, as amended (“O.Reg. 153/04”). Sampling conducted during the construction of the berms is adequate to quantify soil impacts within the berms and a Phase Two ESA would not be required. In addition, concentrations of certain PAHs preclude the re-use of excess soils sourced from the impacted material placed within the berms at any other Sites as per *Ontario Regulation 406/19 – On-site and Excess Soil Management*, as amended (“O.Reg. 406/19”).

- Based on observations made at the time of the Site reconnaissance significant fill placement was observed on the west and south portion of the Site since the 2014 Phase One ESA (AMEC, 2014) in the form of large earthen berms used as soft landscaped areas and to encapsulate impacted soil brought to Zone C from Zone A of Lansdowne Park which is being managed under the CPU for Zone C.

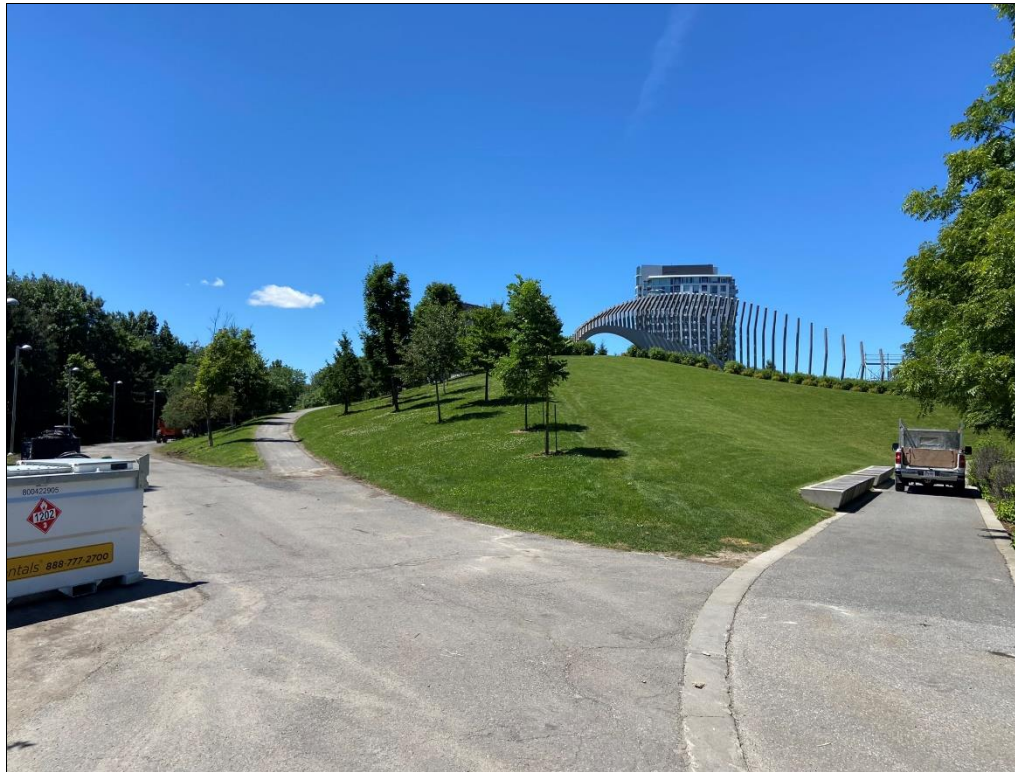
Photo 7:
General view of the southern elevation of the East Berm.
Date: 06/28/24
Direction: Southwest

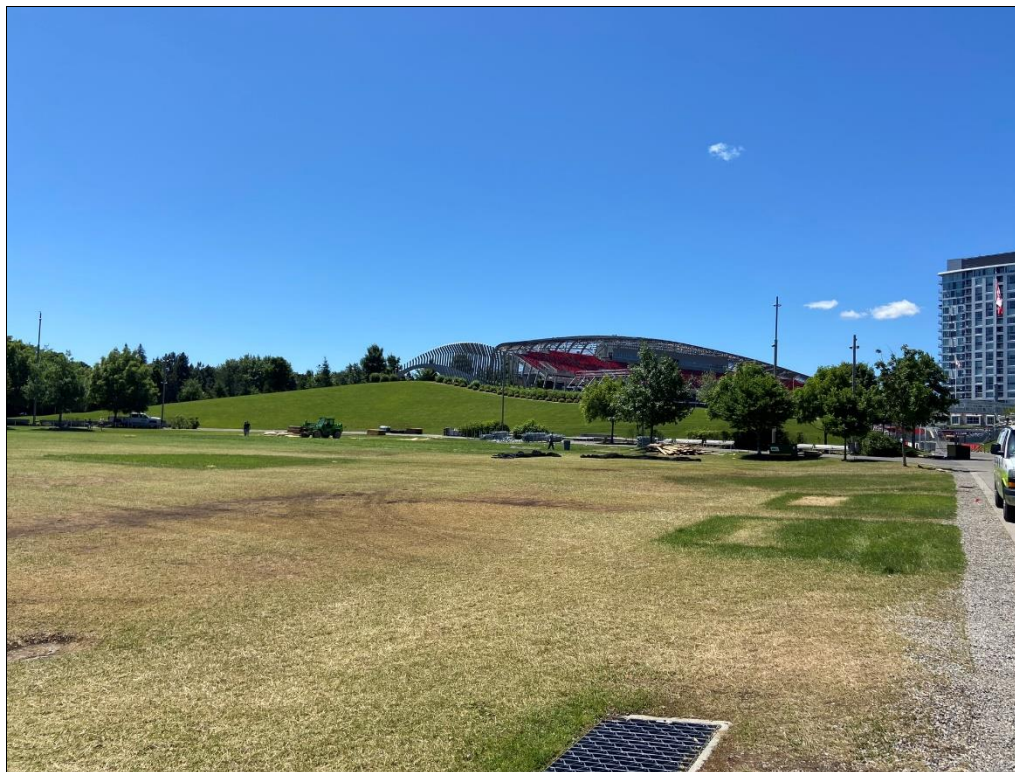
Photo 8:
General view of the eastern elevation of the East Berm.
Date: 06/28/24
Direction: Southwest

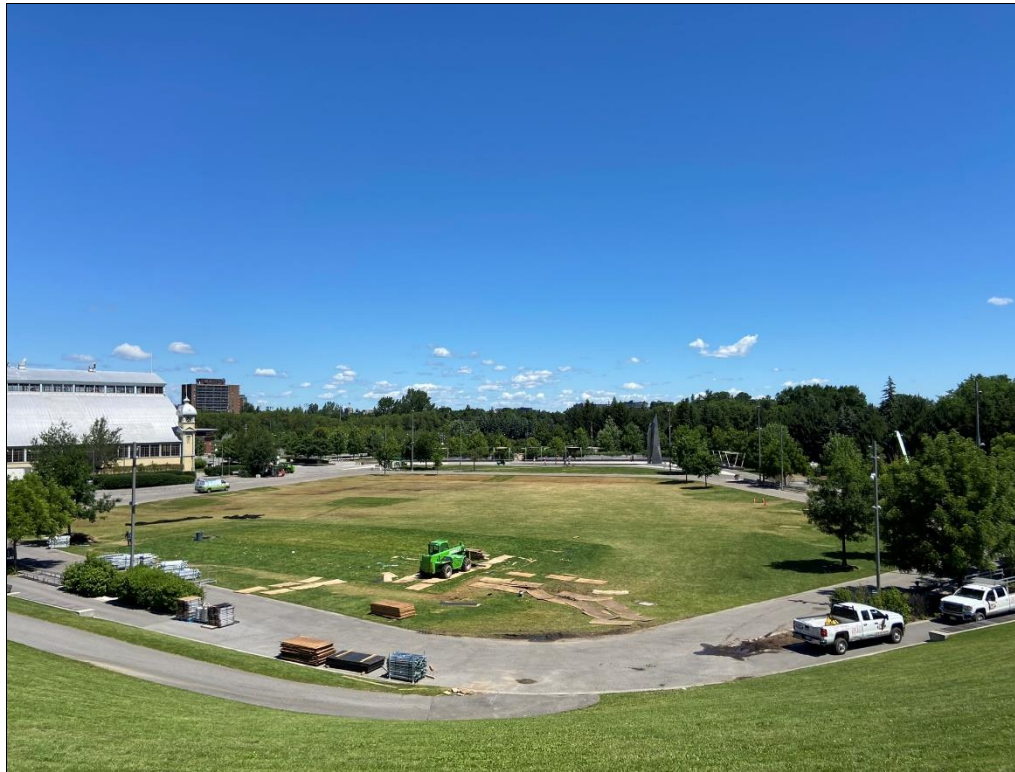
Photo 9:
General view of the Great Lawn area.
Date: 06/28/24
Direction: Northeast

- WSP conducted a walkover of the Site to identify any areas of stressed vegetation. Areas of stressed vegetation were observed on top of the East Berm and within the Great Lawn Area due to regular foot traffic and a recent event held in that area of the park.

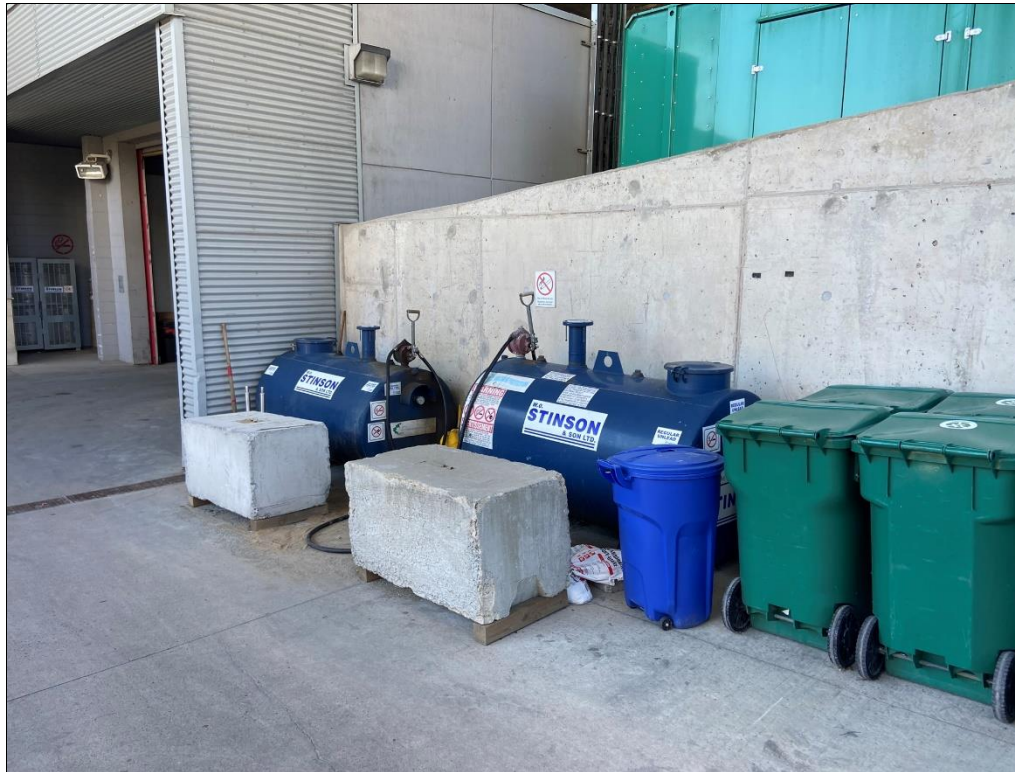
Photo 11:
500 L capacity coloured diesel and gasoline above ground storage tanks located on the ramp outside the loading dock area. Note: fuel spills would flow down the ramp to the grate floor drain.

- WSP was advised by the site representative and observed the presence of three (3) ASTs at the Site during the reconnaissance. Two (2) 500 L double wall steel ASTs, one containing gasoline and one containing colored diesel, were located on the ramp leading to the service level of the facility on the east side of TD Place. These tanks are used to fuel the various equipment and vehicles used to maintain the facility. WSP observed minor staining on the gasoline AST near and below the hand pump suggesting a previous leak at the pump or hose fitting as well as some staining on the ground near the gasoline and diesel fuel ASTs suggesting incidents of overfilling or spillage when fueling equipment or gas cans in the area of the ASTs. One (1) steel AST with a capacity of 5,791 L was noted within the enclosure for the back-up generator. The Site representative advised that only small spills have occurred in the area and are cleaned with adsorbent material.

- WSP conducted a walkover of the Site to identify any areas of stained soil, vegetation or pavement or any other potential indicators of surface spills or leaks. Staining was observed on the concrete floor in the area of the two (2) fuel storage ASTs located on the ramp leading to the loading dock area. Staining was also observed on the concrete floor near the garbage compactors at the base of the ramp in the loading dock area. A trench drain connected to the building's sewer system was located at the base of the ramp in the loading dock area. The Site representative advised WSP that to his knowledge other than the staining observed noted above there are no areas of stained soil, vegetation or pavement are or were ever present at the Site.

During the interview, the Site representative informed WSP that significant spills have not occurred in the areas of APECs 2 and 3. Furthermore, at the time of the Site visit, the concrete floors in these areas was observed to be in good condition and free of significant staining; therefore, impacts to soil and groundwater from these APECs is considered to be low and need not be investigated as part of a Phase Two ESA.

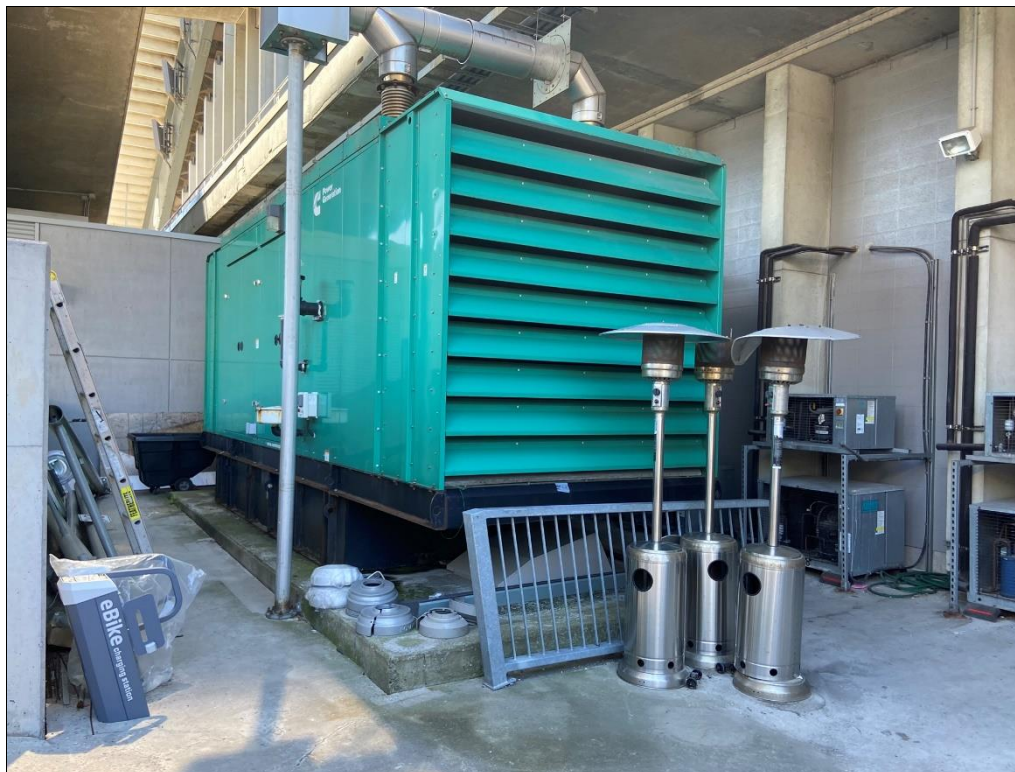
Photo 12:
Back-up generator located outside the loading dock area on the east side of TD Place Stadium. Fitted with a 5,791 L capacity diesel storage tank.
