PHASE ONE ENVIRONMENTAL SITE ASSESSMENT UPDATE LANSDOWNE PARK – PROPOSED EVENT

CENTRE LANDS

PROJECT NO.: CA0037195.1094 DATE: JANUARY 14, 2025

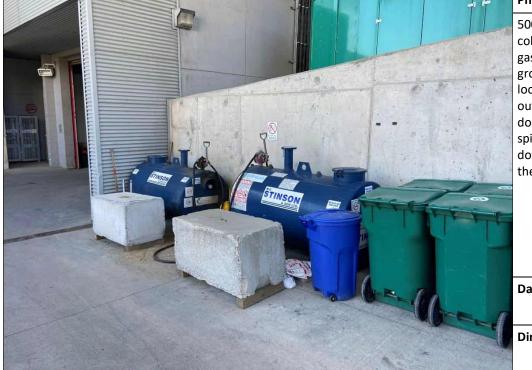
Photo 11:

500 L capacity coloured diesel and gasoline above ground storage tanks located on the ramp outside the loading dock area. Note: fuel spills would flow down the ramp to the grate floor drain.

- WSP was advised by the site representative and observed the presence of three (3) ASTs at the Site during the reconnaissance. Two (2) 500 L double wall steel ASTs, one containing gasoline and one containing colored diesel, were located on the ramp leading to the service level of the facility on the east side of TD Place. These tanks are used to fuel the various equipment and vehicles used to maintain the facility. WSP observed minor staining on the gasoline AST near and below the hand pump suggesting a previous leak at the pump or hose fitting as well as some staining on the ground near the gasoline and diesel fuel ASTs suggesting incidents of overfilling or spillage when fueling equipment or gas cans in the area of the ASTs. One (1) steel AST with a capacity of 5,791 L was noted within the enclosure for the back-up generator. The Site representative advised that only small spills have occurred in the area and are cleaned with adsorbent material.

- WSP conducted a walkover of the Site to identify any areas of stained soil, vegetation or pavement or any
 other potential indicators of surface spills or leaks. Staining was observed on the concrete floor in the area of
 the two (2) fuel storage ASTs located on the ramp leading to the loading dock area. Staining was also
 observed on the concrete floor near the garbage compactors at the base of the ramp in the loading dock area.
 A trench drain connected to the building's sewer system was located at the base of the ramp in the loading
 dock area. The Site representative advised WSP that to his knowledge other than the staining observed noted
 above there are no areas of stained soil, vegetation or pavement are or were ever present at the Site.
