FINAL REPORT

Phase One Environmental Site Assessment

Wateridge Village Phase 4, Part of 1076 Hemlock Private, Ottawa, Ontario

19124906

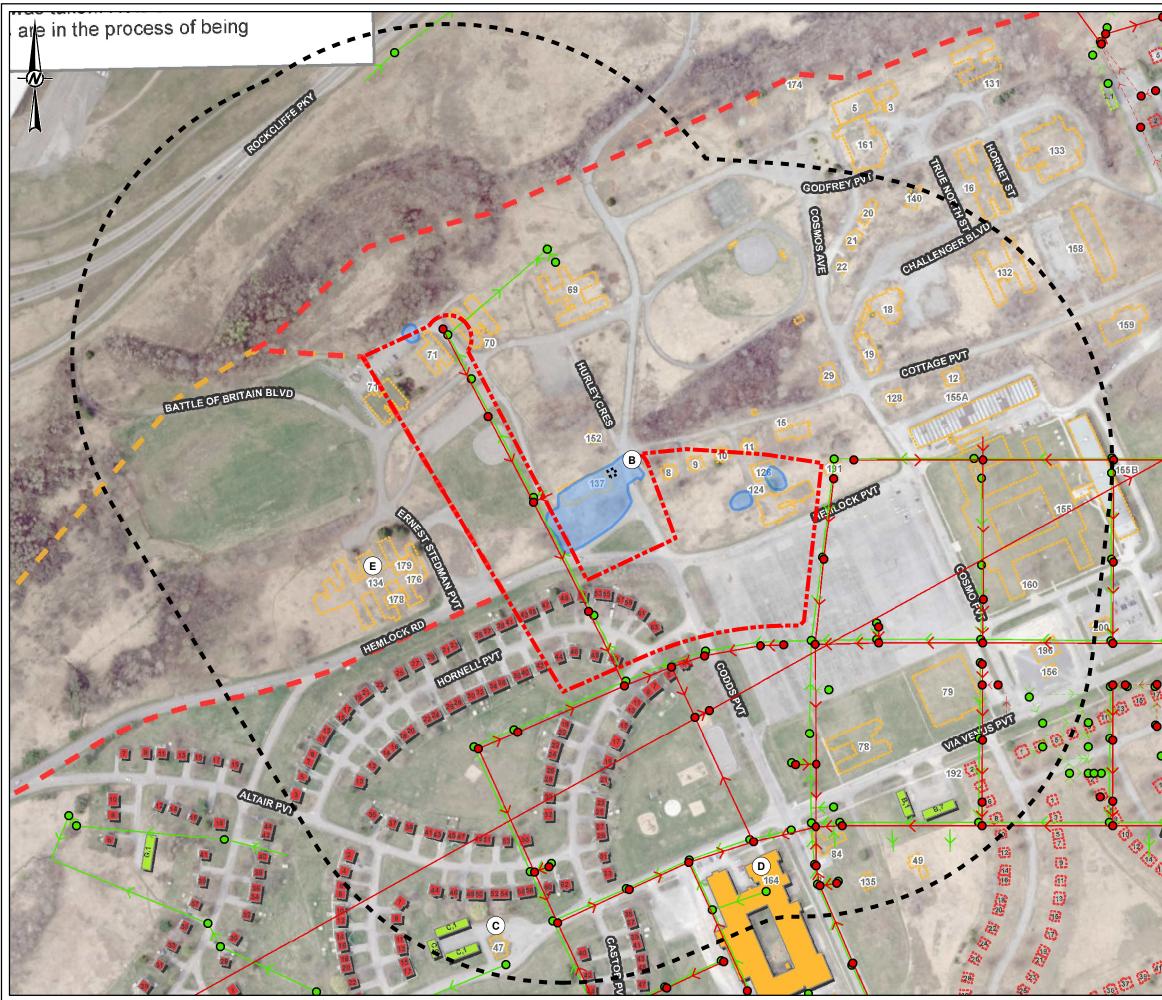
CONSULTANT YYYY-MM-DD 2022-06-01 DESIGNED -----PREPARED JEM REVIEWED TL APPROVED KPH CONTROL PROJECT NO. 19124906 REV. FIGURE 0 1

FORMER FUEL STORAGE TANKS (PCA #28): REMOVED IN 1992 AND LOCATION IS INFERRED BASED ON THE LEVEL OF CONTAMINATION OBSERVED

SITE PLAN WITH POTENTIAL CONTAMINATING ACTIVITIES

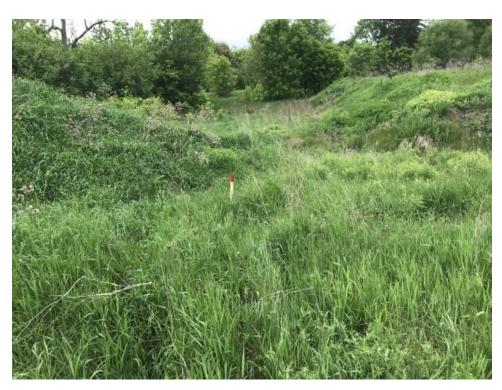
Photo 1: Eastern portion of the site

Presence of Stained Soil, Vegetation, or Pavement	None observed.	Site observations
Presence of Stressed Vegetation	None observed.	Site observations
Areas Where Fill and/or Debris Materials Appear to Have Been Placed	The eastern site boundary appears to be raised with fill and the south half of the west part of the site appeared to have been graded with some fill since the decommissioning of the base.	Site observations
Potentially Contaminating Activity	The presence of fill across the Site is considered as a PCA.	Site observations
Unidentified Substances	None identified.	Site observations

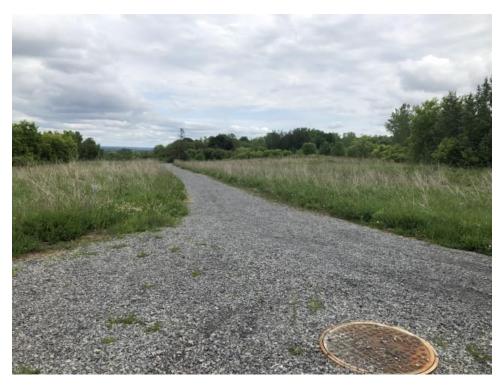
Photo 3: Northern portion of Site looking along sewer line

Sanitary Sewer Connection	The Site is connected to the municipal sanitary sewer via large diameter sewer that runs north- south along the central portion of the Site. Historically, the Sie was serviced by local sanitary sewers.	Site observations
Septic Systems	None identified.	Site observations
Storm Water Flow	Storm water run-off is through natural soil infiltration and the stormwater sewer line that runs through the Site.	Site observations
Storm Sewer ConnectionThe Site is connected to a new storm sewer system running north-south along the central portion of the Site. Historically the Site was serviced by local storm sewers.		Site observations
Interior of Structures Entry and Exit Points for Site Buildings	No buildings or structures were present at the Site.	Site observations
Existing and Former Heating System(s) (include fuel type / source)	As no buildings or structures were present at the Site there were no existing heating systems observed or reported. Historically many of the main site buildings were serviced by a steam line originating at a central heating plant southwest of the Phase One Property. A passing comment in a previous report suggesting that some of the buildings may have for a time been serviced by heating oil ASTs. No evidence of former storage tanks were noted at the time of the site visit and no confirmed storage tank locations were identified on the Phase One Property or historical reports.	Site observations, previous reports.

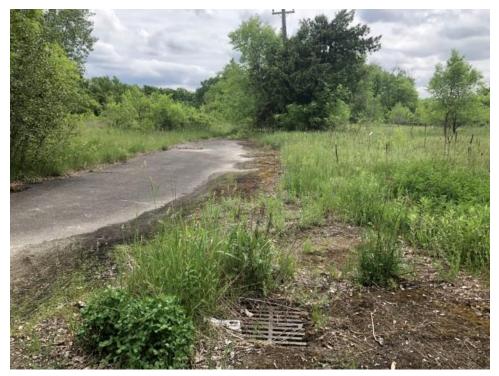
Photo 4: Typical off-site area to NE of Site showing former base infrastucture

East: Vacant land with dense tree coverage in some areas. No buildings or structure present; however, old roadways likely associated with CFB Rockcliffe were observed.

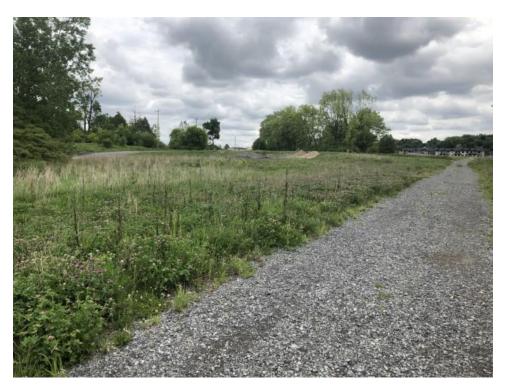
Photo 5: View of the Site looking southeast across former remediation of Building 137
