## Geotechnical Investigation

Proposed Mixed-Use Development  
1518-1526 Stittsville Main Street  
Ottawa, Ontario

Inverness Homes

Report: PG5418-1  
Revision 3

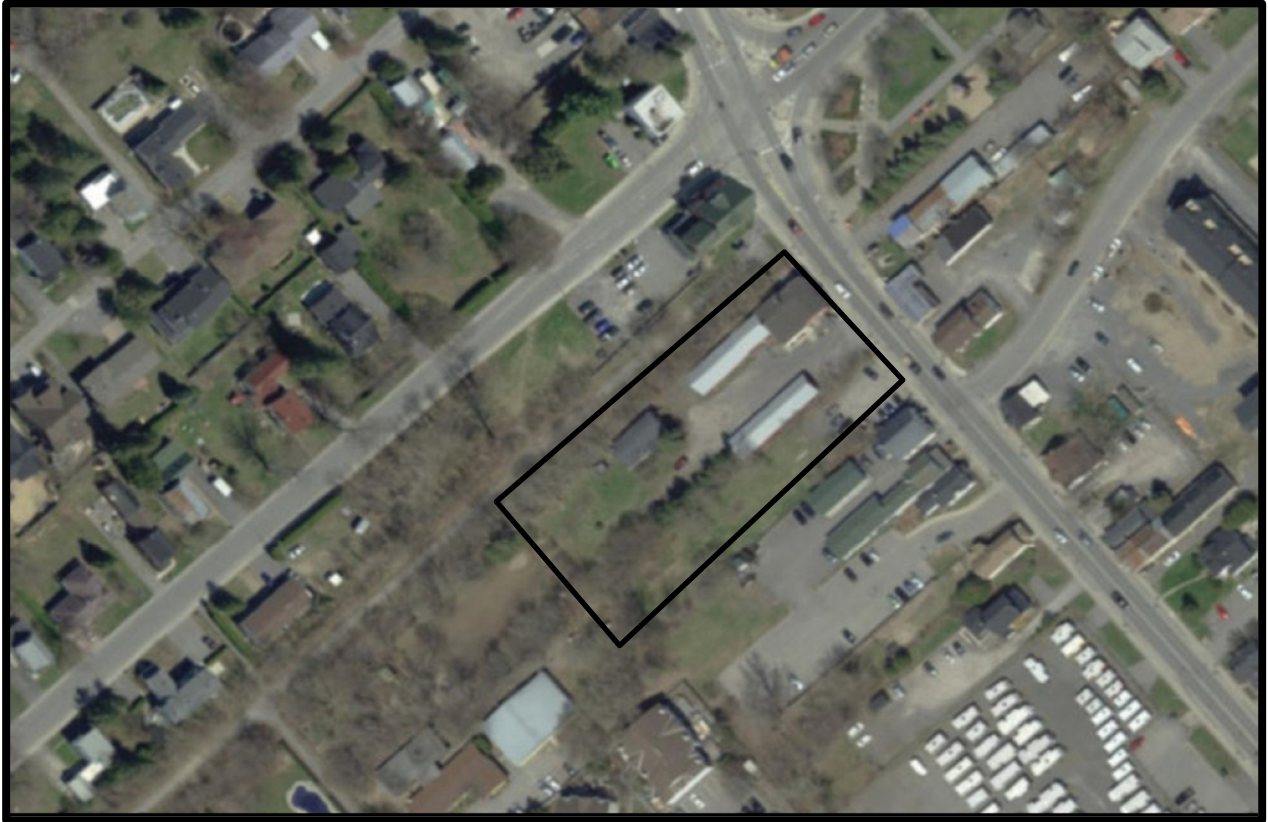
## FIGURE 2

Aerial Photograph - 2014

Based on available historical photographs of the subject site, a building was located in the northeast portion of the site fronting onto Stittsville Main Street as recently as 2014, and was no longer present in 2017. Reference should be made to the aerial photographs in Figure 2 - Aerial Photograph - 2014 and Figure 3 - Aerial Photograph - 2017 which illustrate the former and present site conditions, respectively.

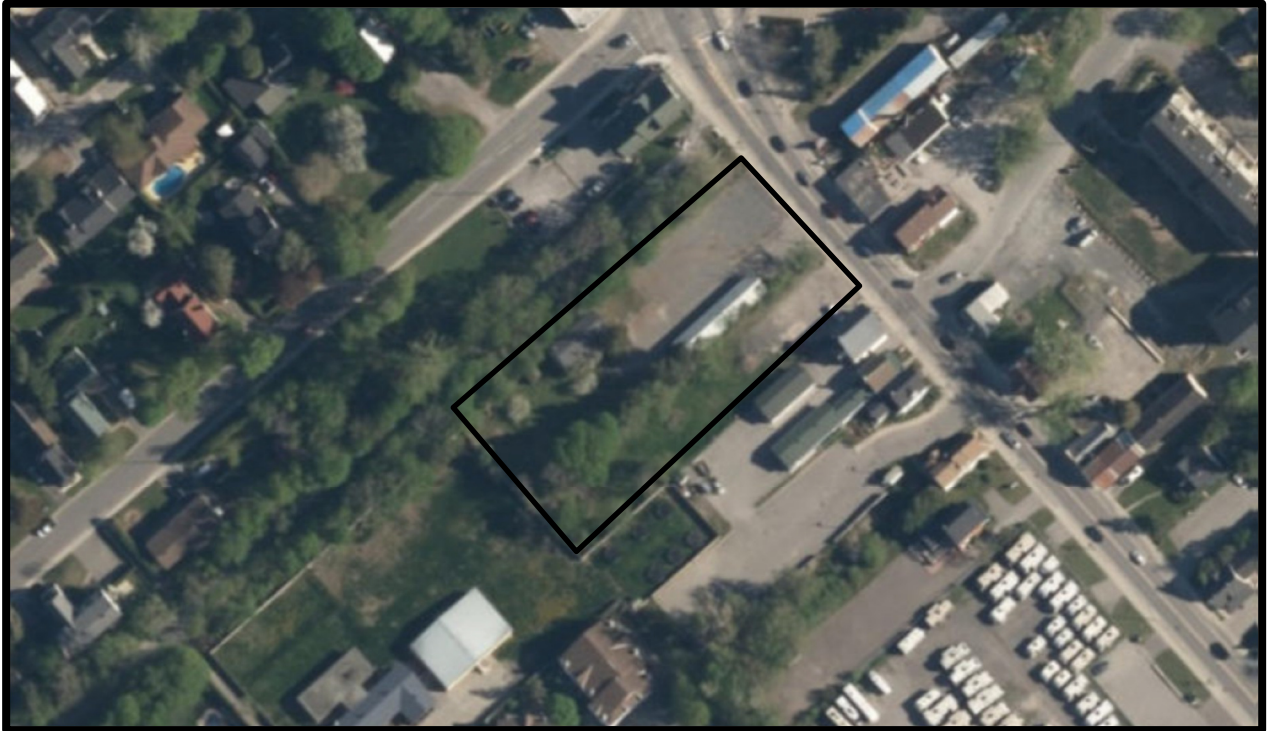
## **FIGURE 3**

**Aerial Photograph - 2017**
