RE: SUMMARY OF GROUNDWATER LEVEL MEASUREMENTS

PROPOSED COMMERCIAL DEVELOPMENT

151-159 WESCAR LANE CITY OF OTTAWA, ONTARIO

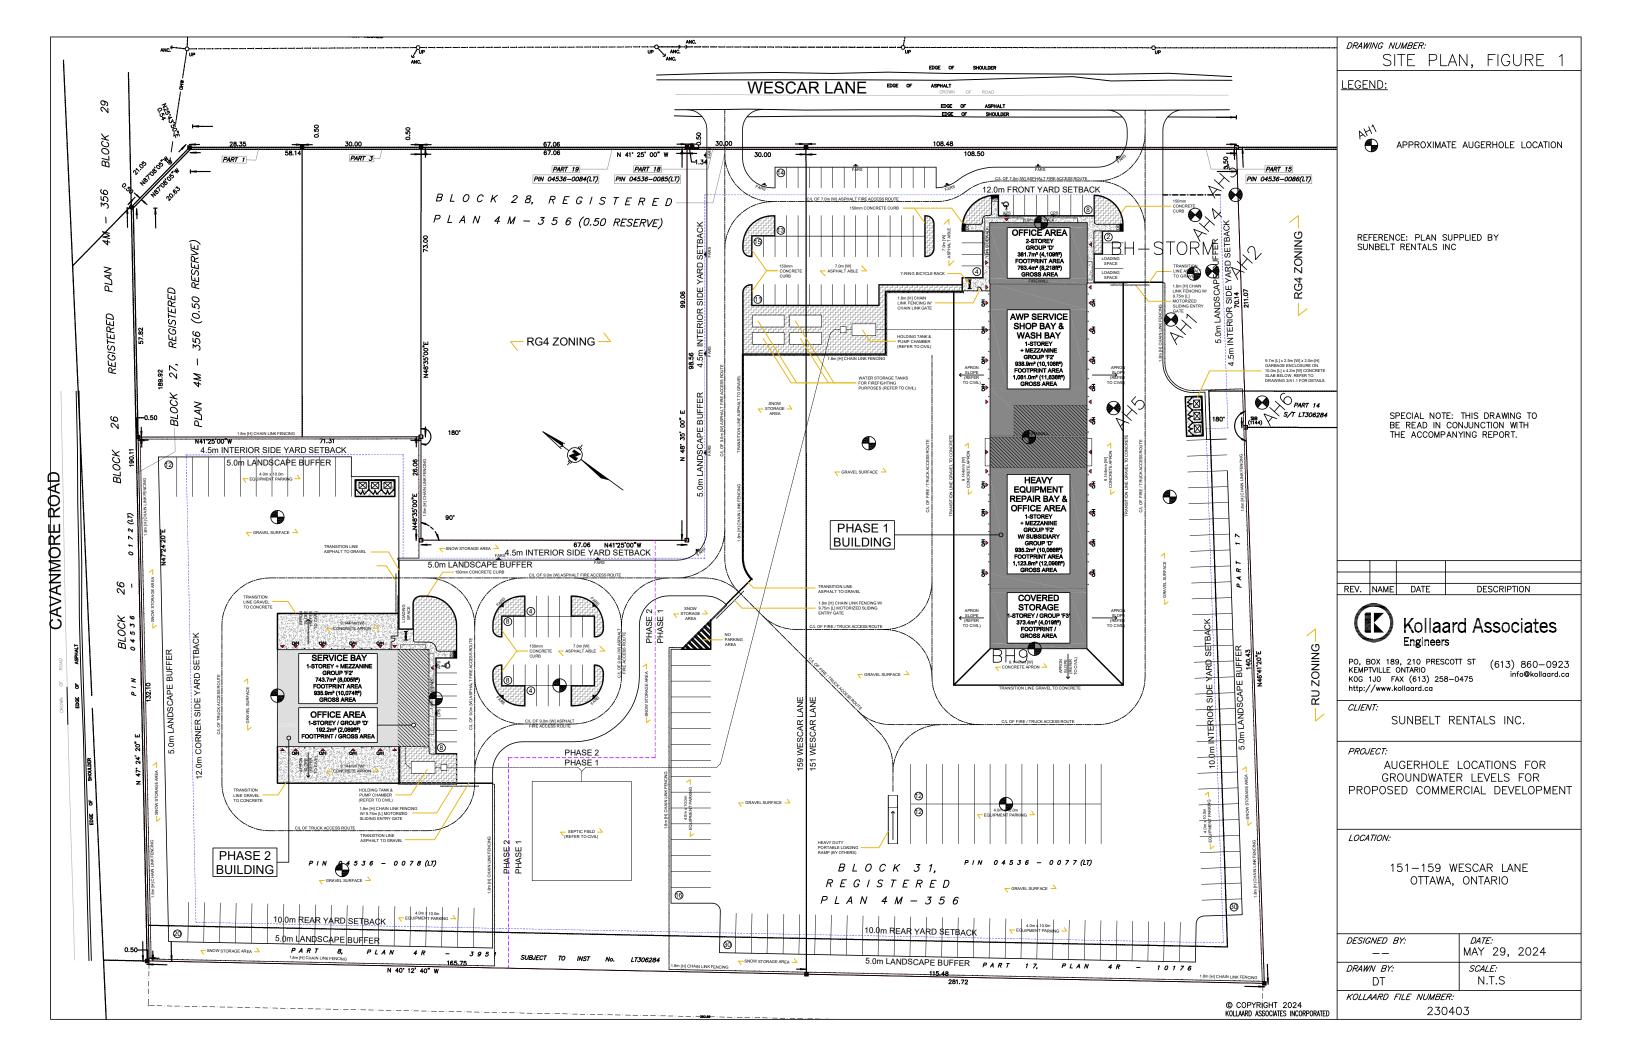
Site Plan, Figure 1 – Augerhole Locations

The location of the hand augerholes are shown on the attached Site Plan, Figure 2. The results of the subsurface conditions encountered in the augerholes are provided in the attached Table I,
