# Phase I Environmental Site Assessment Update

6622 Bank Street, Ottawa, Ontario

**CAMM Heavy Machinery Movers**  
Final Report

August 26, 2024  
02407549.000

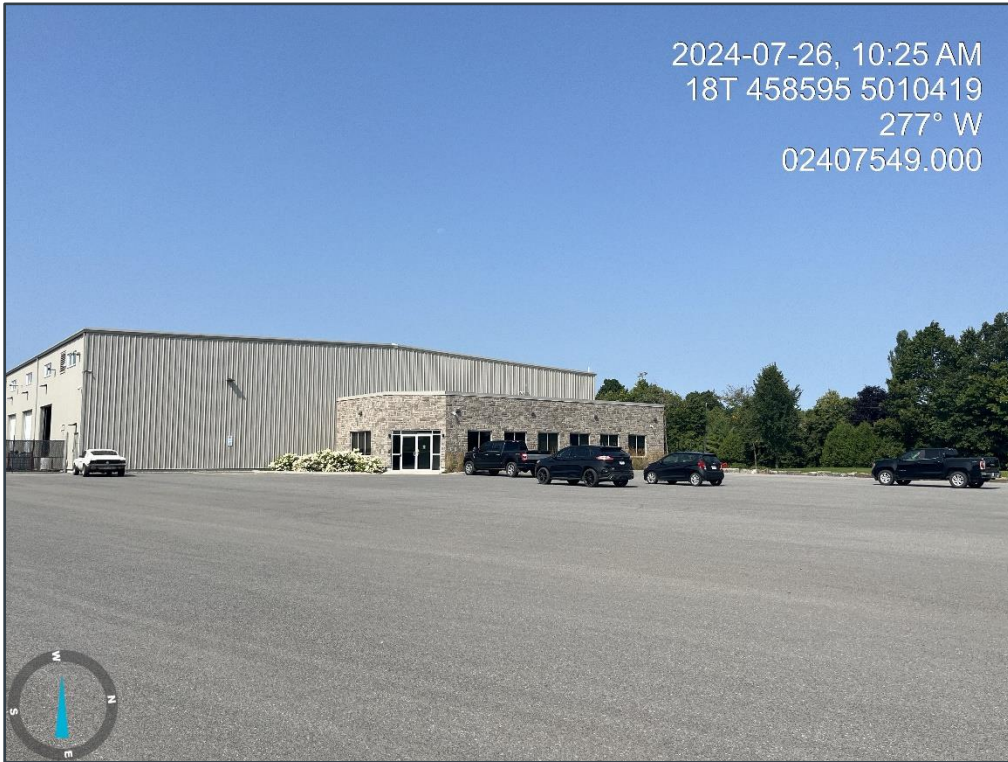
**Photograph 1: Exterior view of the on-Site Building (6622 Bank Street).**

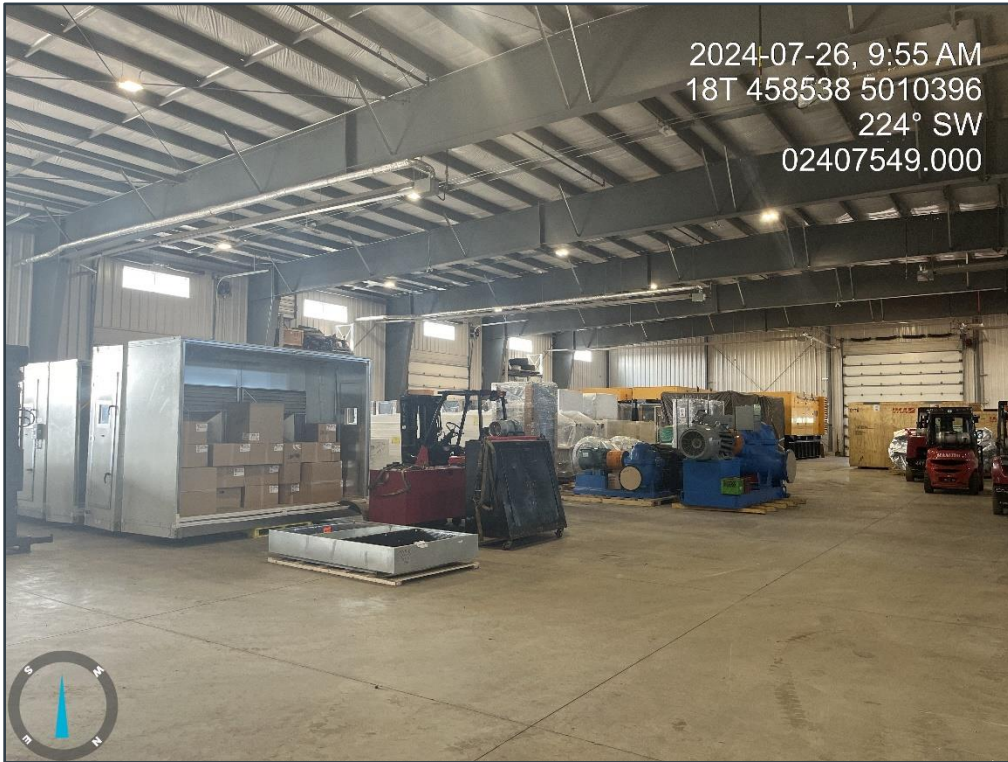
The warehouse building, mainly utilized for the storage of moving equipment and materials, including items like machinery, electrical components, and various fixtures, is situated to the west of the main office area, is a one-story structure in the northeast section of the Site. It features metal siding, a slab-on-grade foundation, and an insulated metal deck roof. The warehouse comprises a spacious storage area, a corridor with a staff room and one washroom, and an electrical room in the northeast corner. The primary entrance leads to a one-story office space with multiple offices and two washrooms. The interior of the office space includes drywall, drop tile ceilings, and tile flooring. The entire building is equipped with a central heating, ventilation, and air conditioning (HVAC) system for climate control, a mix of incandescent and LED lighting, and is serviced by municipal electricity, natural gas, a septic tank sewer system, and water from a potable well.

Photograph 3: Interior Warehouse Space (6622 Bank Street).

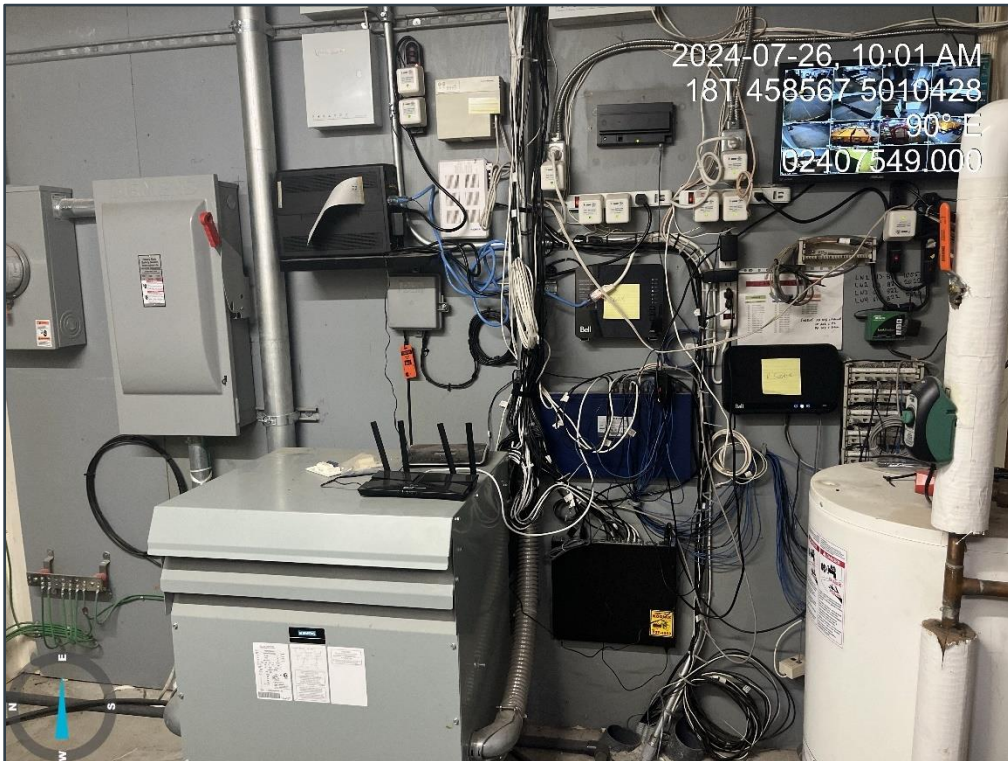
Photograph 6: Electrical Room located in the Staff Room (6622 Bank Street).

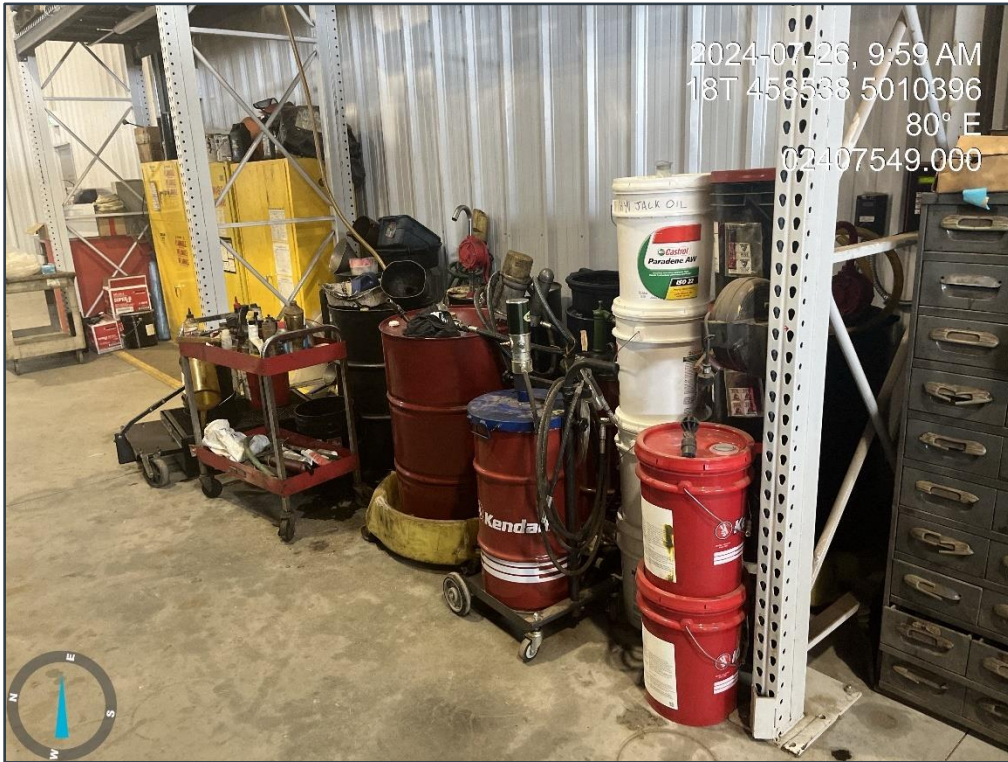
During the Site reconnaissance, Englobe observed the minor storage of various engine fuels, hydraulic oil, and waste oils at the Site, along the east wall of the Warehouse Building.

It was noted that the compressor fluid and diesel engine oil were stored in large plastic pails, which were sealed. All of the containers were observed to be in good condition, with no evidence of leaking, staining, or spills.

Photograph 7: Minor Fuel Storage Area (6622 Bank Street) - PCA 3.

Based on the observed condition of the minor fuel storage and three fuel ASTs on Site, and no evidence of any surficial staining observed in the vicinity, these PCAs are not anticipated to pose a potential environmental concern to the Site at this time.

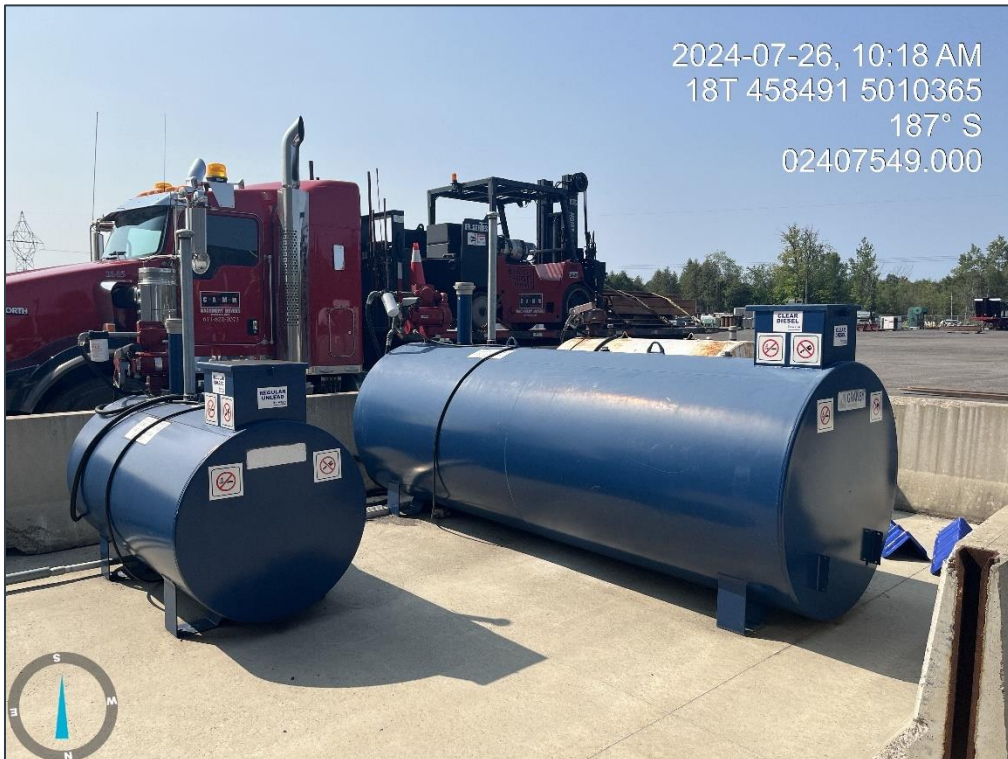
Three fuel ASTs (two diesel and one gasoline) were observed west of the warehouse building, on a concrete pad. All tanks observed appeared to be in good condition with no corrosion, punctures, or visible spills/leaks noted.

Photograph 8: Three Exterior Fuel ASTs (6622 Bank Street) - PCA 2.

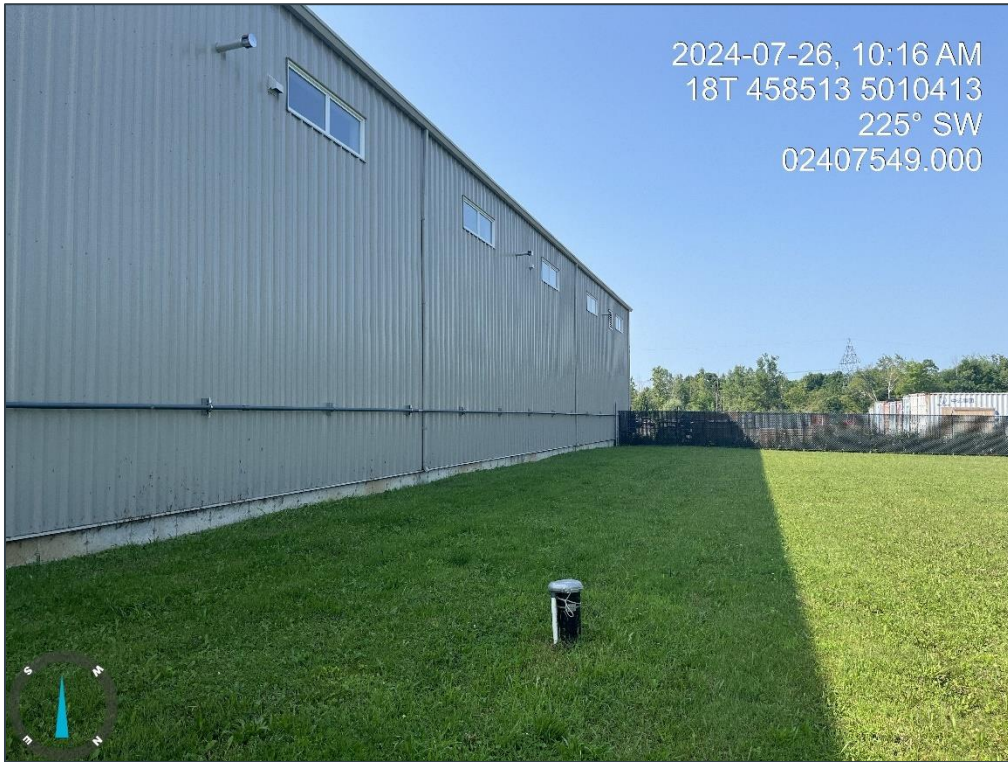
During the Site reconnaissance, Englobe observed one potable drinking water supply well north of the warehouse building.

**Photograph 9: Potable Water Supply Well (6622 Bank Street).**

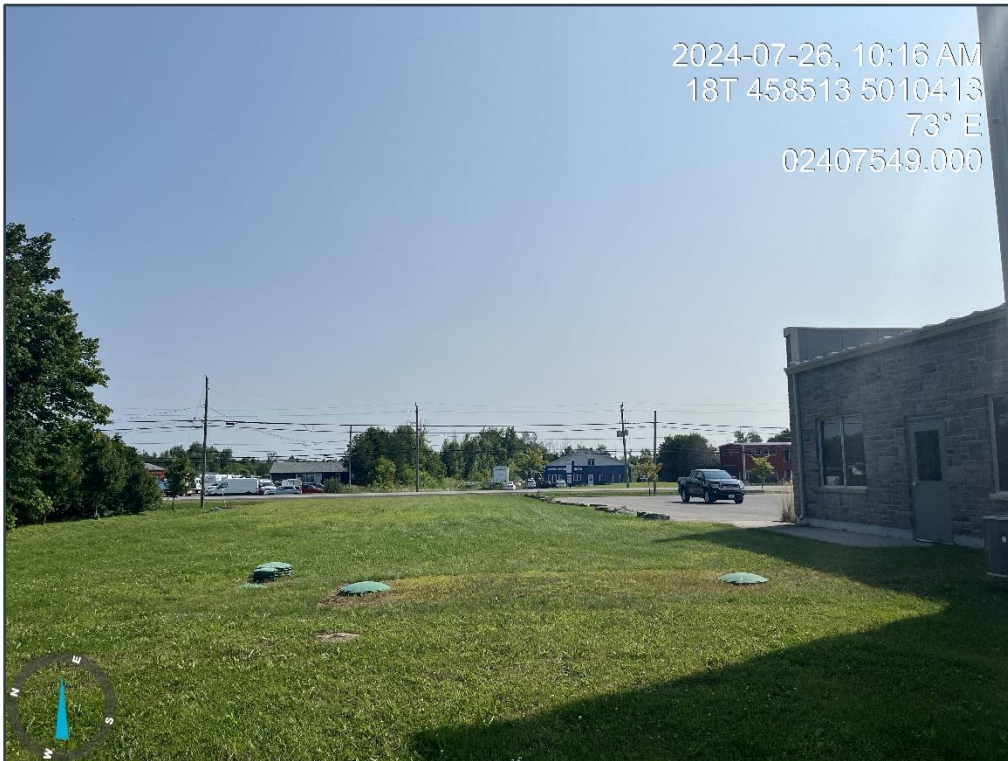
Below-ground structures at the Site included a septic tank with associated tile beds and piping. No other below-ground structures or basements were observed on Site during the Site reconnaissance.

**Photograph 10: Septic Tank Area (6622 Bank Street).**

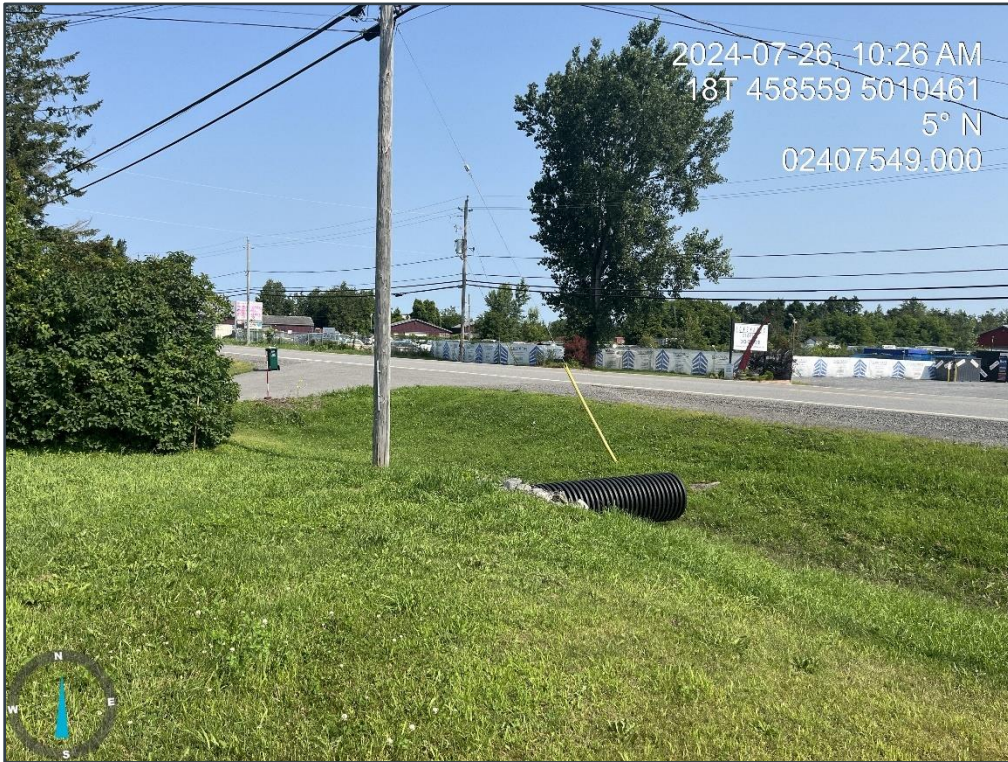
**Photograph 11: Drainage Outlet to City Ditch (6622 Bank Street).**

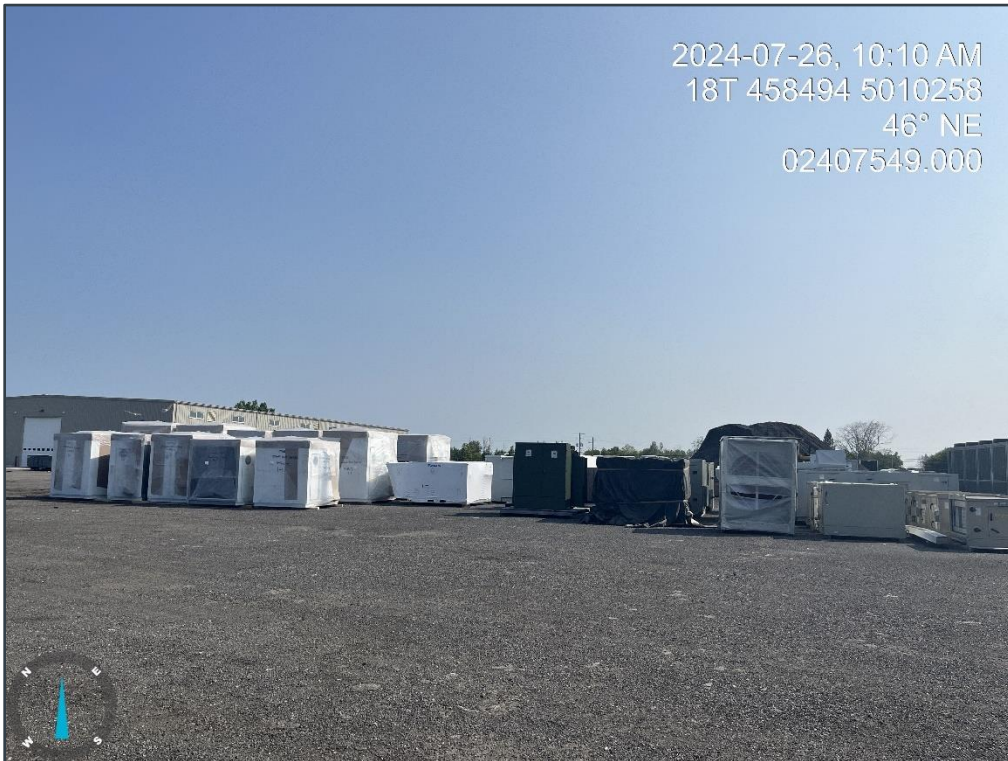
During the site reconnaissance, Englobe noted the presence of used tires and wooden pallets along the western fence line, wooden hydro poles along the southern fence line, and various other equipment along the property lines.

**Photograph 16: Central Exterior Equipment Storage (6622 Bank Street).**
