# HERITAGE IMPACT ASSESSMENT

## 254 ARGYLE AVENUE, OTTAWA

**Revised August 2024 SUBMISSION**

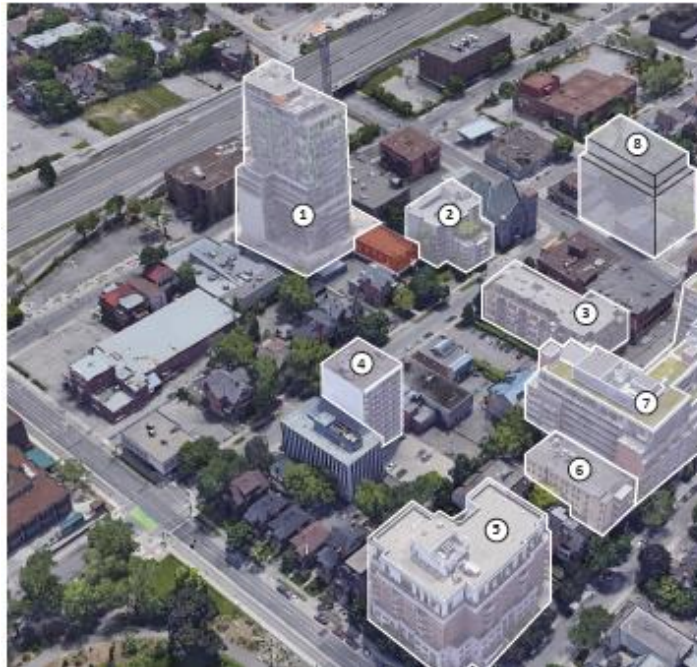
1. 203 Catherine St- SoBa Condominium 209 Units- 21 Floors- 2019
2. 258 Argyle Street- Apartment XX Units- 7 Floors- XXX
3. 255 Argyle Street- Apartment 40 Units- 6 Floors- 1960's
4. 229 Argyle Street- Apartment 79 Units- 12 Floors- 1978
5. 320 McLeod- Opus Condominium 71 Units- 9 Floors- 2007
6. 330 McLeod Street- Apartments ~40 Units- 6 Floors- XXXX
7. 360 McLeod Street- Condominium 164 Units- 9 Floors- 2015
8. 500 Bank street- Apartmenets- 11 Floors- 2022

Figure 4: Aerial view illustrating the built and landscape context within the block bound by Bank, Catherine, O'Connor Streets and Argyle Avenue. The existing development within the site at 254 Argyle is a one-storey Catholic Church constructed circa 1930 (highlighted red). The development integrates the church as a feature of the proposed development. The site is adjacent to 229 Argyle, a 7-storey apartment built pre - 1999. Just south of the site at 203 Catherine is the 21-storey SOBA condominium. Buildings numbered 1-8 identify neighbouring high-rise development. South top of image. Source: Google Earth/Spice.

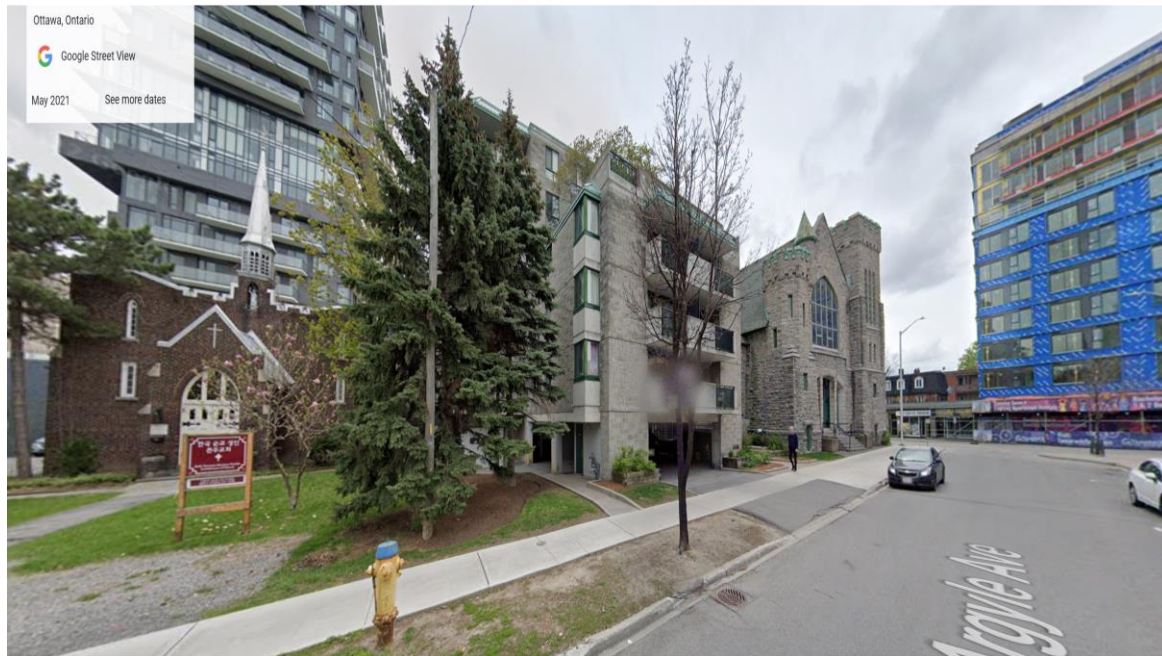
Figure 7: View looking southwest at the corner of Argyle and Bank. Note the position of the former church setback from Argyle. Source: Google Map.

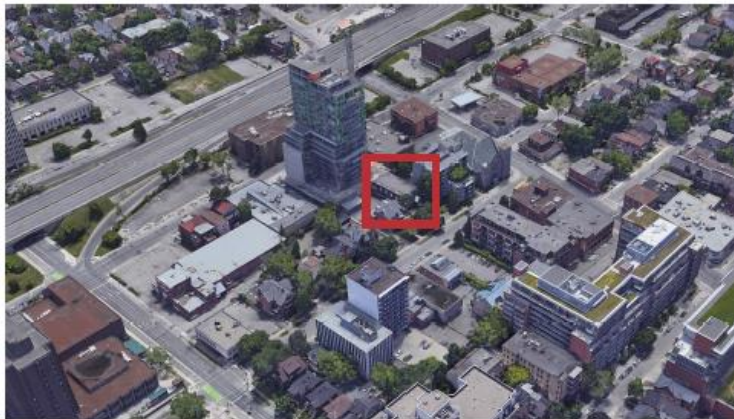
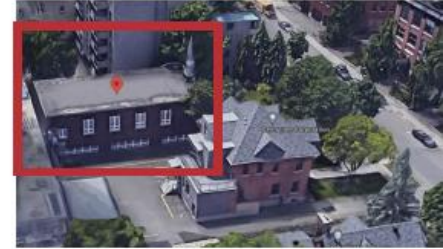
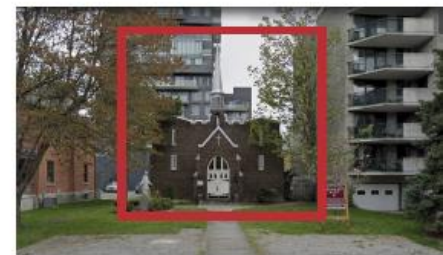
Figure 8: Clockwise Aerial view looking south, a view looking west with the former rectory residential building in the foreground, and a view from Argyle Avenue illustrating the church tucked back between the 12-storey high-rise and the neighbouring red brick residence. Source Spice Design. 2023.

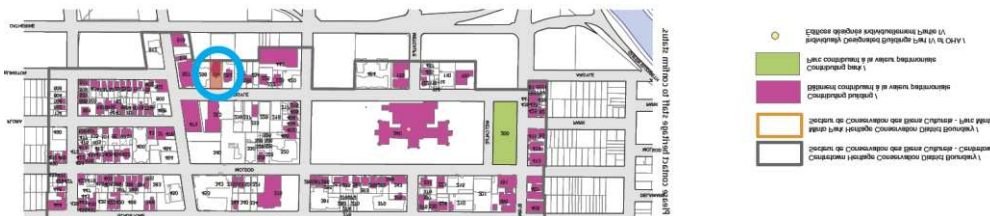
Figure 9: Detail of Map 11, Property Classifications Centretown Heritage Inventory 2020. The plan illustrates the classification of the properties within and adjacent to the development site (254 Argyle Avenue blue bulls' eye) is classified as 'Contributing Building' and 'Character Defining Resource'. Source: Centretown Heritage Inventory, Final Report, May 1, 2020. ERA Architects.

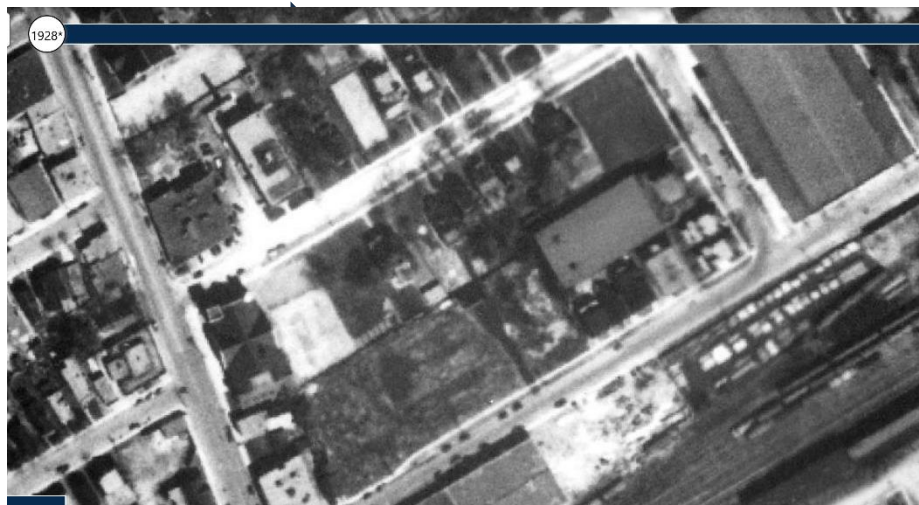
*Figure 10: Aerial view 1928 with the church property undeveloped. Lands along Catherine Street appear as vacant plots. Arrowed. Source: Geoottawa*

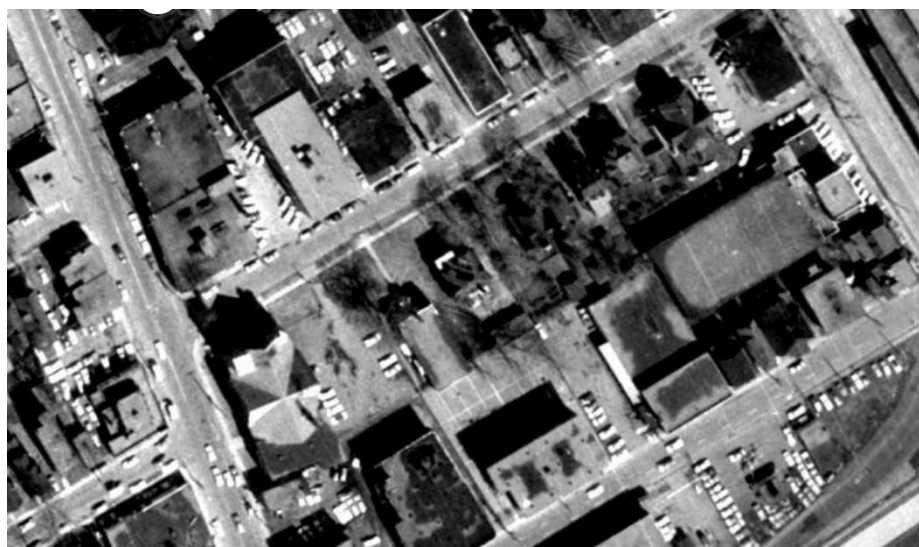
*Figure 11: Aerial view 1958 with the shadows highlighting the steeple of the church. (Arrowed.) The property to the west appears to service as a parking lot and remained undeveloped until after 1991. Source: Geoottawa*

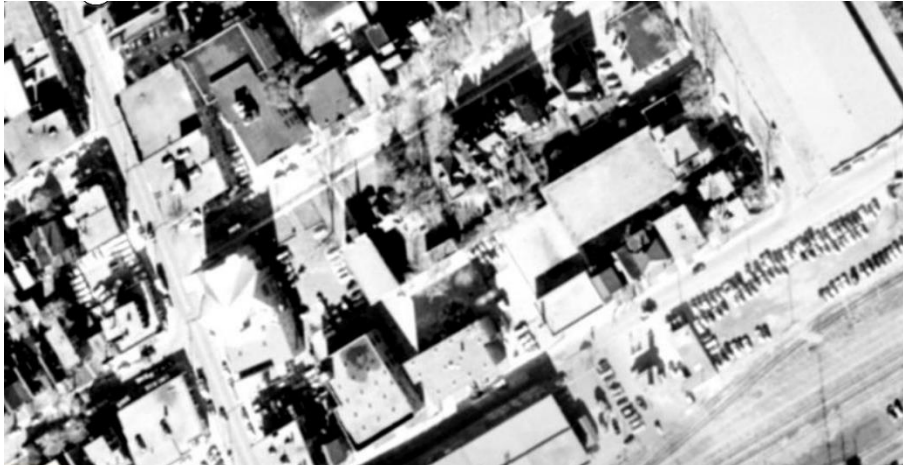
Figure 12: Aerial view 1965 documents the build out along Catherine Avenue with larger flat roofed industrial buildings. Along Argyle, the south side of the street continues to retain its residential character. Source: GeoOttawa

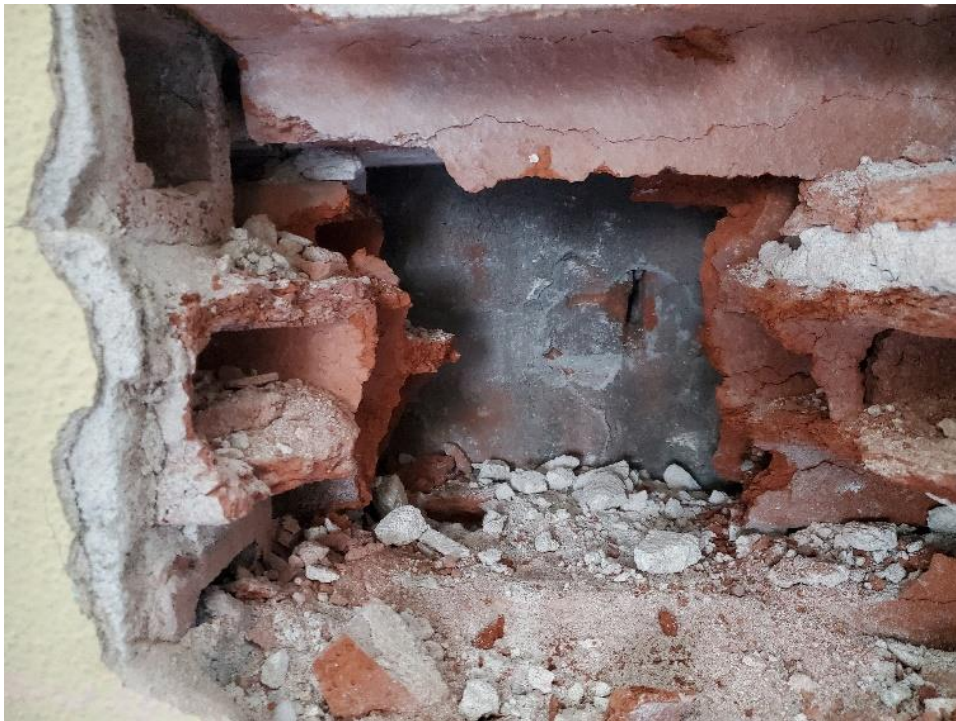
The clay brick is a rust-brown highly textured brick marketed as tapestry brick.

The brick veneer is a single wythe non-structural, decorative layer applied to the exterior of a building and anchored to the structural terra-cotta wall.

*Figure 16: Opening in the Ground Level Wall showing double wythe of hollow terra-cotta with a rough coat and finish coat of plaster on the interior.*

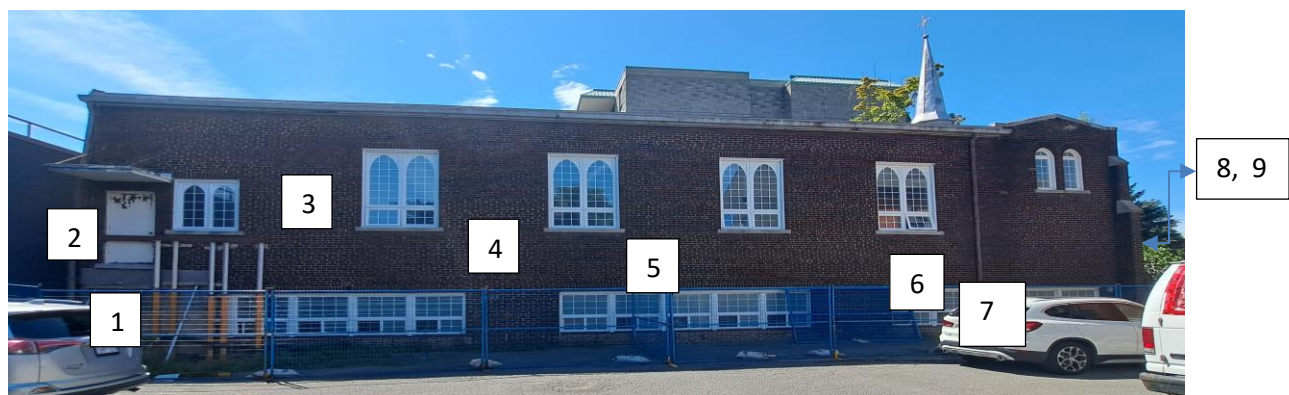
The walls, particularly the east wall, are exhibiting significant deterioration and loss of bonding between the brick veneer and the terra-cotta structural backup. The following list taken from the Remisz report outlines deficiencies:

*Figure 16: A key view of the east façade provides a reference point for the closeup views of the various issues. The reference numbers refer to the detailed close-up views.*

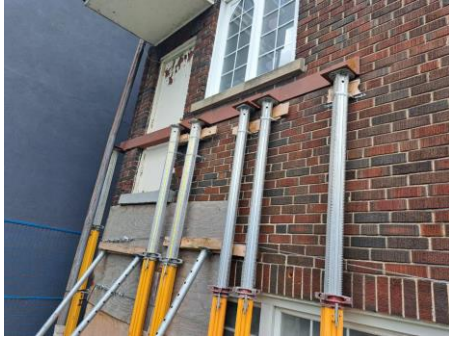
- There is substantial settlement in the southeast corner, which is the closest area to the excavation works performed at 203 Catherine Street back in 2015. The total movement at the southeast corner was 72mm when observed by Keller Engineering on February 24, 2017.

1. Substantial settlement at the corner requiring temporary bracing to prevent collapse of back wall and portion of the east façade.

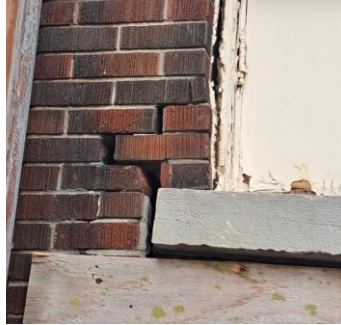
2. Back corner the wall has kicked out and separated requiring extensive temporary bracing.

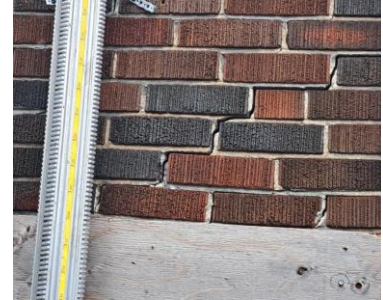
- Dark staining of brick around downspouts and below windowsills and loss of mortar indicates water entry.
- Step cracks ranging from 3mm to 5mm, especially around the windows and at the southeast corner. The cracks indicate settlement of the building and separation of bond.

3. Stepped crack south end of east façade with vertical support lag bolted thro the wall.

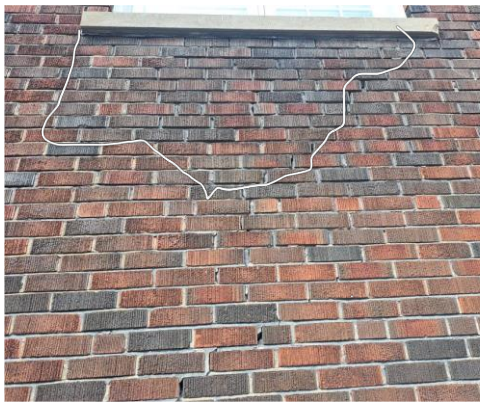
- Step cracks in the brick cladding extend from second floor windows and at the top corners of the two large basement windows. The Windowsills are cracked with several wide cracks at the southeast corner, documenting subsidence or movement to the wall.

4. Staining of the brick under windows indicates long term water running down the face with cracking from the upper to the lower window.

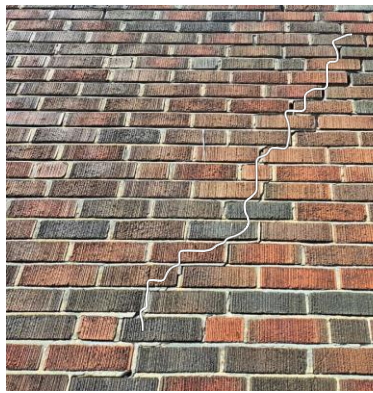
5. Stepped cracks and lost mortar along east façade.

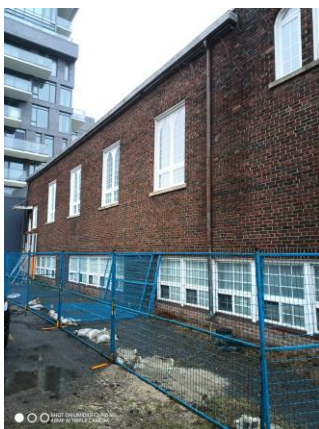
- The entire upper 2' of the east façade at the roofline has been repointed. Along the base under the bank of windows, the brick has been replaced, documenting a history of water infiltration and damage. The replacement brick does not match the original tapestry brick (see figure 16-7)

7. The brick along the base of the church has been replaced using a different brick.

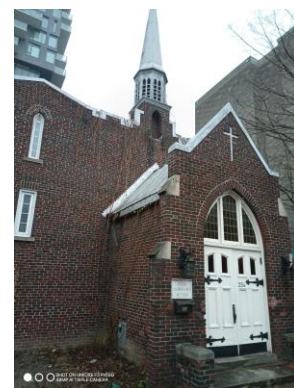
9. Front façade with staining along the base and in the corner.

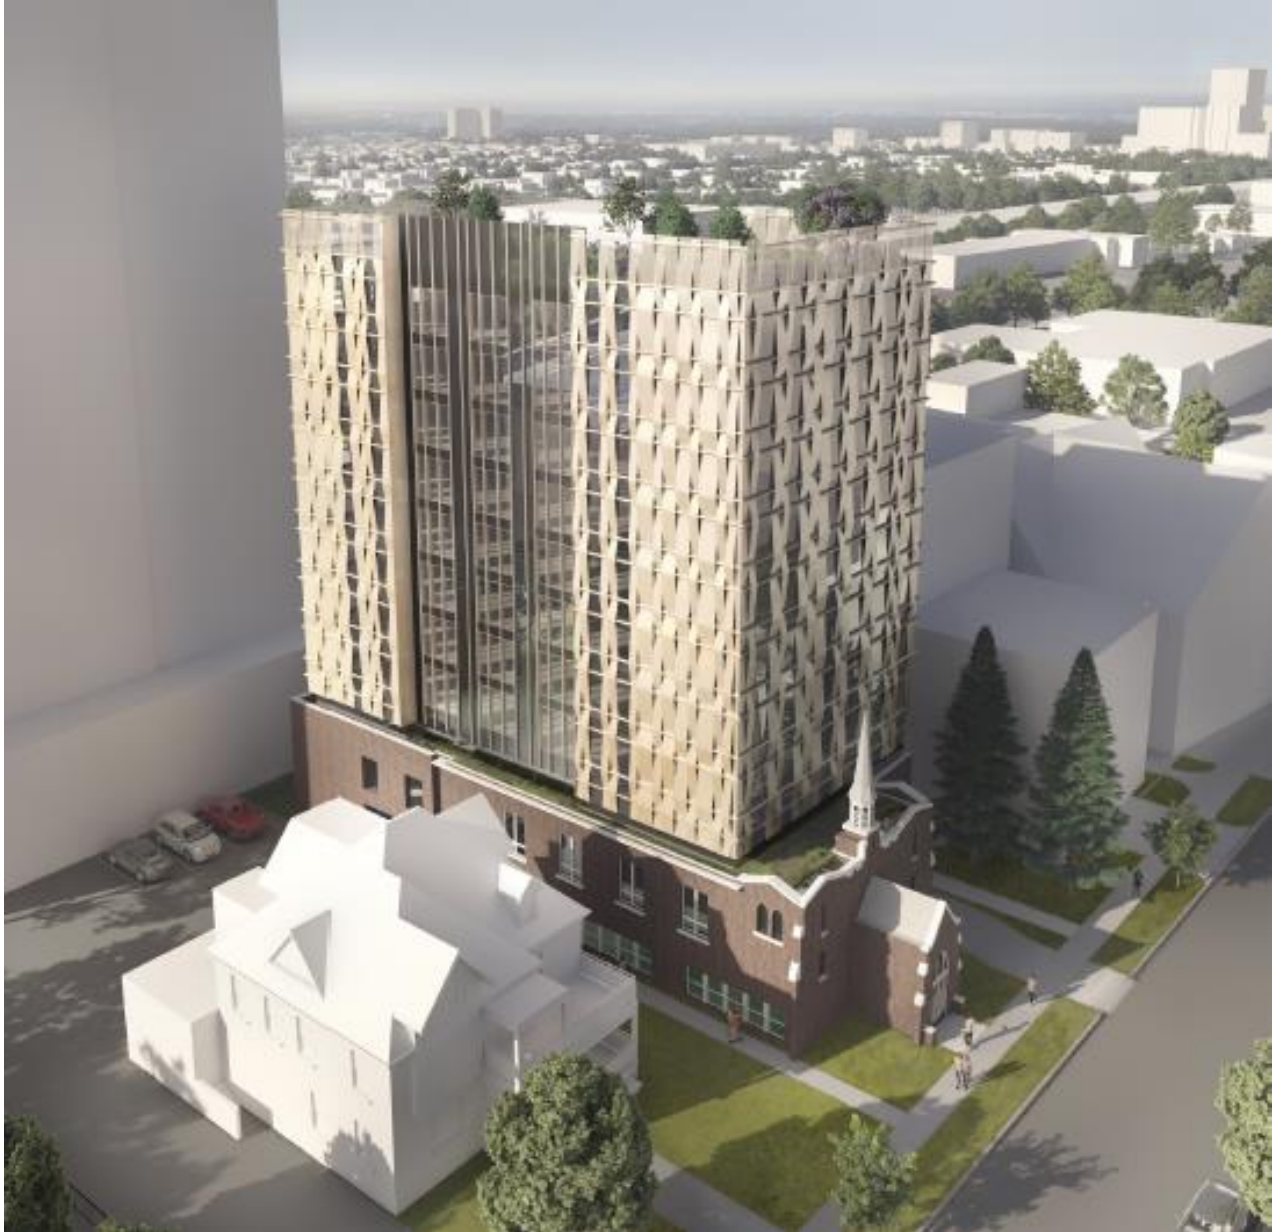
Figure 18: Bird's eye looking southwest, showing the scale and relationship of the proposed development. Source CSV Architects /Spice Design 2024.

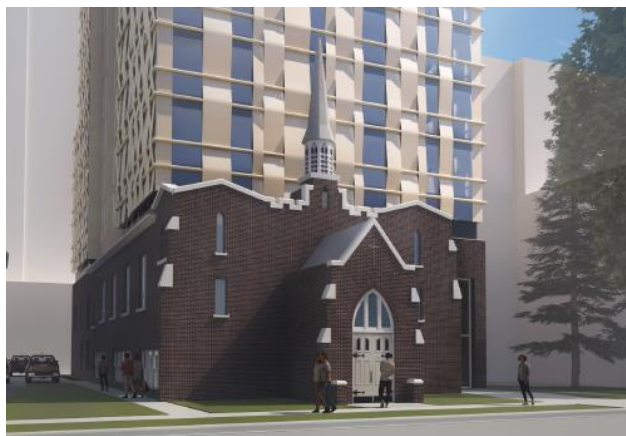
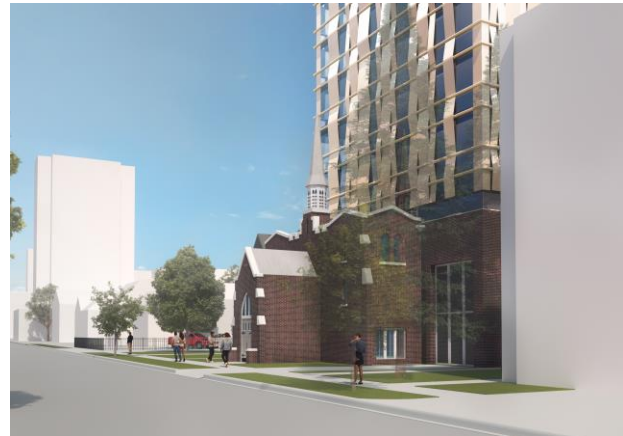
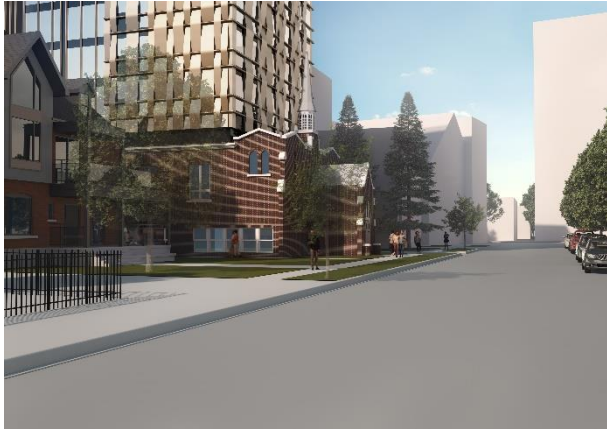
*Figures 19, 20 & 21: Three views from Argyle Avenue looking west and east allow the church to stand proud with positioning similar to the United Church on the corner. This repositioning has given the church a far more defining role on the street. Source: Spice Design 2024.*

Access to basement parking is via a driveway into an enclosed ramp descending along the west side of the Church, thus the full eastern side of the rebuilt Church wall will be visible.

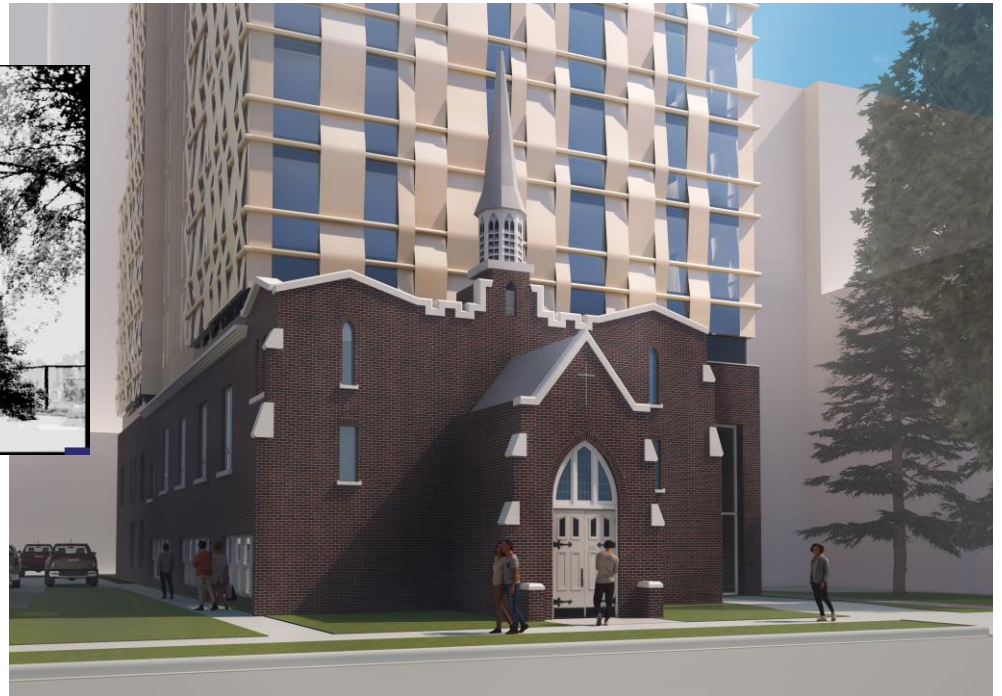
Figure 23: Proposed plan for the ground floor illustrated the reuse of the front of the church as a café/bar, ground floor amenity area, vertical circulation, and ground floor units along the south. The new podium/base (shown in red) reinstates the original material and height of the church is re-clad in salvaged with the salvaged red brick acknowledging the original treatment of the church. Source: Spice Studio/ CSV Architects Design Brief, August 2024.

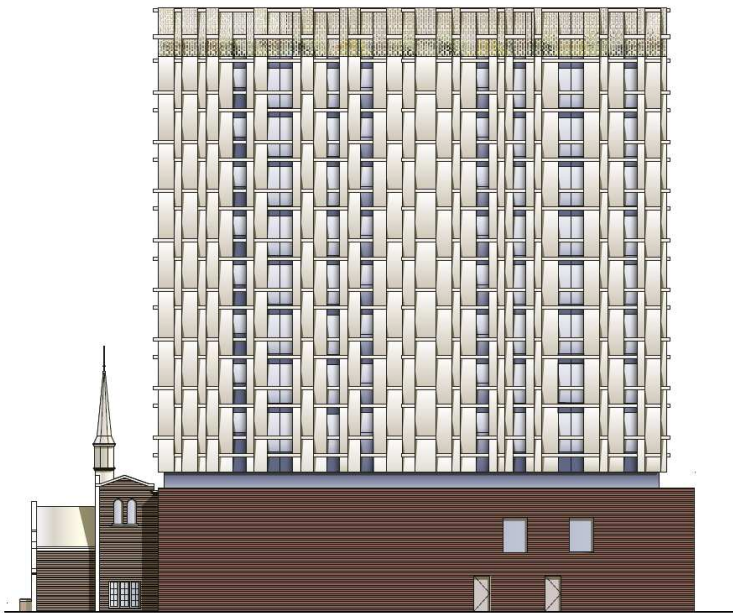
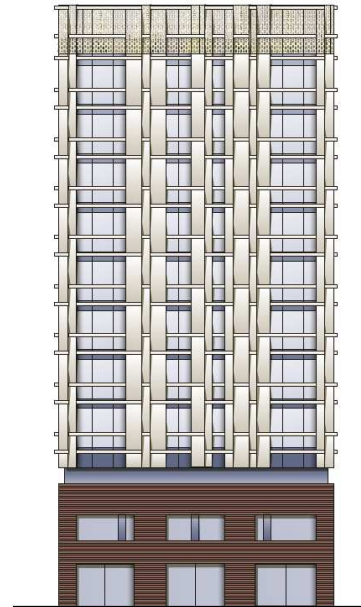
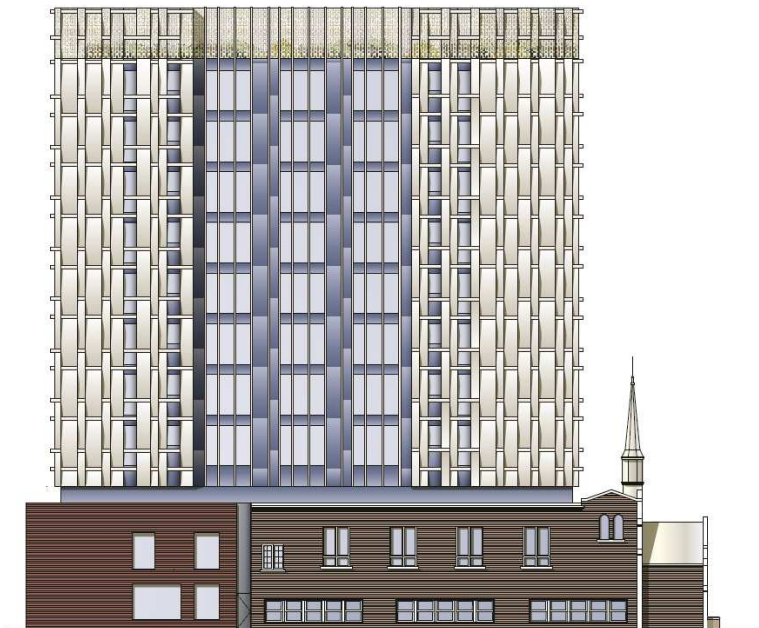
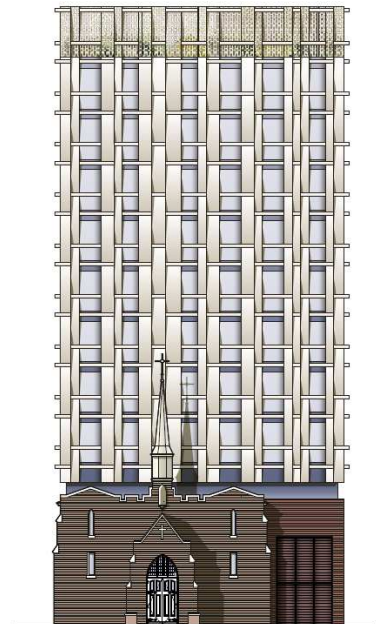
*Figures 25, 26, 27 and 28: **East, South, East, and North elevations** The Former Church serves as a podium that sits proud of the new development setback behind the steeple. The 9 -storey tower setback from the street is positioned to allow the reconstructed church façade to be interpreted on the front and east elevations stand proud. Source: Spice Design 2024.*

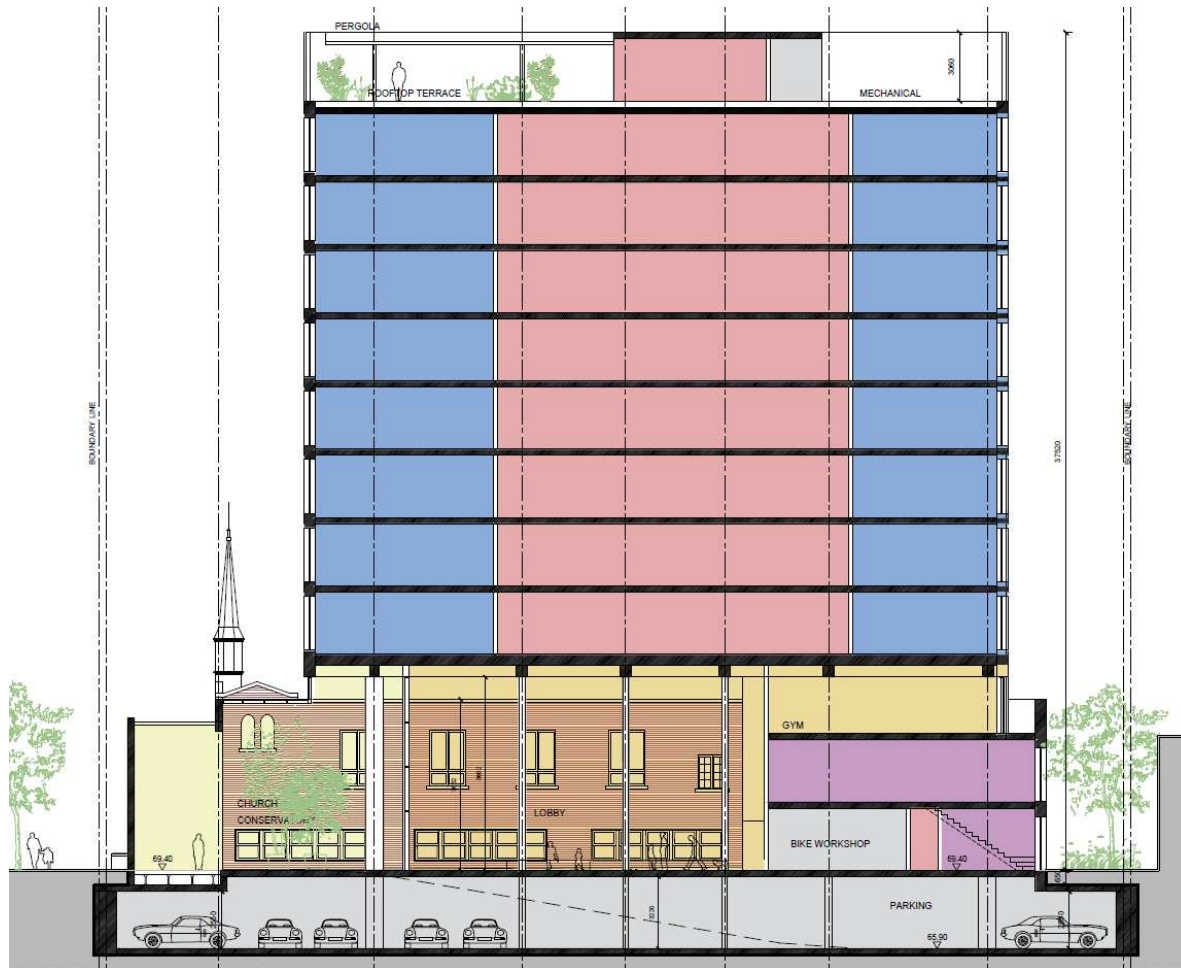
Figure 29: Longitudinal Section with Argyle Avenue to the north. Source: CSV Architecture/ Spice Design 2024.

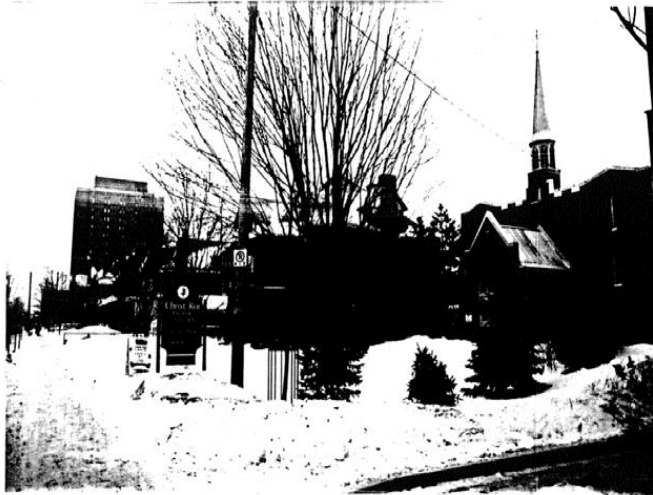
PHOTO DATE: Winter 1996  
 VIEW: SE  
 SOURCE: AY.  
 NEGATIVE NUMBER: A-25

Compatibility With Heritage Environs: very compatible with heritage mixed use environment
