Phase One Environmental Site Assessment

524 Lacolle Way,
Ottawa, Ontario

Prepared for:

Patrice Houle Holdings Inc.
2360 Old Highway 17
Rockland, Ontario
K4K 1K7

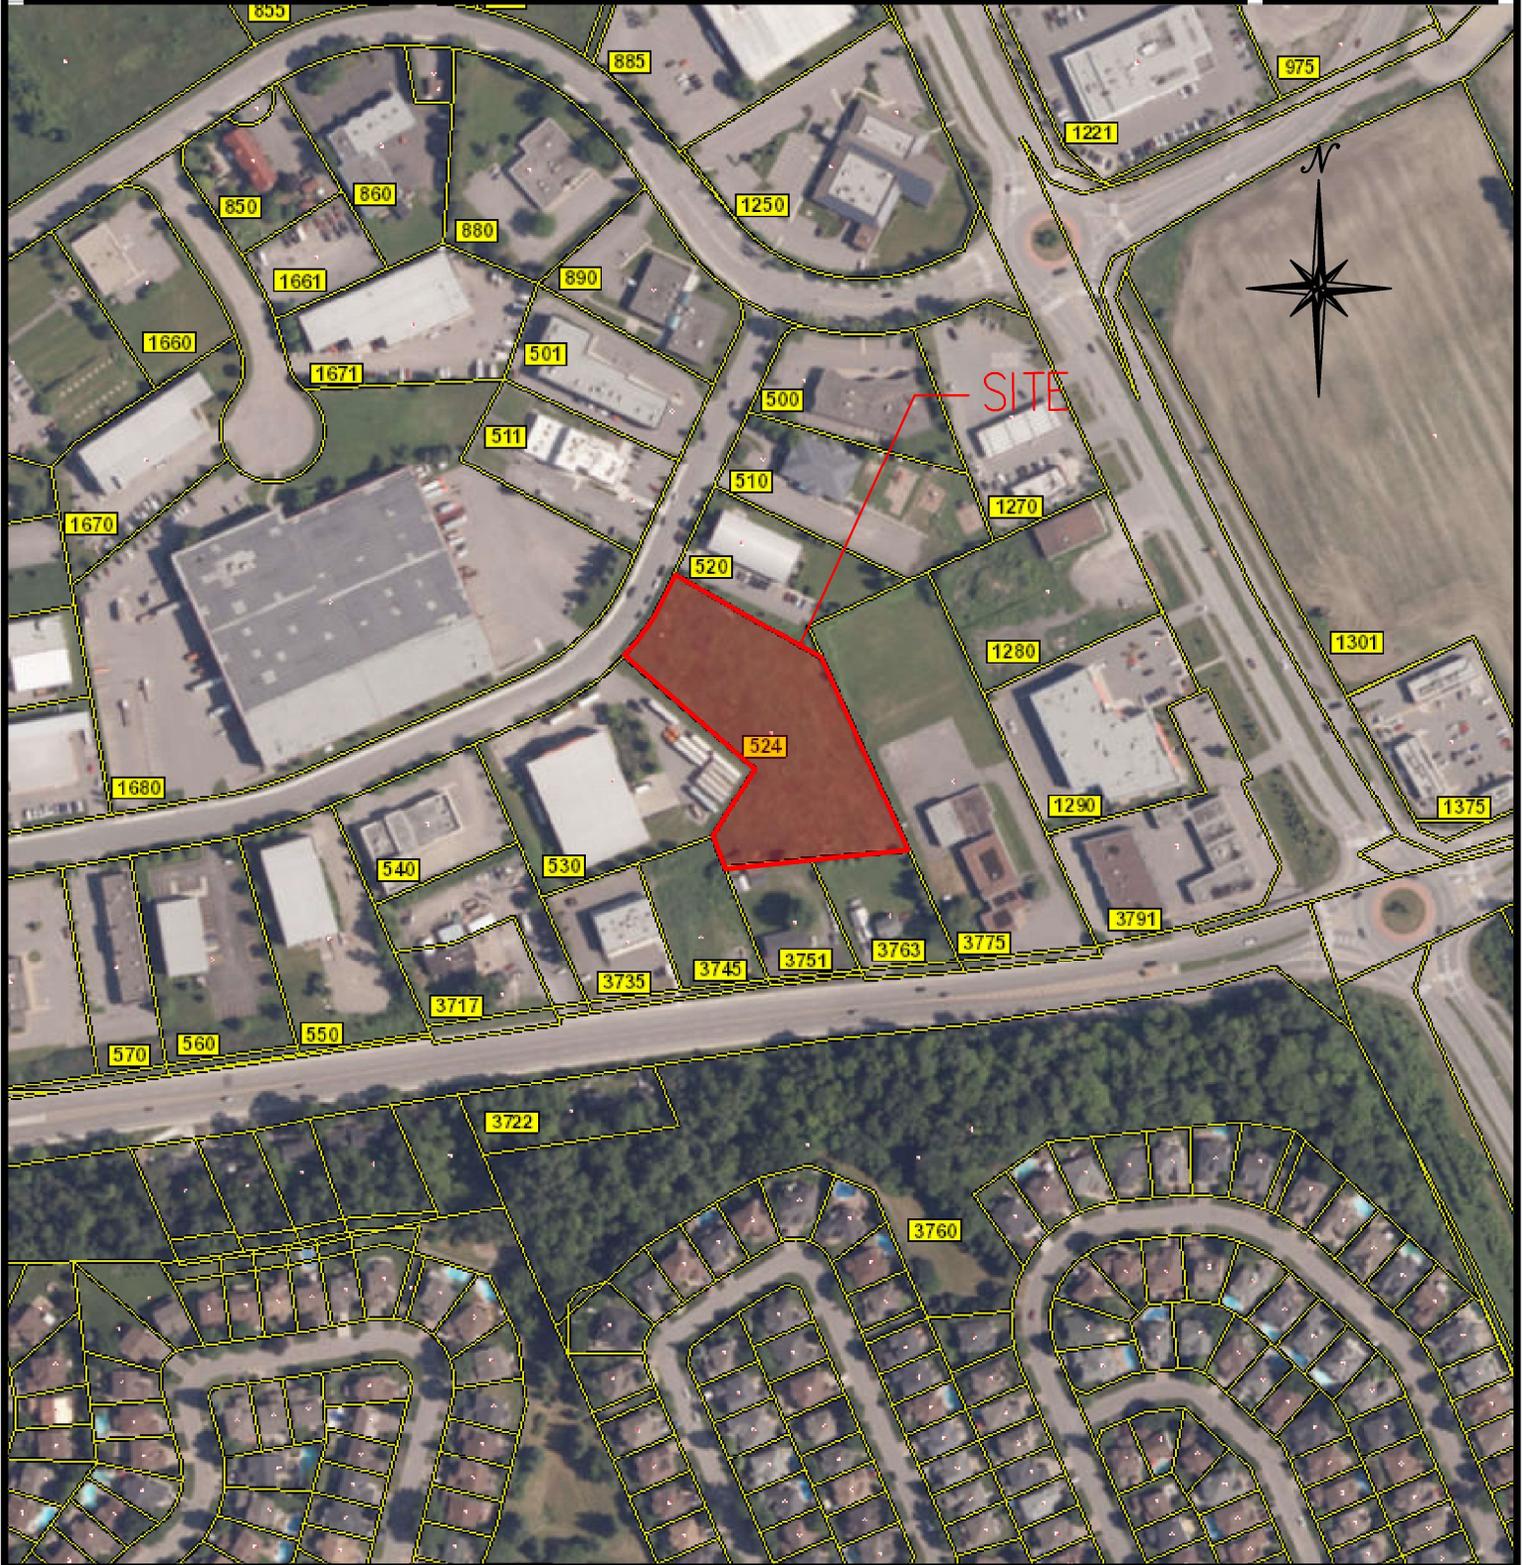
FIGURE 1

Patrice Houle Holdings Inc. has retained LRL Engineering (LRL) to complete a Phase One Environmental Site Assessment (ESA) on the property located at 524 Lacolle Way, Ottawa, Ontario (herein referred to as the “Site”). The Site’s location is shown in **Figure 1**. The Site is currently undeveloped and includes overgrown grass land. It is anticipated that an approximate 2,000 m² warehouse will be developed on Site.

The location of the Site is shown in the attached **Figure 1** and the current layout of the Site is shown in the attached **Figure 2**. PCAs are shown in the included **Figure 3**.

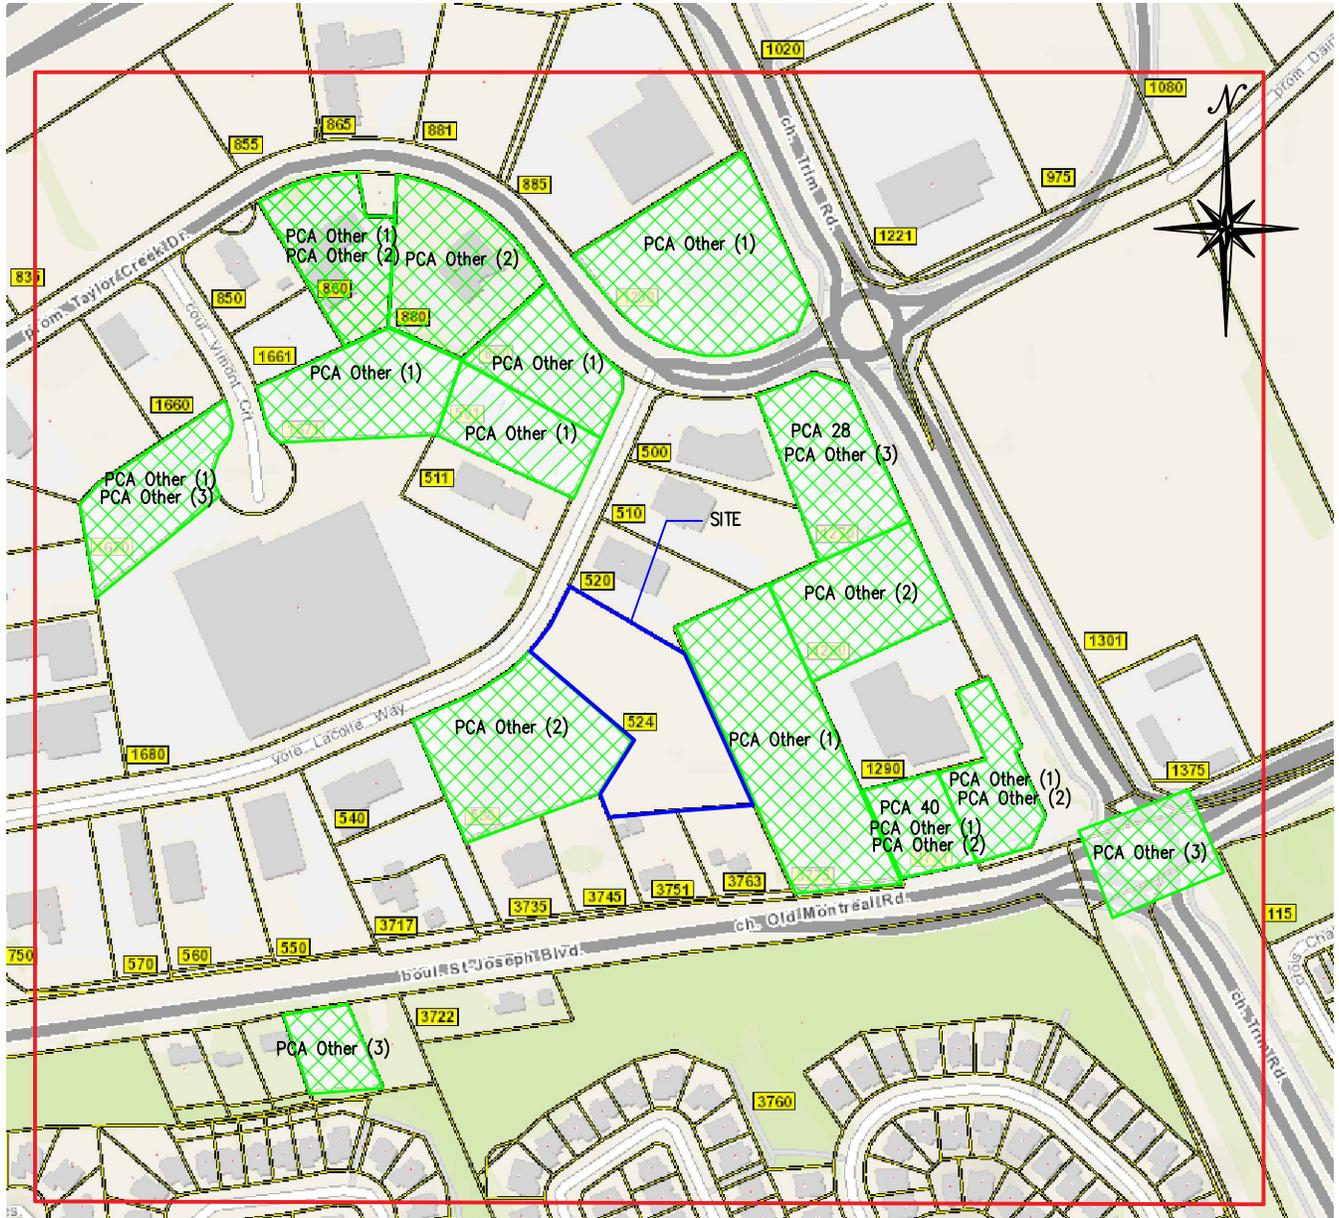
FIGURE 3

Based on the results of the Phase One Environmental Site Assessment, the following areas of potential environmental concern were identified and are presented in **Figure 3**:

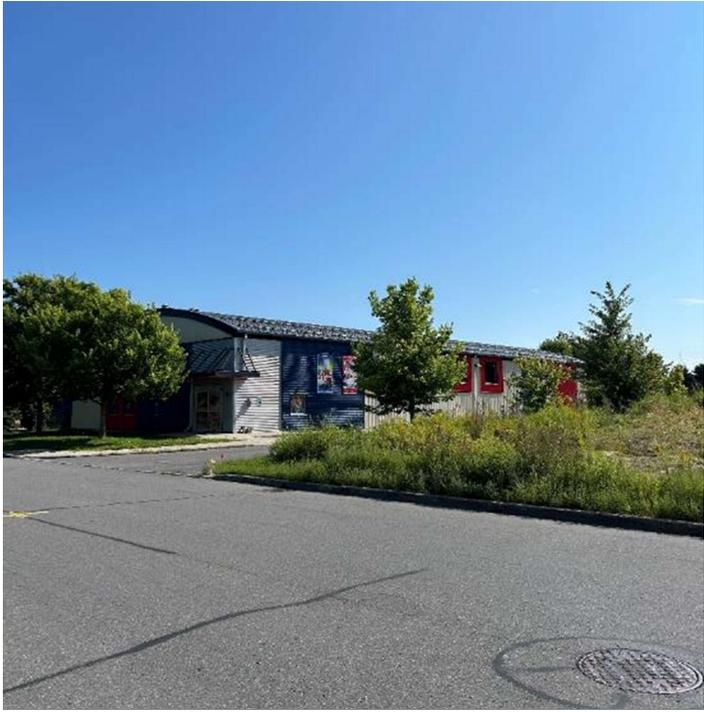
Photograph No. 1

Date: 8/23/2024	
Description Neighbouring property to the north of the Site (520 Lacolle Way) facing northwest.

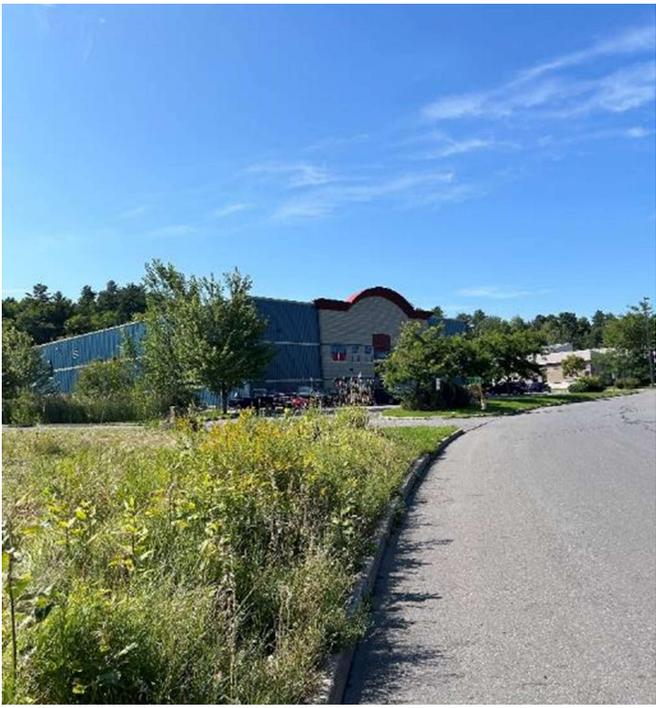
Photograph No. 2

Date: 8/23/2024	
Description Neighbouring property to the west of the Site (530 Lacolle Way) facing southwest.

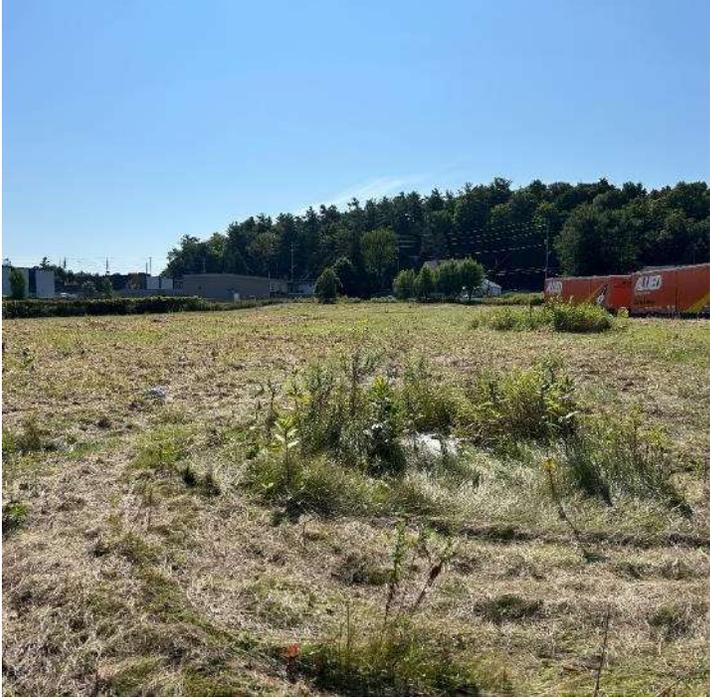
Photograph No. 3

Date: 8/23/2024	
Description Northern extent of the Site facing southeast.

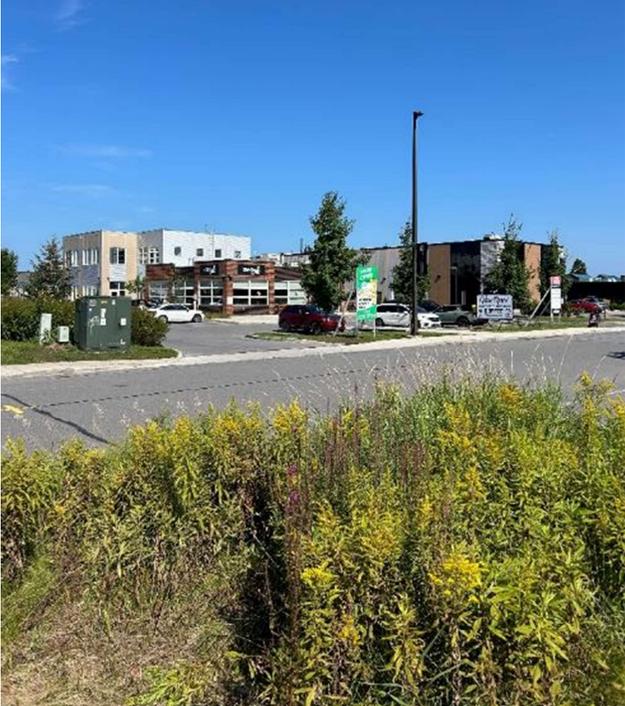
Photograph No. 4

Date: 8/23/2024	
Description Neighbouring properties to the northwest of the Site across Lacolle Way (511 Lacolle Way).

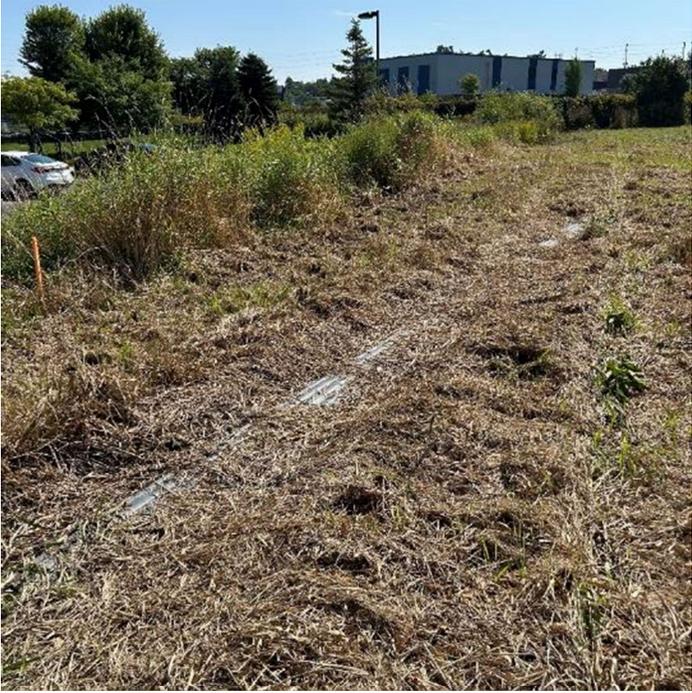
Photograph No. 5

Date: 8/23/2024	
Description Top of culvert exposed on the northeastern portion of the Site.

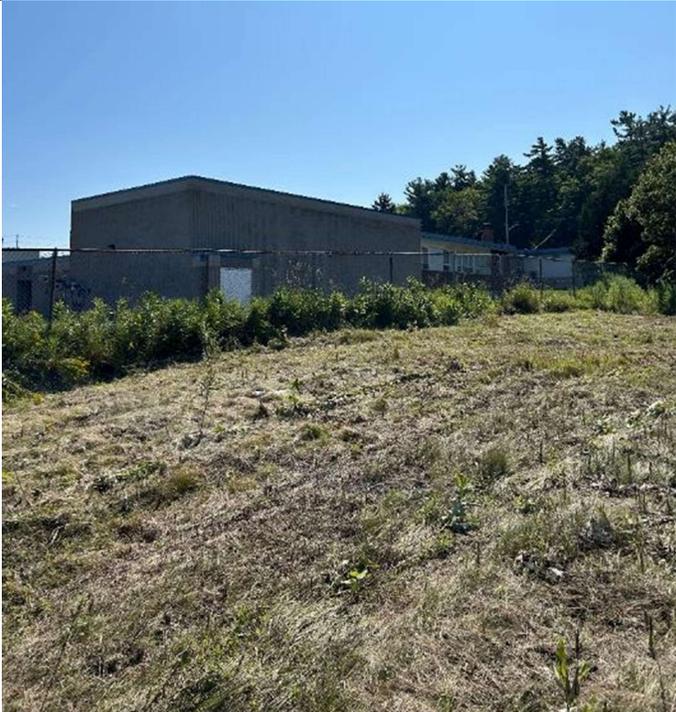
Photograph No. 6

Date: 8/23/2024	
Description Neighbouring property to the east of the Site (3775 St Joseph Blvd) facing southeast.

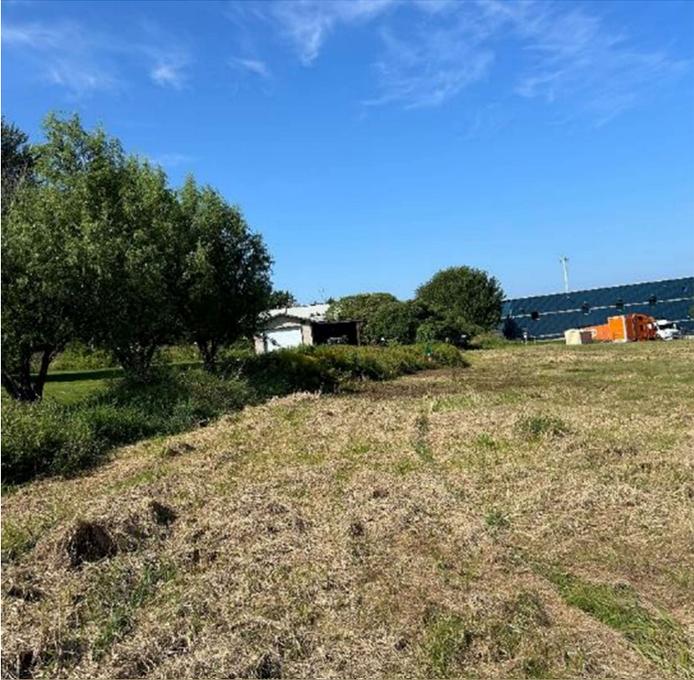
Photograph No. 7

Date: 8/23/2024	
Description Along the southern extent of the Site, facing west.

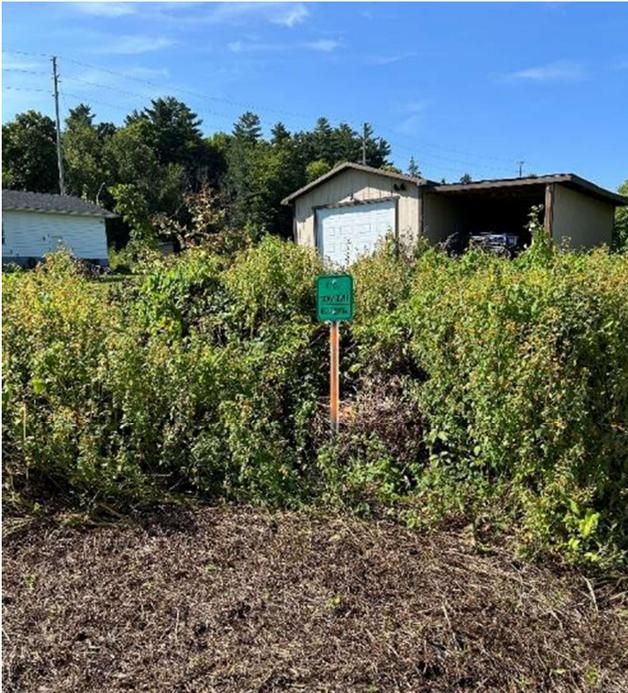
Photograph No. 8

Date: 8/23/2024	
Description Storm sewer found along the southern extent of the Site behind property 3751 St Joseph Blvd.

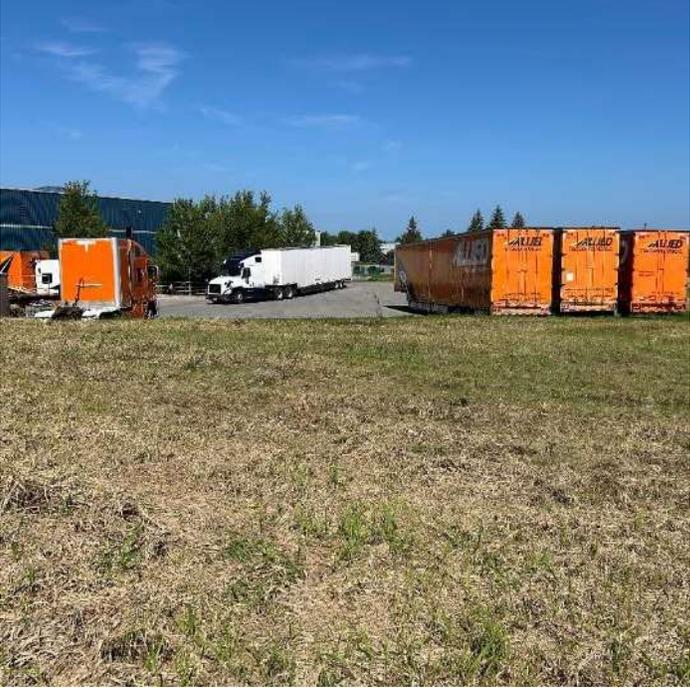
Photograph No. 9

Date: 8/23/2024	
Description Southern extent of neighbouring property 530 Lacolle Way.

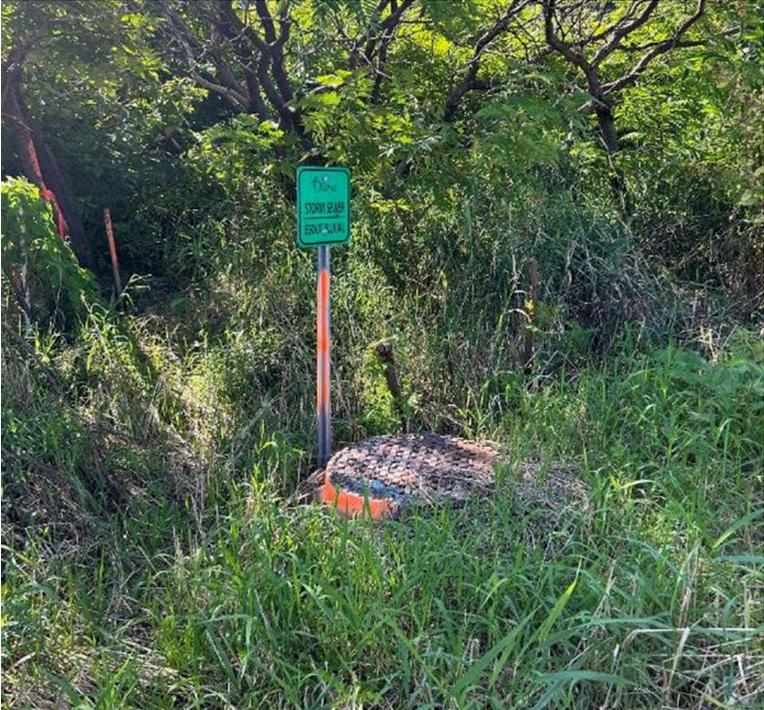
Photograph No. 10

Date: 8/23/2024	
Description Storm sewer found on the southwestern extent of the property.

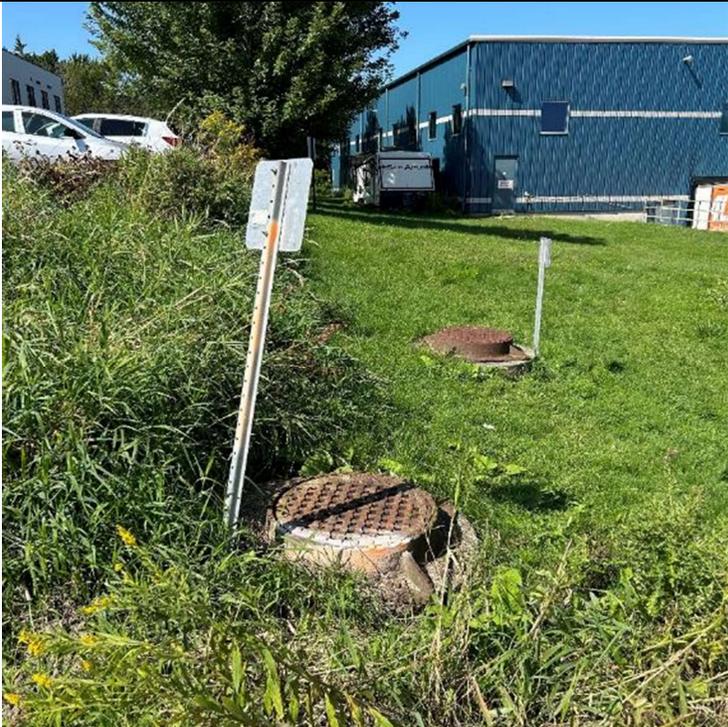
<p>Photograph No. 11</p>

<p>Date: 8/23/2024</p>	
<p>Description</p> <p>Two (2) sewers identified on the southwestern corner of the Site and on the neighbouring 530 Lacolle Way property.</p>

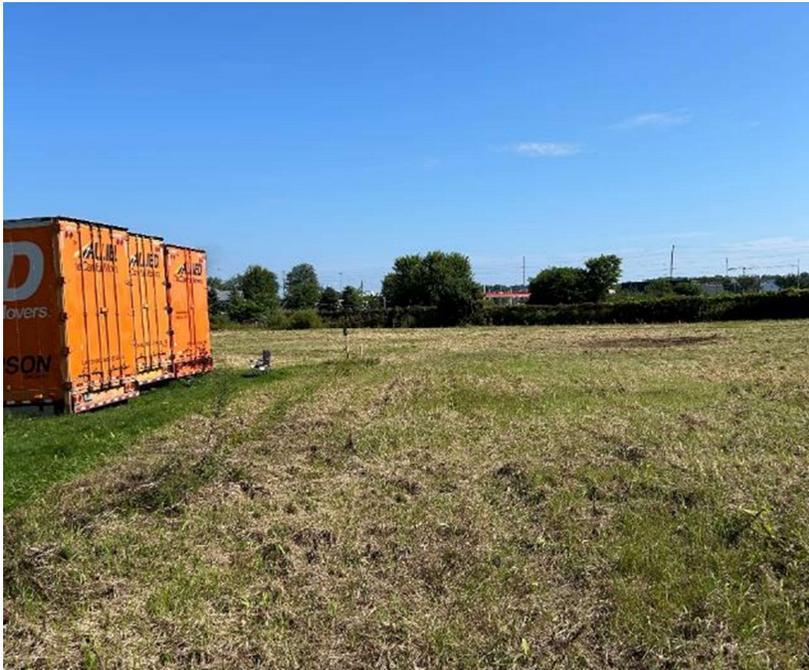
<p>Photograph No. 12</p>

<p>Date: 8/23/2024</p>	
<p>Description</p> <p>Southwestern extent of the Site facing northeast.</p>

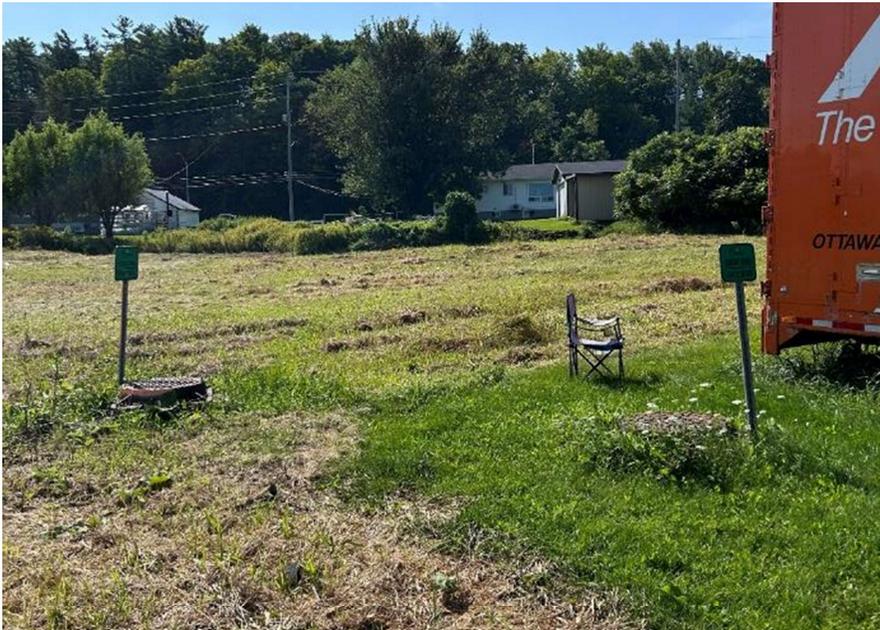
Photograph No. 13

Date: 8/23/2024	
Description Two (2) sewers identified along the western extent of the Site and the neighbouring 530 Lacolle Way property.

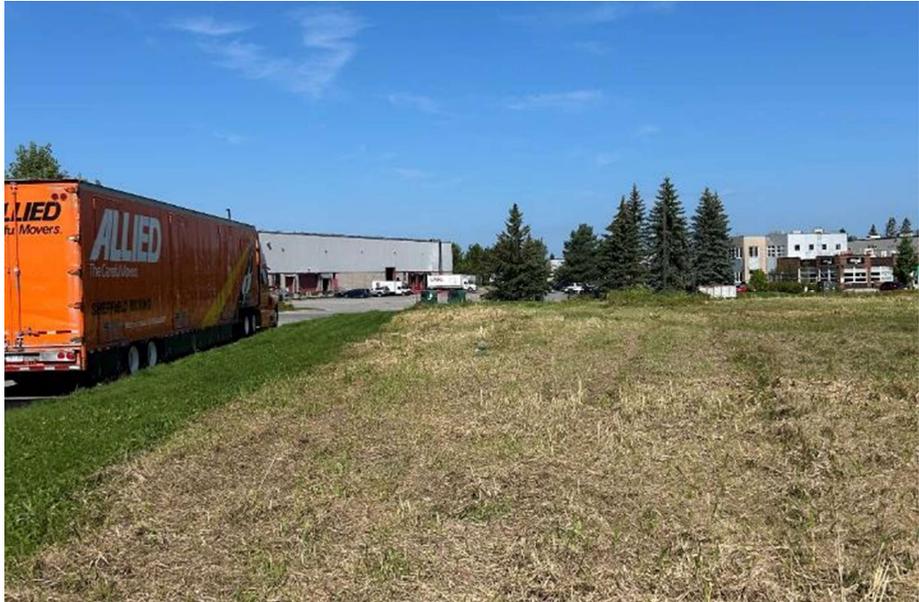
Photograph No. 14

Date: 8/23/2024	
Description Northwestern extent of the Site along neighbouring 530 Lacolle Way property.

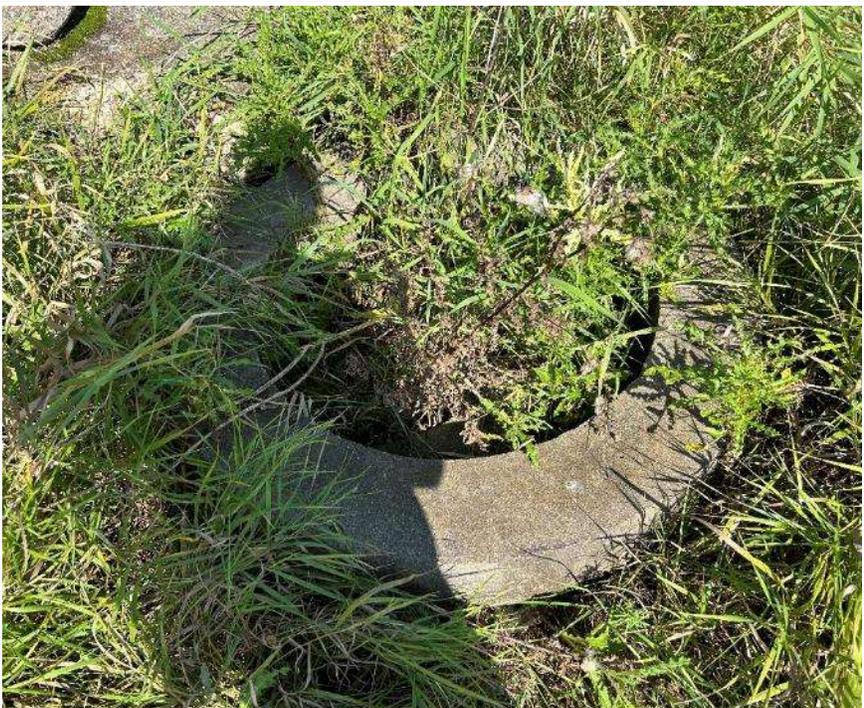
Photograph No. 15

Date: 8/23/2024	
<p>Description</p> <p>Concrete debris encountered on the northwestern portion of the Site.</p>

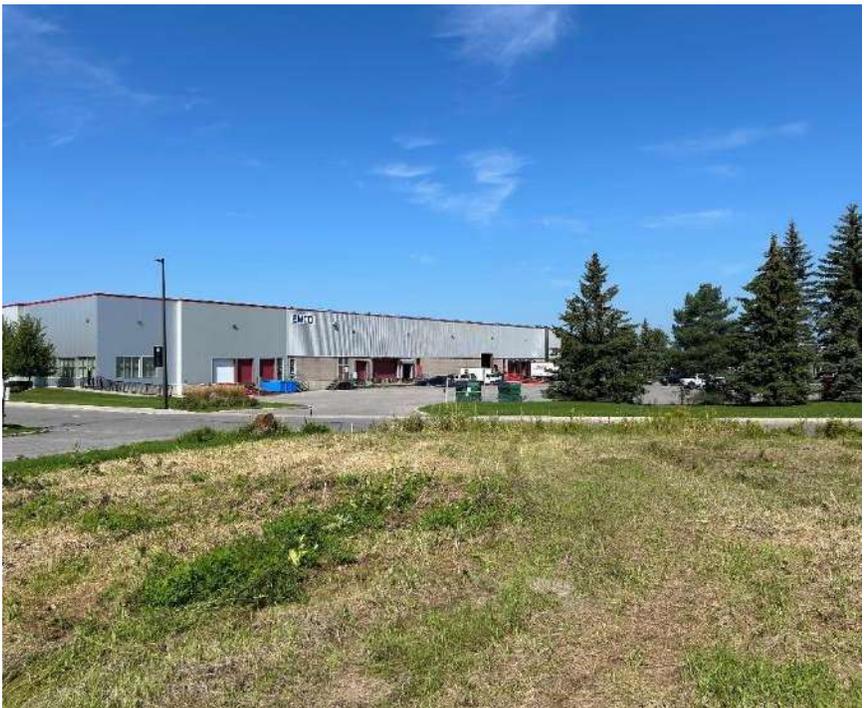
Photograph No. 16

Date: 8/23/2024	
<p>Description</p> <p>Neighbouring property to the northwest of the Site (1680 Vimont Court)</p>
