# **Geotechnical Investigation**

## **Proposed Self-Storage Facility**

1015 & 1045 Dairy Drive Ottawa, Ontario

Report PG6498-1 Revision 4 dated June 10, 2024

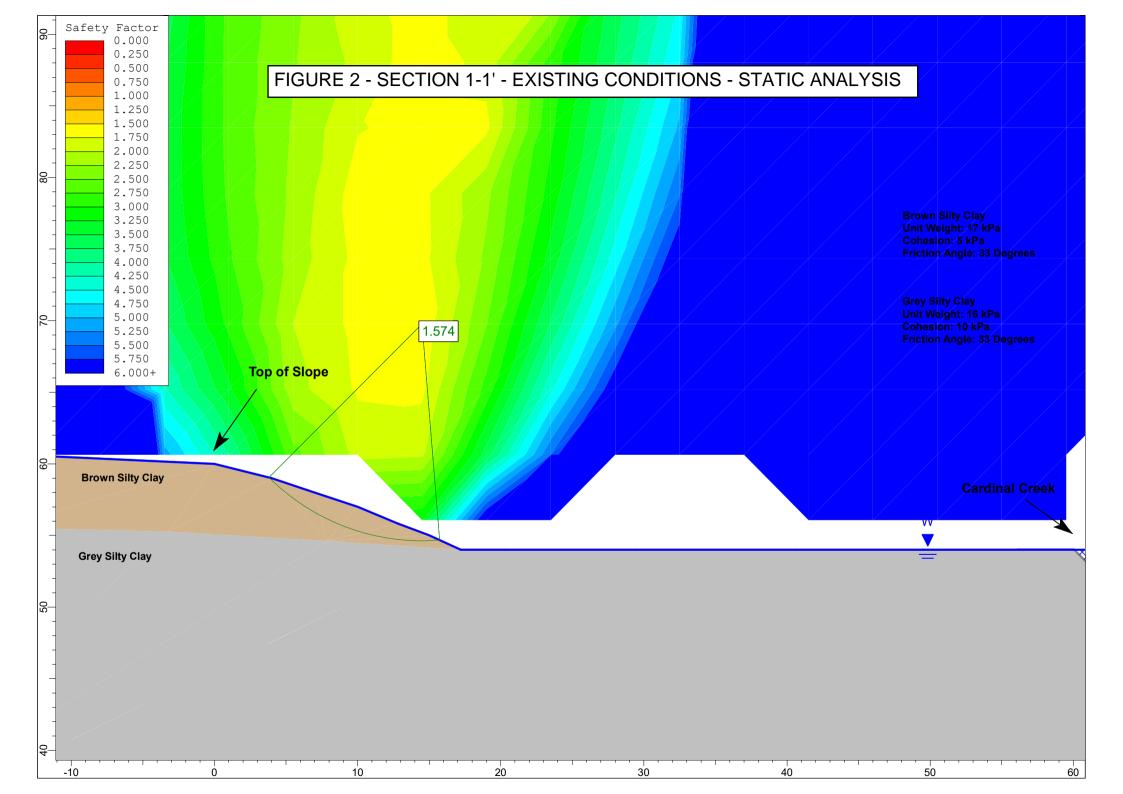
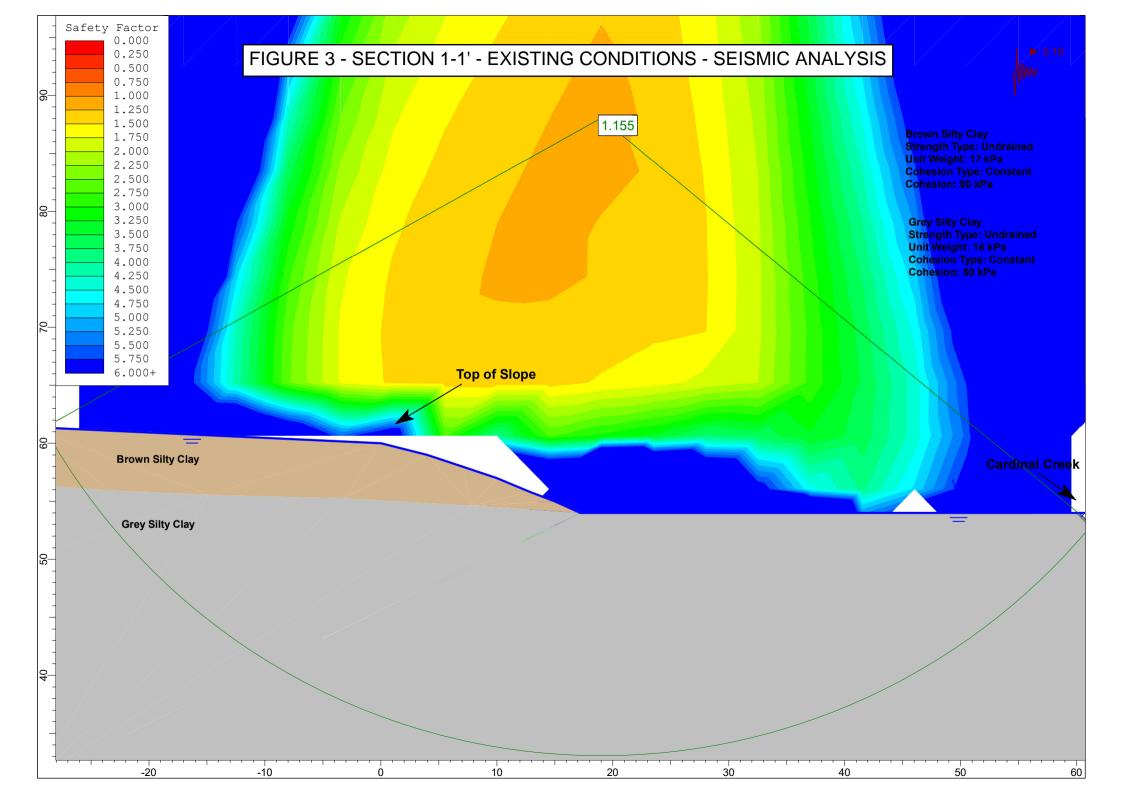
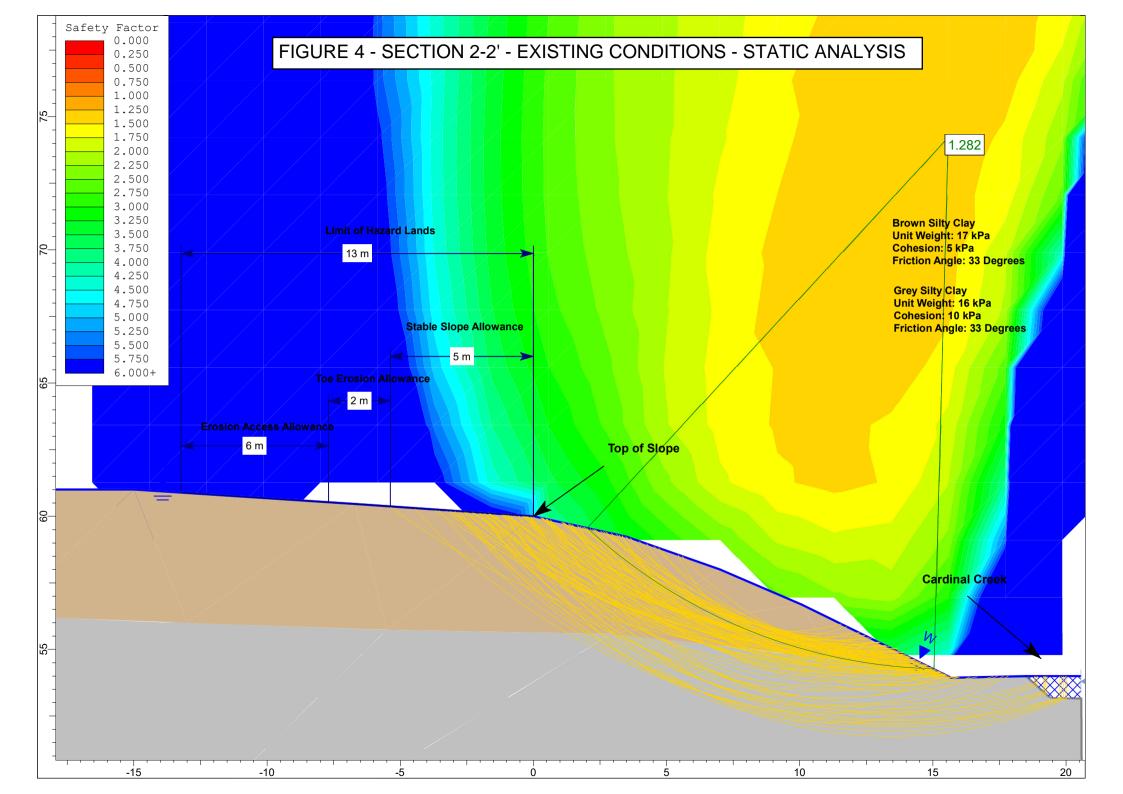
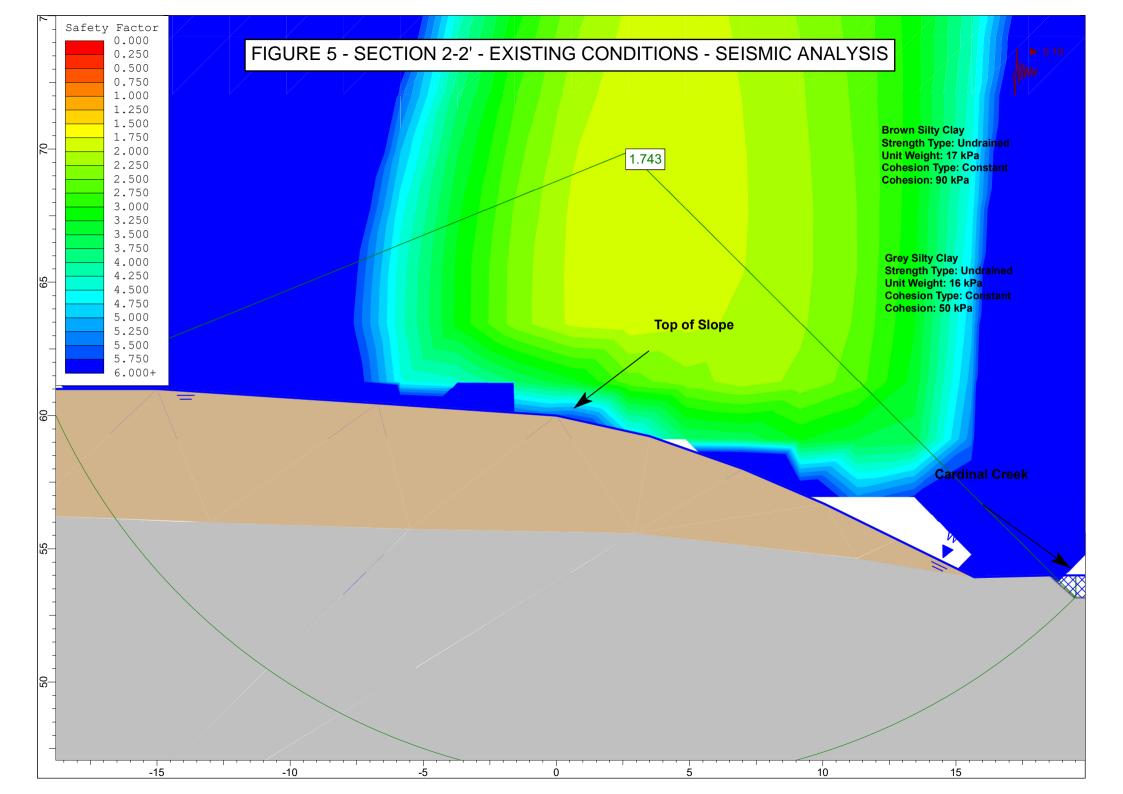
The results for the slope stability analyses under static and seismic conditions at cross-sections 1-1' and 2-2' are shown on Figures 2 to 5, which are attached to the current report in Appendix 2. The results of the slope stability analyses indicate that the factor of safety under seismic conditions exceeds 1.1 for both slope cross-sections.

The results of the slope stability analysis under static conditions at crosssection 1-1' indicate a suitable factor of safety exceeding 1.5. The results of the slope stability analysis under static conditions at slope cross-section 2-2' indicates that a Limit of Hazard Lands setback of 13 m from the top of slope is required. This 13 m Limit of Hazard Lands setback consists of a 5 m stable slope allowance, plus a 2 m toe erosion allowance, and 6 m erosion access allowance. This Limit of Hazard Lands setback is shown on the attached Drawing PG6498-3 – Slope Setback Plan. The setbacks are also shown in cross-section on Drawings PG6498-4, PG6498-5, and PG6498-6. As the subject site boundary and proposed self-storage facility is located approximately 13 m from the top of slope, at its nearest point, the Limit of Hazard Lands does not extend onto the subject site and does not impact the proposed development.

The slope stability analysis of the proposed site conditions was conducted using SLIDE, a computer program which permits a two-dimensional stability analysis using several methods including the Bishop's method, which is a widely used and accepted analysis method. A horizontal acceleration of 0.16 g (50% of PGA = 0.32g) was utilized for the seismic analysis.

The program calculates a factor of safety, which represents the ratio of the forces resisting failure to those favoring failure. Theoretically, a factor of safety (F.o.S.) of 1.0 represents a condition where the slope is stable. However, due to intrinsic limitations of the calculation methods and the variability of the subsoil and groundwater conditions, a F.o.S. greater than one is usually required to ascertain that the risks of failure are acceptable. A minimum F.o.S. of 1.5 is generally recommended for static analysis conditions and a minimum F.o.S. of 1.1 is generally recommended for seismic analysis conditions, where the failure of the slope would endanger permanent structures.

The analyses were completed by conservatively assuming fully-saturated groundwater conditions extending up to the ground surface.
