Phase One Environmental Site Assessment Part of 4270 Innes Road, Orleans, Ontario

Project No. 0208-001.01

January 16, 2025

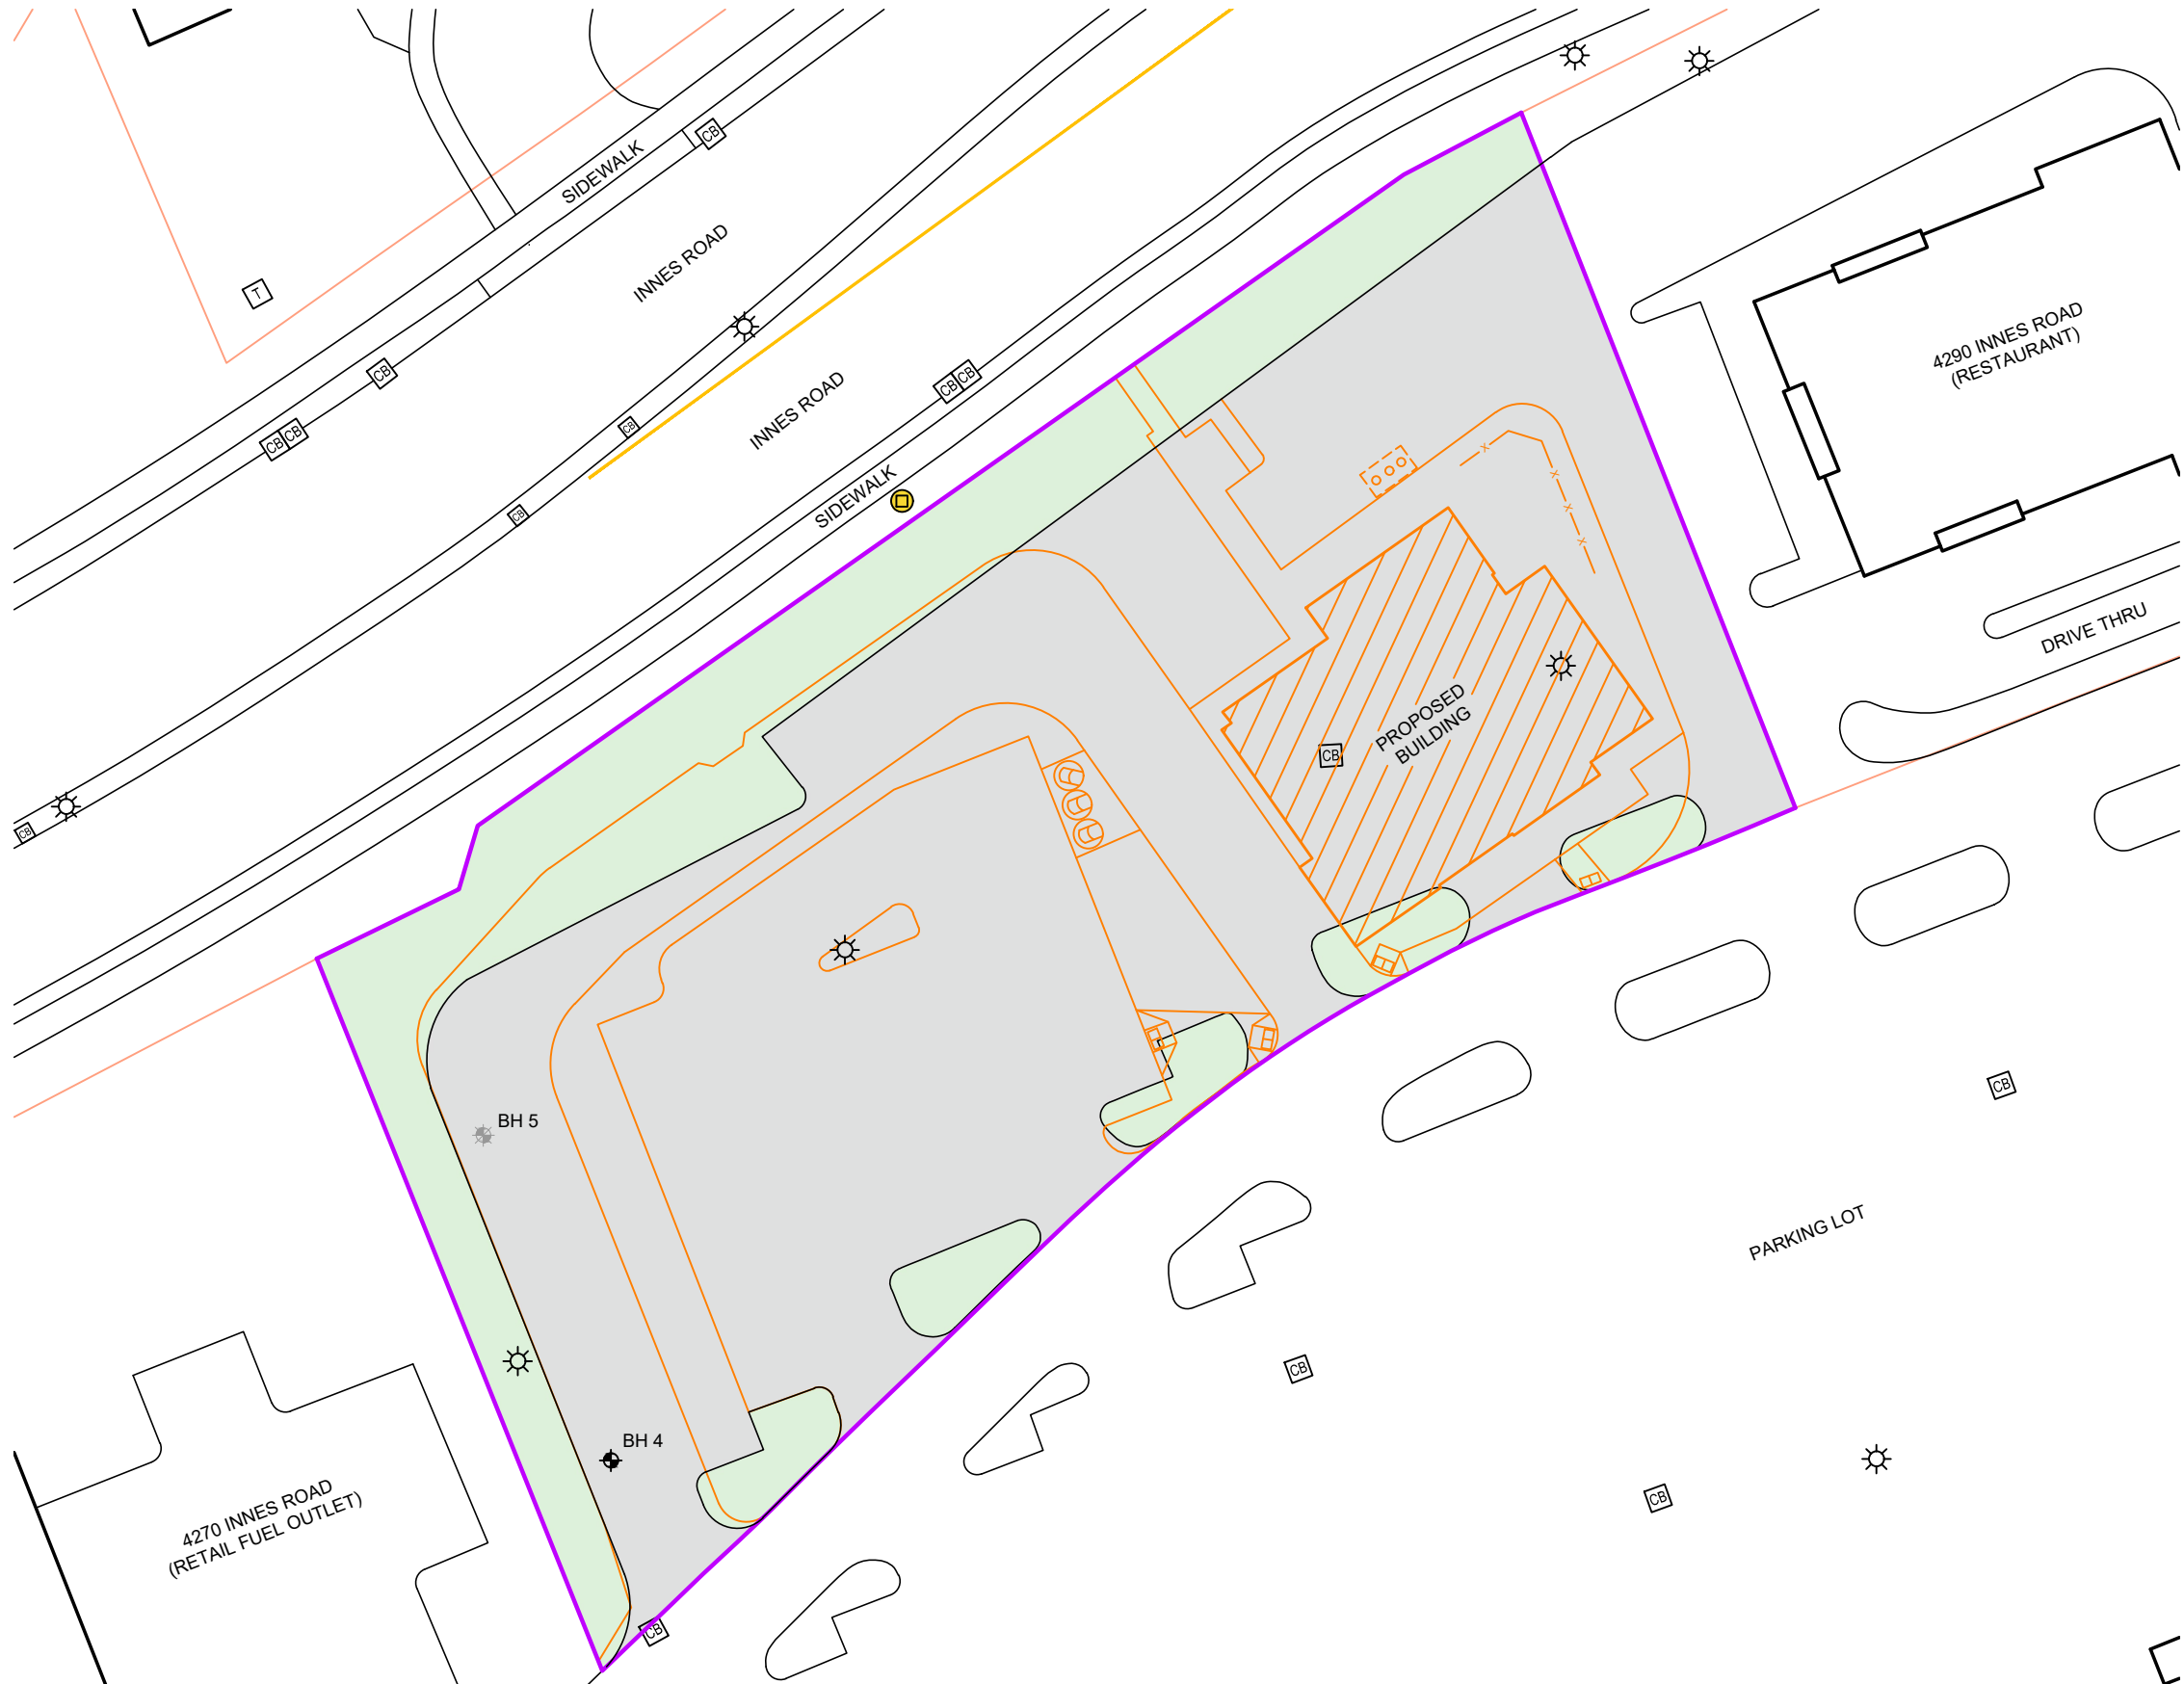
SITE PLAN		
PART OF 4270 INNES ROAD, ORLEANS, ONTARIO		
0208-001.01	JANUARY 2025	FIGURE 2

Neighbouring properties were observed during the Site visit from publicly accessible locations by a BlueFrog representative. Current uses of properties adjacent to the Site are presented on **Figure 2**. Observations made pertaining to the neighbouring properties are as follows.

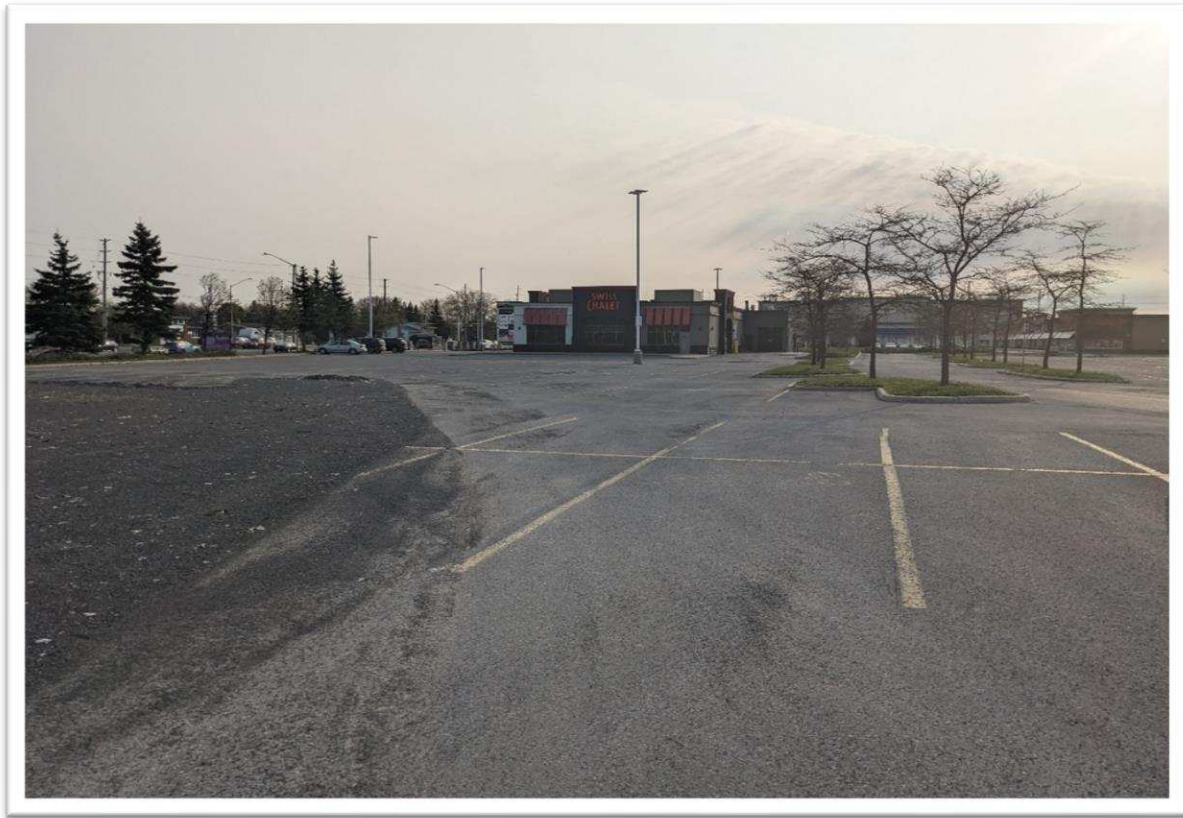
Photo 1: The Site, facing east towards 4290 Innes Road.

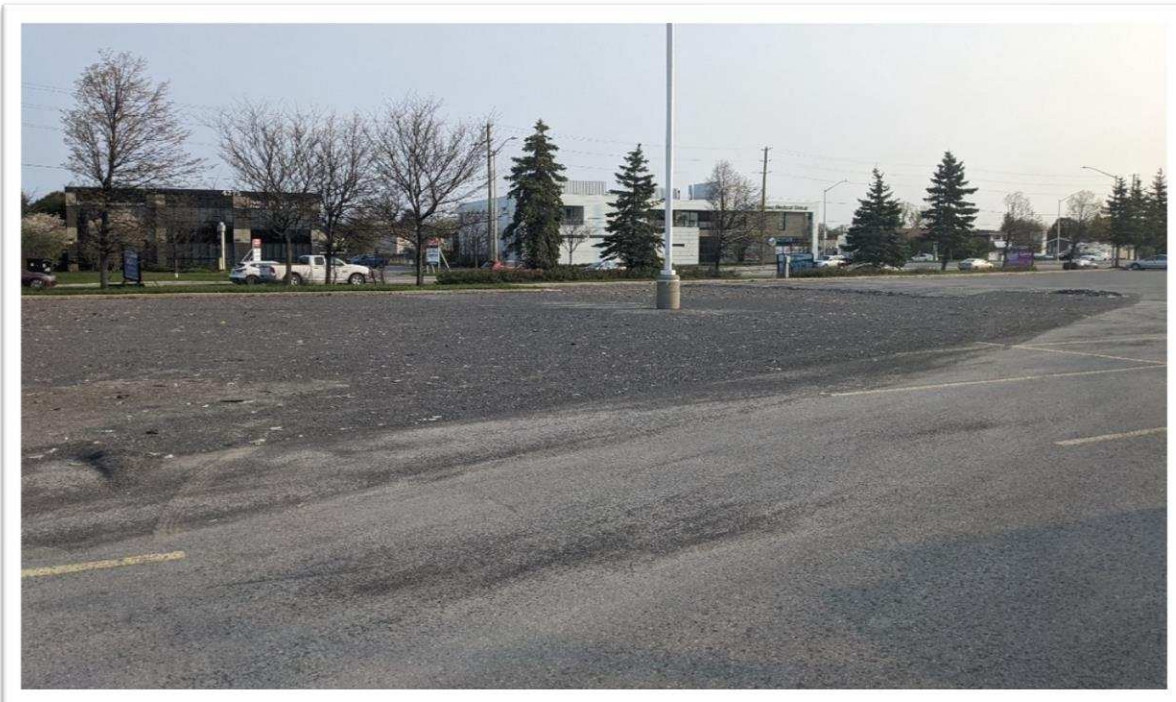
Photo 2: The western boundary of the Site, facing north towards Innes Road.
