October 18, 2024
File: PE6537-LET.01

Subject: **Phase I - Environmental Site Assessment Update
Northern Part of 3610 Innes Road
Ottawa, Ontario**

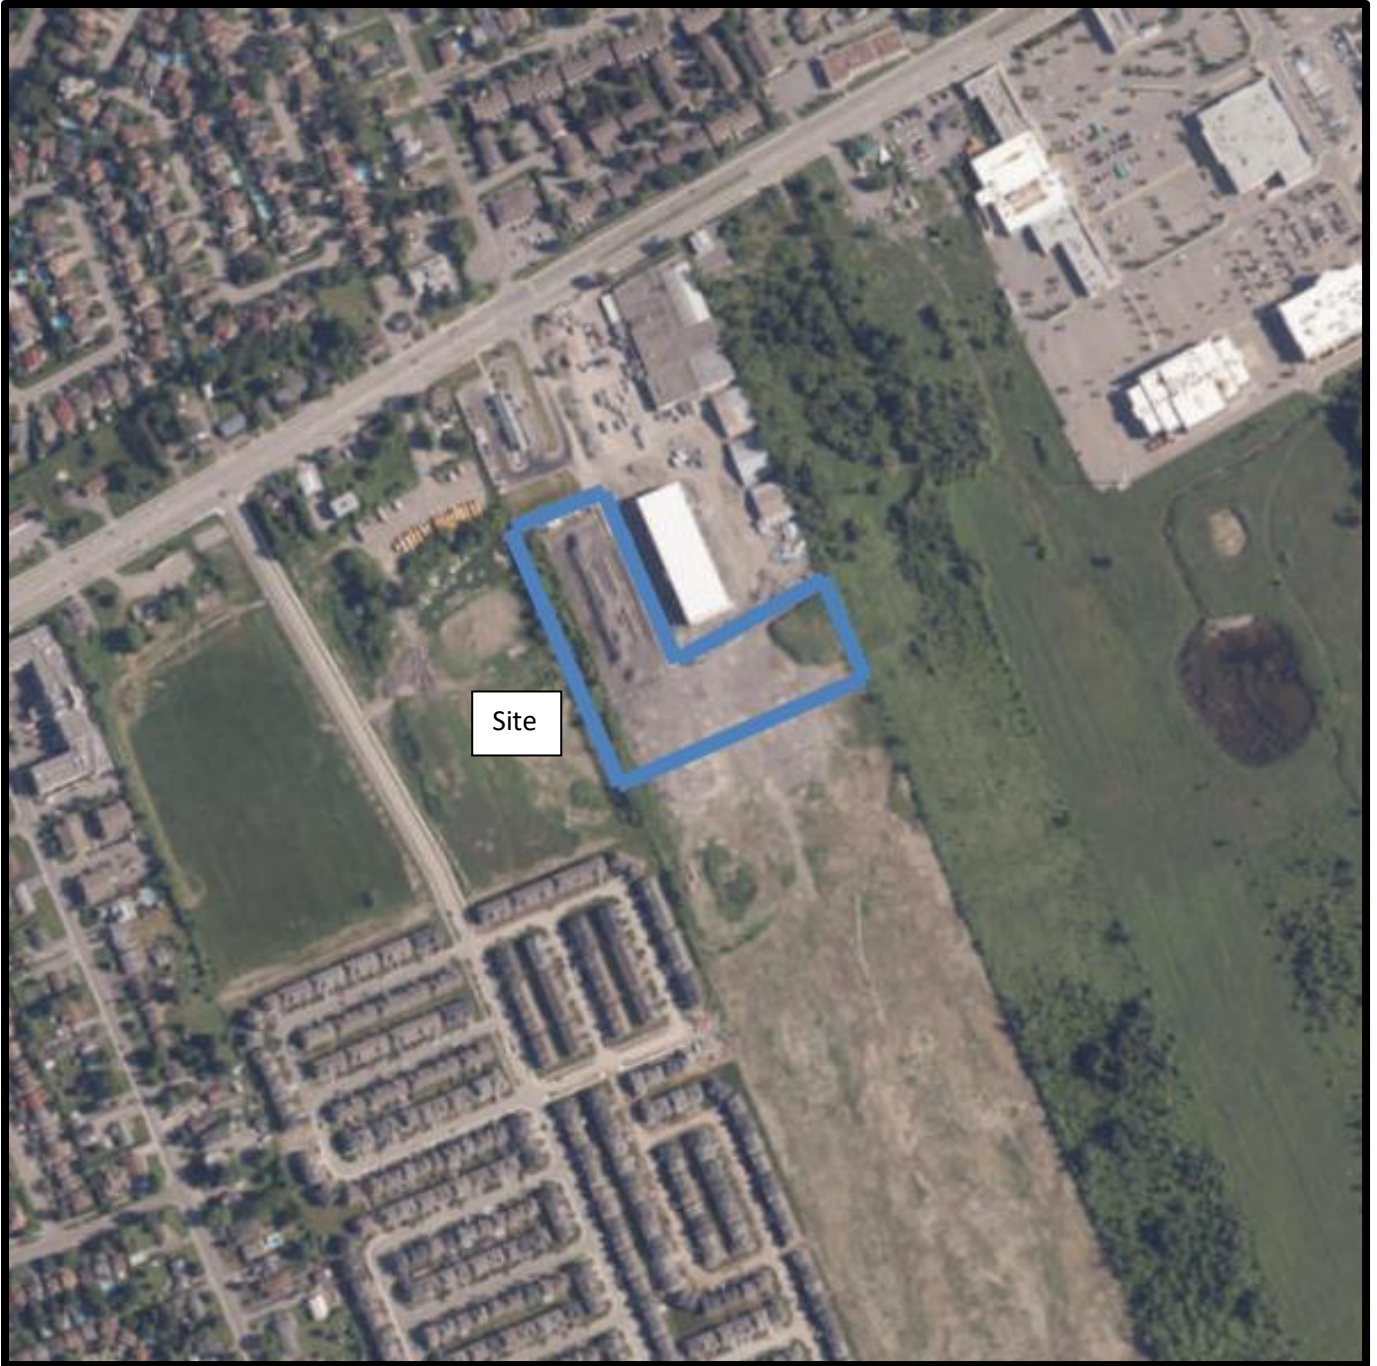
AERIAL PHOTOGRAPH
2022

The latest aerial photograph reviewed for the 2020 Phase I ESA was from 2019. A review of the 2022 aerial photograph shows the north portion of Phase I Property has stockpiles of material. The south portion of the Phase I Property appears to be vacant and grassed along eastern edge. The property adjacent north of the Phase I Property has been developed as a car wash building. A new commercial building has been developed on the property adjacent to northeast of the Phase I Property. Further residential development is observed southwest side of the Phase I Property.
