Broccolini Real Estate Group (Ontario) Inc. 130 Slater Street, Suite 1300 Ottawa, Ontario K1P 6E2

Geotechnical Investigation
Proposed Sanitary Sewer
570 Mach Road
Ottawa, Ontario

September 26, 2025

Project: 103940.009 REV1

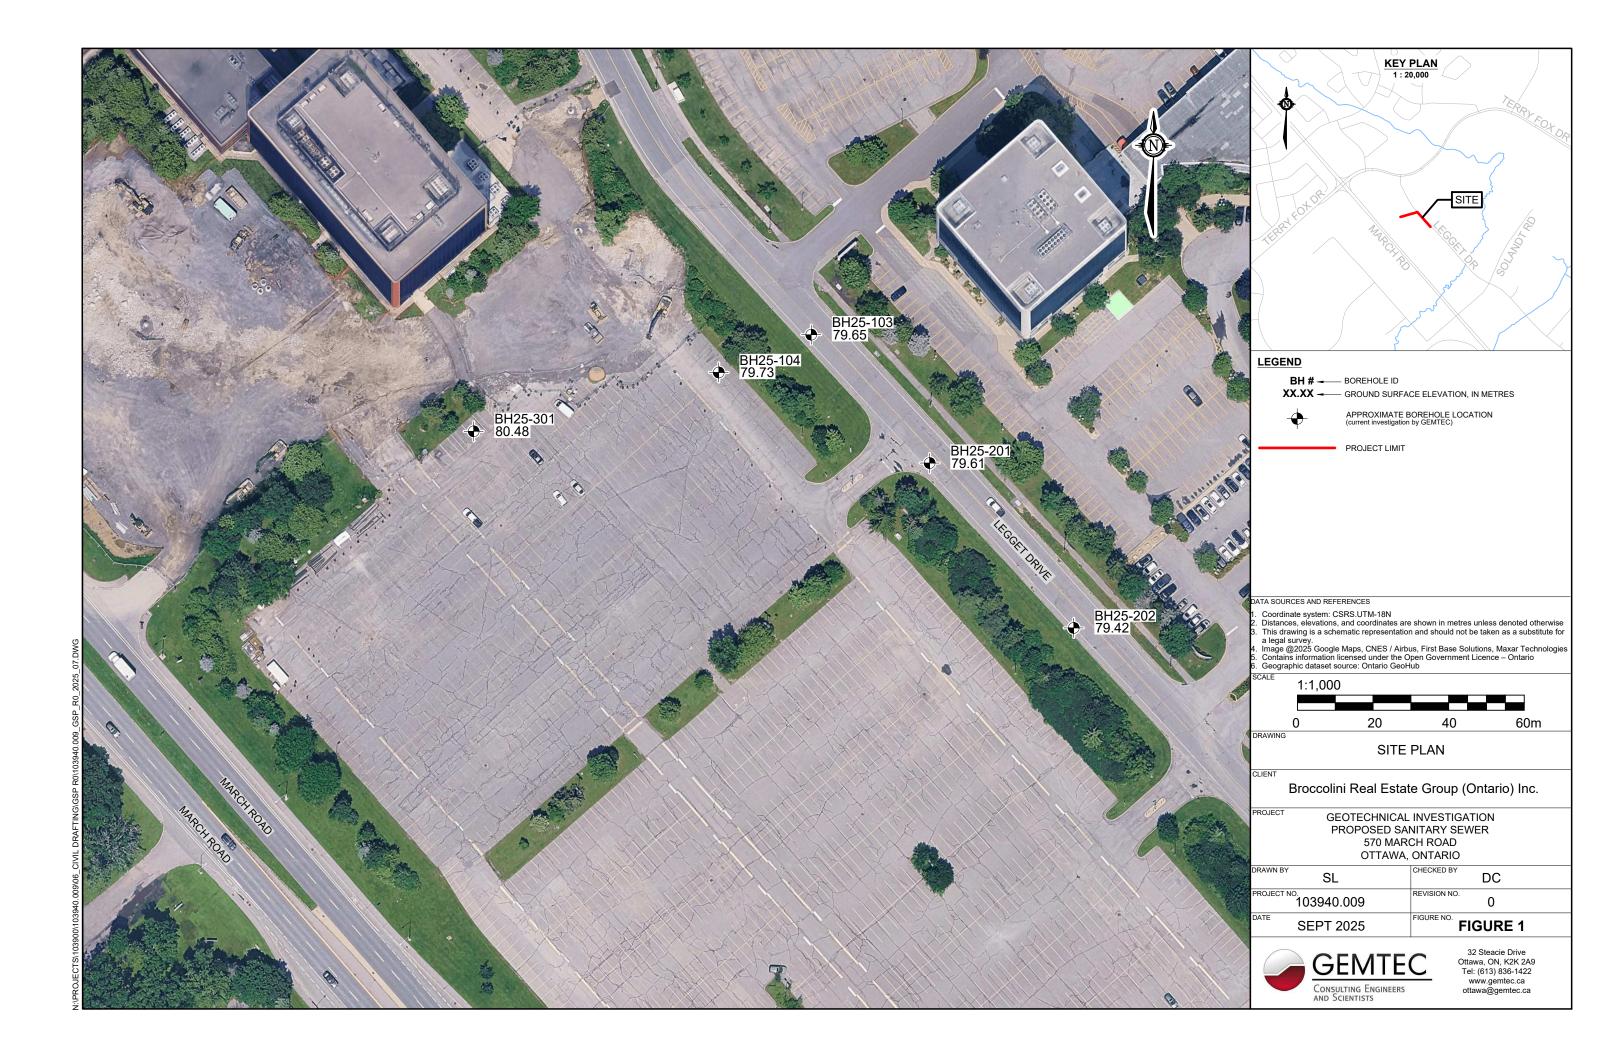
Figure 1 – Site Plan

The fieldwork for this investigation was carried out on June 19 and 20, 2025. On those dates the following boreholes were advanced at the approximate locations shown on the Site Plan, Figure 1 following the text of this report.

- Boreholes 25-103 and 25-104 along Legget Drive;
- Boreholes 25-201 and 25-202 along Legget Drive; and
- Borehole 25-301 within the existing parking lot at 570 March Road.

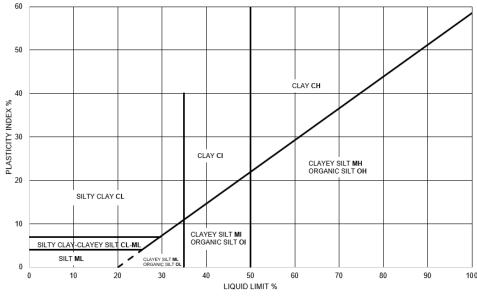
Dual Symbol – Is used to indicate when soils are transitional. For coarse grained soils, it is used when the soil has between 5 and 12% fines (e.g., SP-SC, Sand to Silty Sand). For fine-grained soils it is used when the plasticity index and liquid limit values plot in the area shown in the plasticity chart on this page.

Borderline Symbol – Is used to indicate soils that are not clearly in one soil type but have similar behaviour and properties as similar materials (e.g., CL/CI or GM/SM).

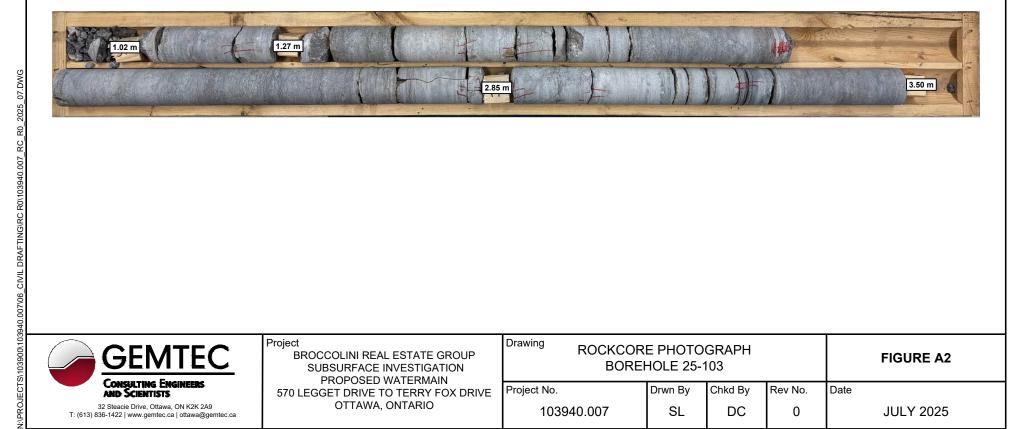
Drawing ROCKCOR BOREI	E PHOTO HOLE 25-1			FIGURE A1
Project No.	Drwn By	Chkd By	Rev No.	Date
103940.007	SL	DC	0	JULY 2025

At the location of borehole 25-103 the sandstone is fresh and generally very thinly to medium bedded. Based on the observations of the Rock Quality Designation (RQD) the bedrock within the depth of investigation can be classified as Good to Excellent, according to the system provided in the Canadian Foundation Engineering Manual, 5th Edition.

DEPTH: 1.02 TO 3.50 METRES BELOW GROUND SURFACE

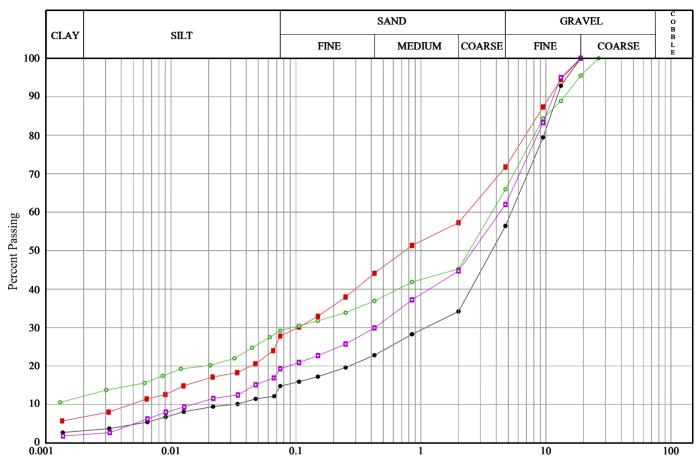
Soils Grading Chart (LS-702/ ASTM D-422)

Grain Size, mm

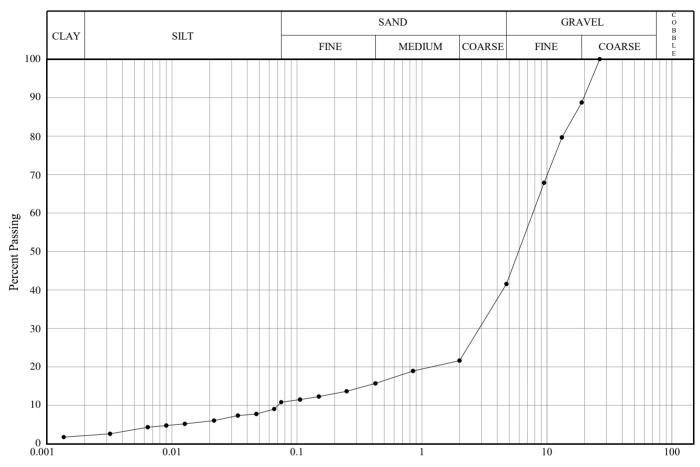
Soils Grading Chart (LS-702/ ASTM D-422)

Line Symbol	Sample	Borehole/ Test Pit	Sample Number	Depth	% Cob.+ Gravel	% Sand	% Silt	% Clay
	Subbase Material	25-301	2	240-330	58.5	30.7	8.7	2.1

Line Symbol	CanFEM Classification	USCS Symbol	D ₁₀	D ₁₅	D ₃₀	D ₅₀	D ₆₀	D ₈₅	% 5-75µm
		N/A	0.071	0.357	2.88	5.94	7.73	16.37	8.7
							F
