# Geotechnical Investigation and Hydrogeological Assessment

600 March Road, Kanata (Ottawa), Ontario

First Gulf

06 March 2024

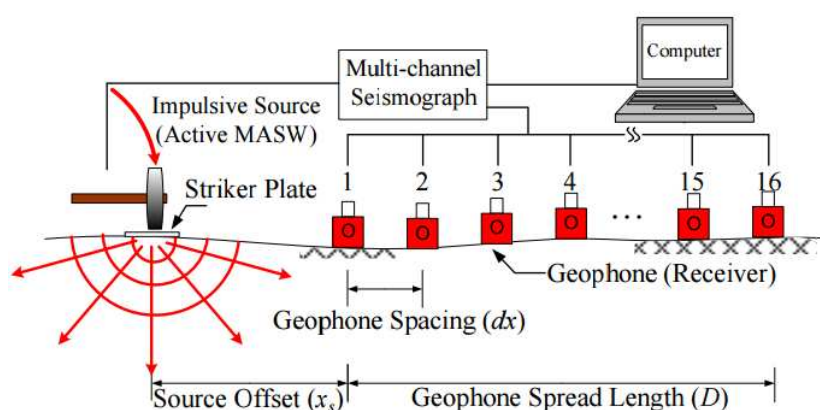
Figure 2.1: Schematic Layout of MASW Test Setup (Sahadewa et al., 2012<sup>2</sup>)
