**Geotechnical Design Report  
Proposed Watermain  
570 March Rd. to Terry Fox Dr.  
Ottawa, Ontario**

July 11, 2025  
Project: 103940.007

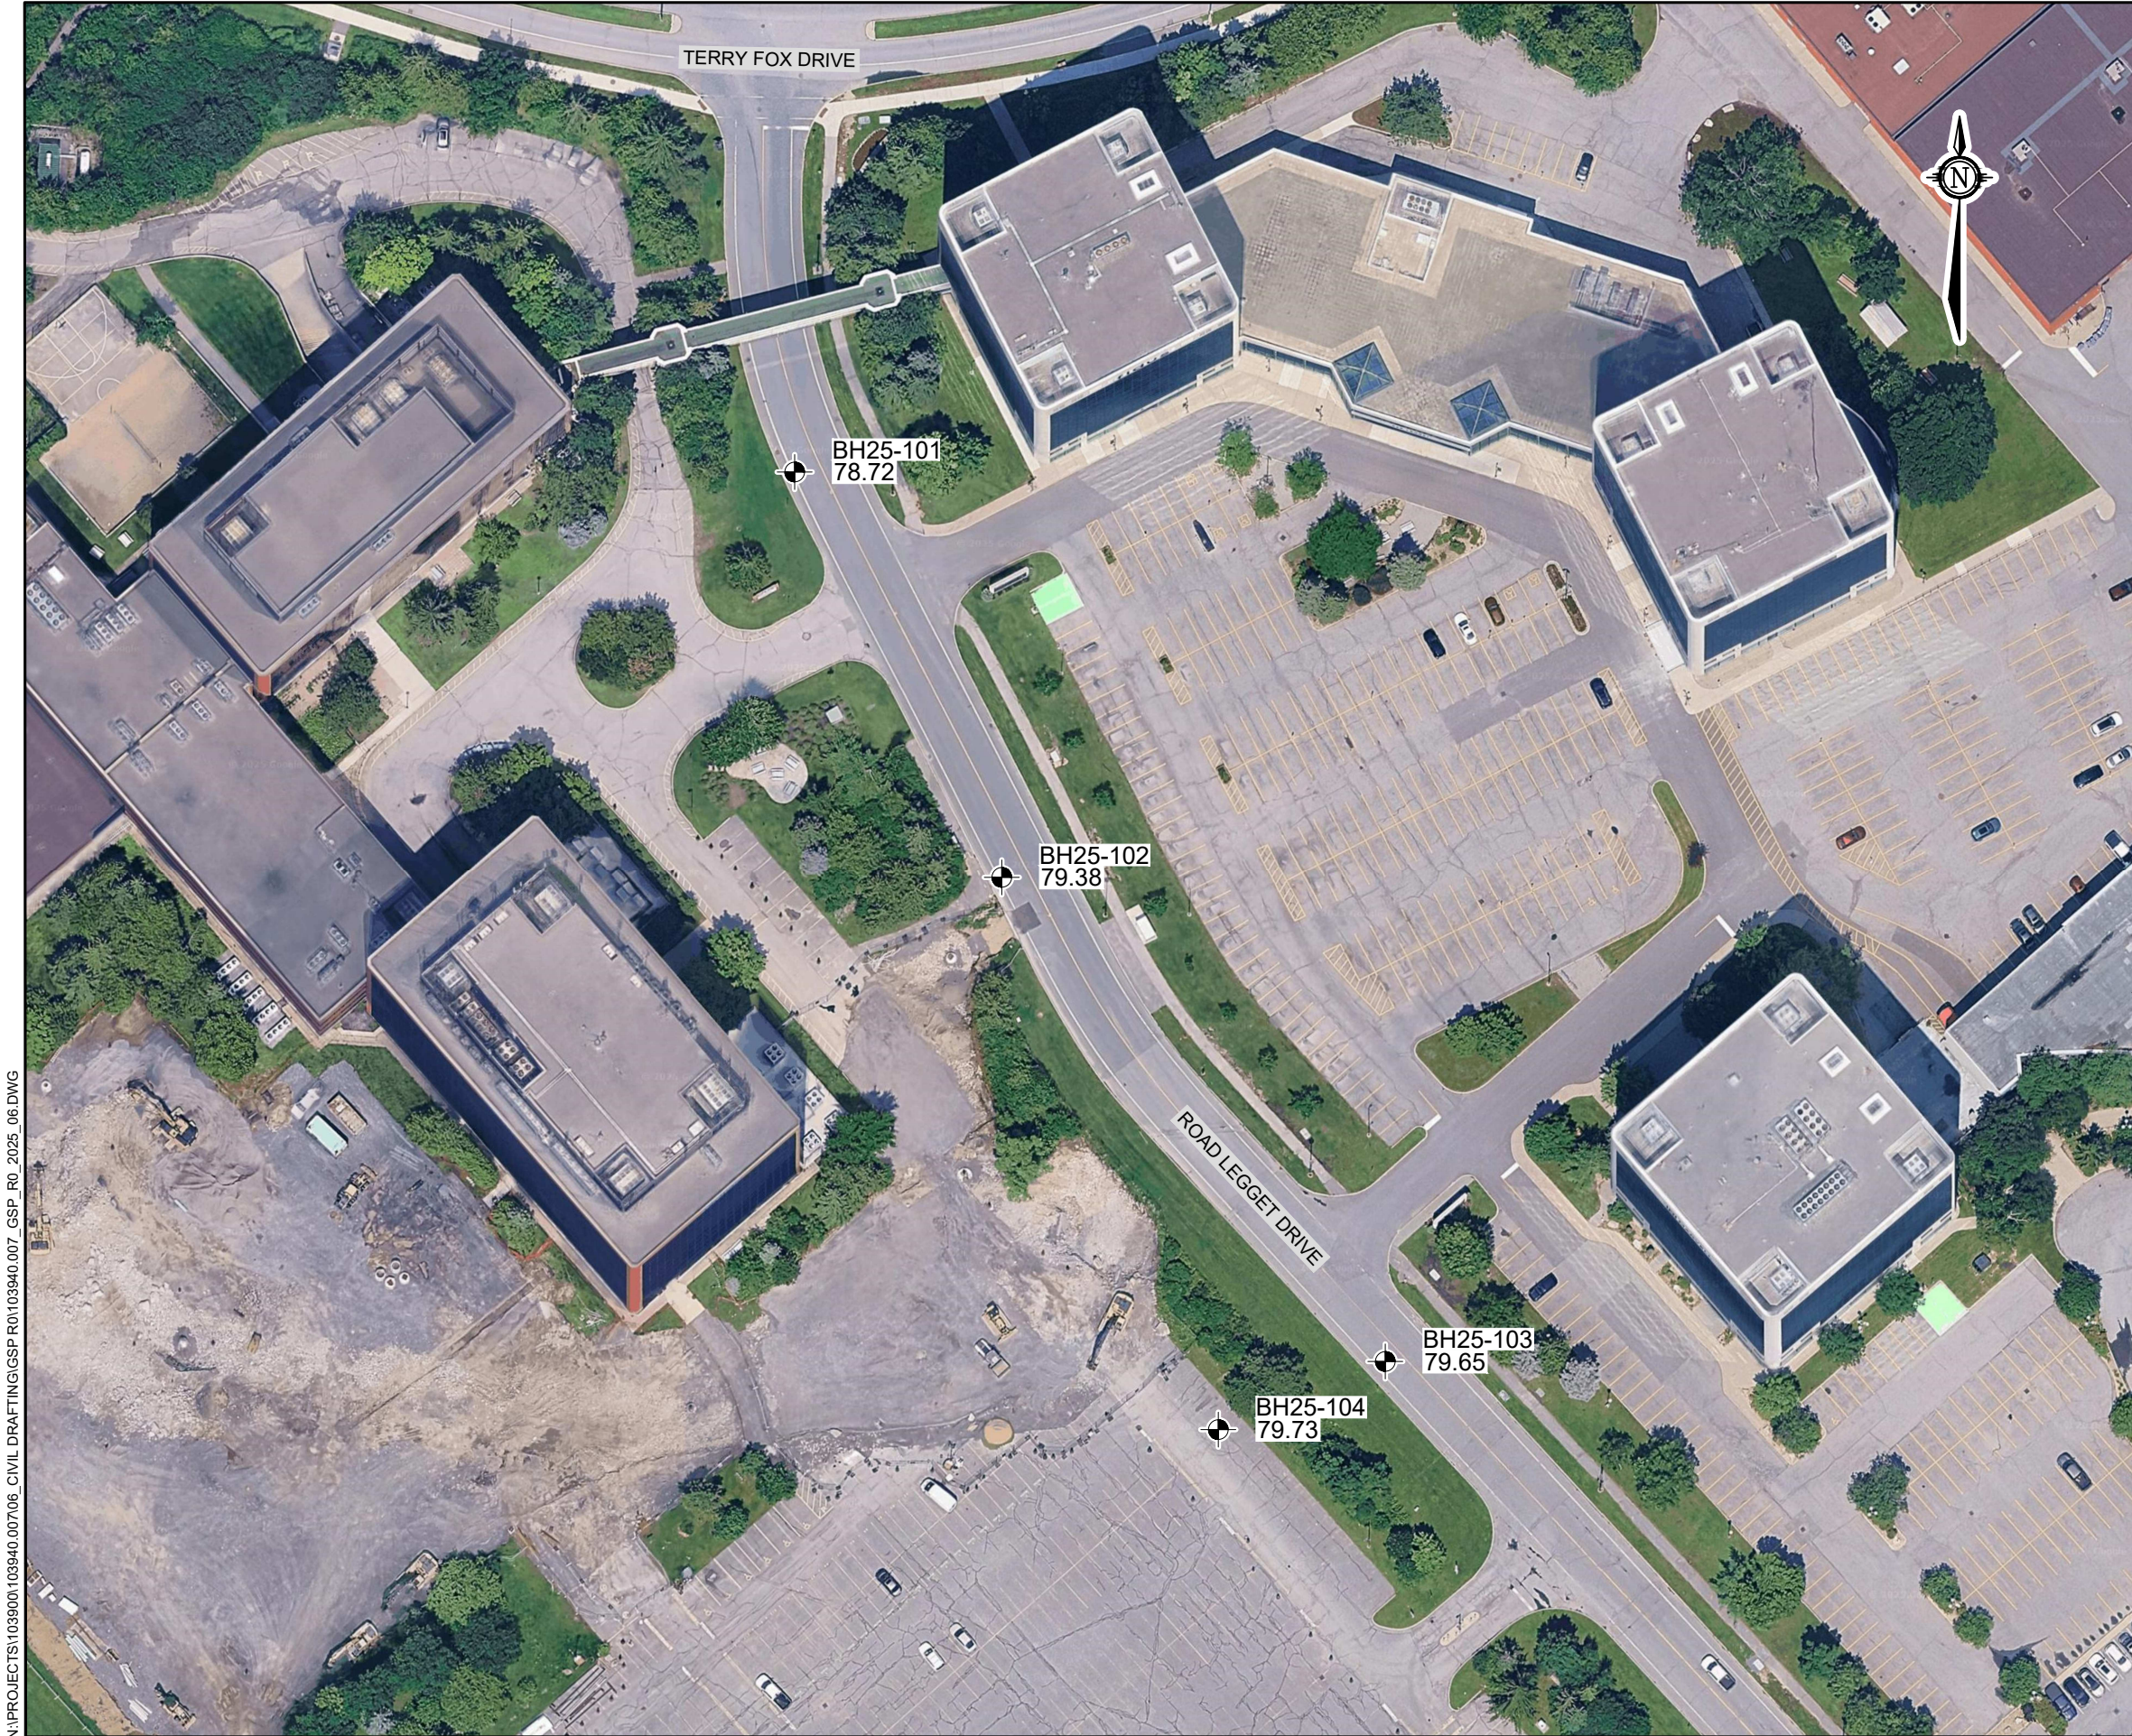
DRAWING

**BH #** — BOREHOLE ID  
**XX.XX** — GROUND SURFACE ELEVATION, IN METRES

The borehole locations and surface elevations from GEMTEC's investigation are presented on the Site Plan, Figure 1. Descriptions of the subsurface conditions logged in the boreholes are provided on the Record of Borehole Sheets in Appendix A.

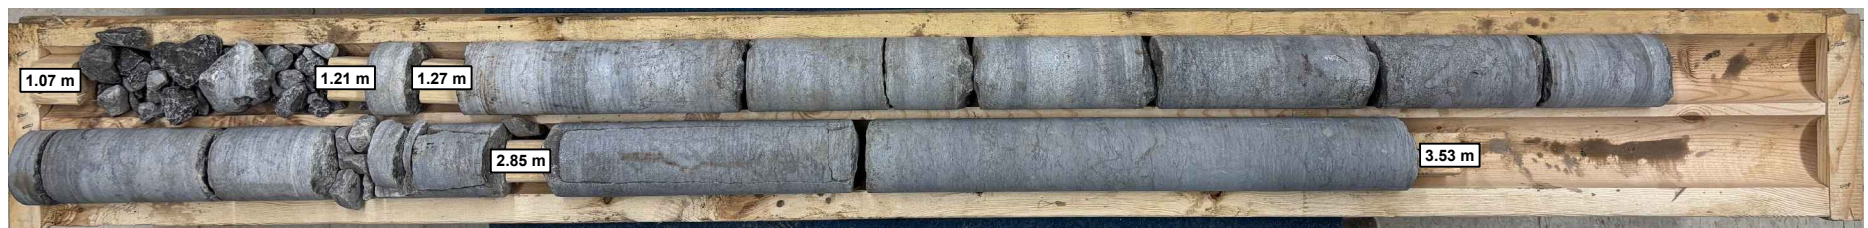
**BOREHOLE: 25-101**  
**BORING DATE: JUNE 18, 2025**  
**DEPTH: 1.07 TO 3.53 METRES BELOW GROUND SURFACE**
