**Geotechnical Investigation
Proposed Sanitary Sewer
570 Mach Road
Ottawa, Ontario**

July 23, 2025
Project: 103940.009

CLIENT: Broccolini Real Estate Group (Ontario) Inc.
 PROJECT: Nokia March Road Campus Sanitary Sewer & Supplemental Site Condition Investigation
 JOB#: 103940.009
 LOCATION: See Borehole Location Plan, Figure 1

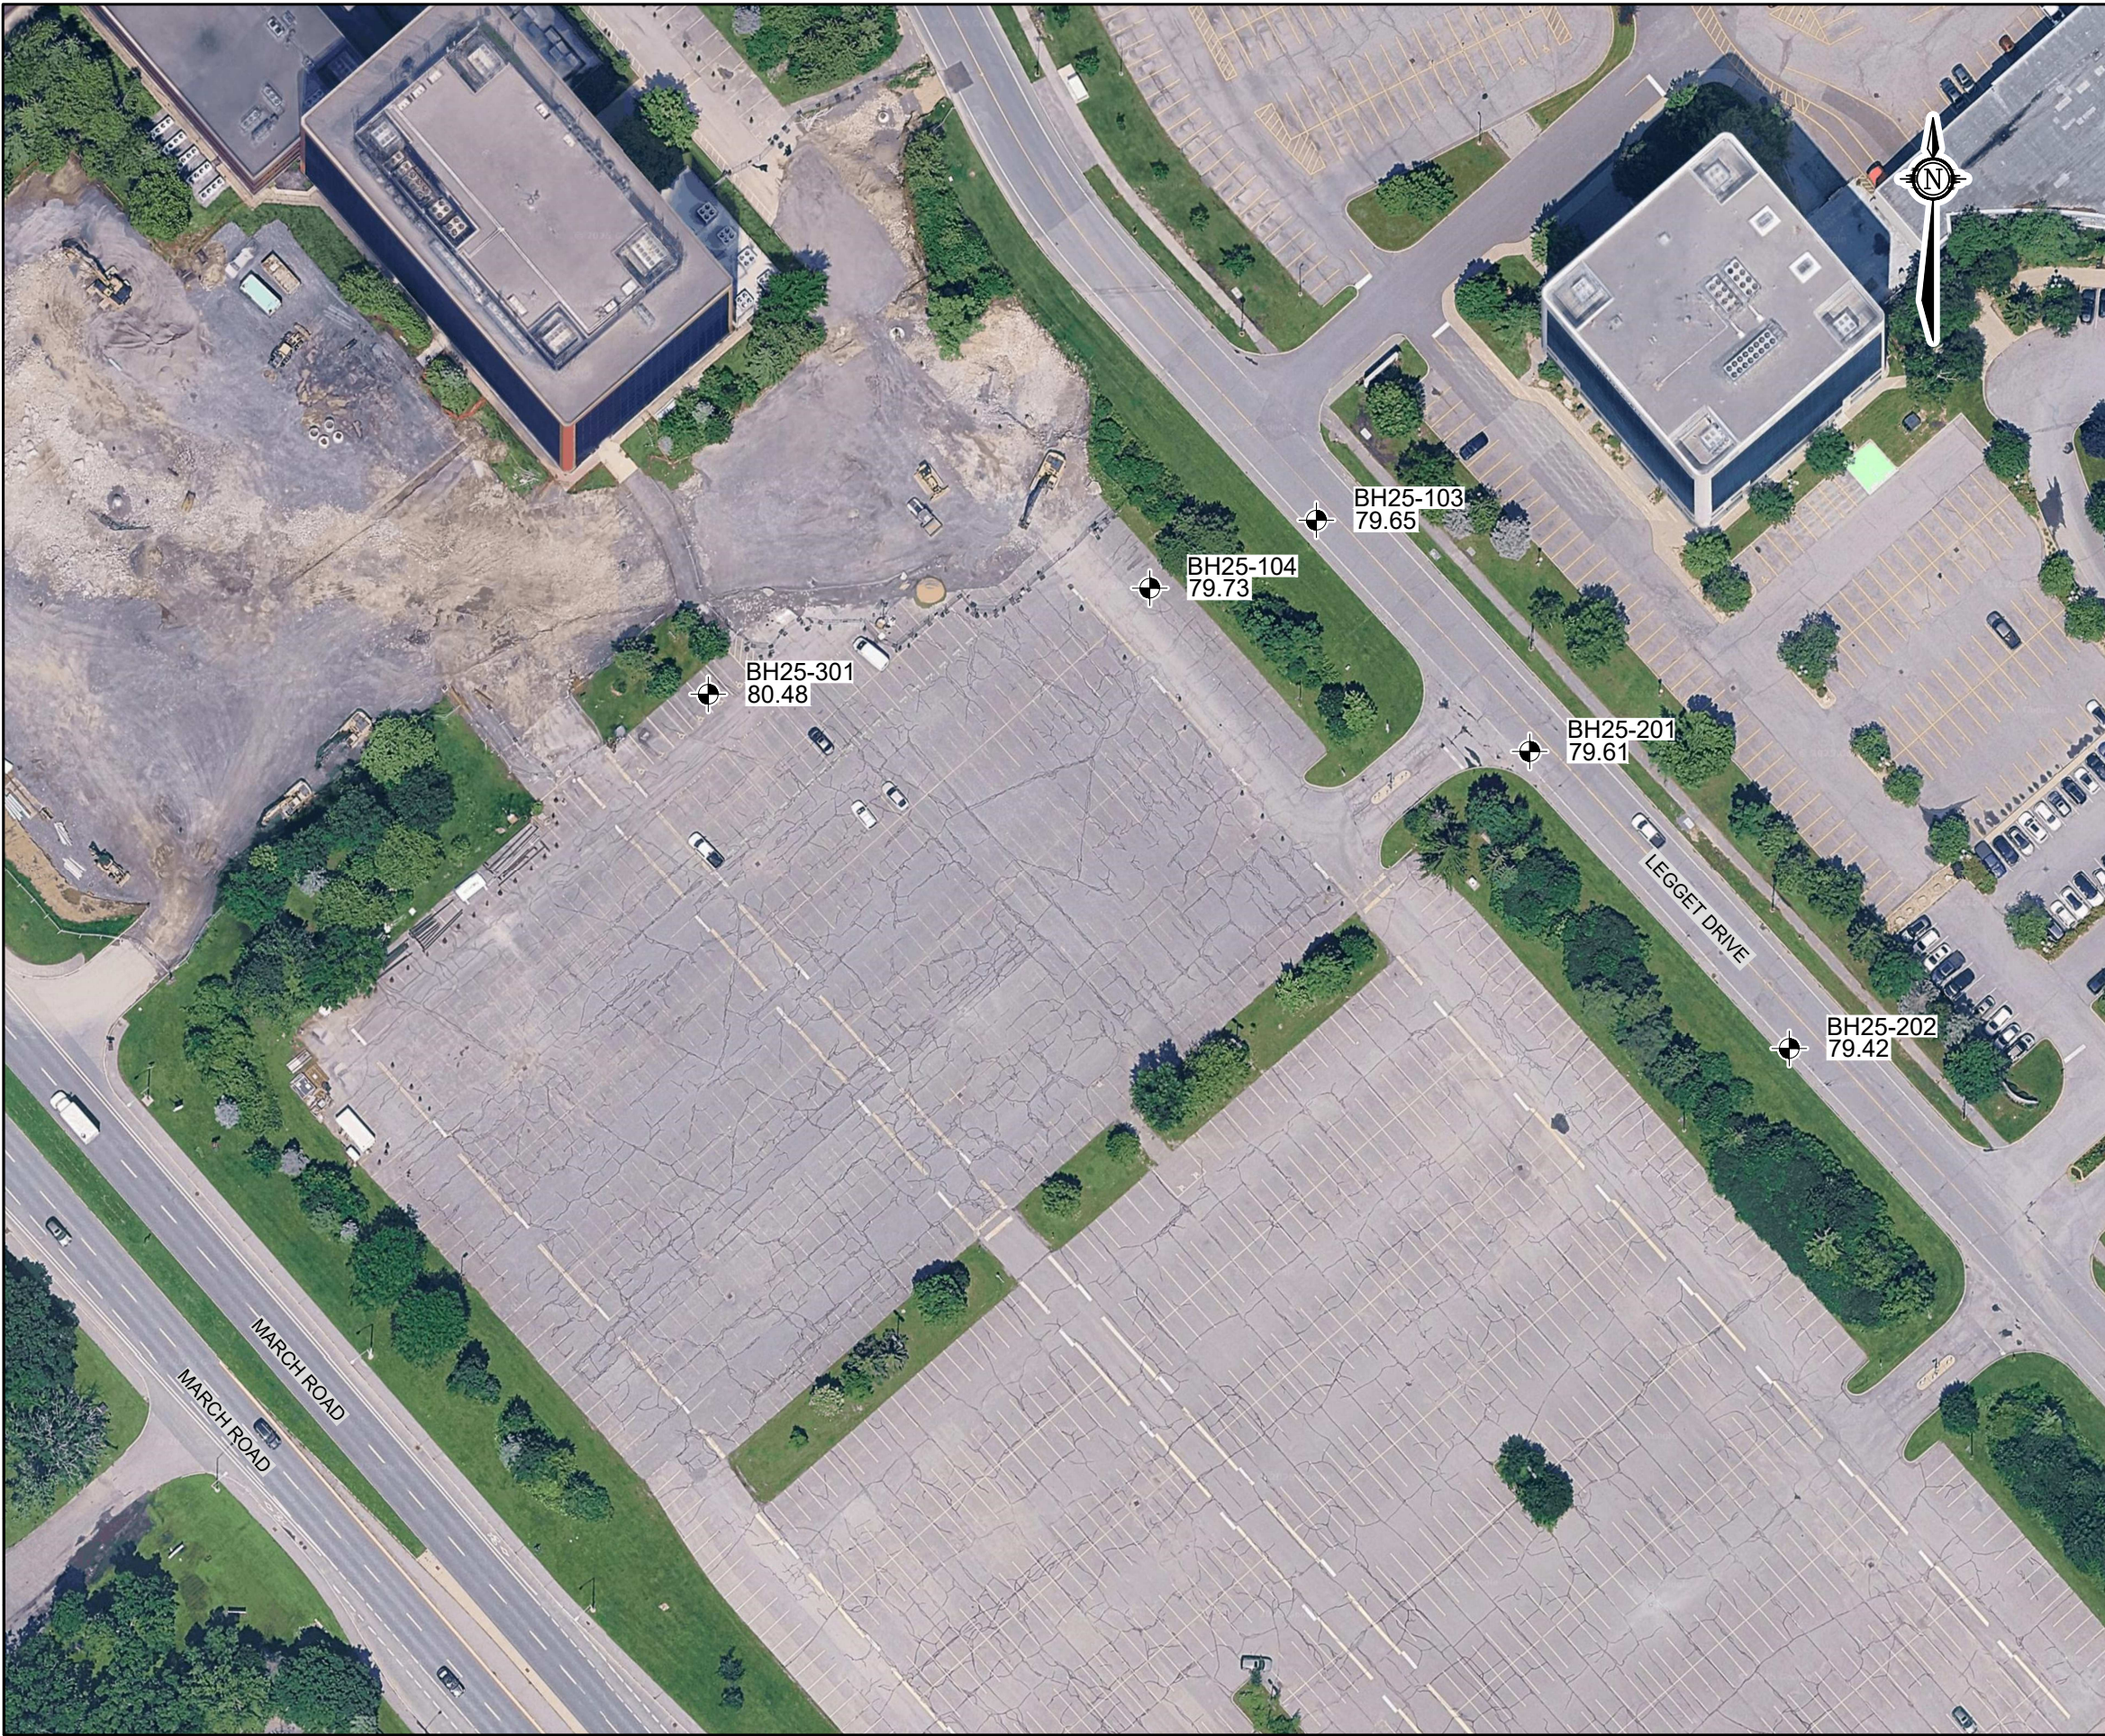
Figure 1 – Site Plan

BH # — BOREHOLE ID
XX.XX — GROUND SURFACE ELEVATION, IN METRES

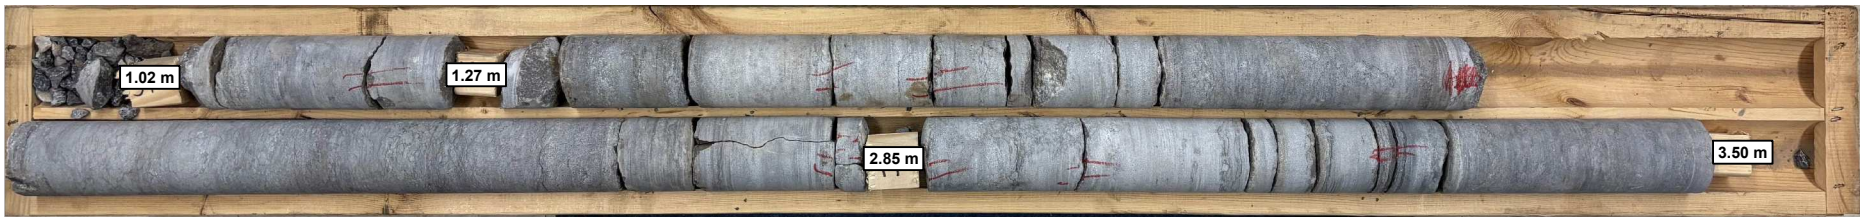
BOREHOLE: 25-103
BORING DATE: MAY 26, 2025
DEPTH: 1.02 TO 3.50 METRES BELOW GROUND SURFACE

One sample of the bedrock core recovered from 25-103 at a depth of about 1.9 metres was tested to determine the unconfined compressive strength of the core. The determined value is 149 Megapascals. According to the core strength classification system set out in the Canadian Foundation Engineering Manual, 5th Edition, the core strength can be described as Very Strong (i.e. > 100 mPa).
