Geotechnical Investigation

Proposed Site Redevelopment 5546 Albion Road South Ottawa, Ontario *Revision 1*

MacEwen Petroleum Inc. 18 Adelaide Street Maxville ON K0C 1T0

June 2022, Revised November, 2023

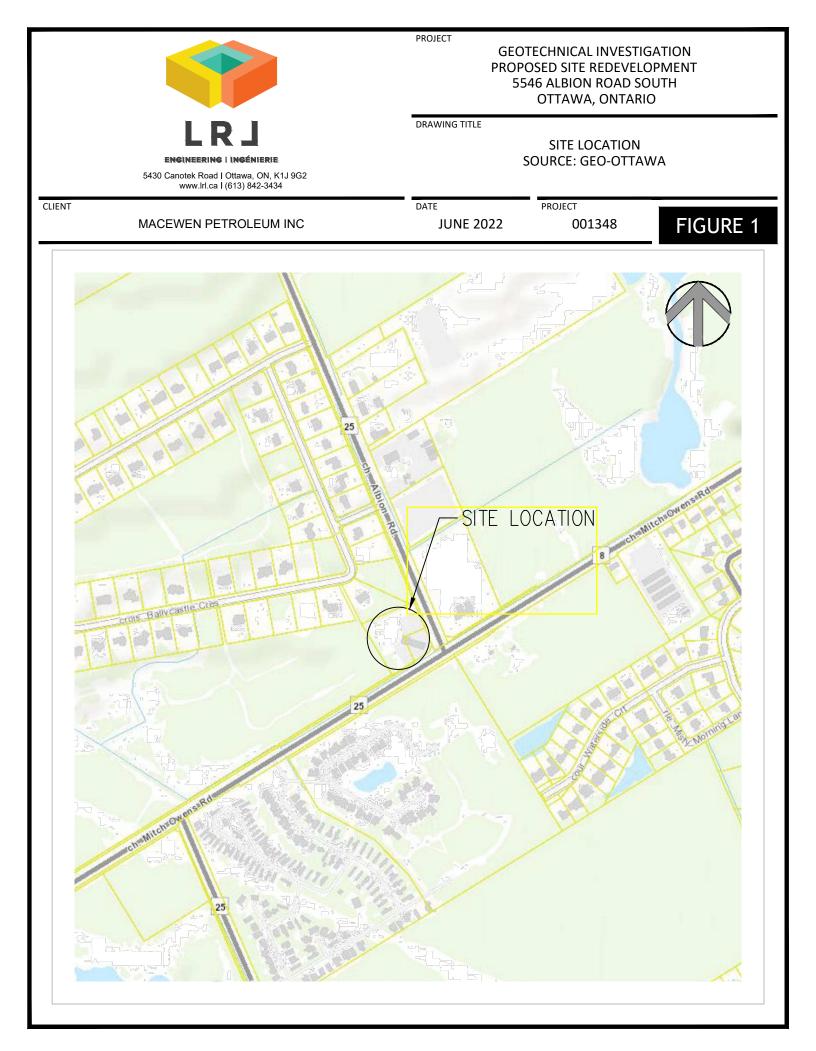
The site under investigation is currently a fully operational gas station, consisting of a convenience store and fuelling canopy. The topography of the site is considered to be relatively flat. The site is bound by Albion Street South to the east, and Mitch Owens Road to the south. Access to the site will come by way of Albion and Mitch Owens Road. The location is presented in Figure 1 included in **Appendix A**.

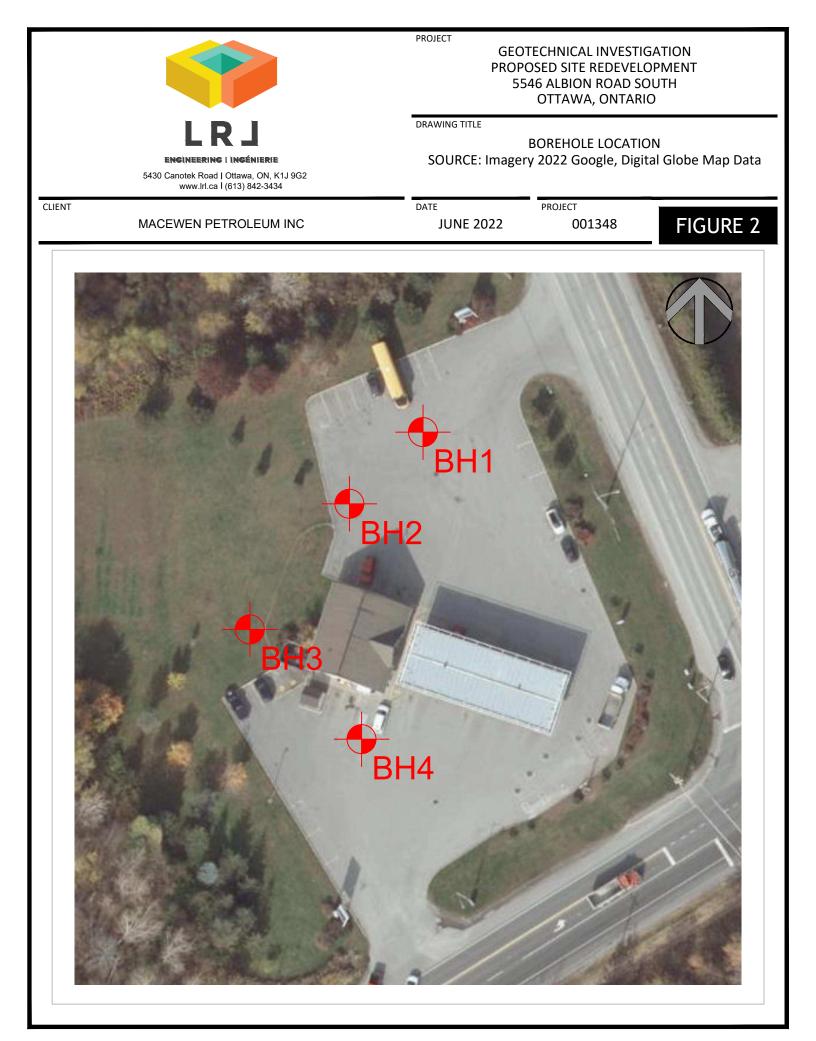
The fieldwork for this investigation was carried out on May 25, 2022. Prior to the fieldwork, the site was cleared for the presence of any underground services and utilities. A total of four (4) boreholes, labelled BH1 through BH4, were drilled onsite to get a general representative of the site's soil condition. It shall be noted, the possible drilling locations was limited to due underground utilities, fuel lines and tanks. The approximate locations of the boreholes are shown in Figure 2 included in **Appendix A**.

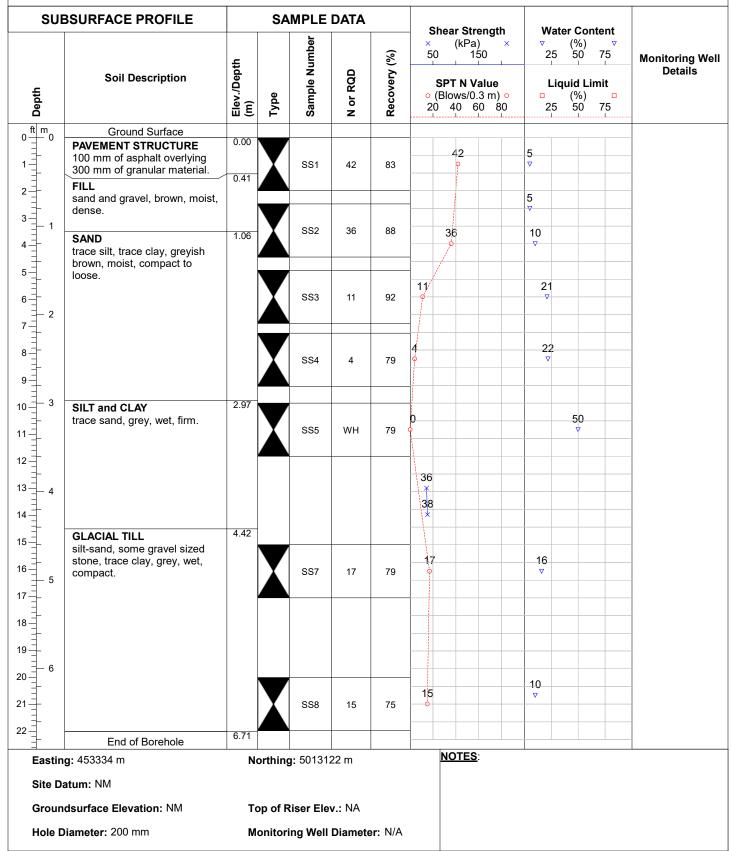
Borehole Log: BH2

Underlying the sand in BH2 and BH3, a layer of silt and clay was encountered and extended to a depth of 4.42 and 4.12 m bgs. respectively. This material can be described as having trace sand, grey, and wet. The SPT "N" values were found to be WH. The natural moisture contents were determined to be 46 and 50%.

In-situ vane shear readings were carried out in this material and were found to range between 30 and 38 kPa, indicating the material is firm.

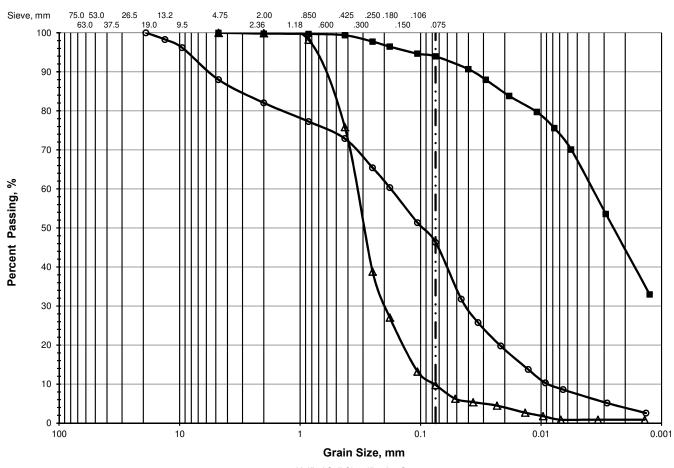
ASTM D 422 / LS-702

> 75 mm	75 mm % GRAVEL			% SAN	D	% FINES			
	- 15 1111	Coarse	Fine	Coarse	Medium	Fine	Silt	Clay		
\triangle	0.0	0.0	0.0	0.1	24.0	66.1	8.9	0.9		
	0.0	0.0	0.0	0.2	0.4	5.4	51.6	42.4		
0	0.0	0.0	12.0	5.9	9.1	26.6	42.7	3.7

The laboratory reports can be found in **Appendix D** of this report.
