# **Phase II – Environmental Site Investigation**

Part of 1850 Bantree Street  
Ottawa, Ontario

**Report: PE6234-2**

**Date: September 29, 2023**

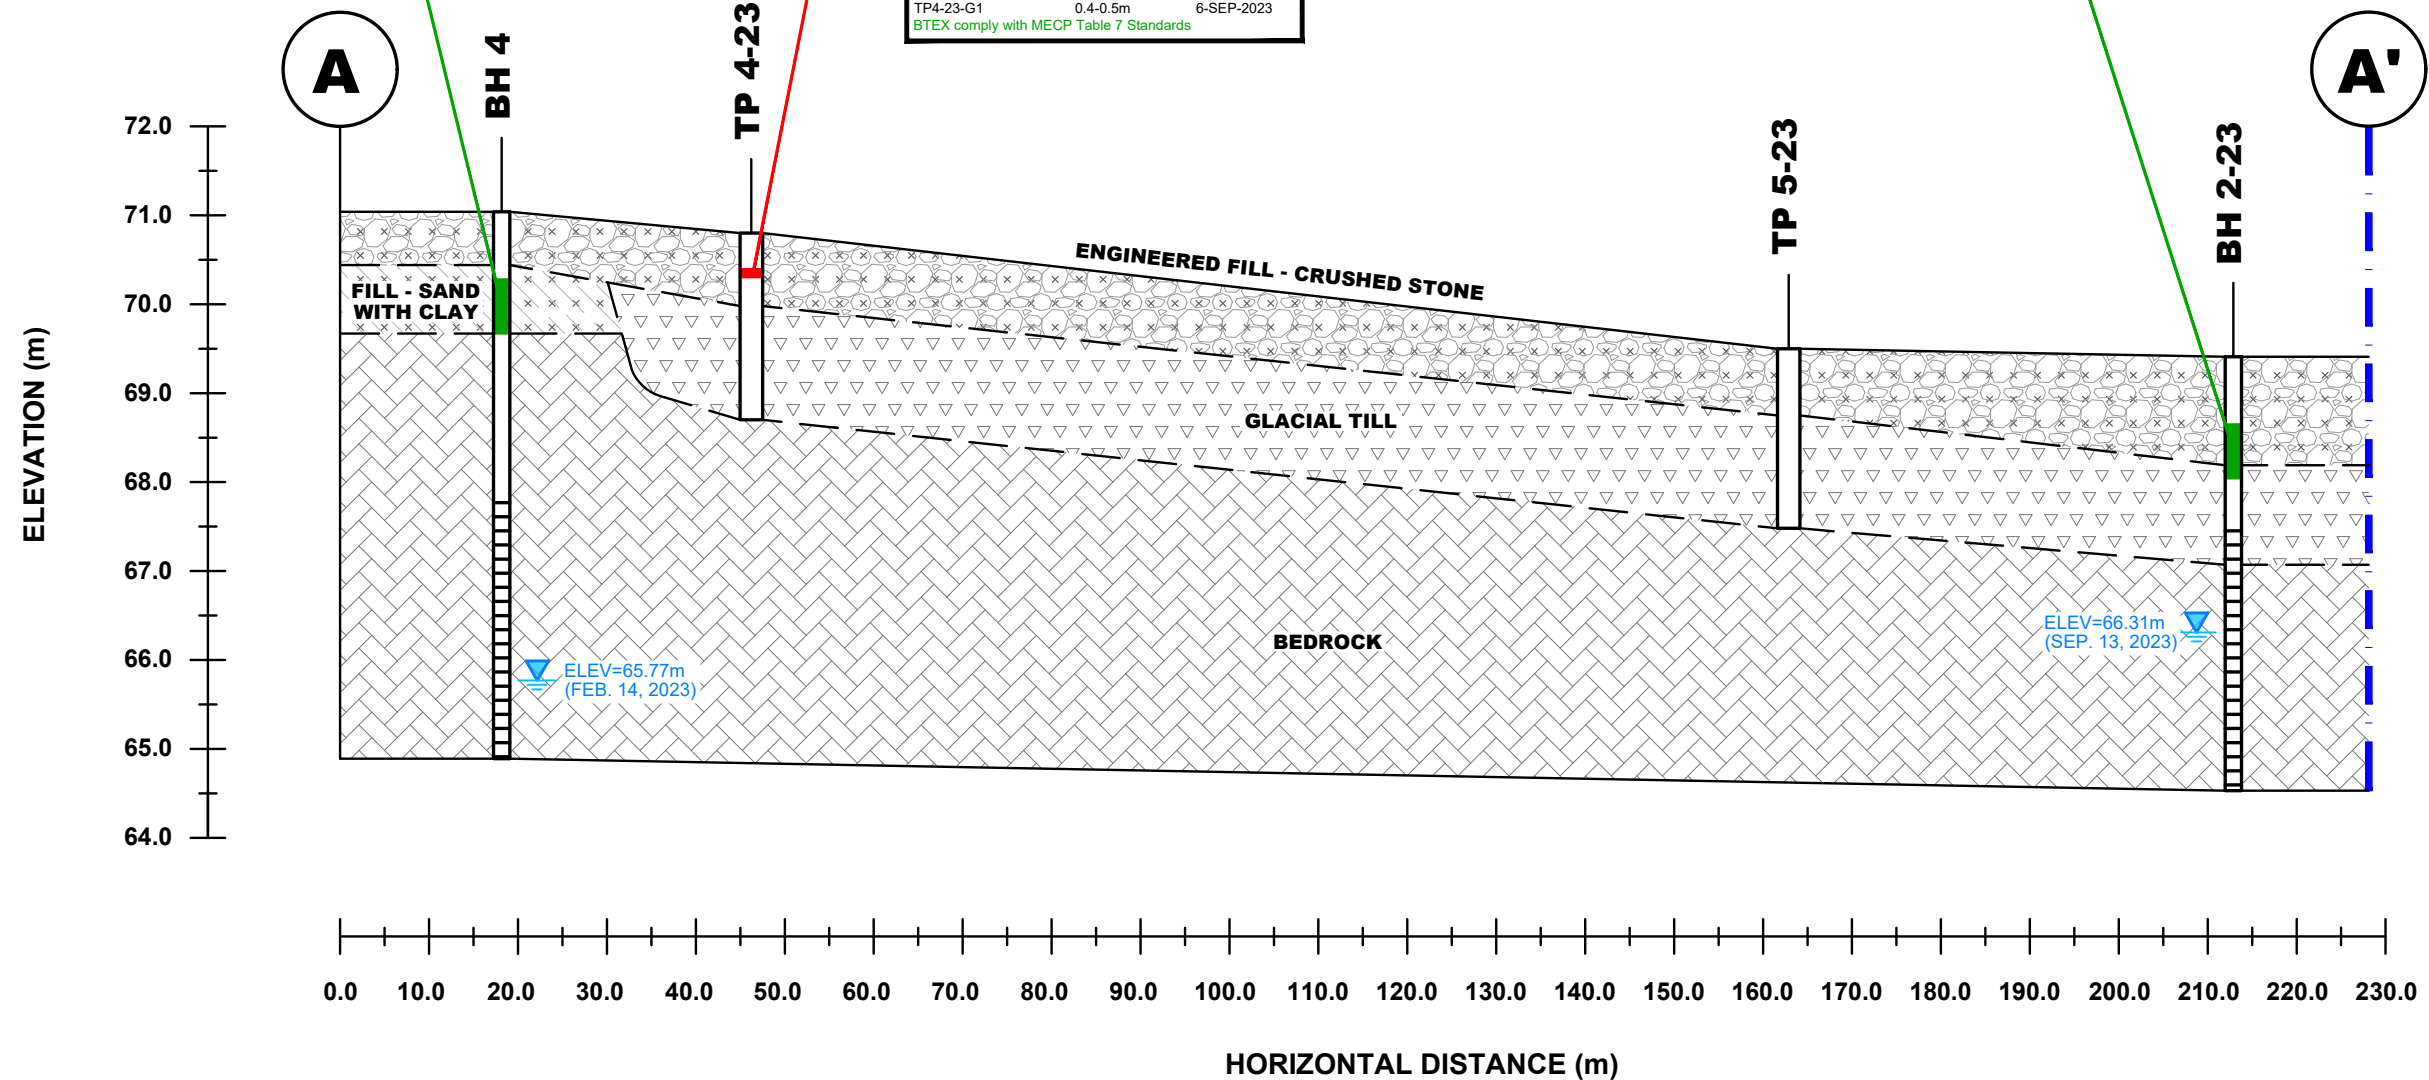
Scale:	AS SHOWN	Date:	10/2023
Drawn by:	YA	Report No.:	PE6234-2
Checked by:	SB	Dwg. No.:	<b>PE6234-4A</b>
Approved by:	KM	Revision No.:

HARBOUR ENVIRONMENTAL GROUP LTD.  
 PHASE II - ENVIRONMENTAL SITE ASSESSMENT  
 PART OF 1850 BANTREE STREET  
 OTTAWA, ONTARIO  
 Title: **CROSS SECTION - SOIL**

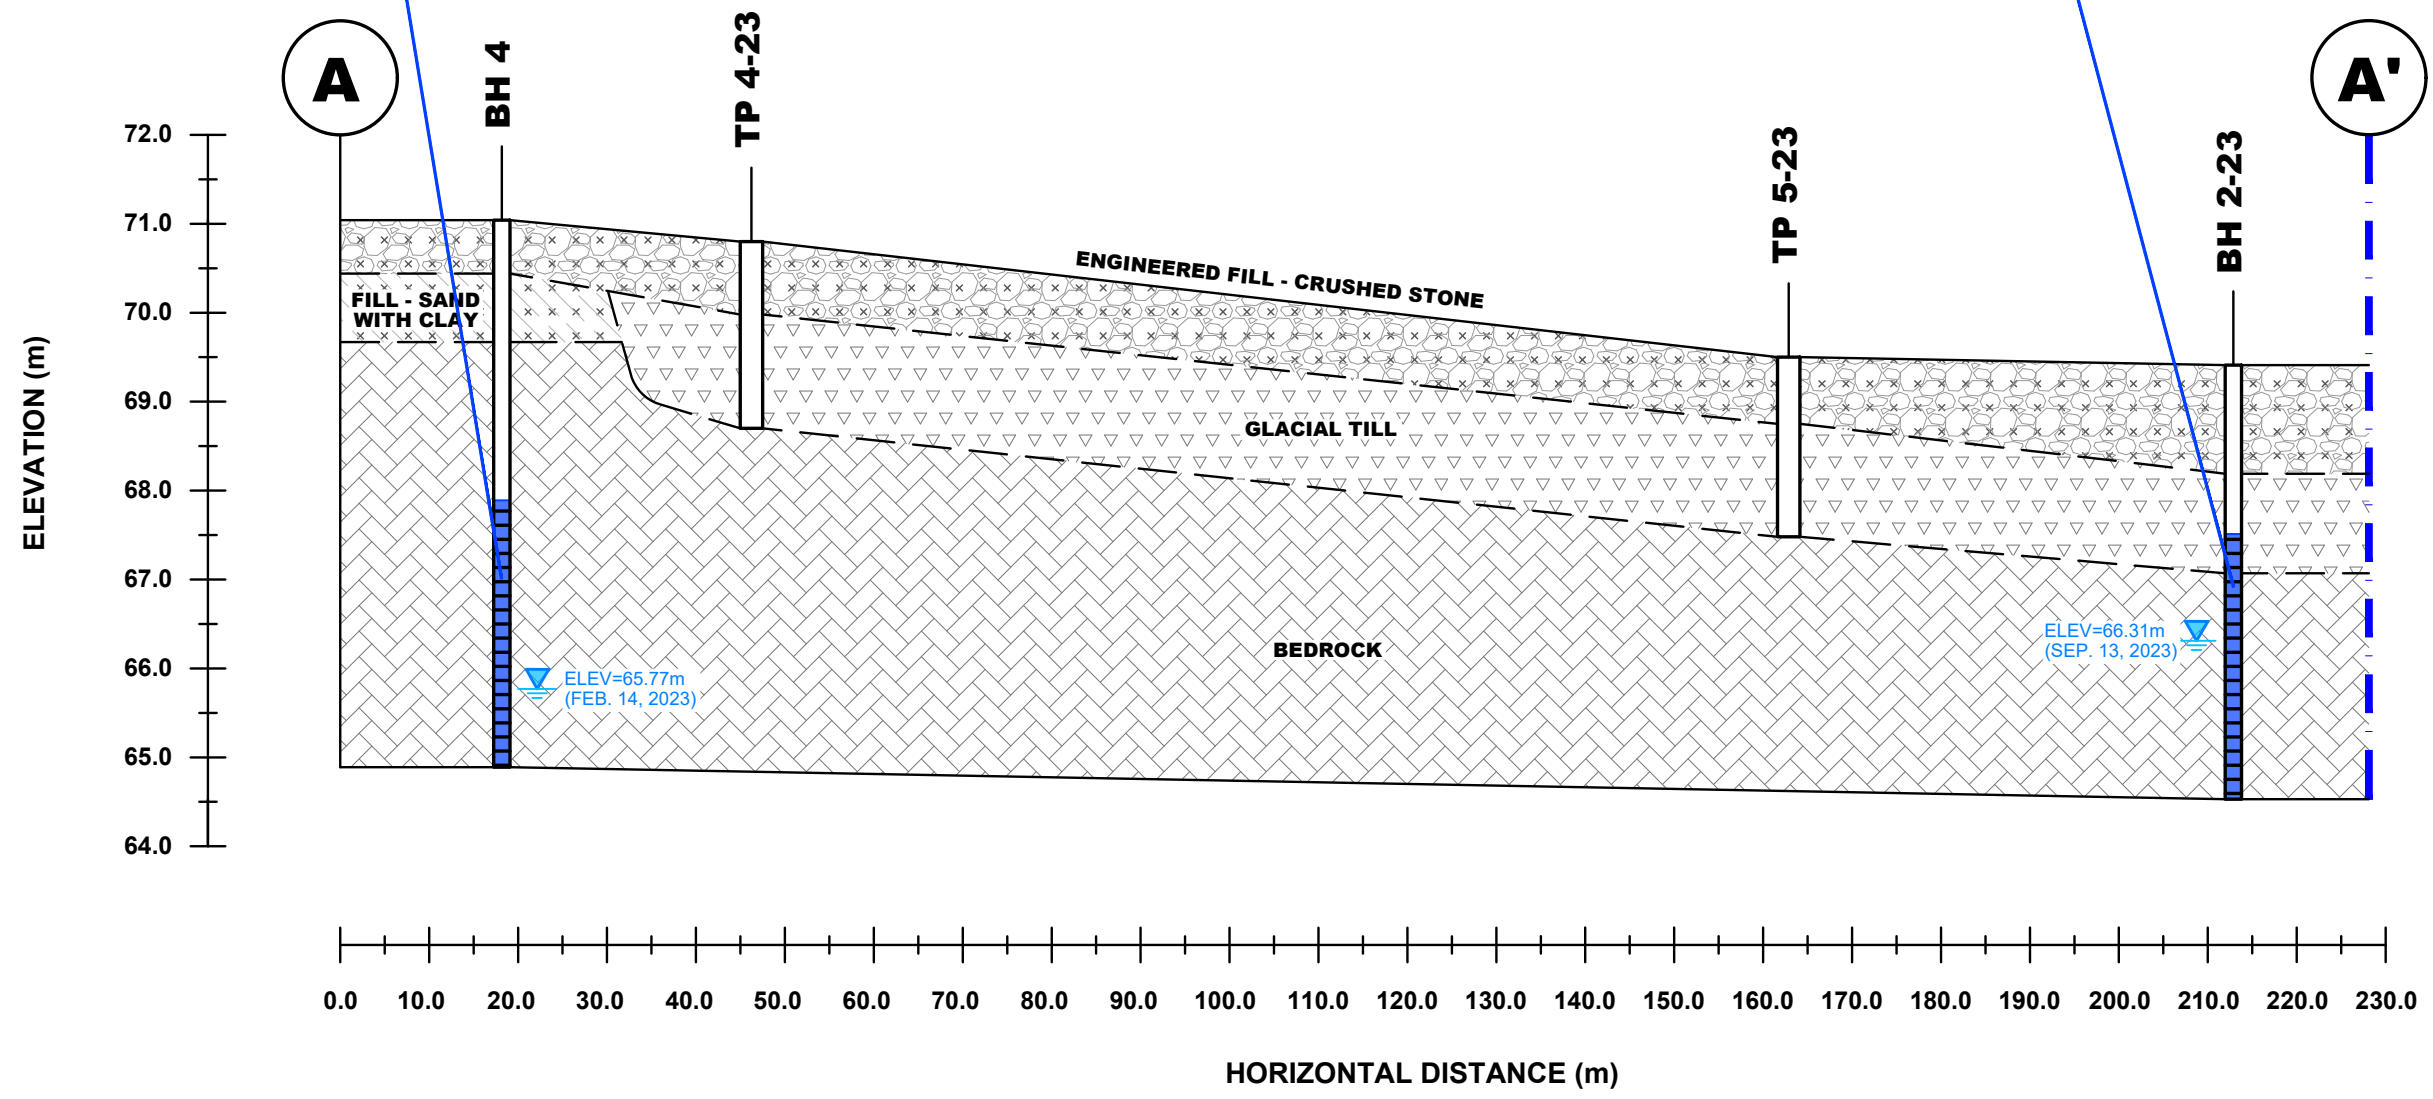
**DRAWING PE6234-5A – CROSS-SECTION A – A' – GROUNDWATER**

HARBOUR ENVIRONMENTAL GROUP LTD.  
 PHASE II - ENVIRONMENTAL SITE ASSESSMENT  
 PART OF 1850 BANTREE STREET  
 OTTAWA, ONTARIO  
**CROSS SECTION - GROUNDWATER**
