1440 Prince of Wales Drive,
Ottawa, Ontario

Shell Canada Products

AtkinsRéalis Ref: 694129

Final – Updated Phase Two Environmental Site Assessment

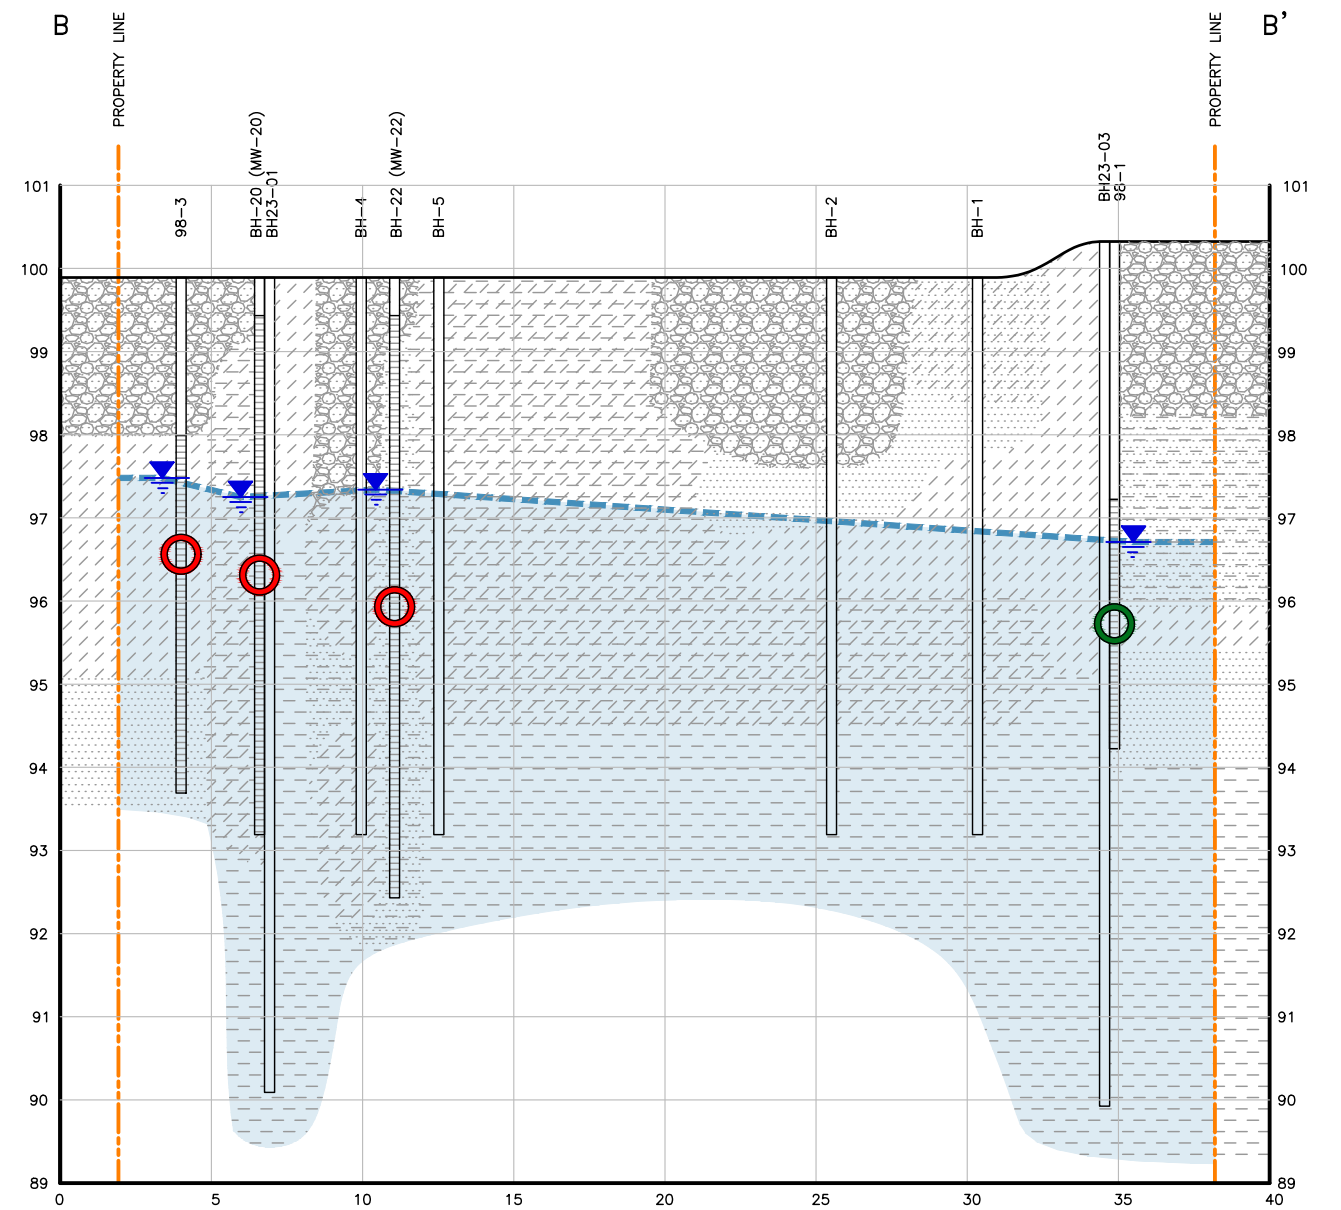
FIGURE 14
PAGE FORMAT: 17x22

LEGEND	
GROUNDWATER ELEVATIONS (JUNE 20, 2023)	SAND AND GRAVEL FILL
BOREHOLE	SAND
MONITORING WELL	SILT
SILTY SAND, SANDY SILT	SAND AND CLAY
CLAY	LOCATION WHERE MOST RECENT GROUNDWATER SAMPLE MET STANDARDS FOR ALL PARAMETERS THAT WERE ANALYSED
SILT AND CLAY, CLAYEY SILT	LOCATION WHERE MOST RECENT GROUNDWATER SAMPLE EXCEEDED STANDARDS FOR AT LEAST ONE PARAMETER THAT WAS ANALYSED
INFERRED LIMITS OF CONTAMINATION AS DEFINED IN ACCORDANCE WITH O. REG 153/04 SCHEDULE E, PART III, SECTION 7(4)
