**Phase II Environmental Site Assessment
73-79, 83 Ste-Cecile,
Vanier, Ontario**

CM3 Project SDC1009

December 20, 2022

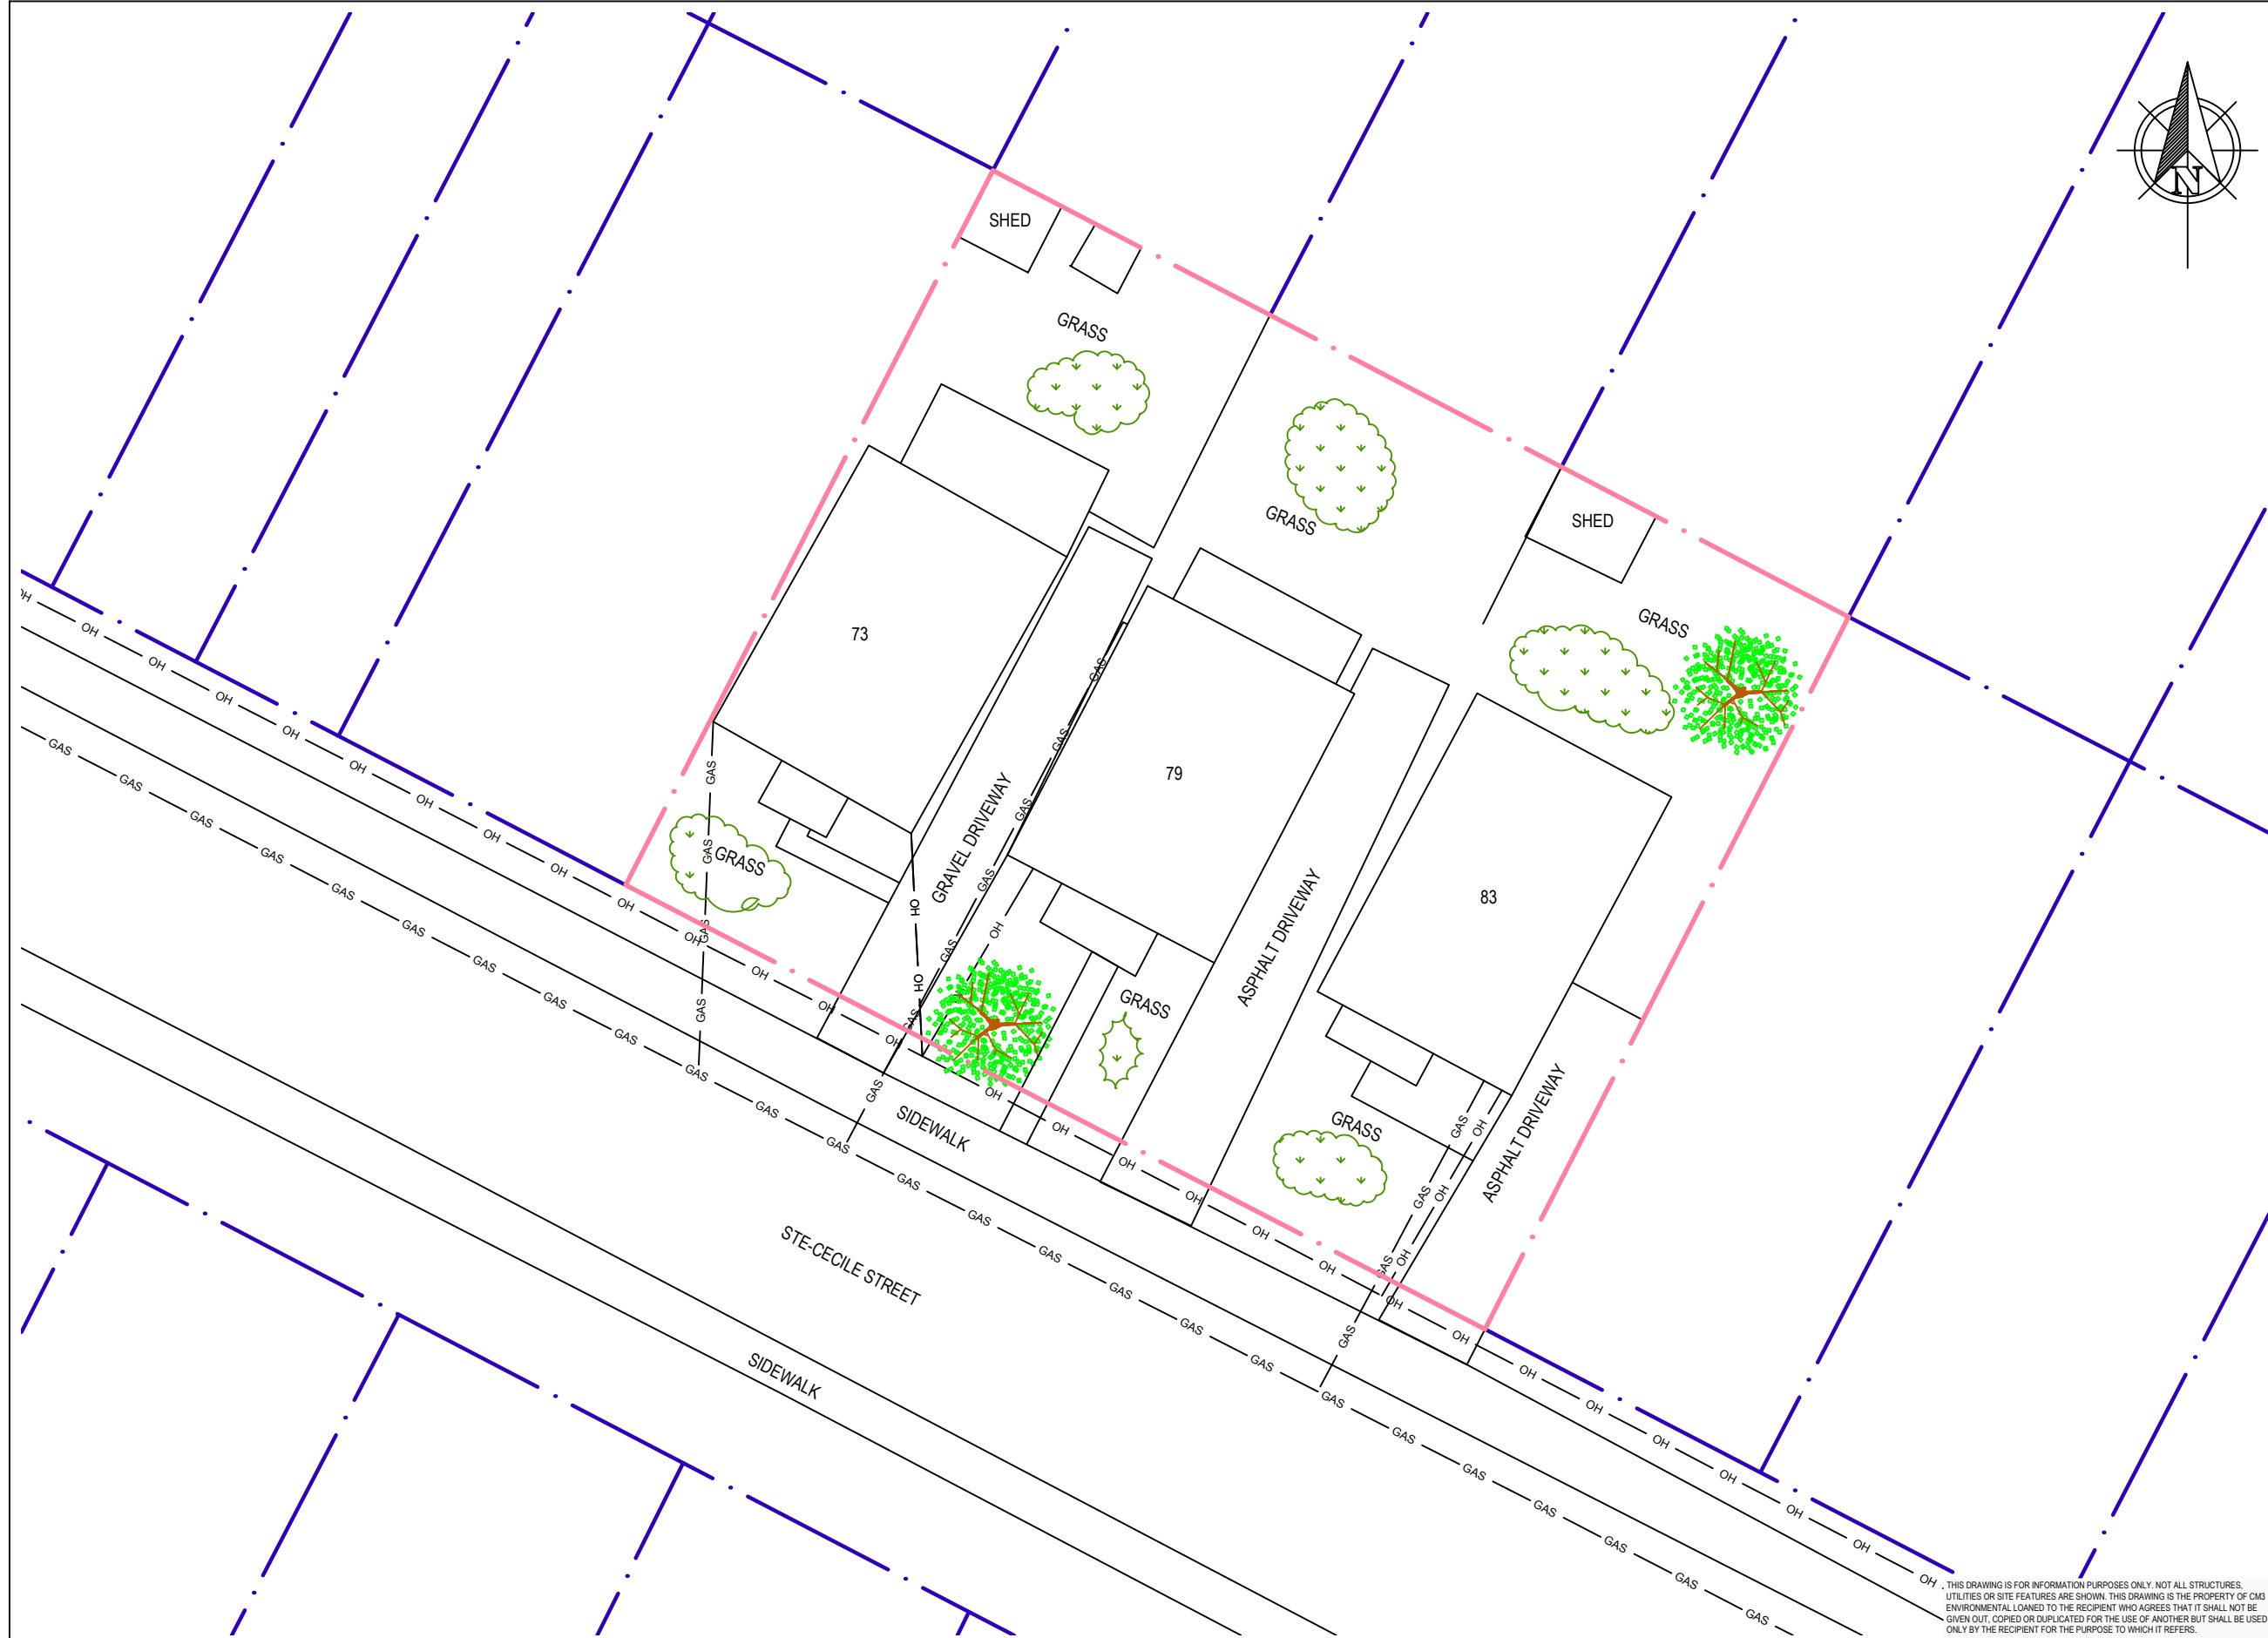
SITE PLAN

A site plan is provided as **Figure 2**.

The subject properties comprised the three civic addresses 73, 79 and 83 Ste-Cecile Street, Ottawa, Ontario. The subject properties are rectangular in shape and bounded by the Ste-Cecile Street to the south, residential properties on Marquette Avenue to the north, and residential properties to the east and west. The total area of the subject properties is approximately 1,112 square metres (0.1 hectares). Buildings at the properties included a south-facing residential building on each lot. 73 and 83 Ste-Cecile were bungalow style single residence buildings. 79 Ste-Cecile was a two-storey multi unit-residential building. There were small sheds in the back yards of 73 and 83 Ste-Cecile.

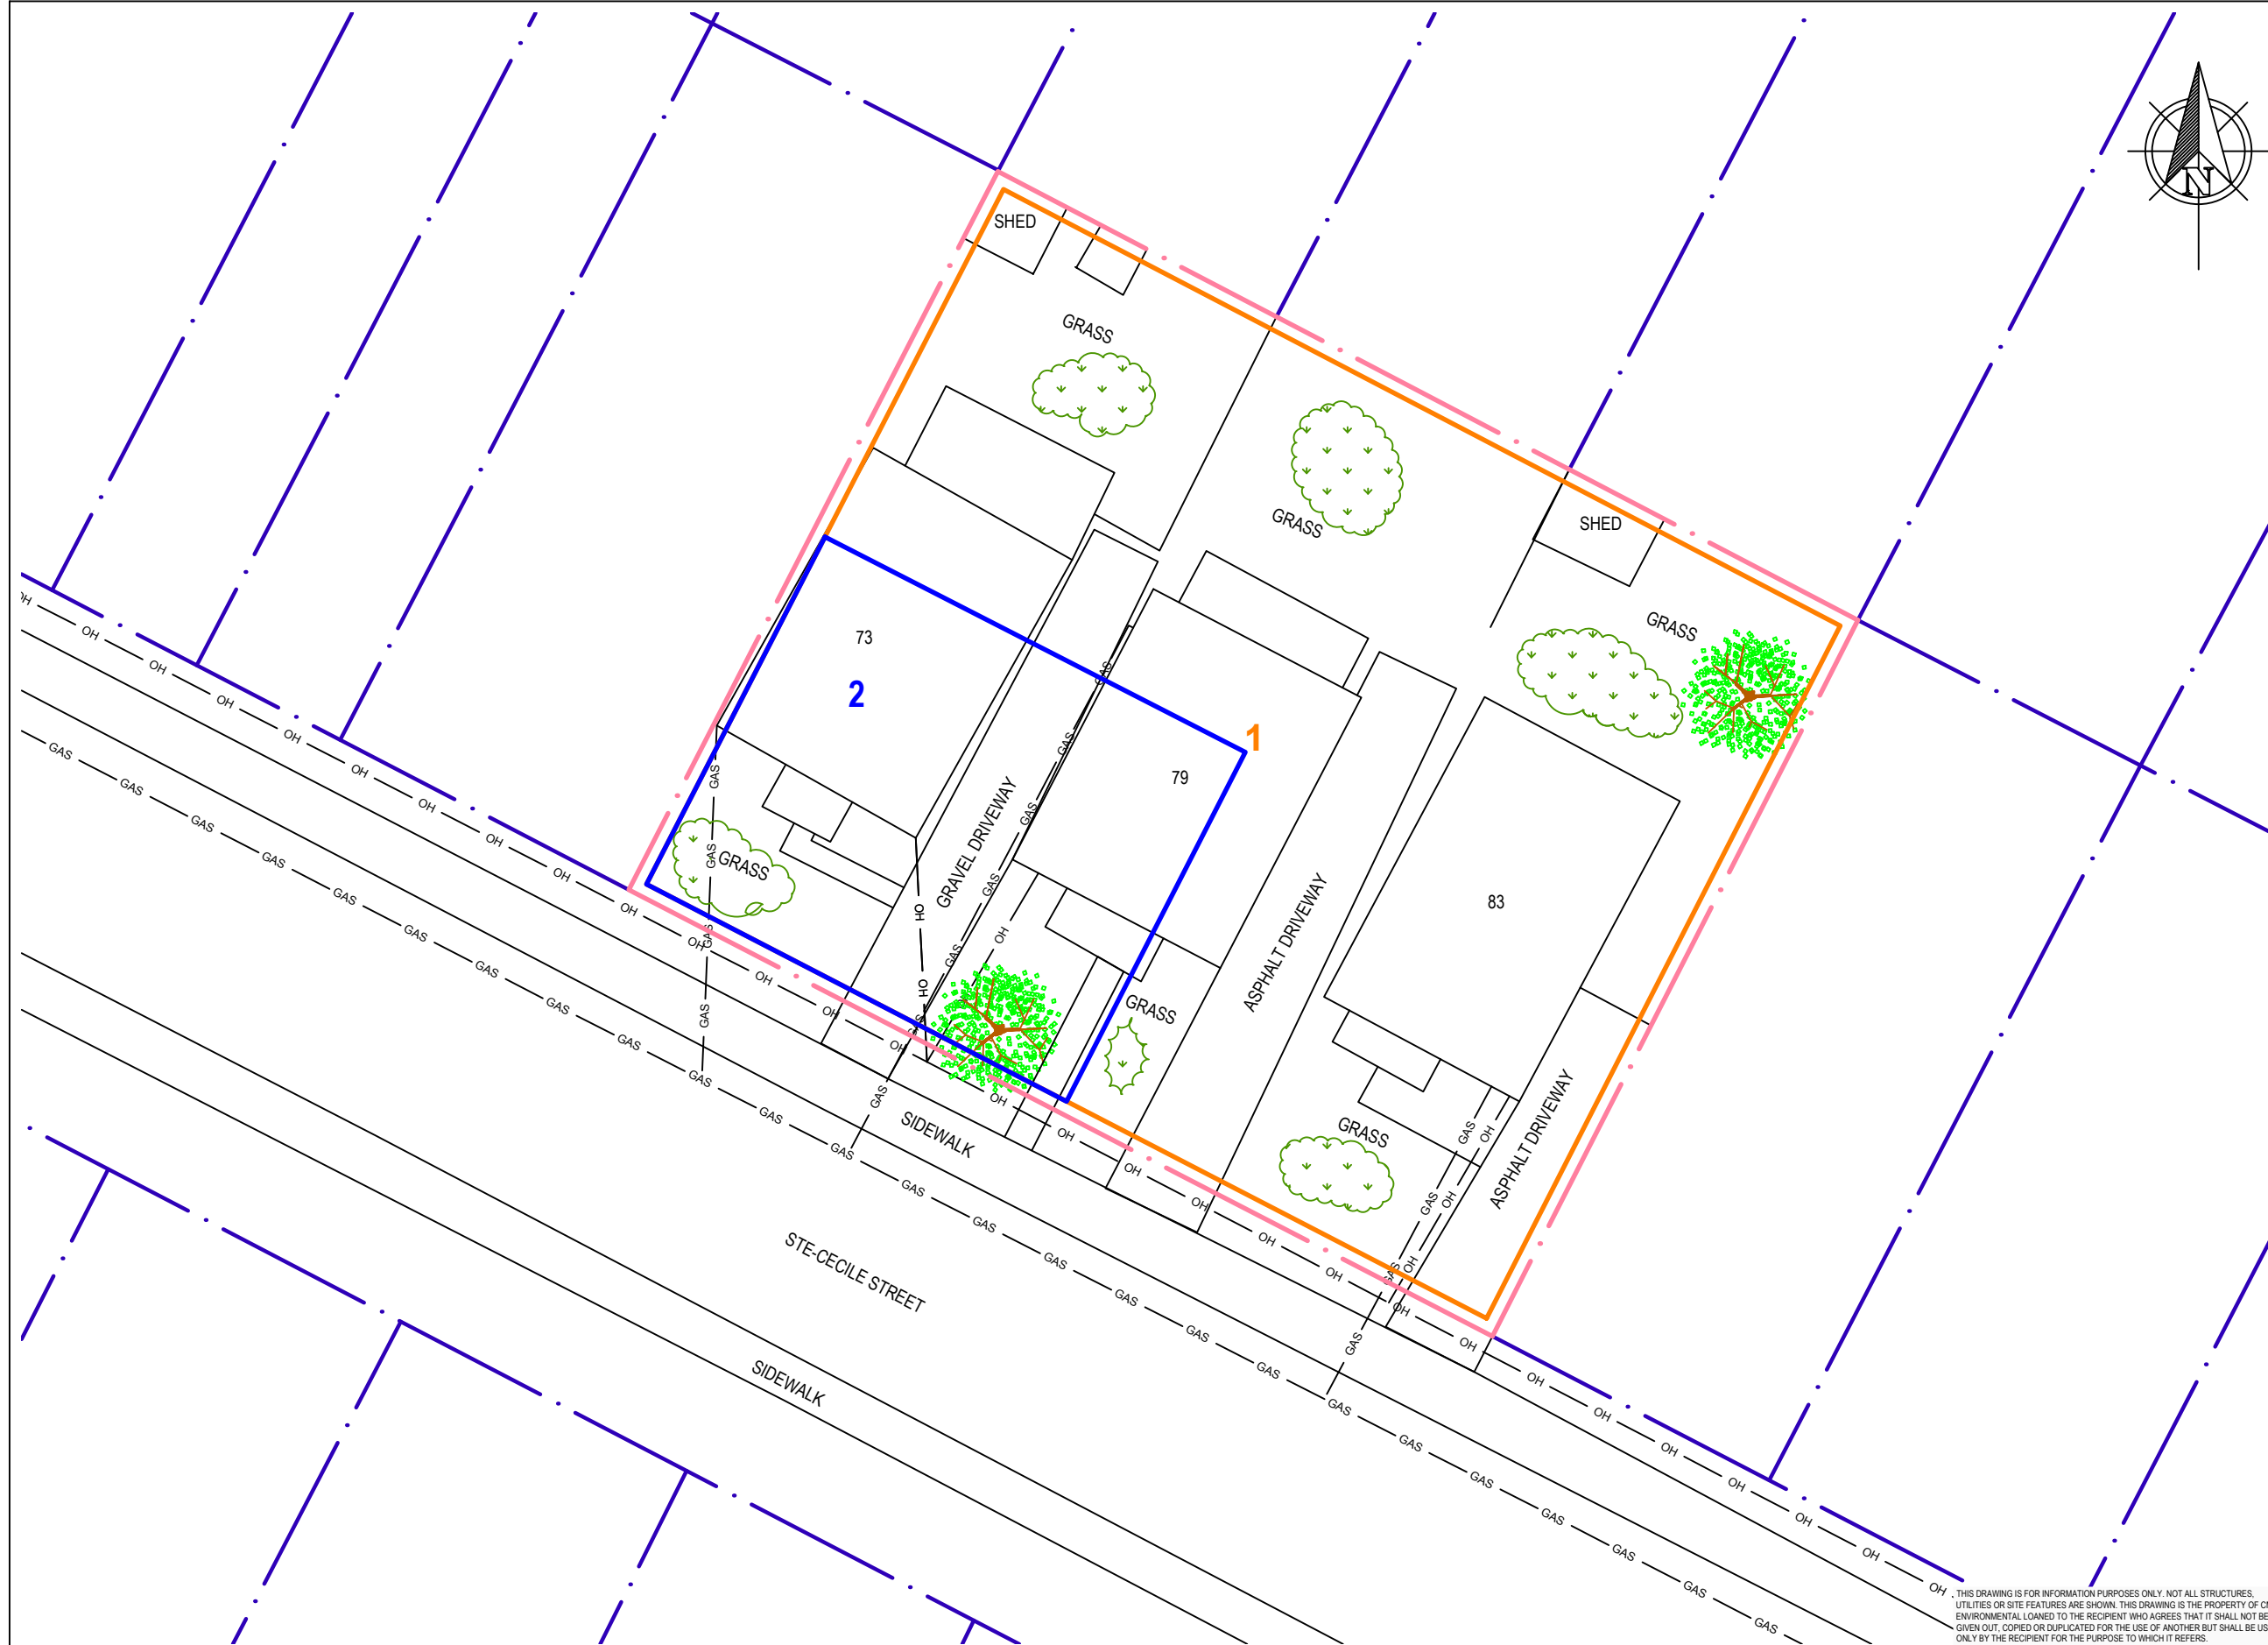
AREAS OF POTENTIAL ENVIRONMENTAL CONCERN

- PROPERTY BOUNDARY
- SITE
- BUILDING
- NATURAL GAS
- OVERHEAD ELECTRICAL
- 1** APEC 1 - UNKNOWN QUALITY OF IMPORTED FILL
73, 79 AND 83 STE. CECILE ST.
(PCA 1)
- 2** APEC 2 - METAL FABRICATION OFF-SITE (PCA 2)

Areas of Potential Environmental Concern			
APEC	Location	Cause of Concern	COCs
1	Subject property.	PCA 1 – Importation of fill material of unknown quality.	VOCs, PHCs F1-F4 fractions, metals, PAHs
2	South-west of the subject site at 72 Ste-Cecile St.	PCA 2 – Former metal fabrication.	VOCs, metals

The findings of the Phase I ESA identified two areas of potential environmental concern on the subject properties due to historic and current land use at the site. APECs are shown on **Figure 3**. The contaminants of concern were identified as VOCs, PHCs F1-F4 fractions, PAHs and metals, and potentially contaminated media included soil and groundwater. CM3 concluded that the PCAs and APECs could result in adverse environmental conditions at the subject property and a Phase II ESA was required to characterize soil and groundwater conditions and assess the presence of contamination at the APECs.

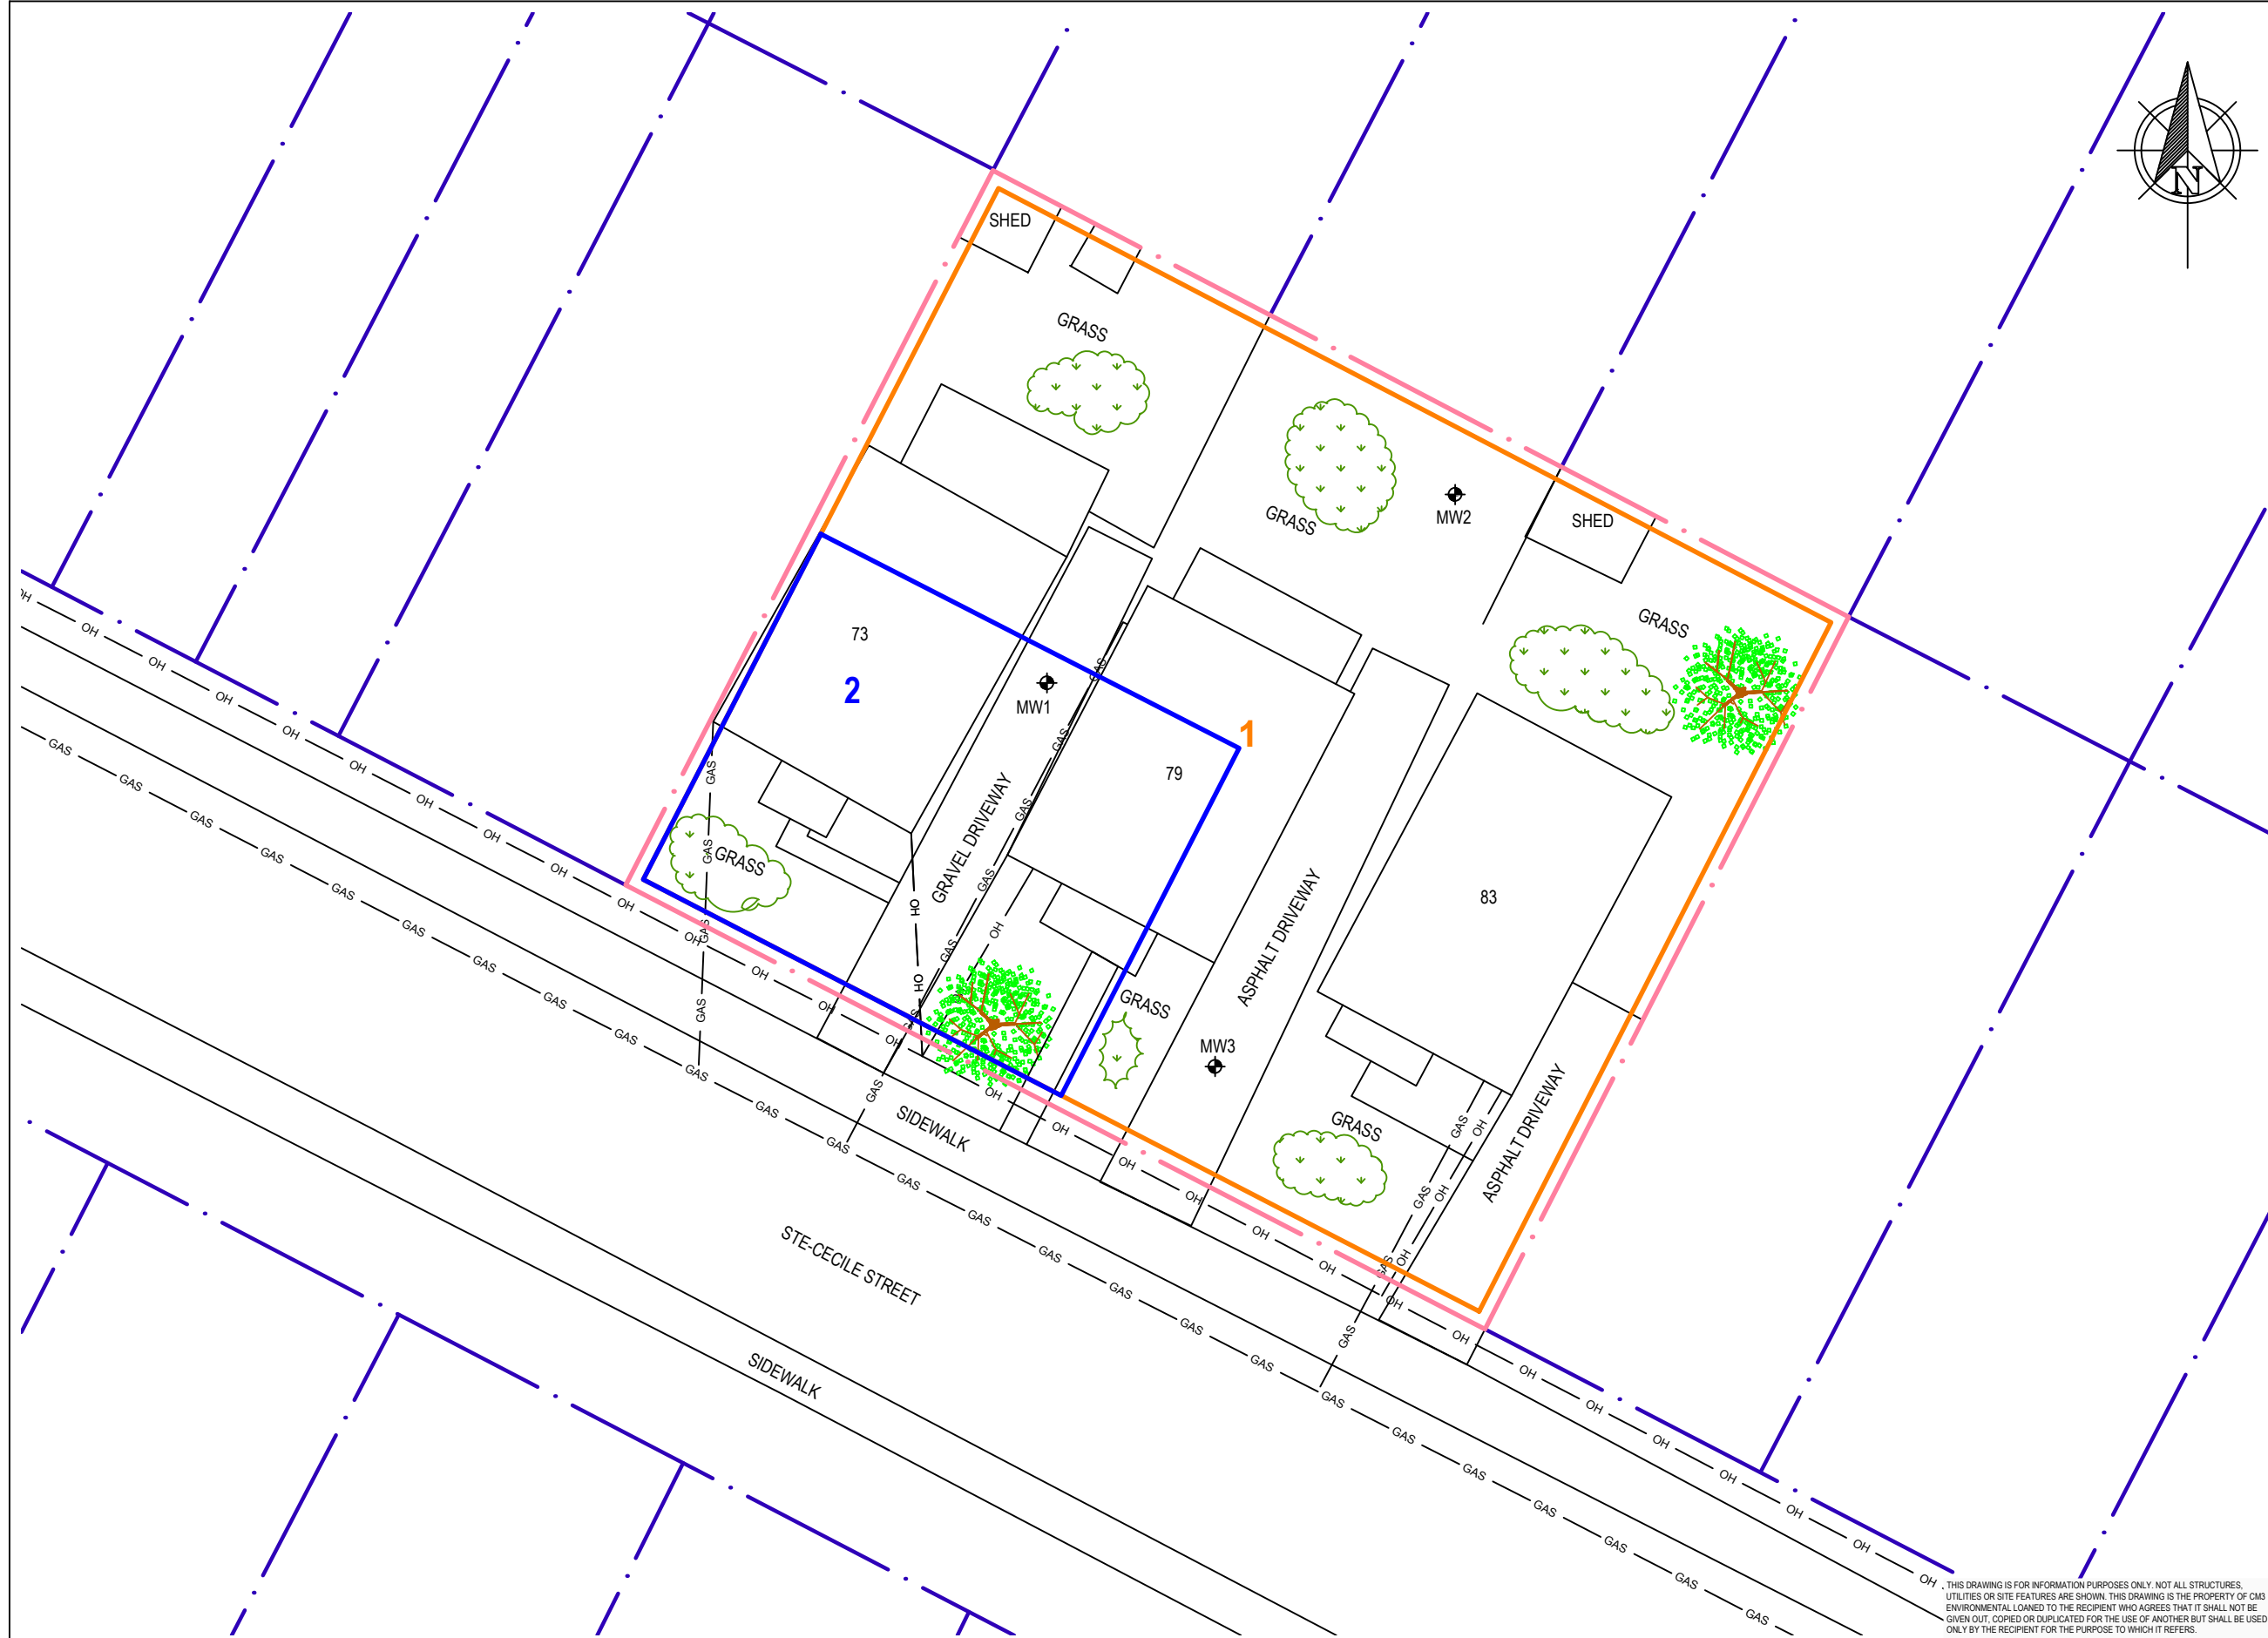
MONITORING WELL LOCATIONS

- PROPERTY BOUNDARY
- SITE
- BUILDING
- NATURAL GAS
- OVERHEAD ELECTRICAL
- MONITORING WELL
- 1 APEC 1 - UNKNOWN QUALITY OF IMPORTED FILL
73, 79 AND 83 STE. CECILE ST.
(PCA 1)
- APEC 2 - METAL FABRICATION
OFF-SITE (PCA 2)

Boreholes MW1, MW2 and MW3 were completed as monitoring wells. Monitoring well construction consisted of 32 mm or 50 mm outside diameter, flush-threaded schedule 40 PVC well screens and risers. At each borehole, a 10-slot well screen was placed to intercept the water table to allow for the detection of LPH. A silica sand pack was placed around the outside of the well screen in the annular space of the borehole, to a minimum of 0.3 m above the screened interval. A bentonite seal was placed above the sand pack to approximately 0.3 m bg. All monitoring wells were capped with lockable j-plugs and finished at below grade in flush-mounted manhole protective casings set in gravel, asphalt or grass.

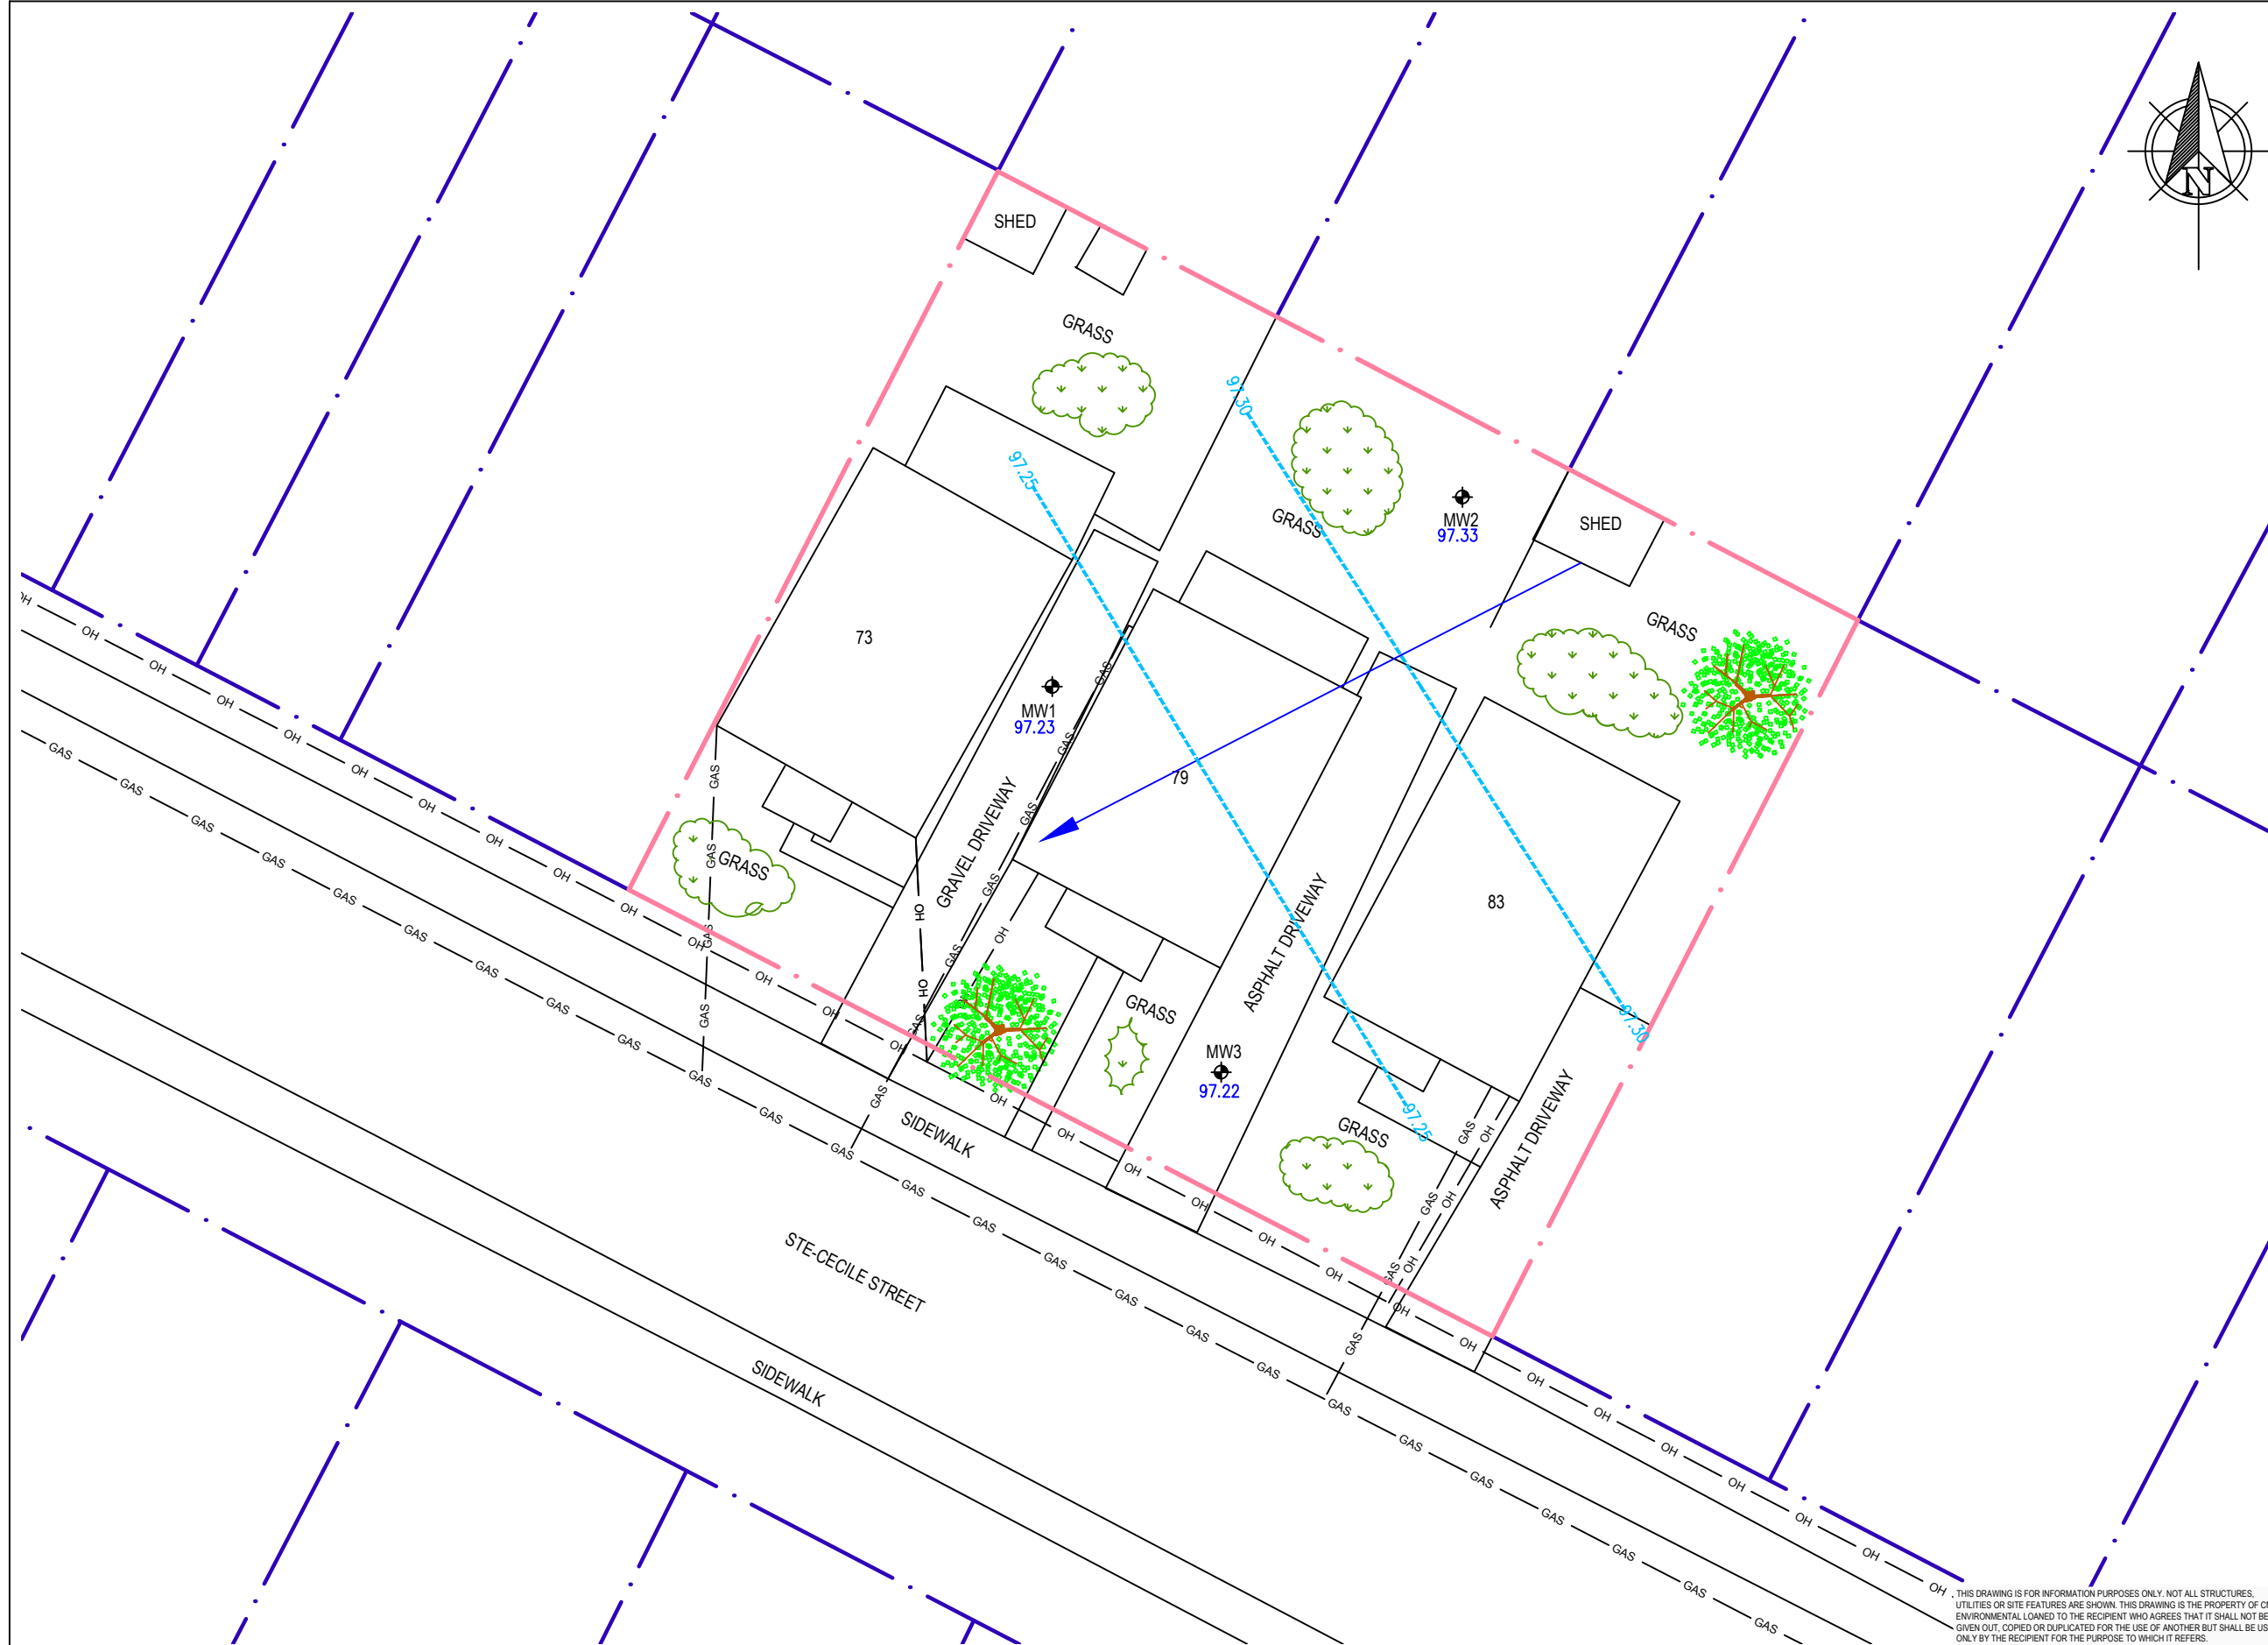
GROUNDWATER FLOW
DECEMBER 2022

The groundwater flow direction was determined to be south-west based on the groundwater data. The groundwater elevations, contours and flow direction are provided on **Figure 5**.

The depth to LPH (if present) and groundwater was measured in all monitoring wells on December 5, 2022. The December 5, 2022 water levels were at a relative elevation of 97.22 m arl to 97.33 m arl, and the average groundwater elevation was 97.26 m arl (2.74 m bg). The depth to LPH and water level measurements are provided in **Table 1**.

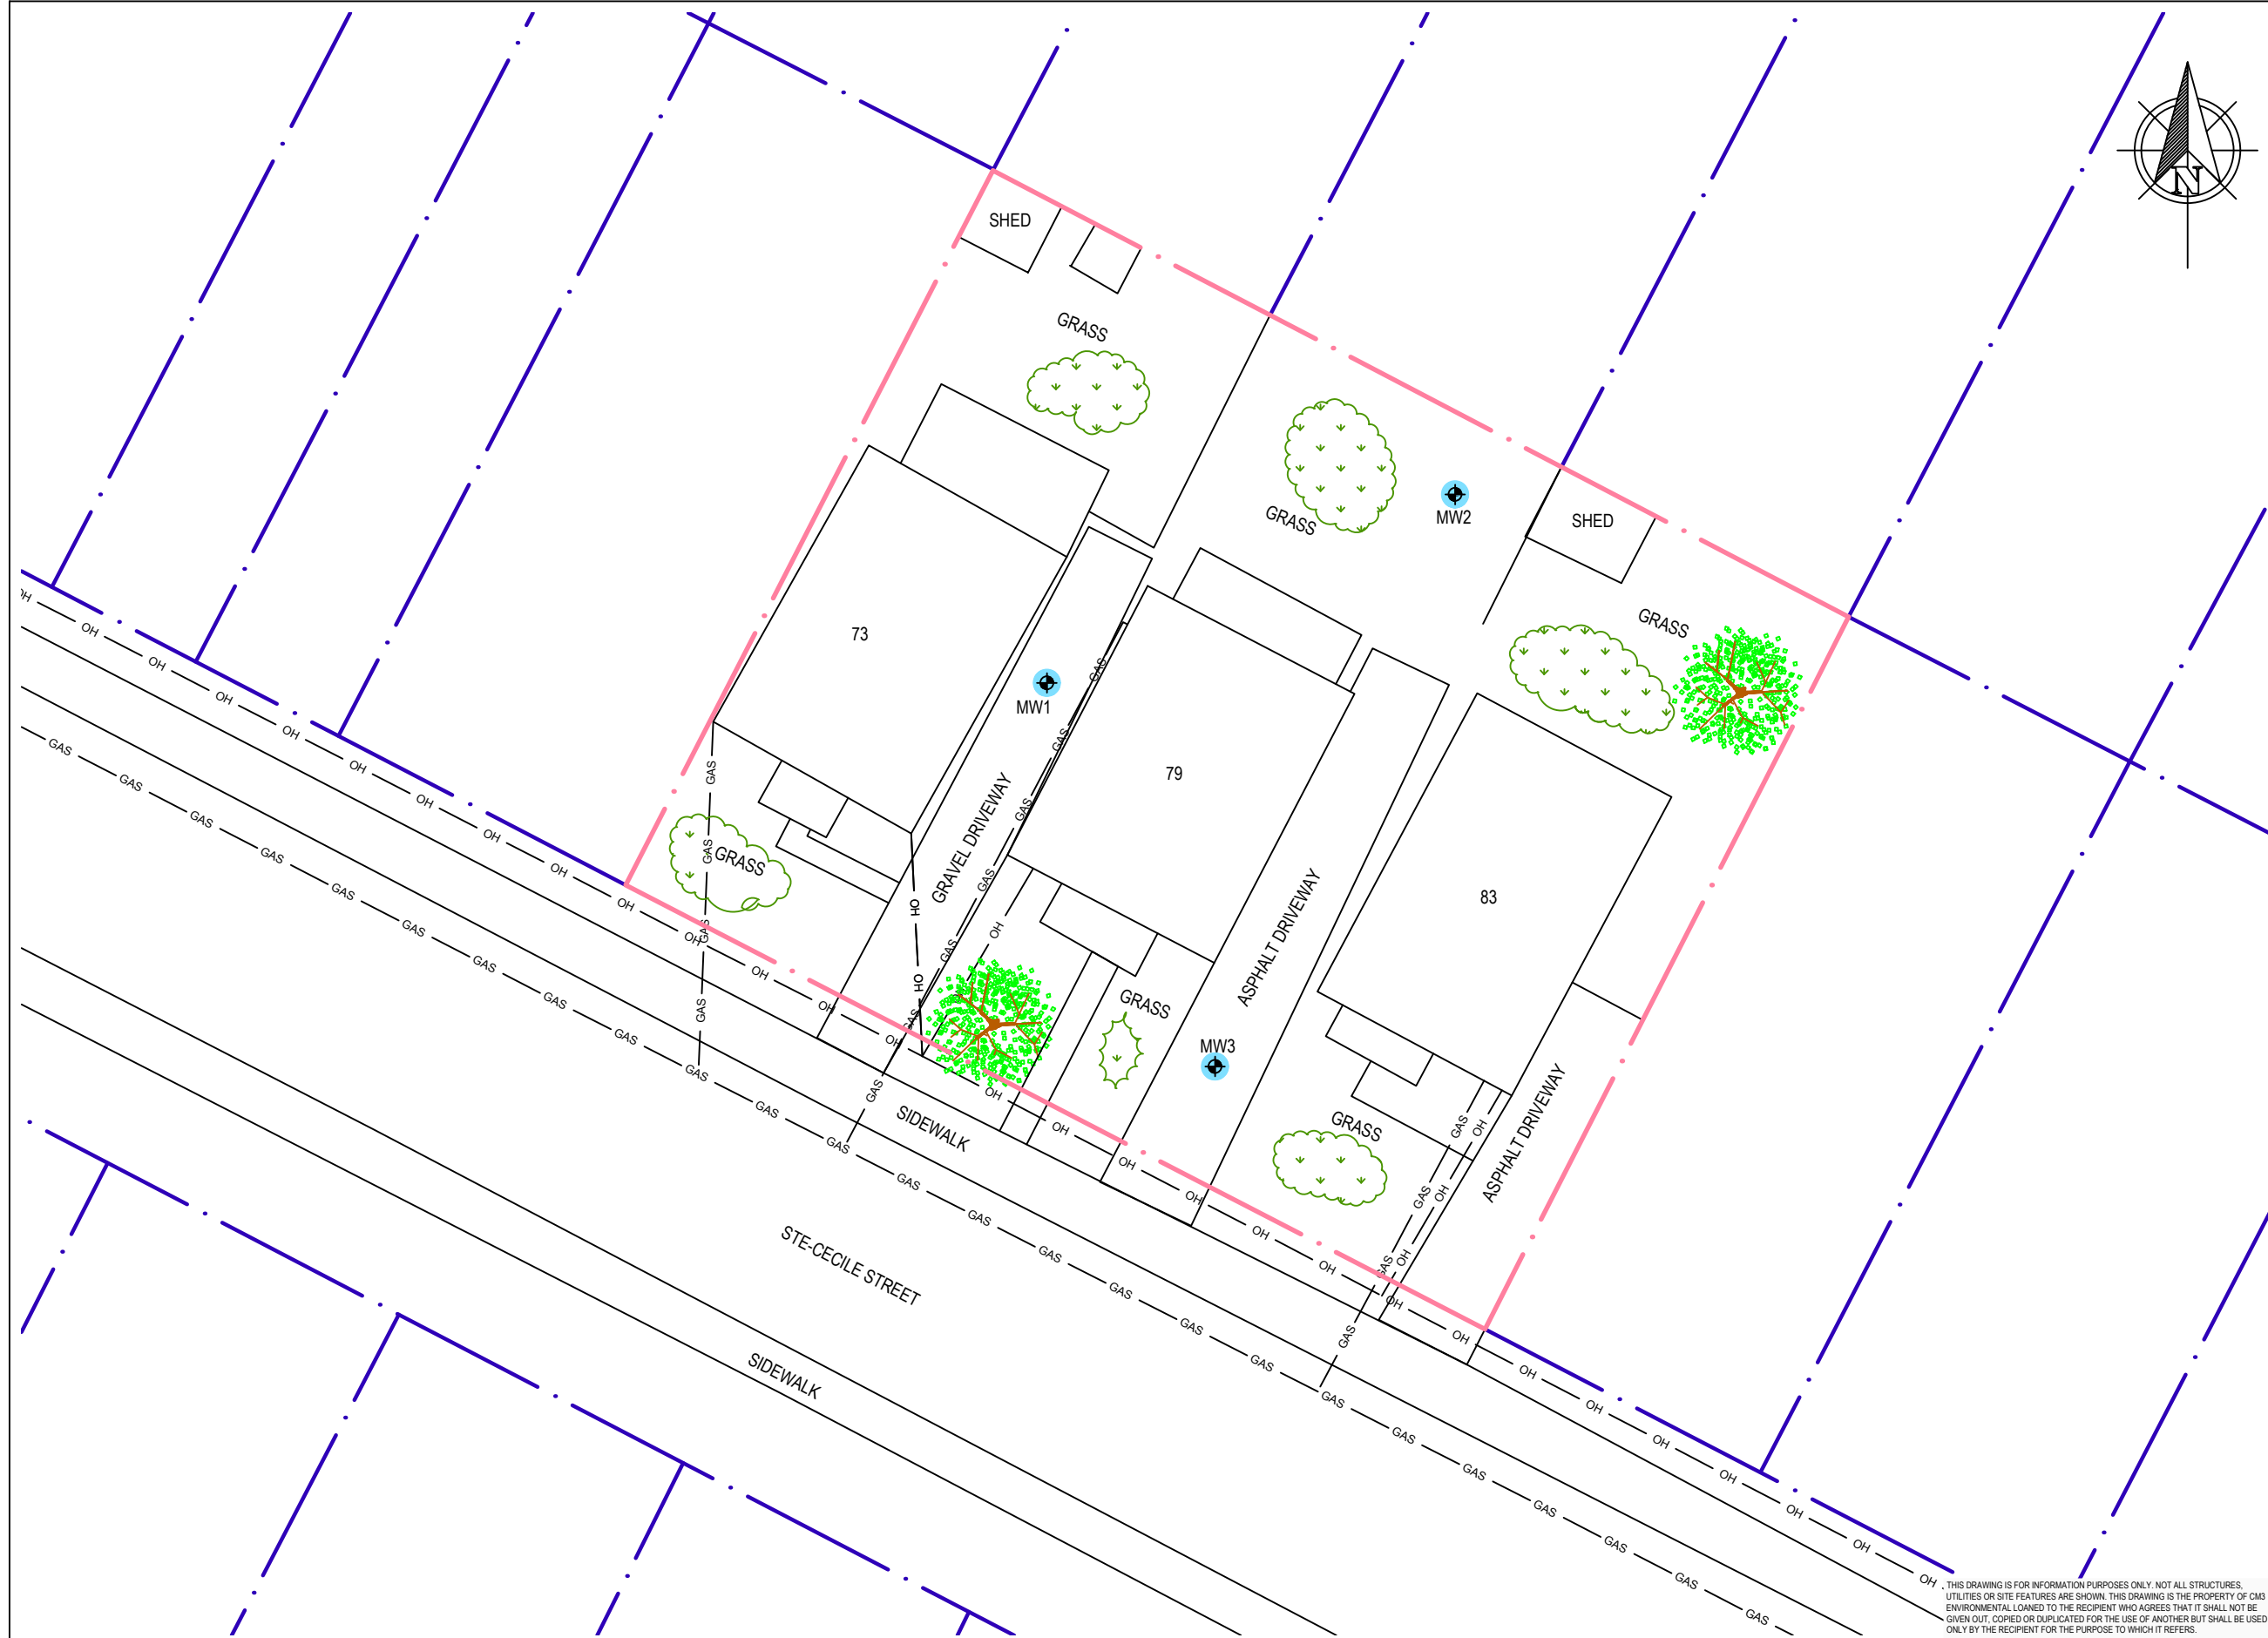
SOIL QUALITY

- LEGEND**
- PROPERTY BOUNDARY
 - SITE
 - BUILDING
 - NATURAL GAS
 - OVERHEAD ELECTRICAL
 - MONITORING WELL
 - SOIL COMBUSTIBLE VAPOUR CONCENTRATION (ppm)
 - SOIL SAMPLES ANALYSED*:
 - ANALYSED PARAMETERS NOT DETECTED
 - ANALYSED PARAMETERS <MECP TABLE 3 SCS
 - ANALYSED PARAMETERS >MECP TABLE 3 SCS
- * - REFER TO TABLE 1 FOR SAMPLING DATES AND FULL RESULTS

A total of 18 soil samples were collected from boreholes MW1, MW2 and MW3 for field screening and combustible vapour analysis. The vapour concentrations in borehole MW1 varied at depth and were between 40 ppm to 100 ppm. Vapour concentrations in borehole MW2 were between 35 to 110 ppm and vapour concentrations in MW3 were between 30 to 60 ppm. The borehole locations are provided on **Figure 4** and the vapour concentrations and field observations are included on the borehole logs, **Appendix A**.

A total of three soil samples were analysed for one or more of the COCs, including VOCs, PHCs F1-F4 fractions, PAHs and metals. The soil sample analytical results are summarized in **Table 2**. The borehole soil sample locations and soil quality are provided on **Figure 6**. The soil sample laboratory reports are provided in **Appendix B**.
