**Phase II Environmental Site Assessment
73-79, 83 Ste-Cecile,
Vanier, Ontario**

CM3 Project SDC1009

December 20, 2022

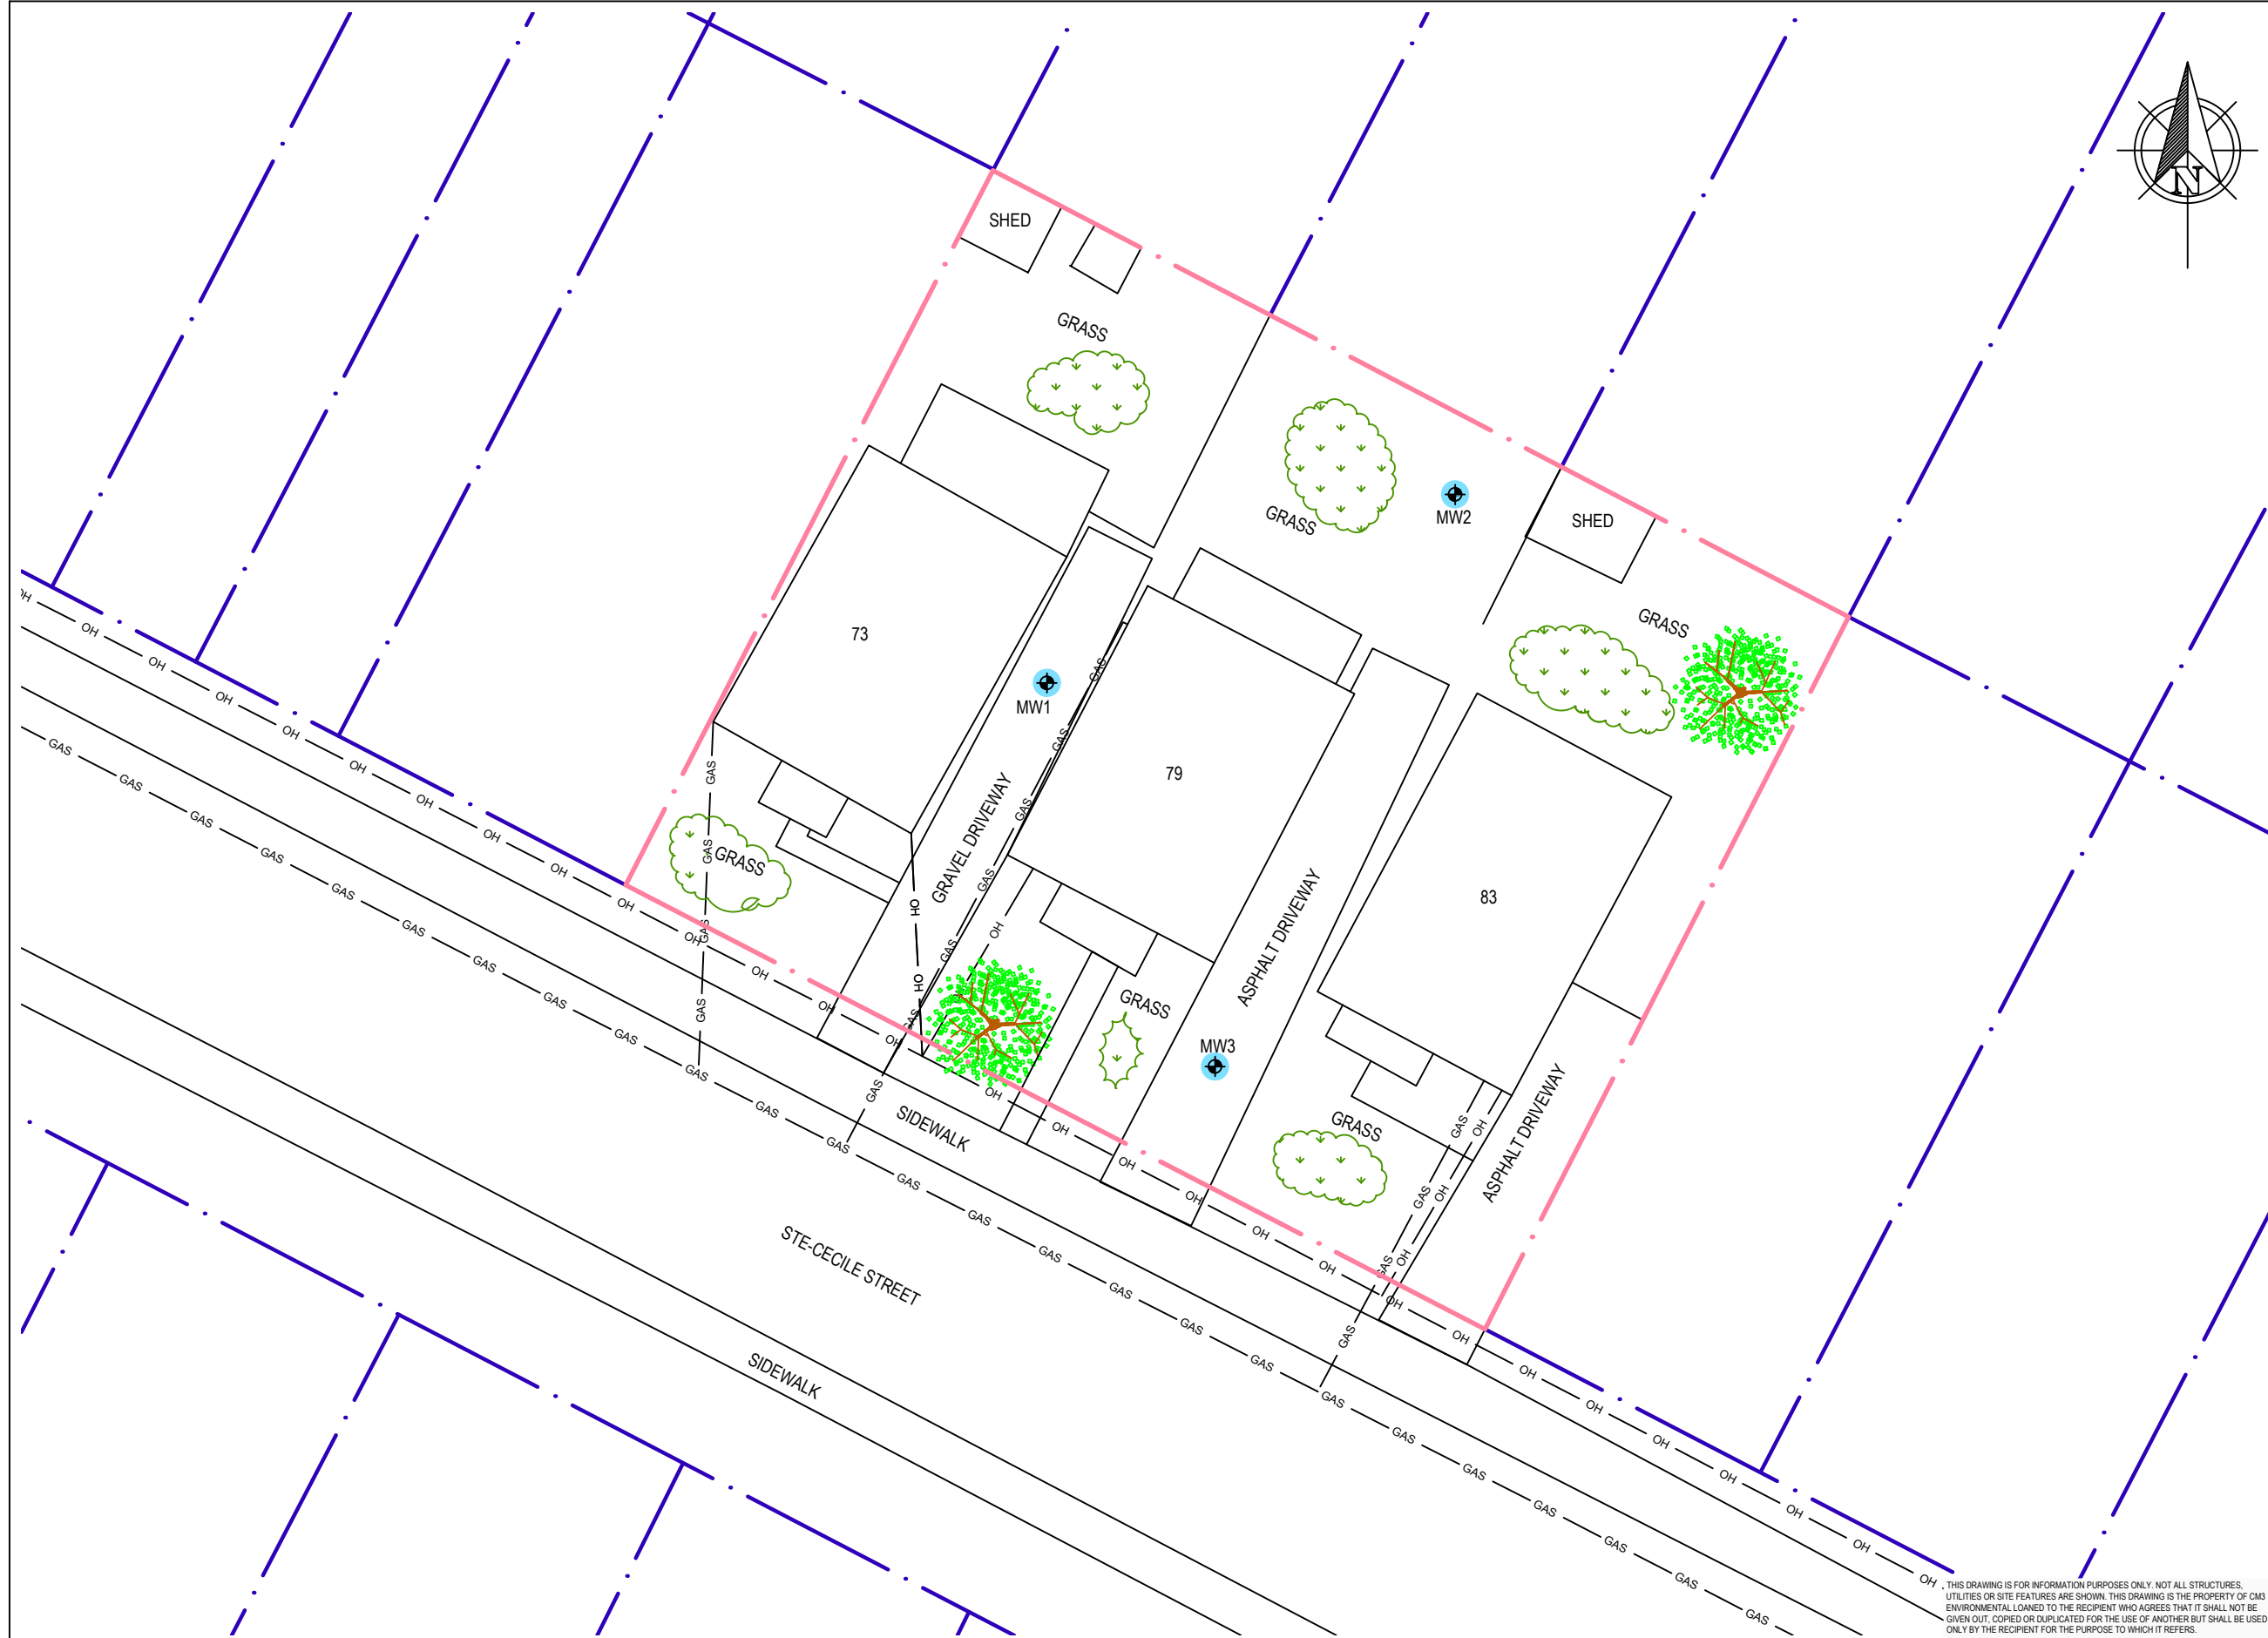
GROUNDWATER QUALITY

- ANALYSED PARAMETERS NOT DETECTED
- ANALYSED PARAMETERS <MECP TABLE 5 SCS
- ANALYSED PARAMETERS >MECP TABLE 5 SCS

Groundwater samples MW1, MW2 and MW3 were analysed for VOCs, PHCs F1-F4 fractions, PAHs and metals. The groundwater sample analytical results are summarized in **Table 3**. The monitoring well locations and groundwater quality are provided on **Figure 7**. The groundwater sample laboratory reports are provided in **Appendix B**.

PAHs were not detected in samples MW1 and MW3, meeting the MECP Table 5 SCS. Several PAHs were detected in sample MW2 at concentrations that met the MECP Table 5 SCS.

Several metals were detected in all three samples, at concentrations below the MECP Table 5 SCS.
