# Geotechnical Investigation Report

**1386 & 1394 Greely  
Lane, Ottawa, Ontario**

April 13, 2023

Cambium Reference: 17281-001

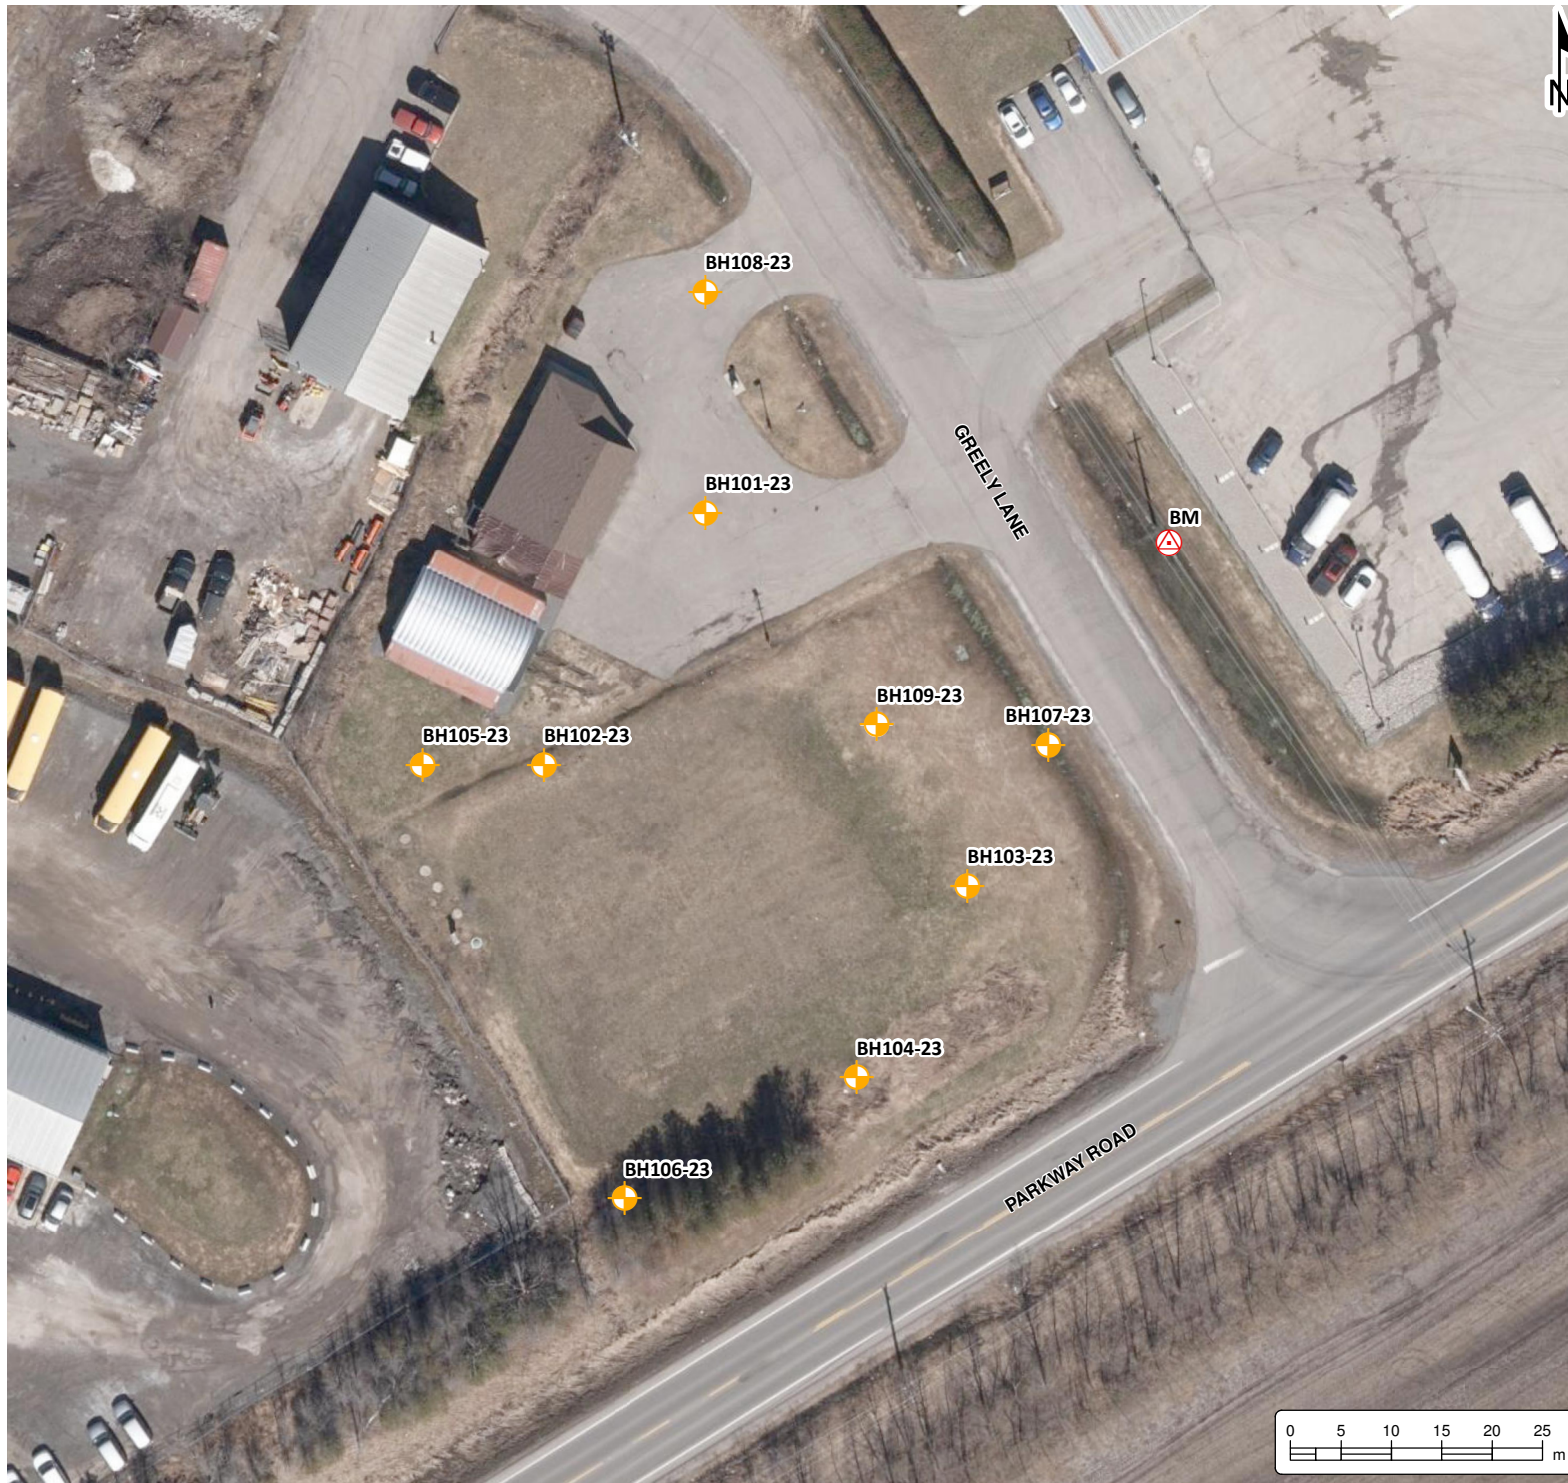
| Figure:<br><b>1</b> | |

The locations of the boreholes relative to the existing site conditions are provided as Figure 2.

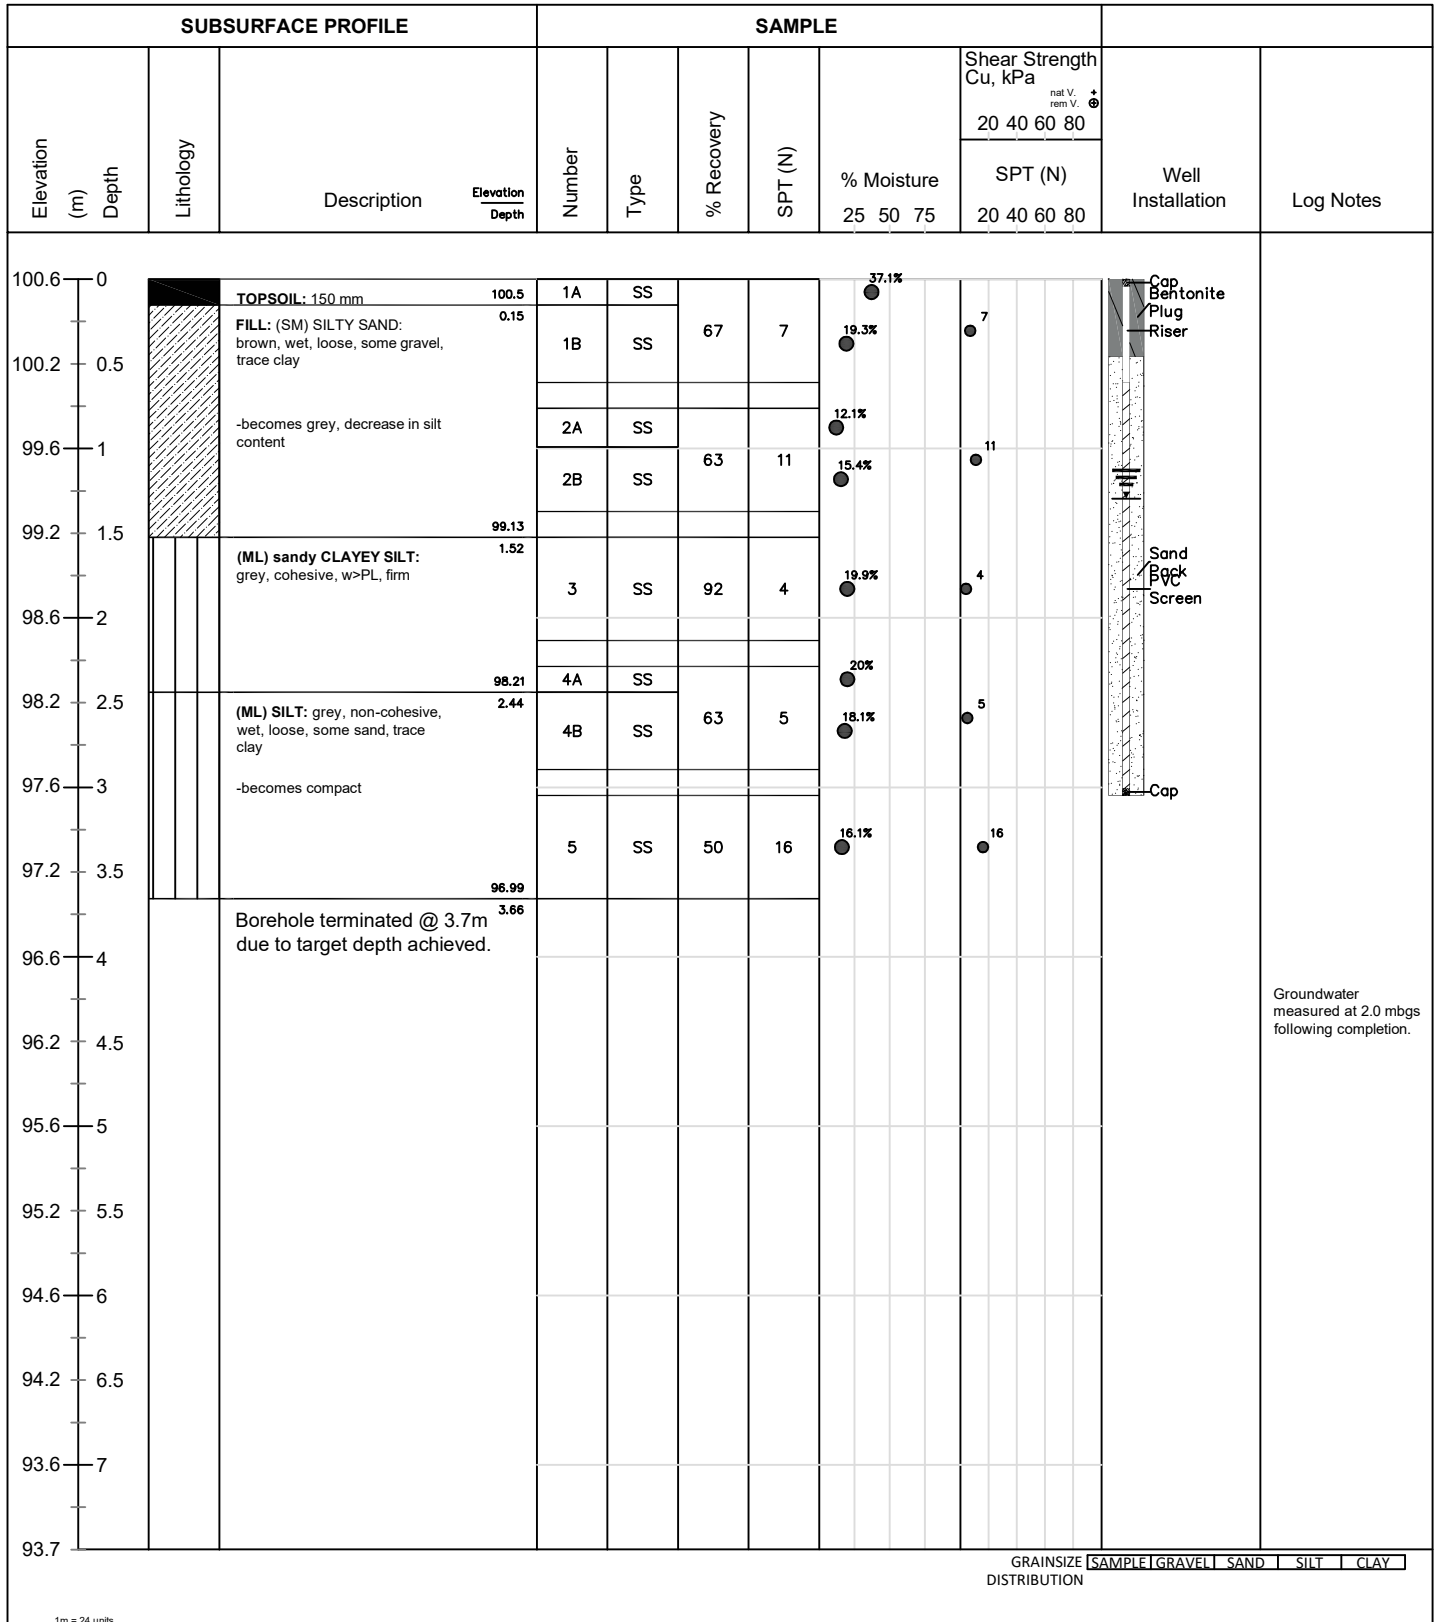
**Log of Borehole:** BH105-23  
**Page:** 1 of 1  
**Date Completed:** March 8, 2023

**Client:** Cassidy EW Construction **Project Name:** 1386 & 1394 Greely Lane  
**Contractor:** OGS Inc. **Method:** Track Mounted Hollow Stem Auger  
**Location:** Ottawa, ON **Elevation:** 100.65 mREL  
**Project No.:** 17281-001 - B **UTM:** 18 T **N:** 5011843 **E:** 455141

Unstabilized groundwater level observations were made following drilling at all borehole locations. Three groundwater monitoring wells were installed in select boreholes (BH105-23 through BH107-23). These boreholes were installed to measure stabilized groundwater conditions as well as provide groundwater data for the Phase II ESA, submitted separately.

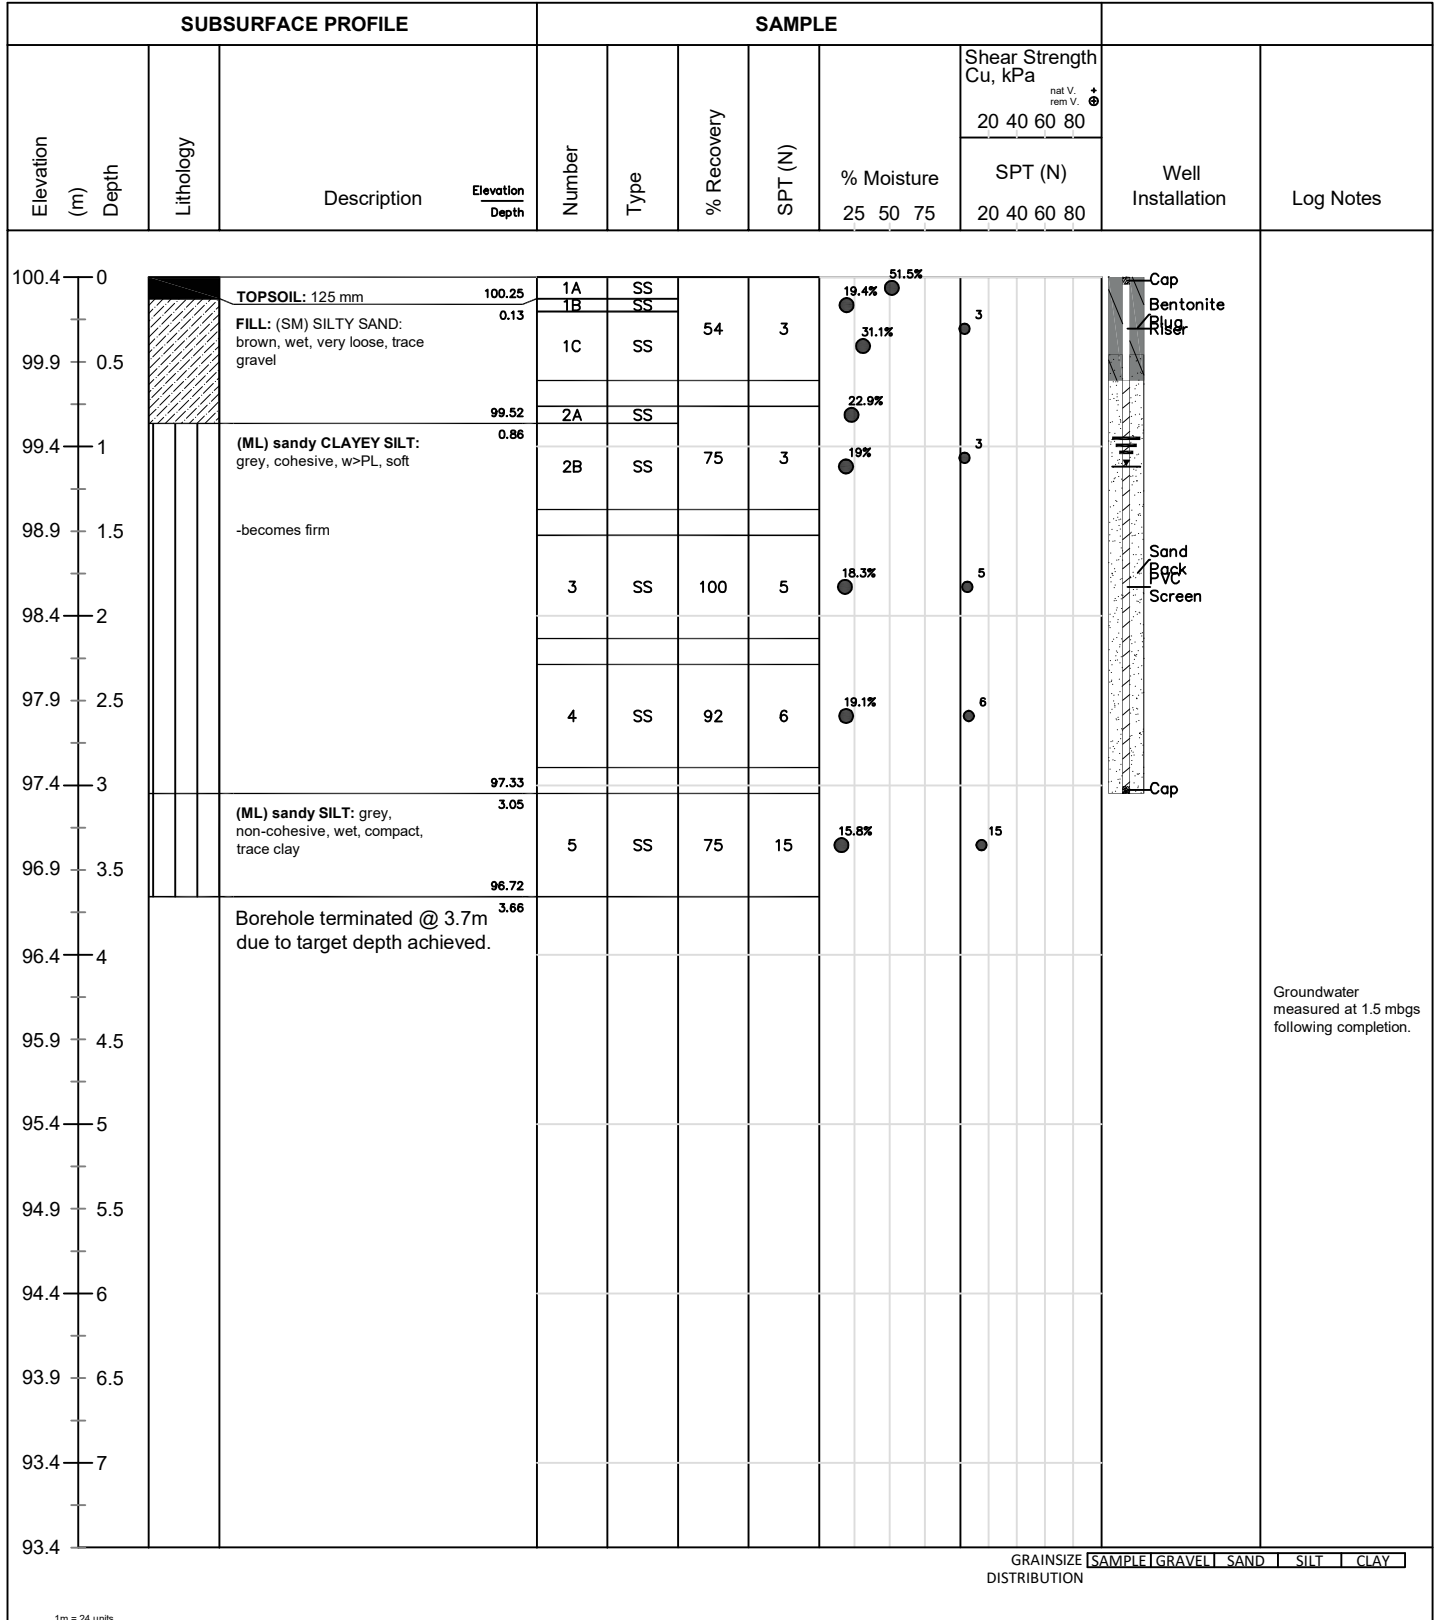
**Log of Borehole:** BH106-23  
**Page:** 1 of 1  
**Date Completed:** March 7, 2023

**Client:** Cassidy EW Construction **Project Name:** 1386 & 1394 Greely Lane  
**Contractor:** OGS Inc. **Method:** Track Mounted Hollow Stem Auger  
**Location:** Ottawa, ON **Elevation:** 100.38 mASL  
**Project No.:** 17281-001 - B **UTM:** 18 T **N:** 5011800 **E:** 455161

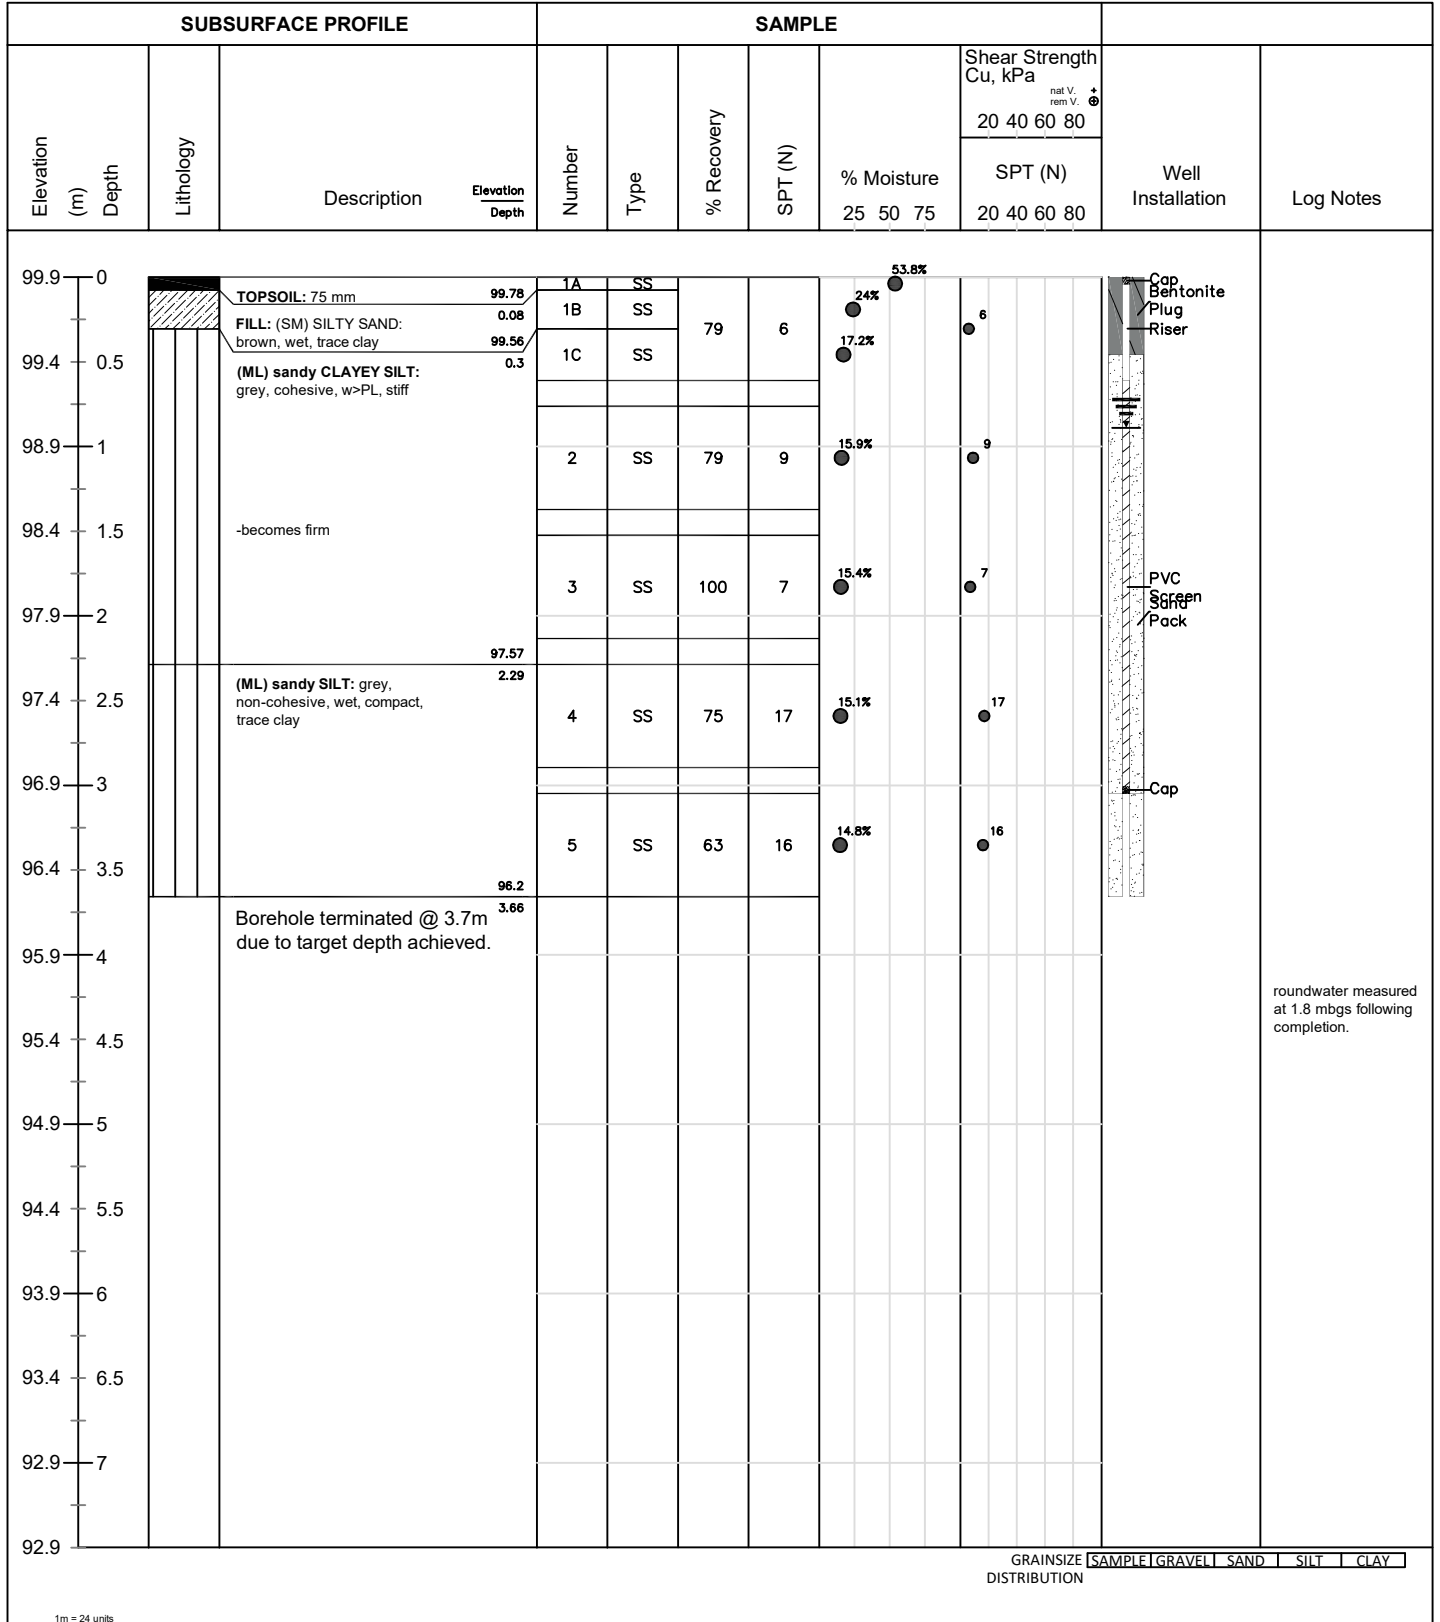
Log of Borehole: BH107-23  
Page: 1 of 1  
Date Completed: March 8, 2023

Client: Cassidy EW Construction Project Name: 1386 & 1394 Greely Lane  
Contractor: OGS Inc. Method: Track Mounted Hollow Stem Auger  
Location: Ottawa, ON Elevation: 99.86 mREL  
Project No.: 17281-001 - B UTM: 18 T N: 5011845 E: 455203

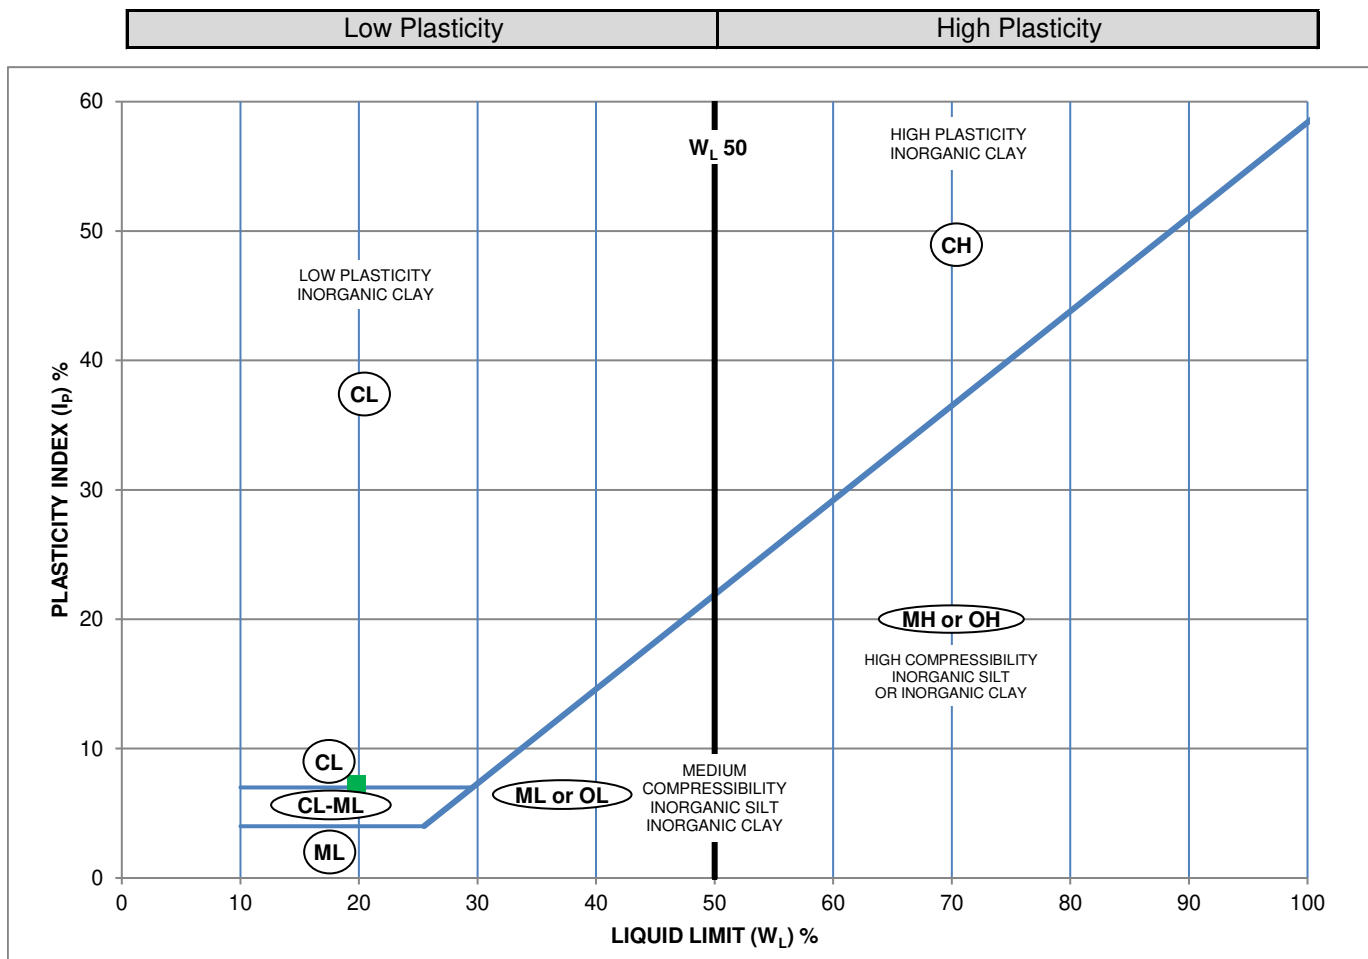
| Symbol | Borehole | Sample | Depth | Description |
|---|---|---|---|---|
| ■ | BH 101-23 | SS 3 | 1.5 m to 2.1 m | Low Plasticity Clay |

Physical laboratory testing was completed on select soil samples to assess geotechnical parameters. Natural moisture contents were measured for all soil samples (ASTM D2216), and particle size distribution testing and Atterberg index tests were completed on select samples (ASTM D6913, D1140, and D4318). The results are summarized in the respective stratigraphy sections in Section 3.0 and noted on the corresponding borehole logs. Detailed results diagrams of the particle size distribution testing and Atterberg Limits tests are provided in Appendix B.

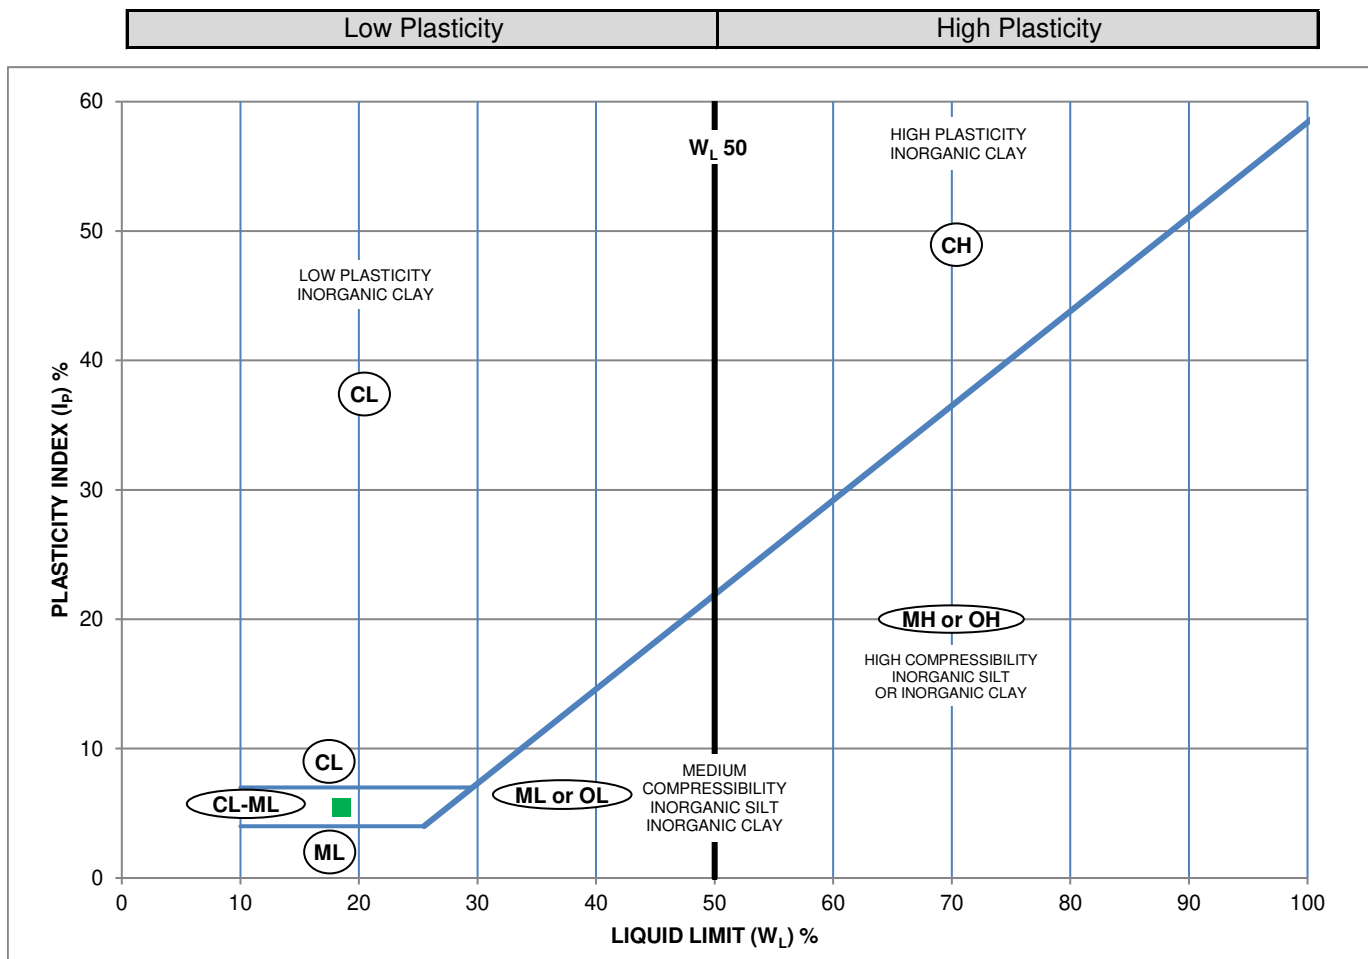
| Symbol | Borehole | Sample | Depth | Description |
|---|---|---|---|---|
| ■ | BH 104-23 | SS 4 | 2.3 m to 2.9 m | CL-ML |
