# **Geotechnical Investigation Report – Proposed New Warehouse Structure**

**1309 Carling Avenue, Ottawa, Ontario**

Project Number TR1363B

July 10, 2025

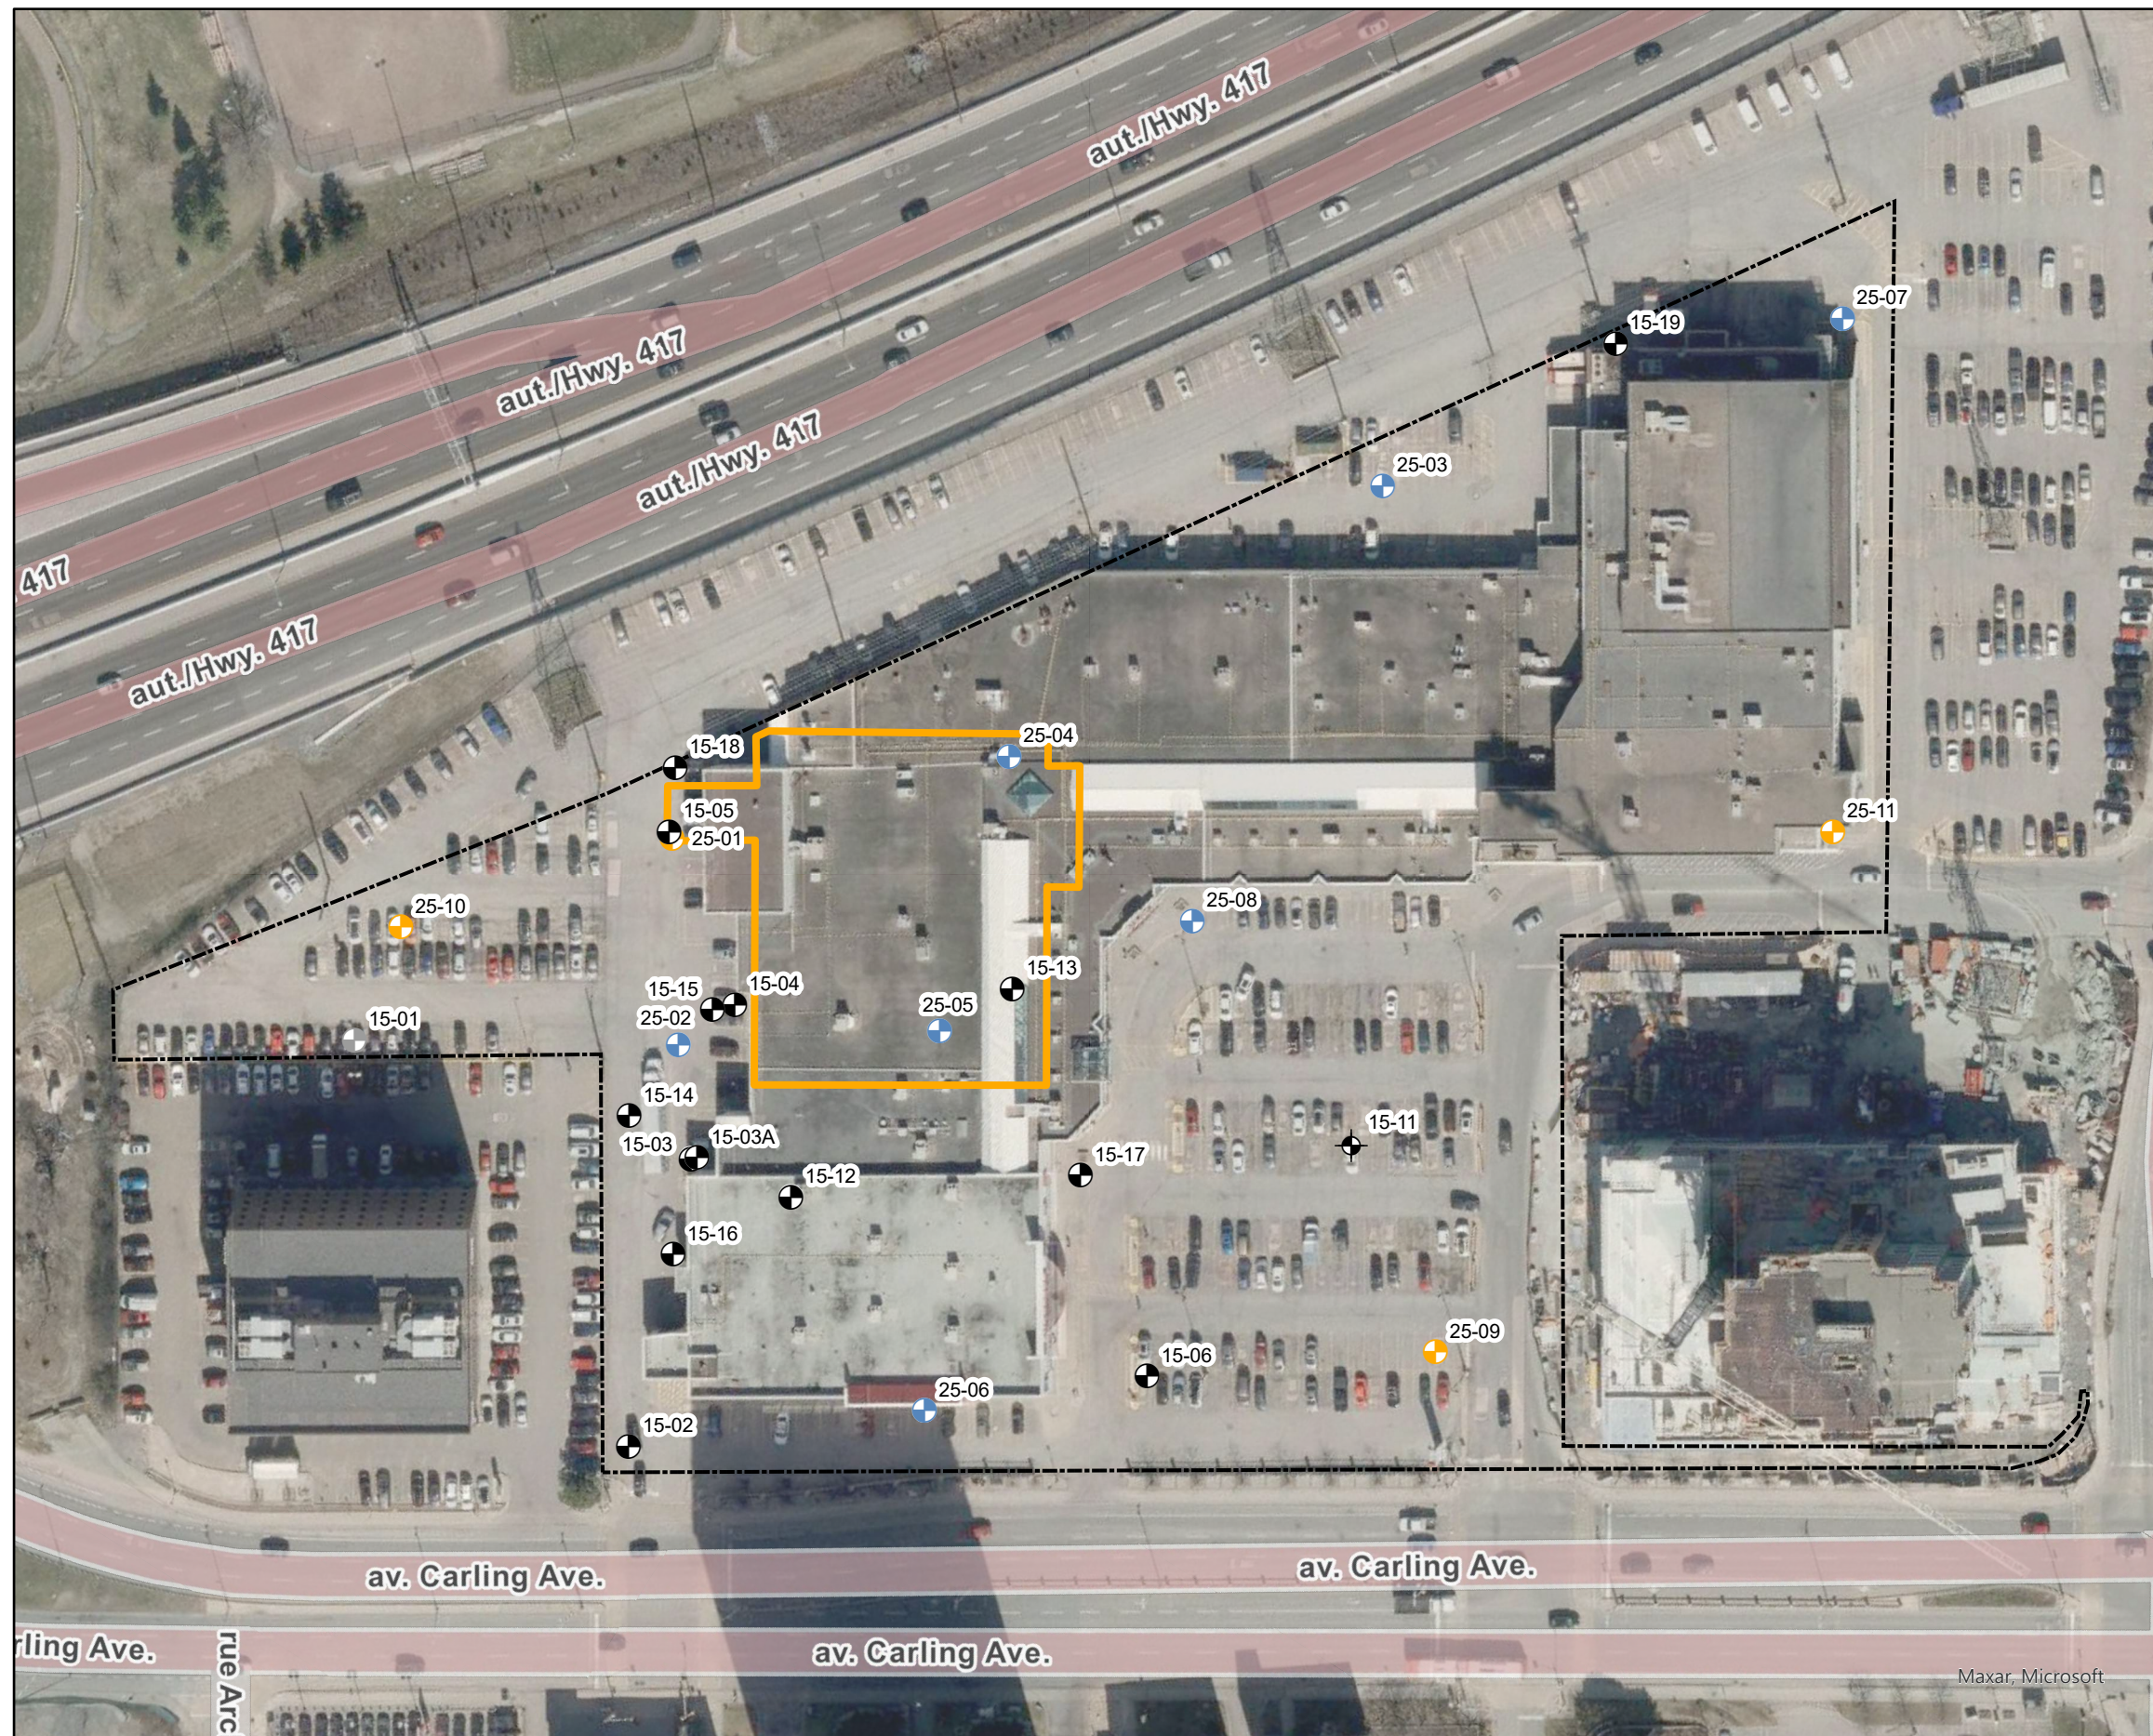
-   Borehole (Geosyntec)
-   Monitoring Well (Geosyntec)
-   Previous Borehole (Golder)
-   Previous Monitoring Well (Golder)
-   Unlocatable Previous Monitoring Well (Golder)
-   Phase Two Property Boundary
-   Building Footprint (approximate)

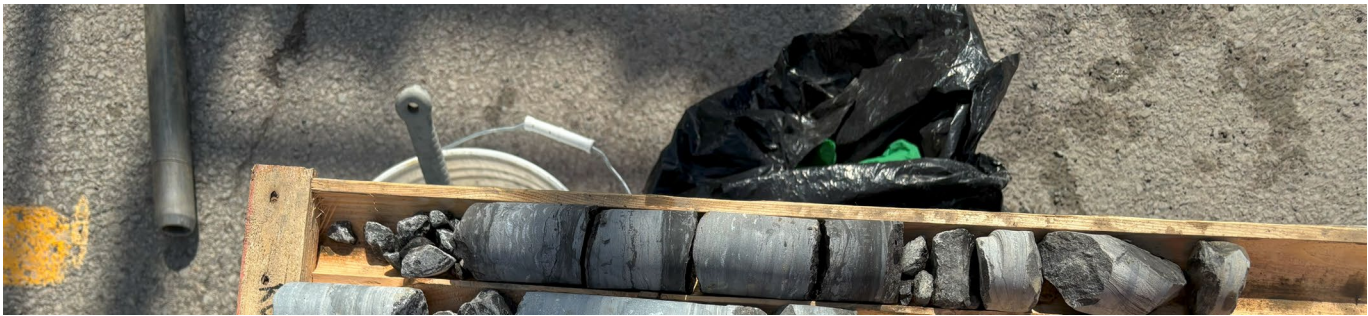
Borehole 25-01	Depth: 12.4 m – 13.2 m	Bedrock, Run1, RQD 0%
----------------	------------------------	-----------------------

It is identified as a grey limestone with black shale interbeds. The upper 0.5 to 1.5 m of bedrock was found to be highly weathered and fractured in boreholes 25-01 and 25-08 with Rock Quality Designation (RQD) of zero; however, this highly weathered zone was absent at borehole 25-02 location. At borehole 25-02 a fractured and very poor quality zone was observed between the approximate depths of 11.8 m bgs and 12.5 m bgs. The rock quality improved with depth within the investigated bedrock zone, with RQD varying between 80% and 95%, indicating good to excellent quality.

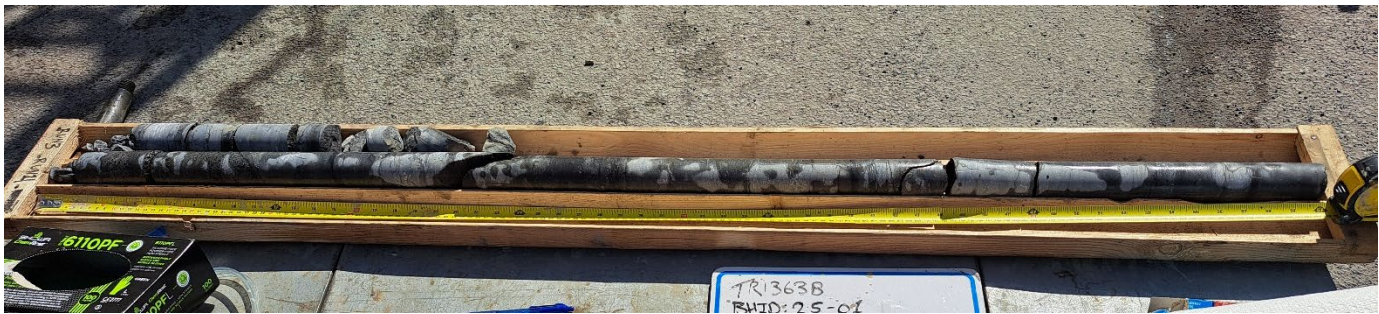
Borehole 25-01	Depth: 13.2 m – 14.6 m	Bedrock, Run2, RQD 95%
----------------	------------------------	------------------------

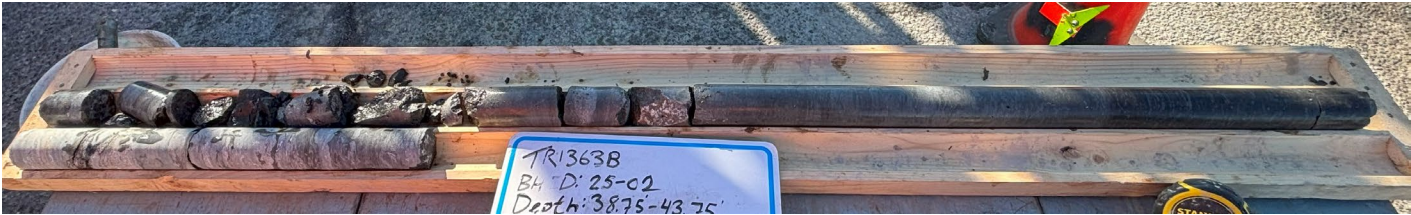
Borehole 25-02	Depth: 11.8 m – 13.3 m	Bedrock, Run2, RQD 52%

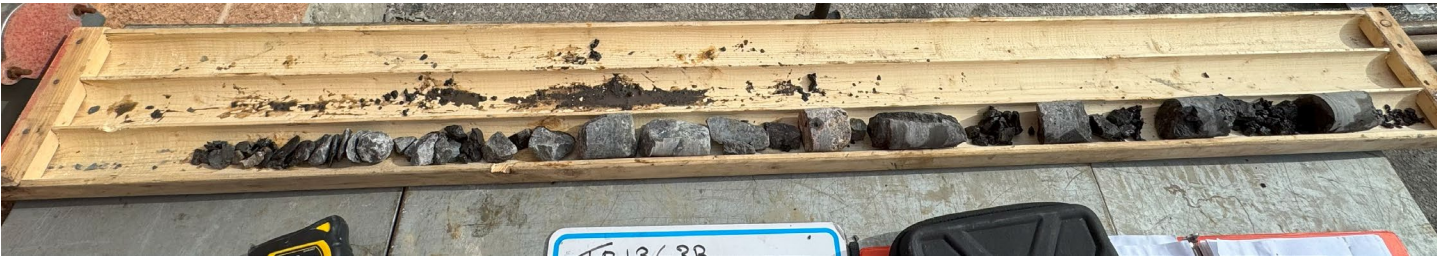
Borehole 25-08	Depth: 17.8 m – 19.4 m	Bedrock, Run1, RQD 0%

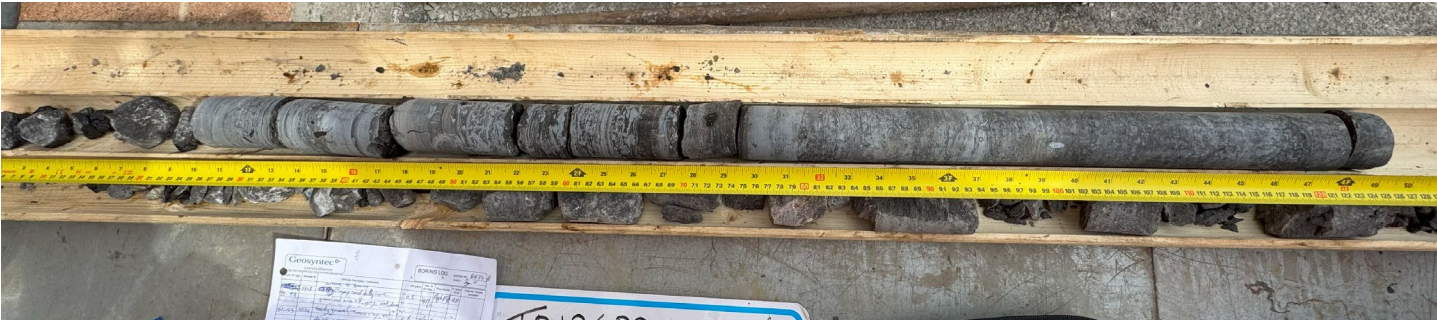
Borehole 25-08	Depth: 19.4 m – 20.6 m	Bedrock, Run2, RQD 80%
