**re: Retaining Wall Global Stability Analysis**  
**Proposed Retaining Walls**  
**1009 Trim Road – Ottawa, Ontario**

**file:** PG5336-MEMO.07

Further to your request and authorization, Paterson Group (Paterson) prepared the current memorandum to provide the results of the global stability analysis for the proposed retaining wall structures to be located at the aforementioned site. This memorandum should be read in conjunction with Paterson Group Report PG5336-1 Revision 4, dated May 30, 2025.

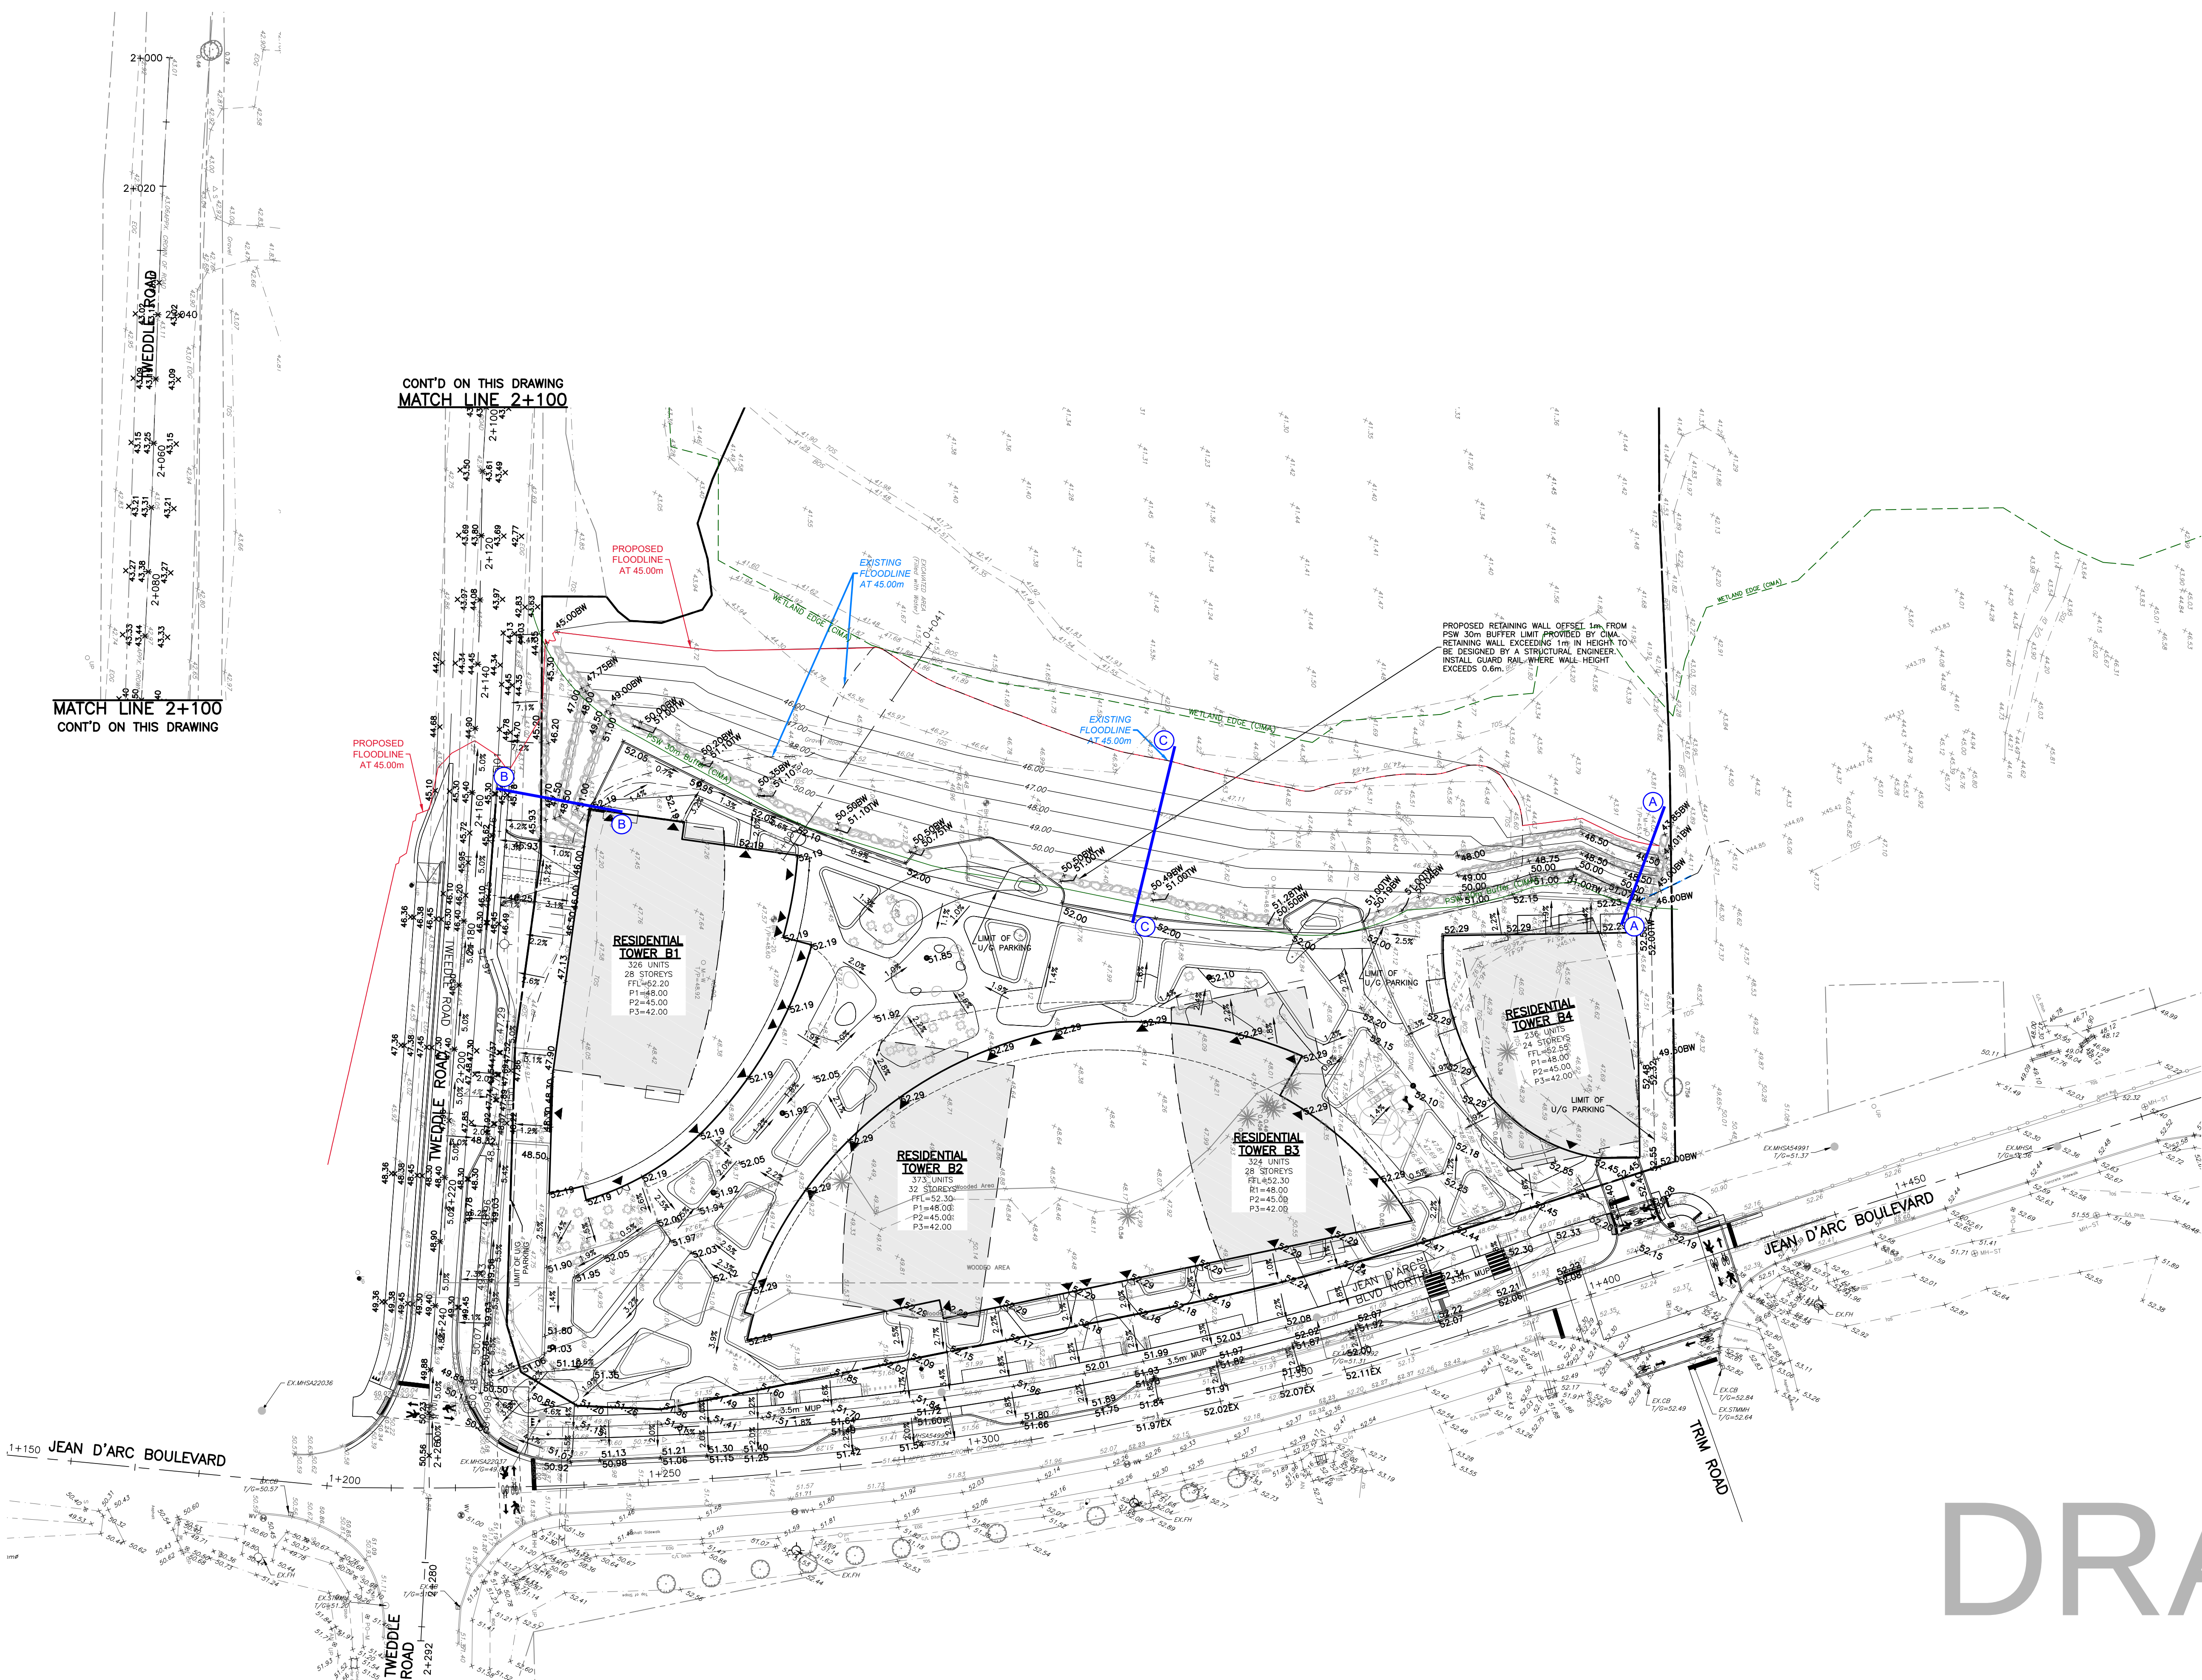
# SITE GRADING PLAN

Three (3) cross-sections, considered as the “worst case” scenario, has been analyzed for global stability, where the proposed slope and/or retaining walls have more than 2m height. The location of the cross-section is shown on the attached drawing.

Based on the grading plan provided by the client, it is understood that Armor stone retaining walls will be used to raise the grade along this area.
