**PH4924-LET.01**

Subject: **Hydrogeological Assessment and Terrain Analysis  
Proposed Commercial Development  
5923 Ottawa Street  
Ottawa, Ontario**

Further to your request, Paterson has conducted a Hydrogeological Assessment and Terrain Analysis in support of a Site Plan Control Application for the proposed commercial development to be located at 5923 Ottawa Street in Ottawa, Ontario.

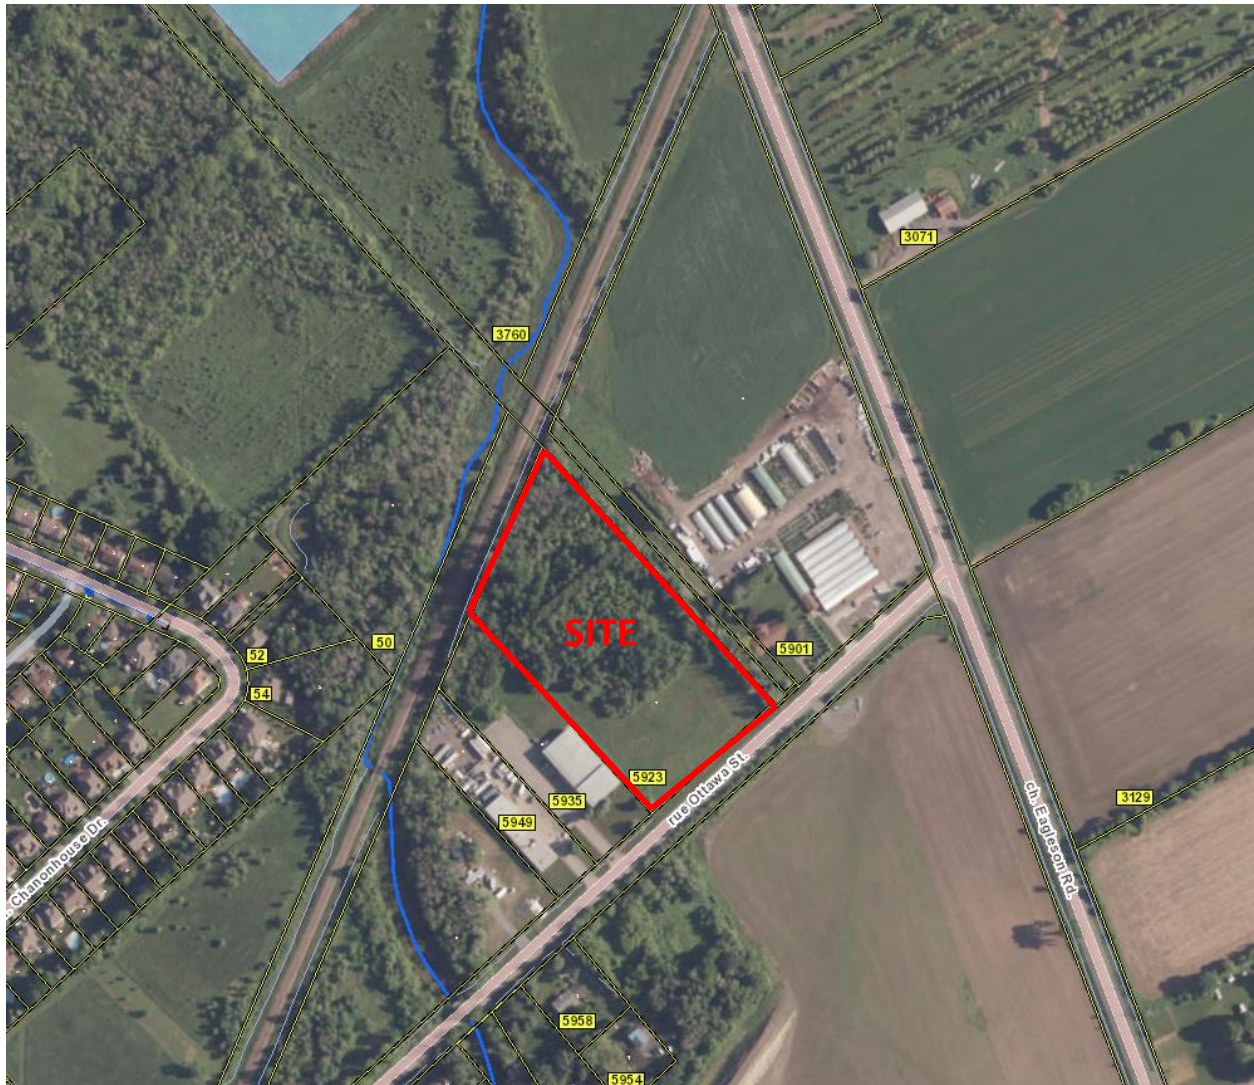
**FIGURE 1**

**KEY PLAN**
