Geotechnical Investigation

Proposed Residential Development

Northridge Subdivision

Report PG6009-1 Revision 3 dated August 24, 2022

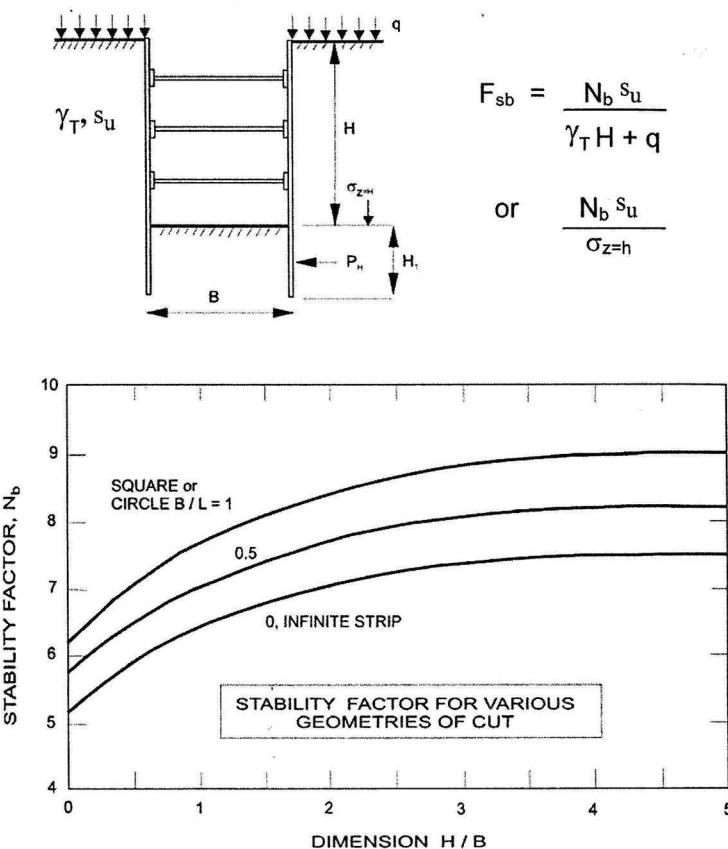
Figure 1 – Stability Factor of Various Geometries of Cut

s_u - undrained shear strength of the soil below the base level

σ_z - total overburden and surcharge pressures at the bottom of the excavation

In the case of stiff clays, a factor of safety of 2 is recommended for base stability.

Shear failure of excavation bases is typically rare in granular soils if adequate lateral support is provided. Inadequate dewatering can cause instability in excavations made through granular or layered soils. The potential for base heave in cohesive soils should be determined for stability of flexible retaining systems.

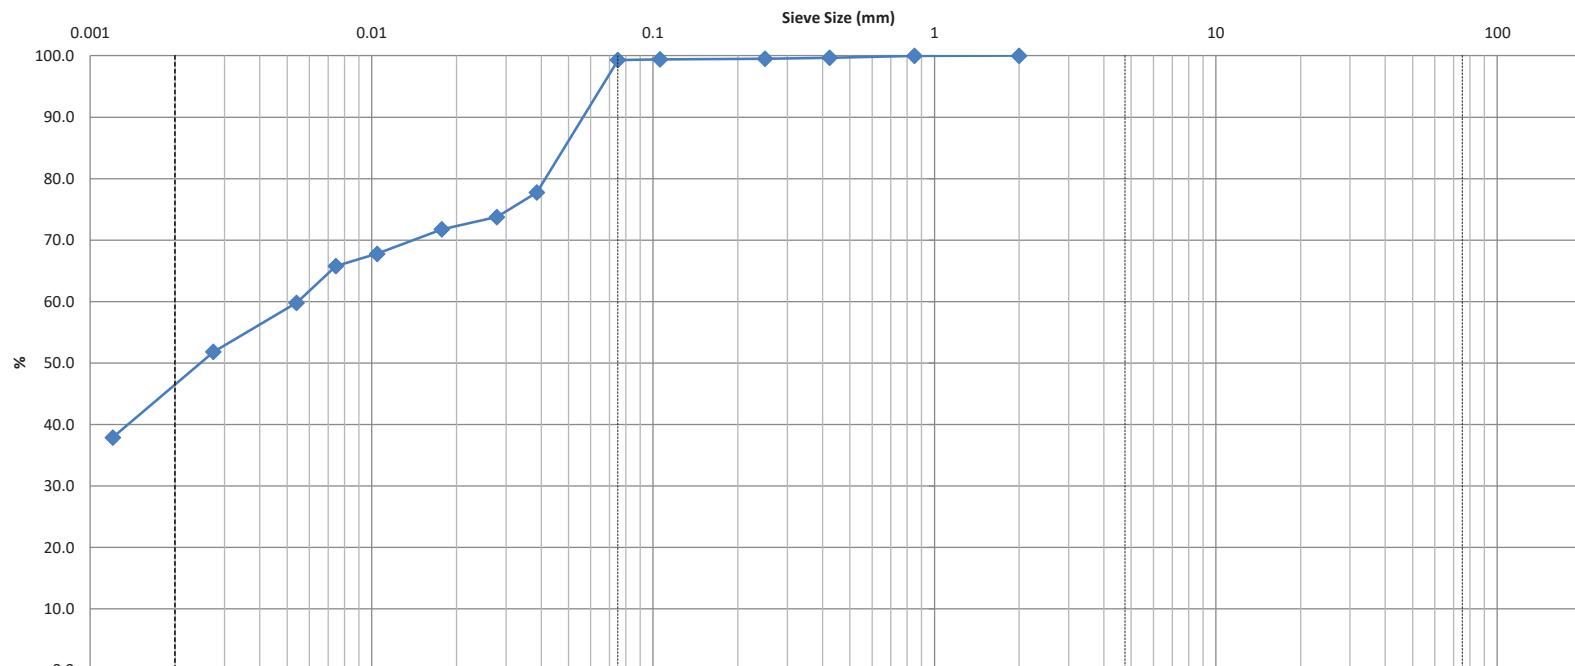
CLIENT:	Valecraft Homes	DEPTH:	1.8 - 1.9m	FILE NO:	PG5145
CONTRACT NO.:		BH OR TP No.:	TP4B - G3	LAB NO:	14615
PROJECT:	1020 to 1070 March Road			DATE RECEIVED:	12-Dec-19
DATE SAMPLED:	6-Dec-19			DATE TESTED:	13-Dec-19
SAMPLED BY:	D.P.			DATE REPORTED:	17-Dec-19
				TESTED BY:	O.M.

Identification	Soil Classification					MC(%)	LL	PL	PI	Cc	Cu
	Fine	Medium	Coarse	Fine	Coarse						
						25.4					
	D100	D60	D30	D10	Gravel (%)		Sand (%)		Silt (%)	Clay (%)	
					0.0		0.7		52.8	46.5

Atterberg limits testing, as well as associated moisture content testing, were completed on the recovered silty clay samples at selected locations throughout the subject site. The results of the Atterberg limits tests are presented in Table 1 and on the Atterberg Limits' Results sheet in Appendix 1.

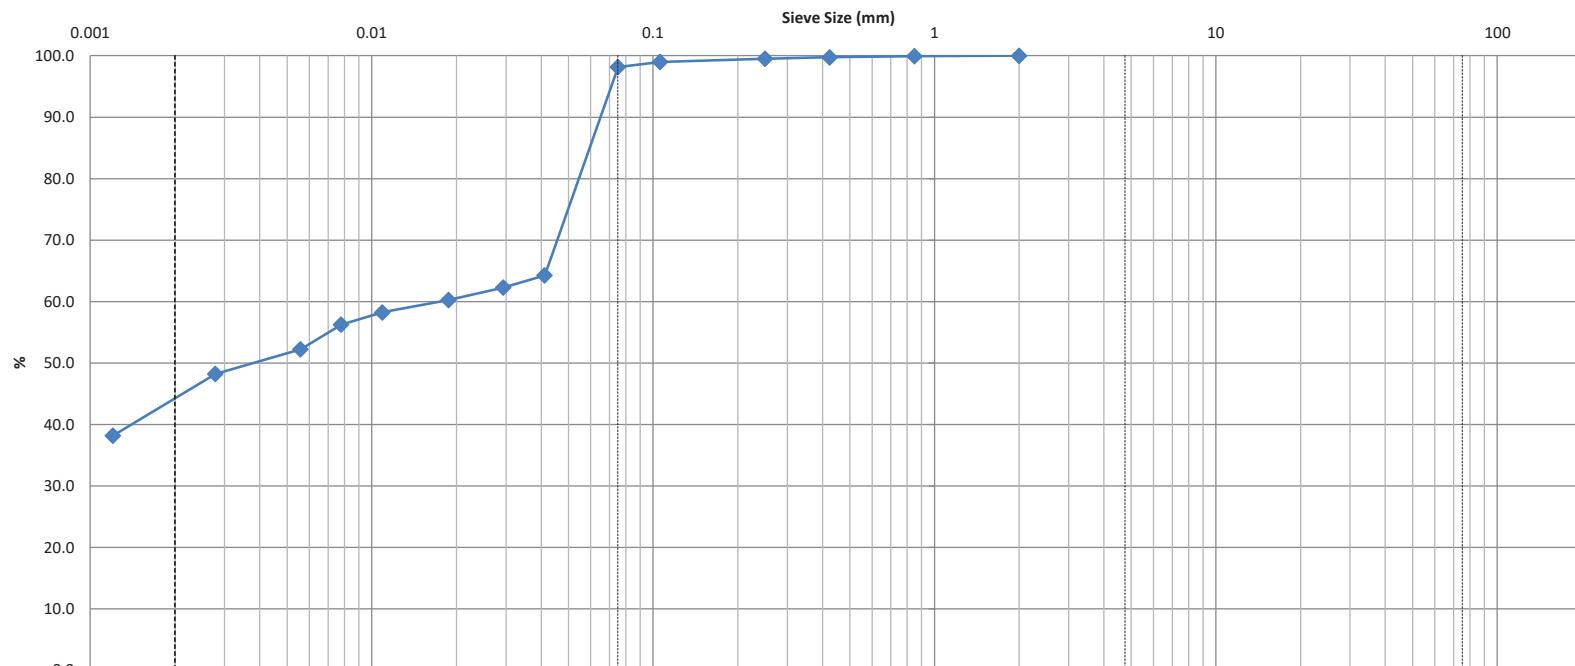
CLIENT:	Valecraft Homes	DEPTH:	1.6 - 1.7m	FILE NO:	PG5145
CONTRACT NO.:		BH OR TP No.:	TP5 - G4	LAB NO:	14616
PROJECT:	1020 to 1070 March Road			DATE RECEIVED:	12-Dec-19
DATE SAMPLED:	6-Dec-19			DATE TESTED:	13-Dec-19
SAMPLED BY:	D.P.			DATE REPORTED:	17-Dec-19
				TESTED BY:	O.M.

Identification	Soil Classification					MC(%)	LL	PL	PI	Cc	Cu
	Fine	Medium	Coarse	Fine	Coarse						
						34.6					
	D100	D60	D30	D10	Gravel (%)		Sand (%)		Silt (%)	Clay (%)	
					0.0	1.8			55.0	43.2

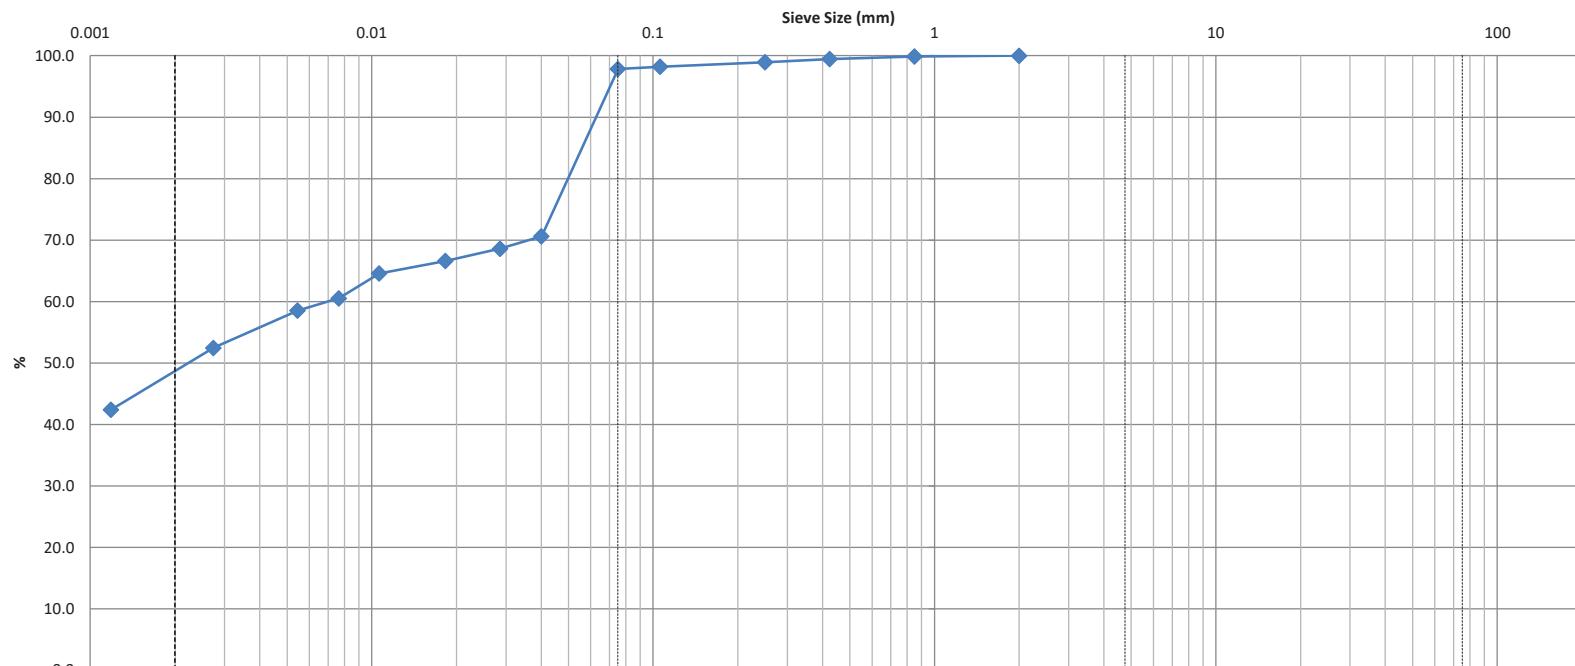
CLIENT:	Valecraft Homes	DEPTH:	1.6 - 1.7m	FILE NO:	PG5145
CONTRACT NO.:		BH OR TP No.:	TP8 - G4	LAB NO:	14617
PROJECT:	1020 to 1070 March Road			DATE RECEIVED:	12-Dec-19
DATE SAMPLED:	6-Dec-19			DATE TESTED:	13-Dec-19
SAMPLED BY:	D.P.			DATE REPORTED:	17-Dec-19
				TESTED BY:	O.M.

Identification	Soil Classification					MC(%)	LL	PL	PI	Cc	Cu
	Fine	Medium	Coarse	Fine	Coarse						
						33.0					
	D100	D60	D30	D10	Gravel (%)		Sand (%)		Silt (%)		Clay (%)
					0.0	2.2			49.3		48.5
