# **Geotechnical Investigation**

## **Proposed Commercial Development**

2300 Bank Street  
Ottawa, Ontario

**Report PG7467-1 Revision 1 dated December 18, 2025**

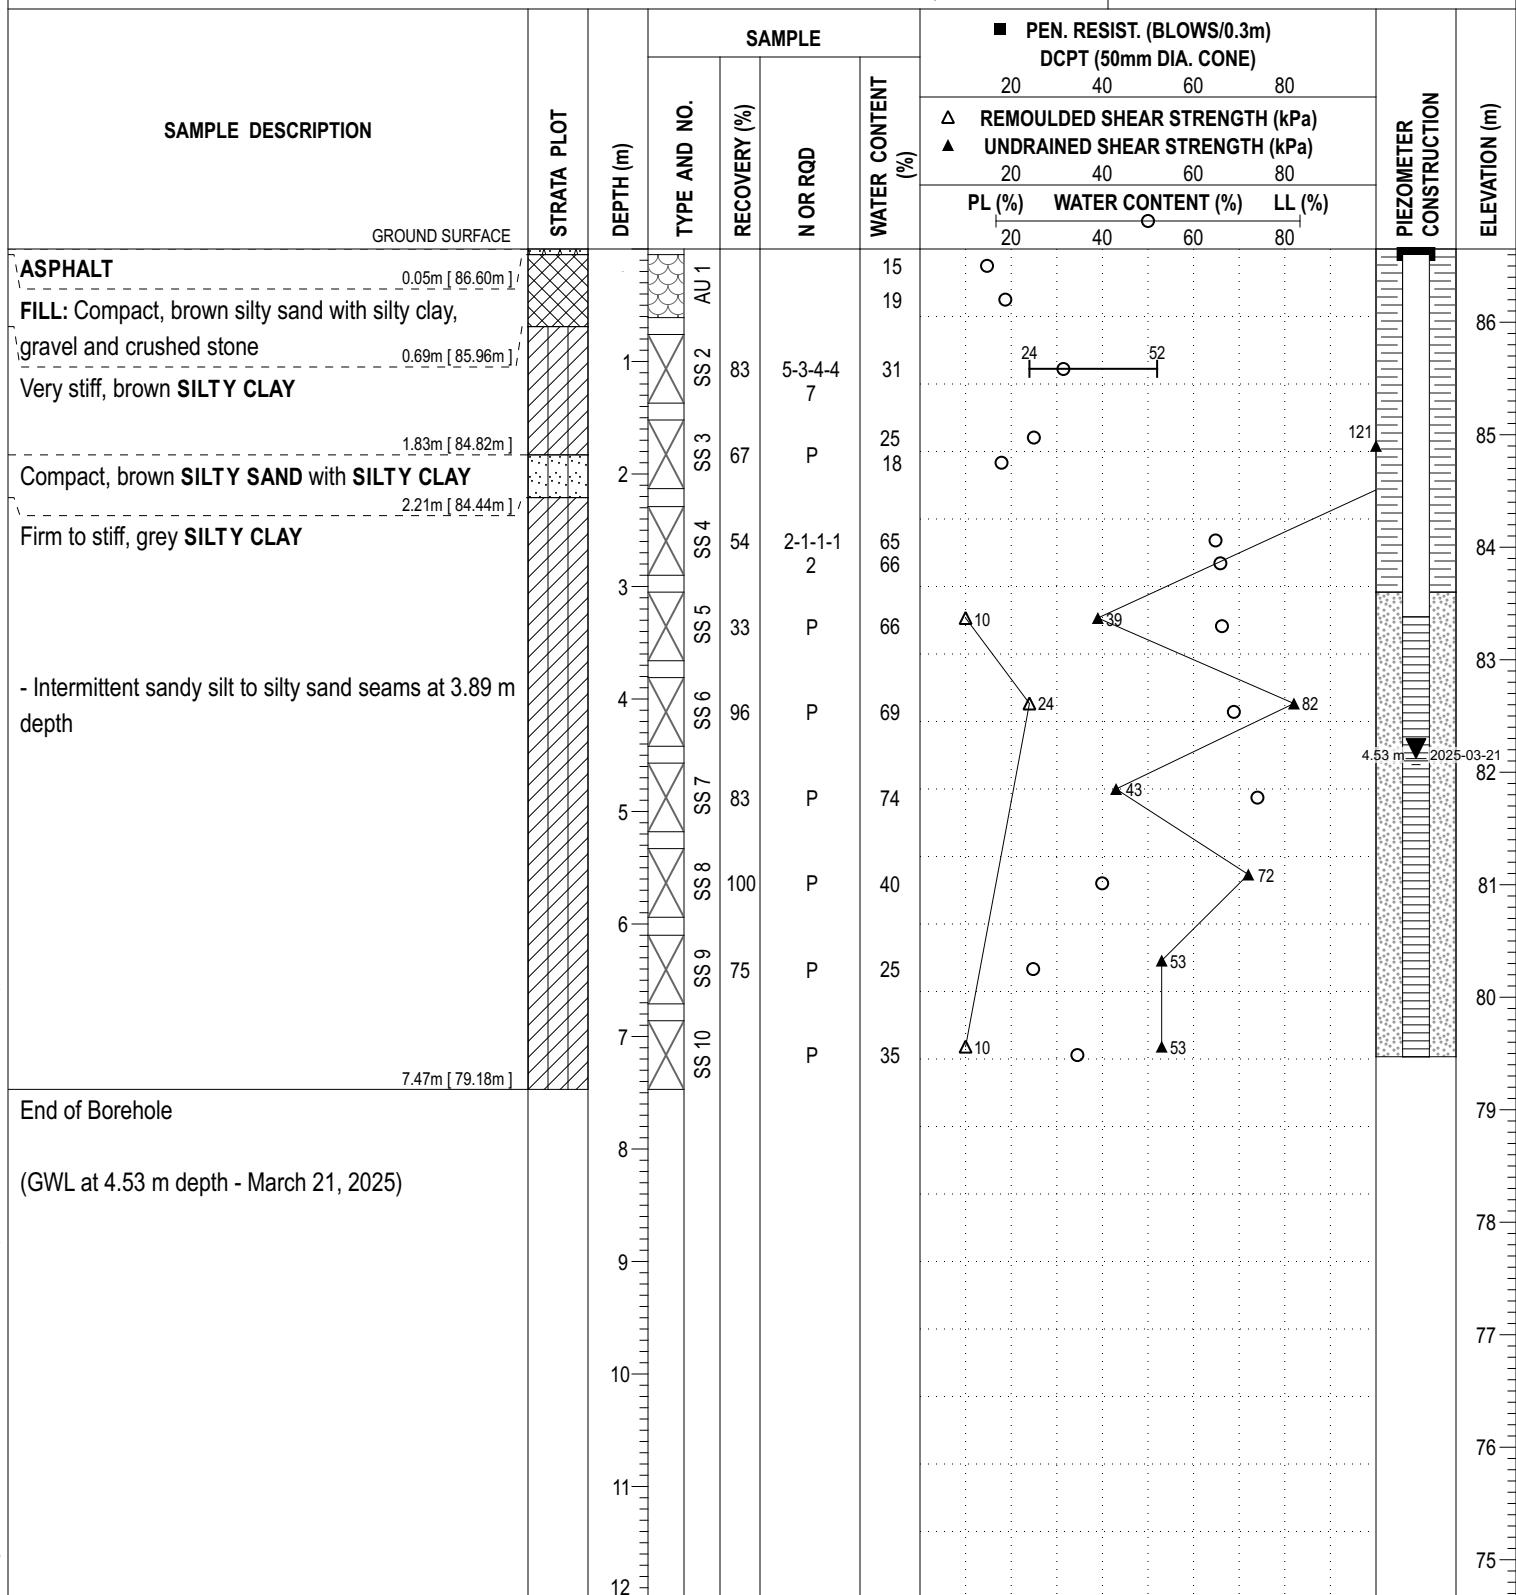
HOLE NO.: BH 2-25

(GWL at 4.53 m depth - March 21, 2025)

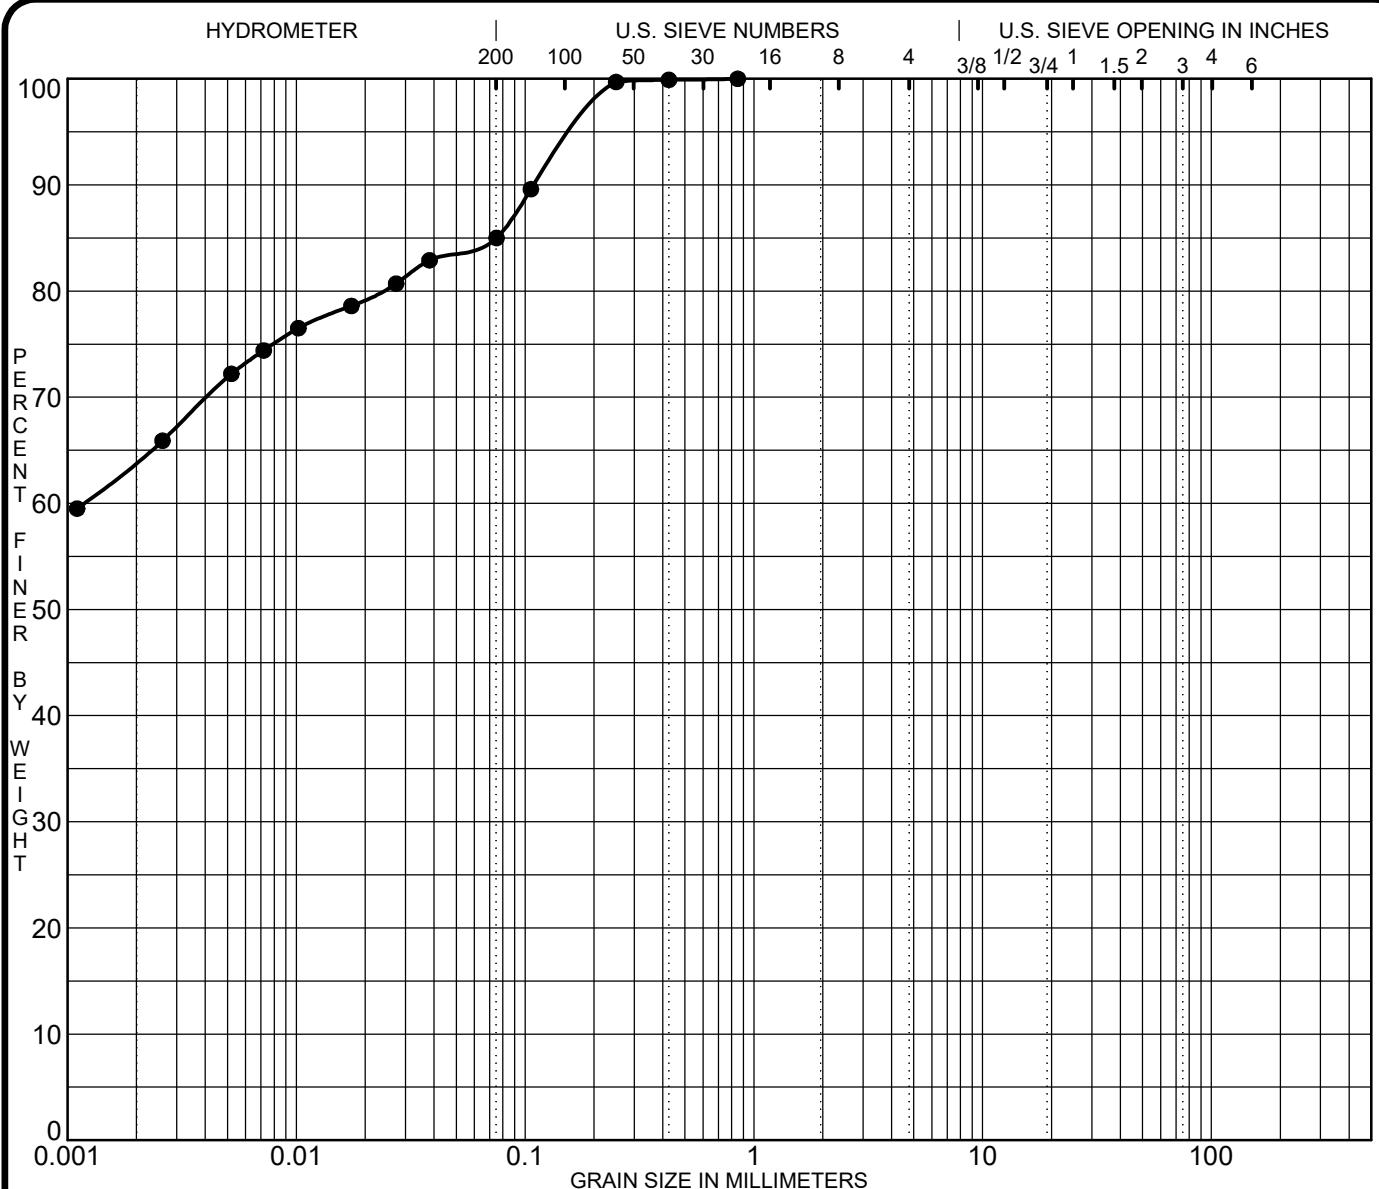
# ATTERBERG LIMITS' RESULTS

Specimen Identification		Classification				MC%	LL	PL	PI	Cc	Cu
●	<b>BH 3-25</b>	<b>SS3</b>	<b>MH - Inorganic silts of high plasticity</b>	<b>38.9</b>	<b>82</b>	<b>44</b>	<b>38</b>				
☒											
▲											
★											
Specimen Identification		D100	D60	D30	D10	%Gravel	%Sand	%Silt	%Clay		
●	<b>BH 3-25</b>	<b>SS3</b>	<b>0.85</b>	<b>0.00</b>			<b>0.0</b>	<b>15.0</b>	<b>21.7</b>	<b>63.3</b>	
☒											
▲											
★

Atterberg Limits testing, as well as associated moisture content testing, was completed on a select silty clay samples. The results of the Atterberg Limits tests are presented in Table 1 and on the Atterberg Limits Results sheet in Appendix 1. The results of the moisture content testing are presented on the Soil Profile and Test Data Sheets in Appendix 1. The tested silty clay samples classify as inorganic clays of high plasticity (CH) and inorganic silts of high plasticity (MH) in accordance with the Unified Soil Classification System (USCS).

Based on the results of the Atterberg Limits testing mentioned above, the plasticity index was found to be less than 40% in the tested silty clay samples.

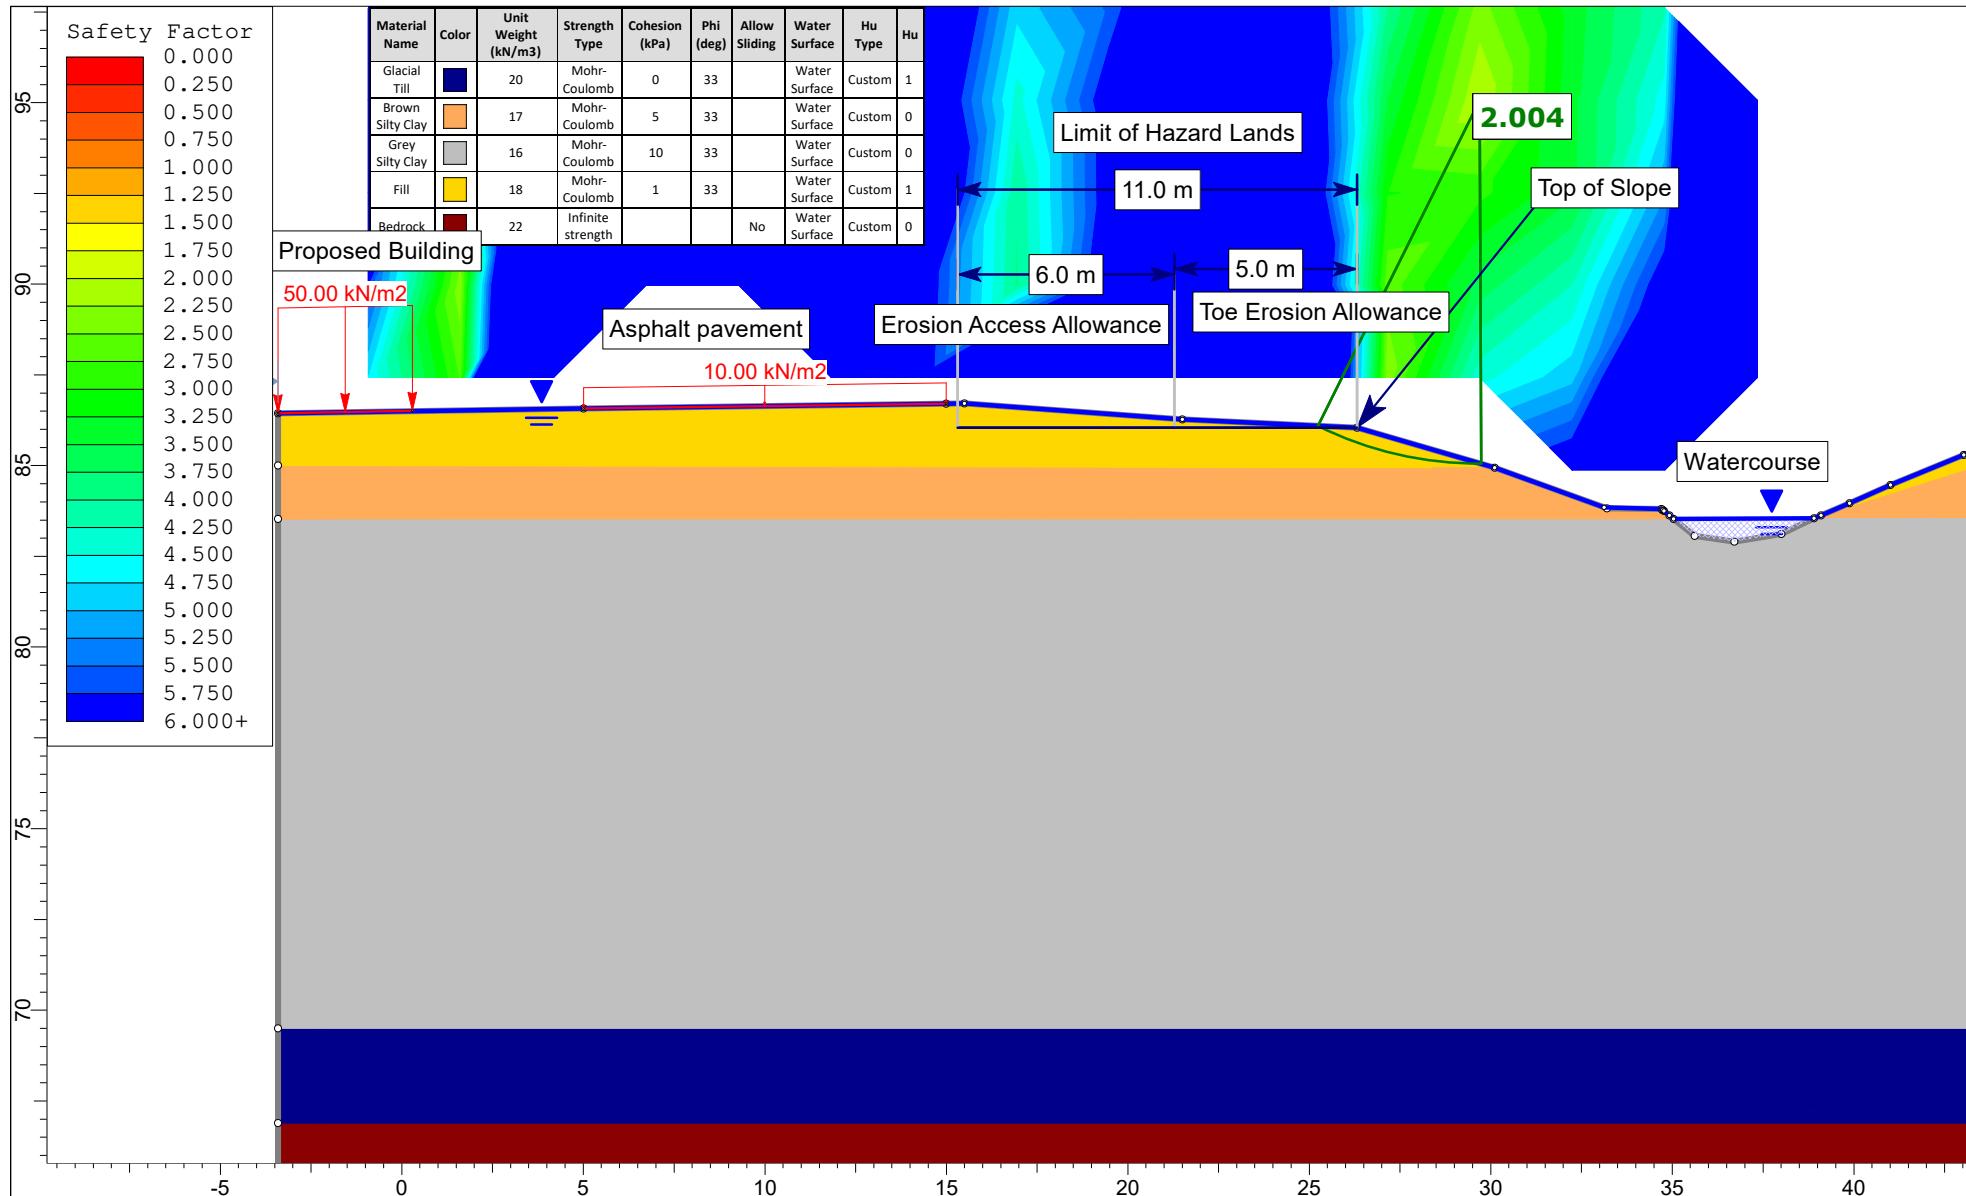
<p><b>PATERSON GROUP</b></p> <p>SLIDEINTERPRET 9.025</p>	Project		PG7467 - 2300 Bank Street	
	Slope Section	A	Scenario	Proposed Static Loading
	Drawn By	DR	Company	Trinity Group
	Date	2025-04-03	File Name	Figure 2A

The slope stability analysis of the proposed site conditions was conducted using SLIDE, a computer program which permits a two-dimensional stability analysis using several methods including the Bishop's method, which is a widely used and accepted analysis method. A horizontal acceleration of 0.16 g (50% of PGA = 0.32g) was utilized for the seismic analysis.

The results for the slope stability analyses under static and seismic conditions at cross-sections A-A' are shown on Figures 2A and 2B, which are attached to the current report in Appendix 2.

The results of the slope stability analysis under static conditions at cross-section A-A' indicate a suitable factor of safety exceeding 1.5, while the results of the slope stability analysis under seismic conditions at cross-section A-A' indicate a suitable factor of safety exceeding 1.1.

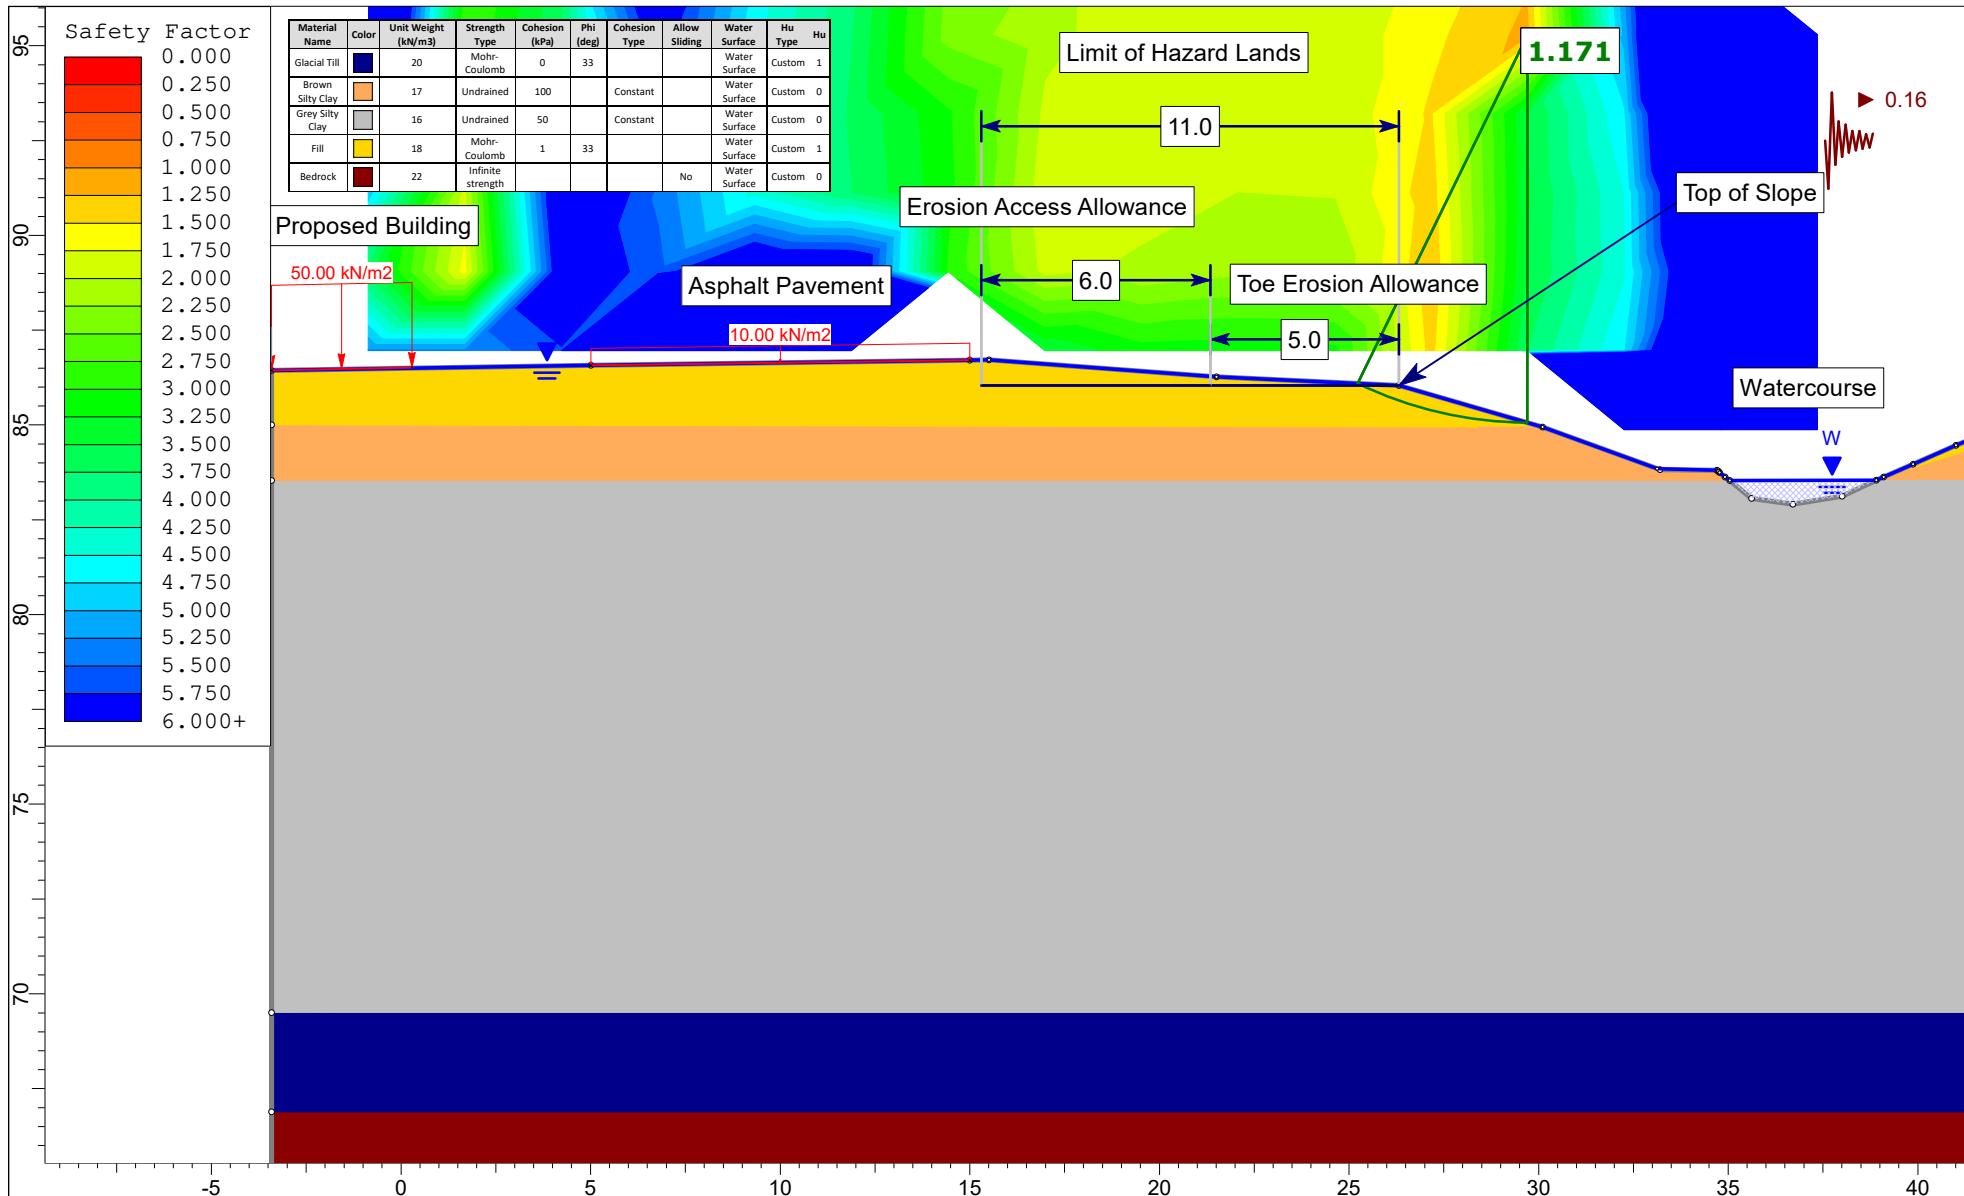
<p><b>PATERSON GROUP</b></p> <p>SLIDEINTERPRET 9.025</p>	Project		PG7467 - 2300 Bank Street	
	Slope Section	A	Scenario	Proposed Seismic Loading
	Drawn By	DR	Company	Trinity Group
	Date	2025-04-03	File Name	Figure 2B

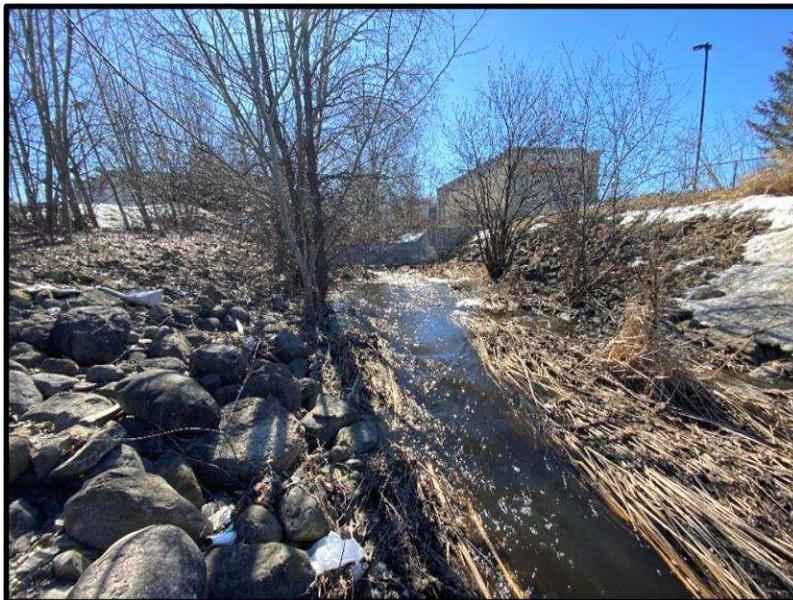
**Photo 1:** Photograph of running water Creek and toe of slope taken at the northwestern portion of the site towards the south illustrating crushed stone riprap with few tress, grass and shrubs covered side slopes, no toe erosion was observed.

The slope conditions were reviewed on-site by Paterson at the time of the field investigation. At that time, the slope adjacent to the subject site was observed to be vegetated with grass and some mature trees with no significant signs of erosion observed along the toe of the slope. The bottom portion of the slope was observed to be partially covered with rip rap.

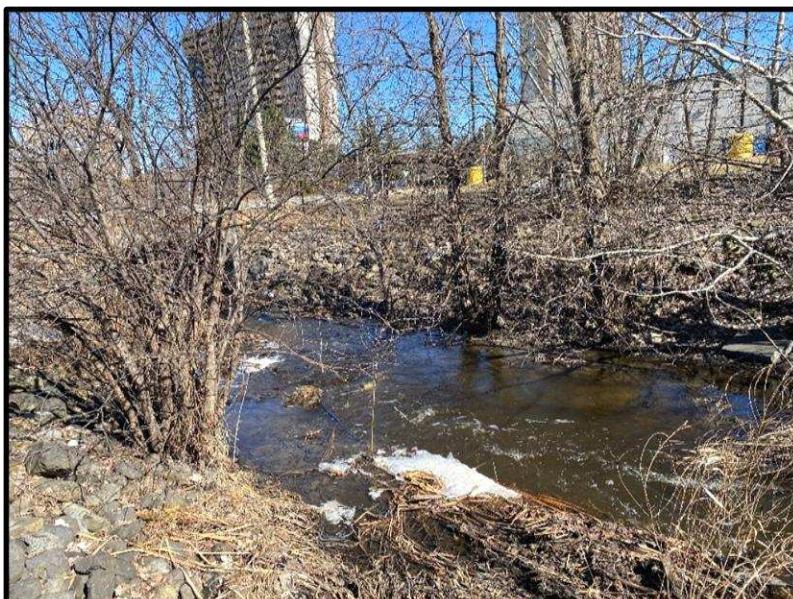
**Photo 2:** Photograph of creek, facing north illustrating crushed stone riprap with few tress, grass and shrubs covered side slopes.

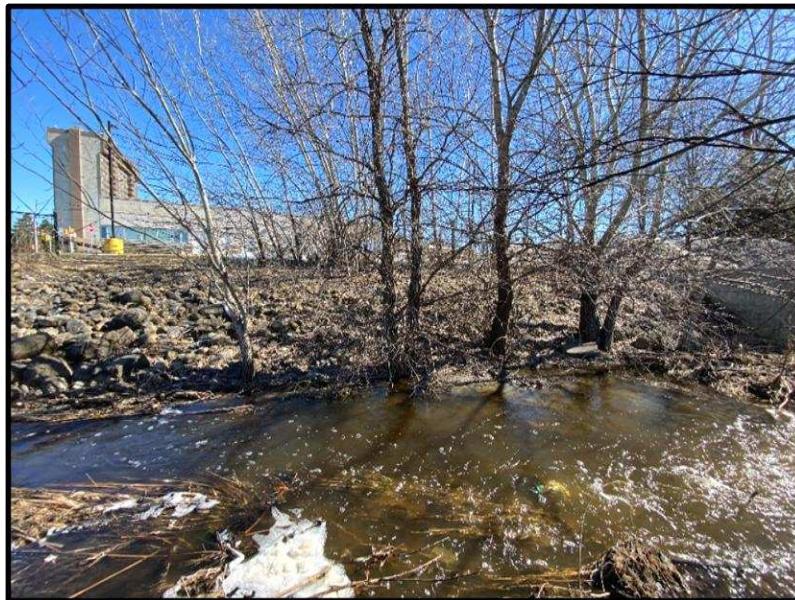
**Photo 3:** Photograph of Creek, facing north east illustrating crushed stone riprap with few trees, grass and shrubs covered side slopes.

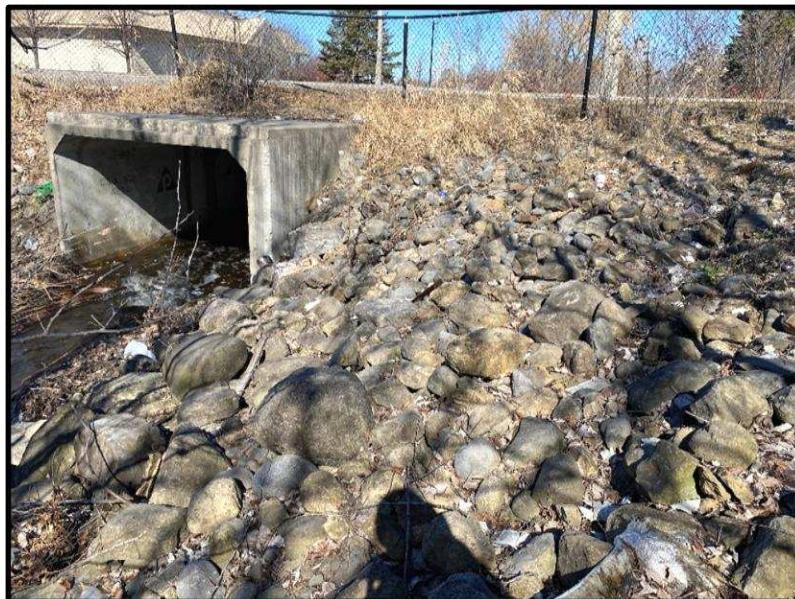
**Photo 4:** Photograph of creek with culvert, facing west illustrating crushed stone riprap with grass and shrubs covered side slopes.
