# Geotechnical Investigation

## National Capital Business Park

Site 3 - 4055 Russell Road

Report PG4854-3 Revision 2 dated December 10, 2025

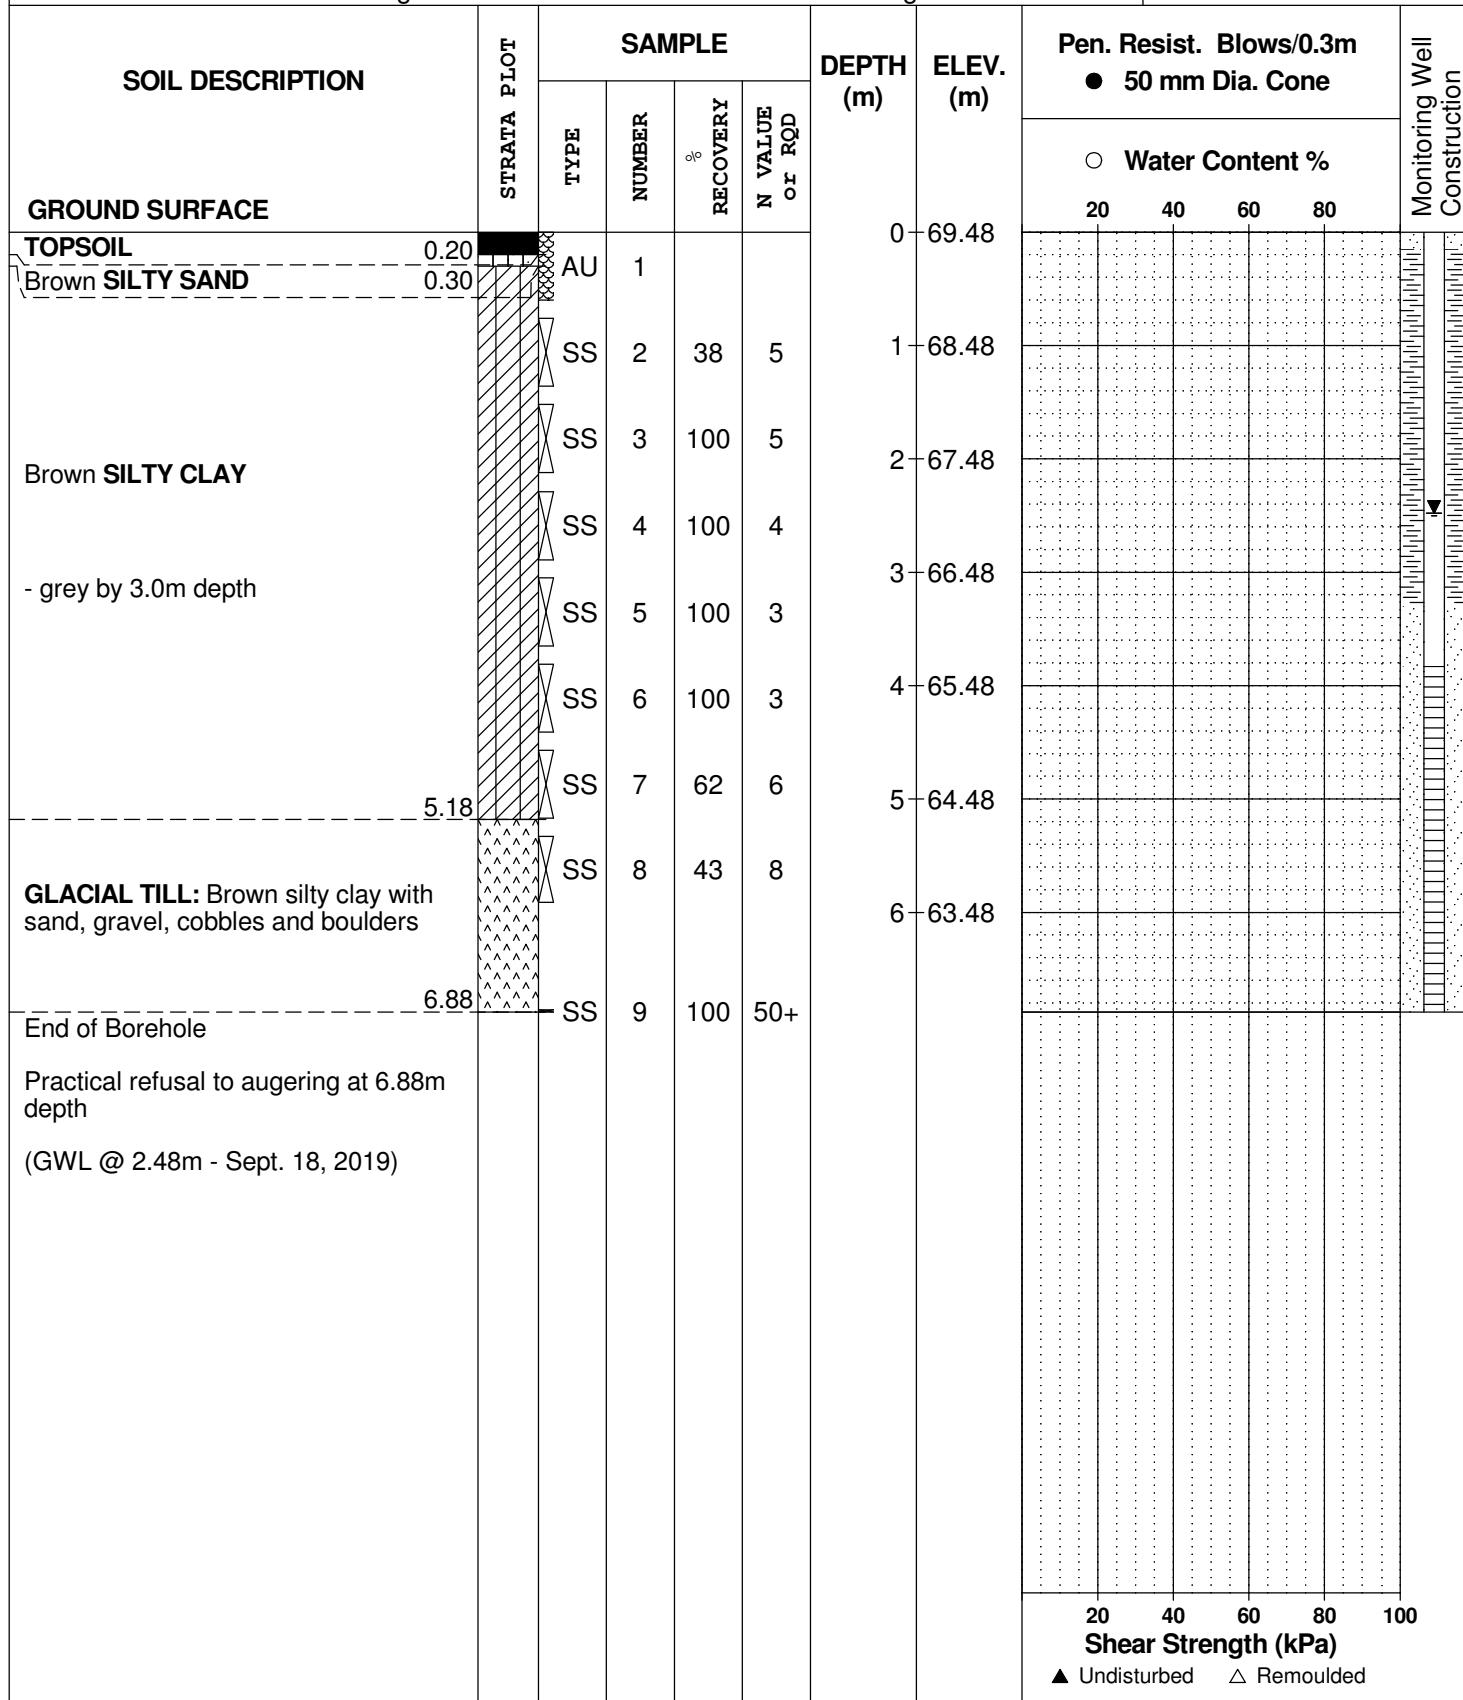
HOLE NO. **BH 1**

The subsurface conditions observed in the test holes were recorded in detail in the field. The soil profiles are logged on the Soil Profile and Test Data sheets in Appendix 1 of this report.

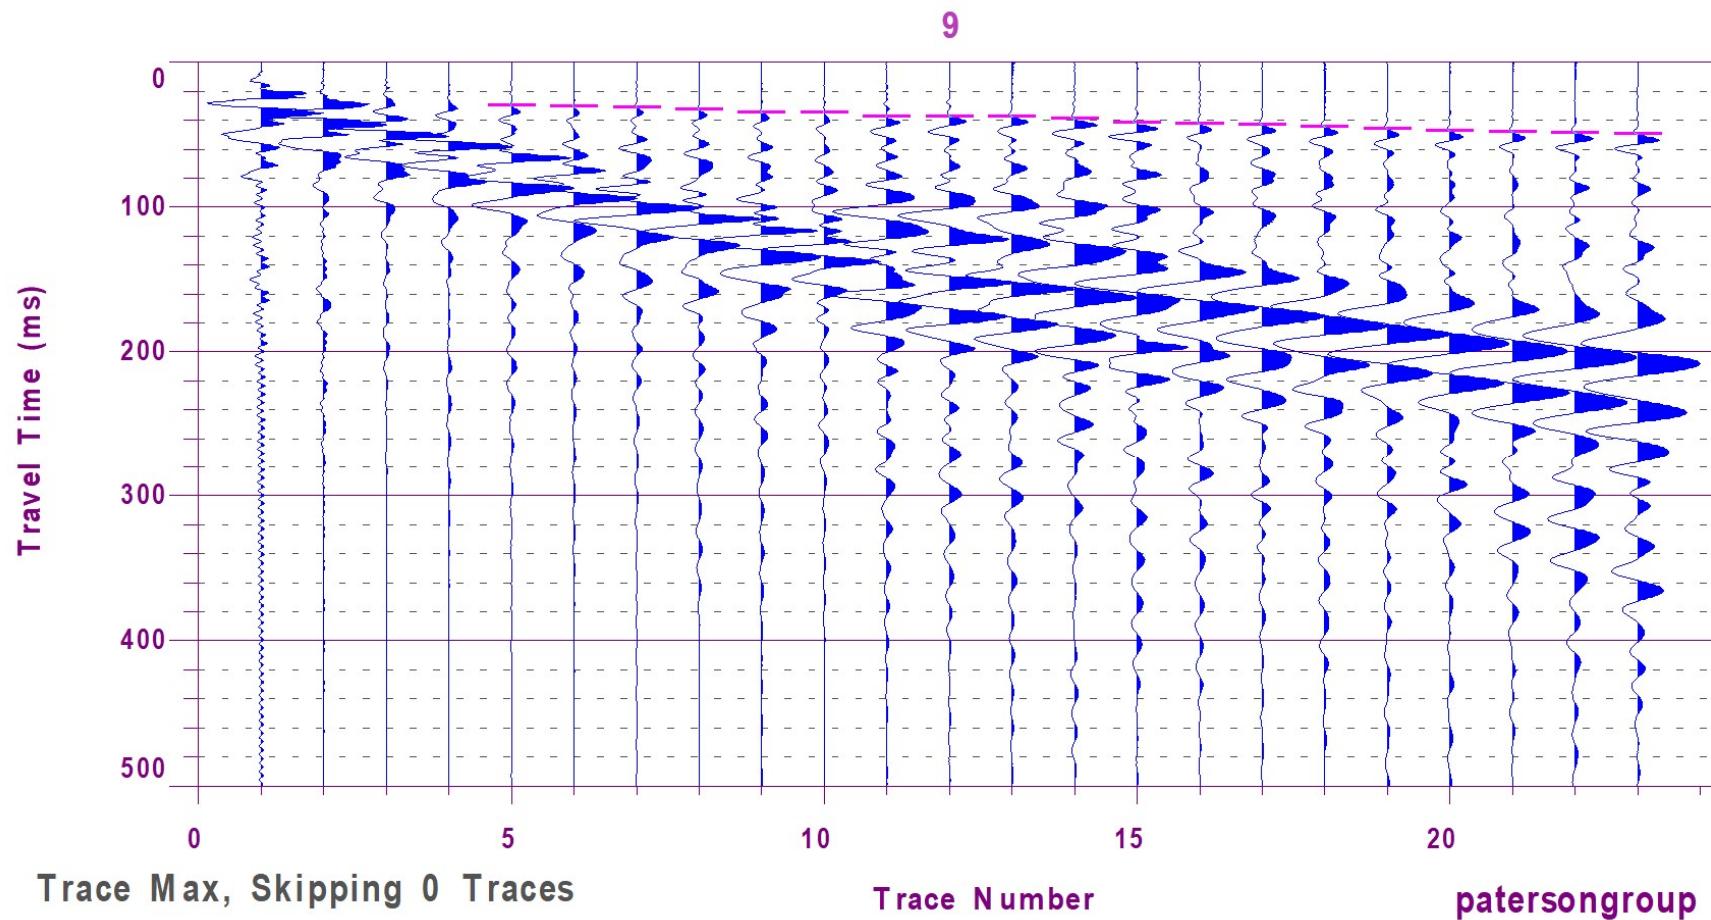
Figure 2 – Shear Wave Velocity Profile at Shot Location -2 m

The interpretation is repeated at each shot location to provide an average shear wave velocity,  $V_{s30}$ , of the upper 30 m profile, immediately below the building foundations. The layer intercept times, velocities from different layers and critical distances are interpreted from the shear wave records to compute the bedrock depth at each location.

The bedrock velocity was interpreted using the main refractor wave velocity, which is considered a conservative estimate of the bedrock velocity due to the increasing quality of the bedrock with depth. It should be noted that as bedrock quality increases, the bedrock shear wave velocity also increases.

Based on the results of the shear wave velocity testing, the average shear wave velocity  $V_{s30}$  is **1,356 m/s** for buildings with conventional spread footings founded within 3 m of the bedrock surface. Therefore, a **Site Class X<sub>1,356</sub>** is considered applicable for the design of the proposed buildings in this scenario, as per Table 4.1.8.4.A of the OBC 2024. This is anticipated to apply for **Building B**, where the bedrock surface was encountered at an approximate average geodetic elevation of 65.1 m.

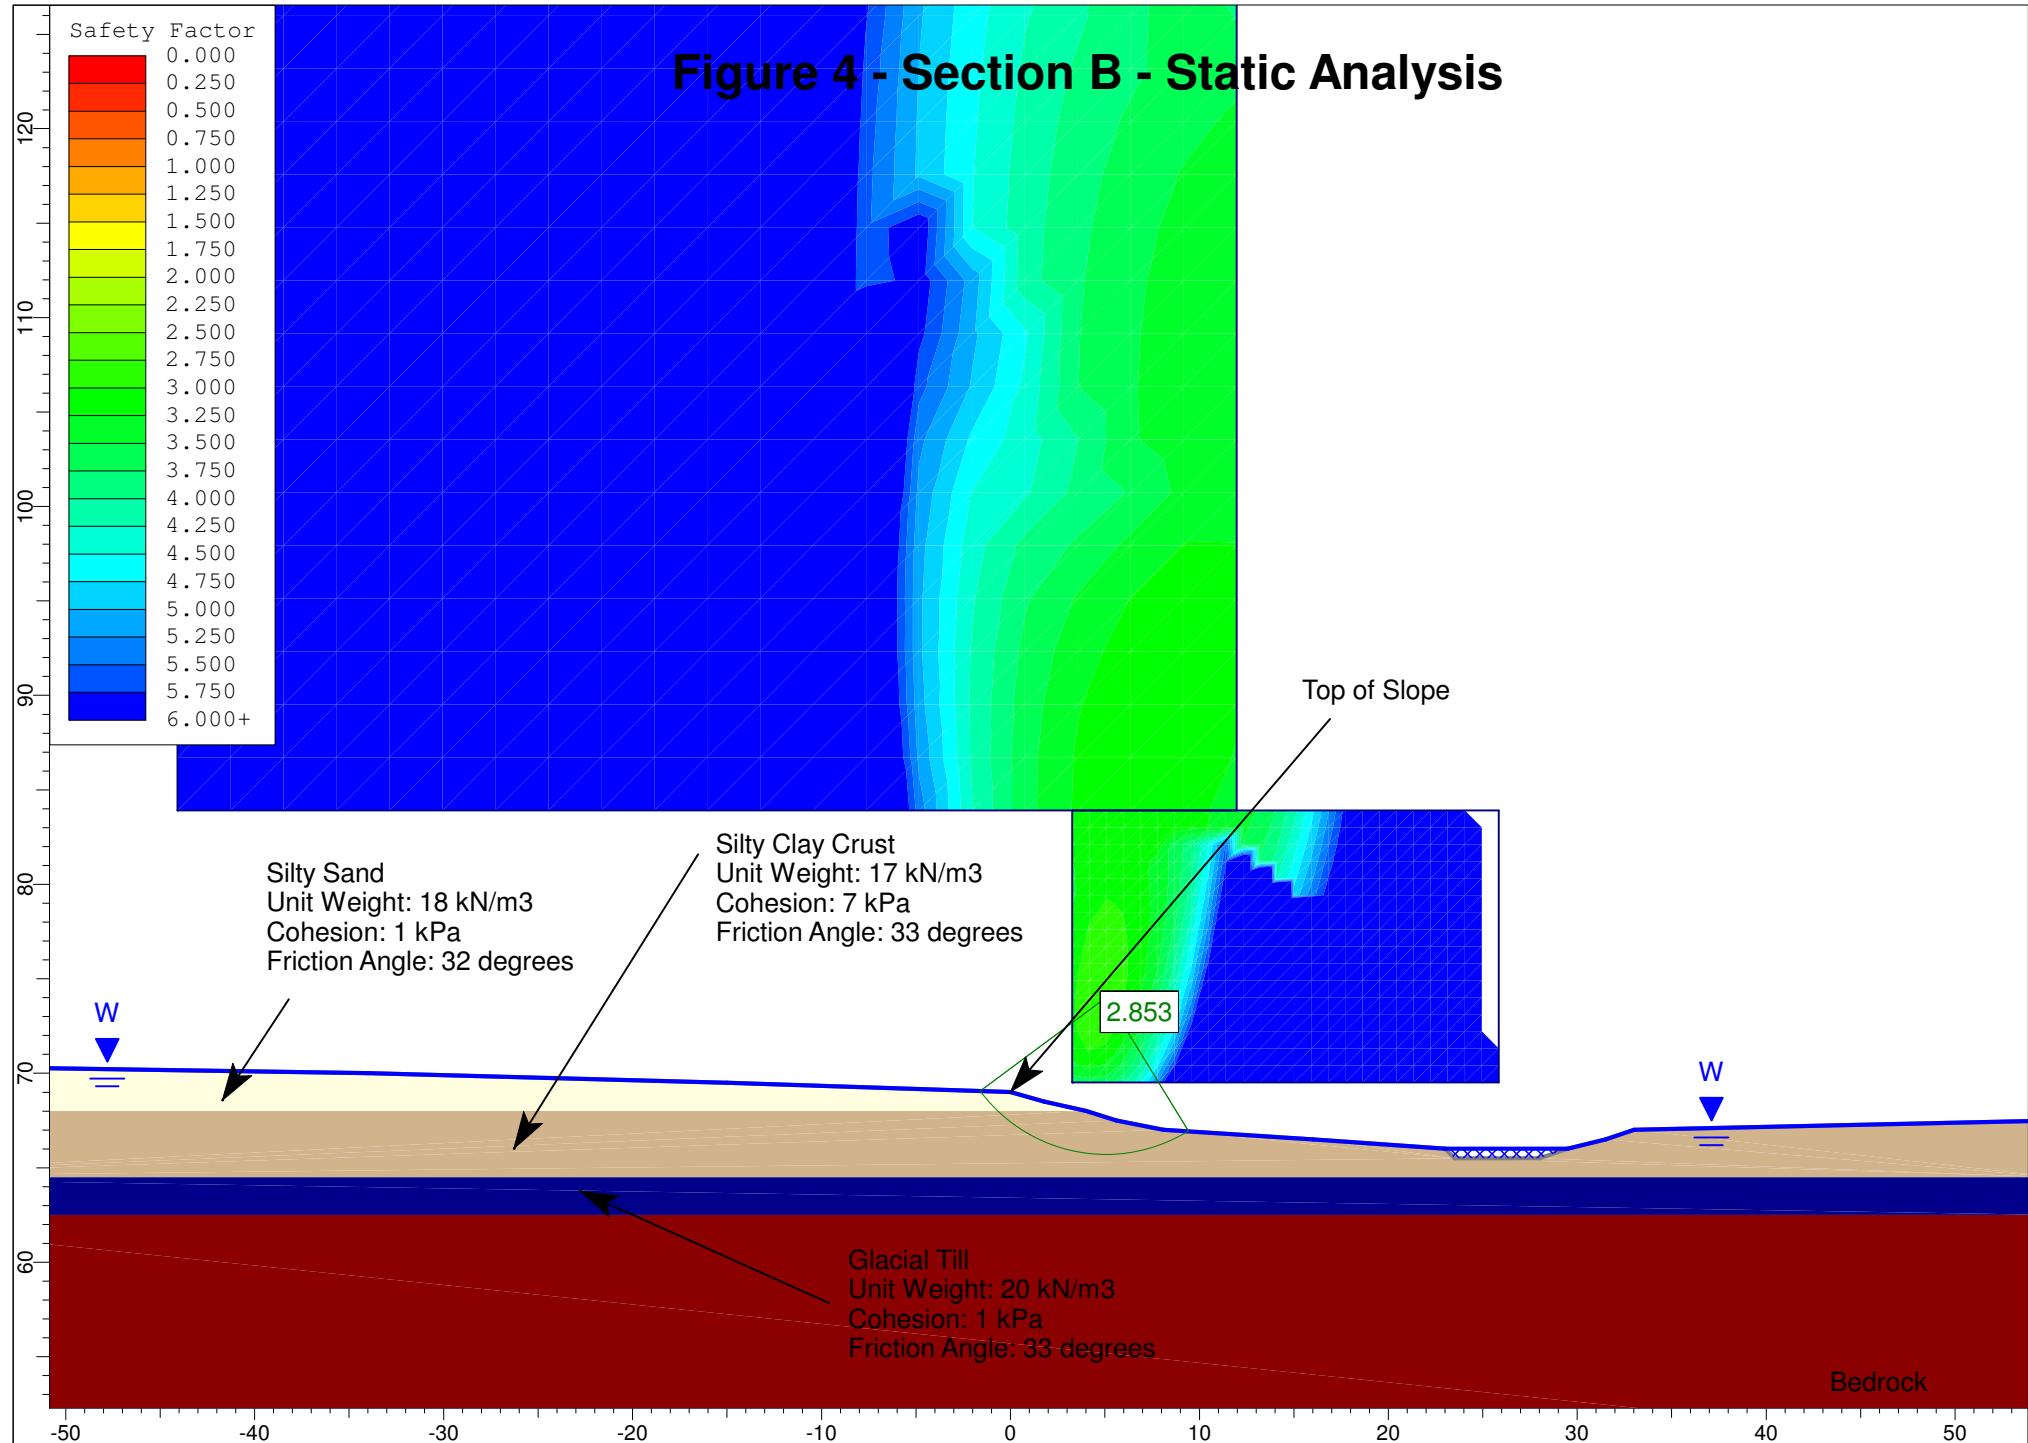
## Figure 4 - Section B - Static Analysis

The static analysis results for slope Section B-B are presented in Figure 4 in Appendix 2. Based on the results of our analysis, the factor of safety for the slope was greater than 1.5 for the proposed conditions under static analysis. Further, the results of the analysis with seismic loading are shown in Figure 5 in Appendix 2. The results indicate that the factor of safety for the slope is greater than 1.1 for the proposed conditions under seismic analysis.

The slope stability analysis was modeled in SLIDE, a computer program which permits a two-dimensional slope stability analysis calculating several methods including the Bishop's method, which is a widely accepted slope analysis method. The program calculates a factor of safety, which represents the ratio of the forces resisting failure to forces favoring failure. Theoretically, a factor of safety of 1.0 represents a condition where the slope is stable.

However, due to intrinsic limitations of the calculation methods and the variability of the subsurface soil and groundwater conditions, a factor of safety greater than 1.0 is generally required for the failure risk to be considered acceptable. A minimum factor of safety of 1.5 is generally recommended for conditions where the slope failure would comprise permanent structures.

As noted above, 1 slope cross-section (Section B-B) was studied as the worst-case scenario within the subject site. It should be noted that details of the slope height and slope angle at the cross-section locations are presented in Figures 4

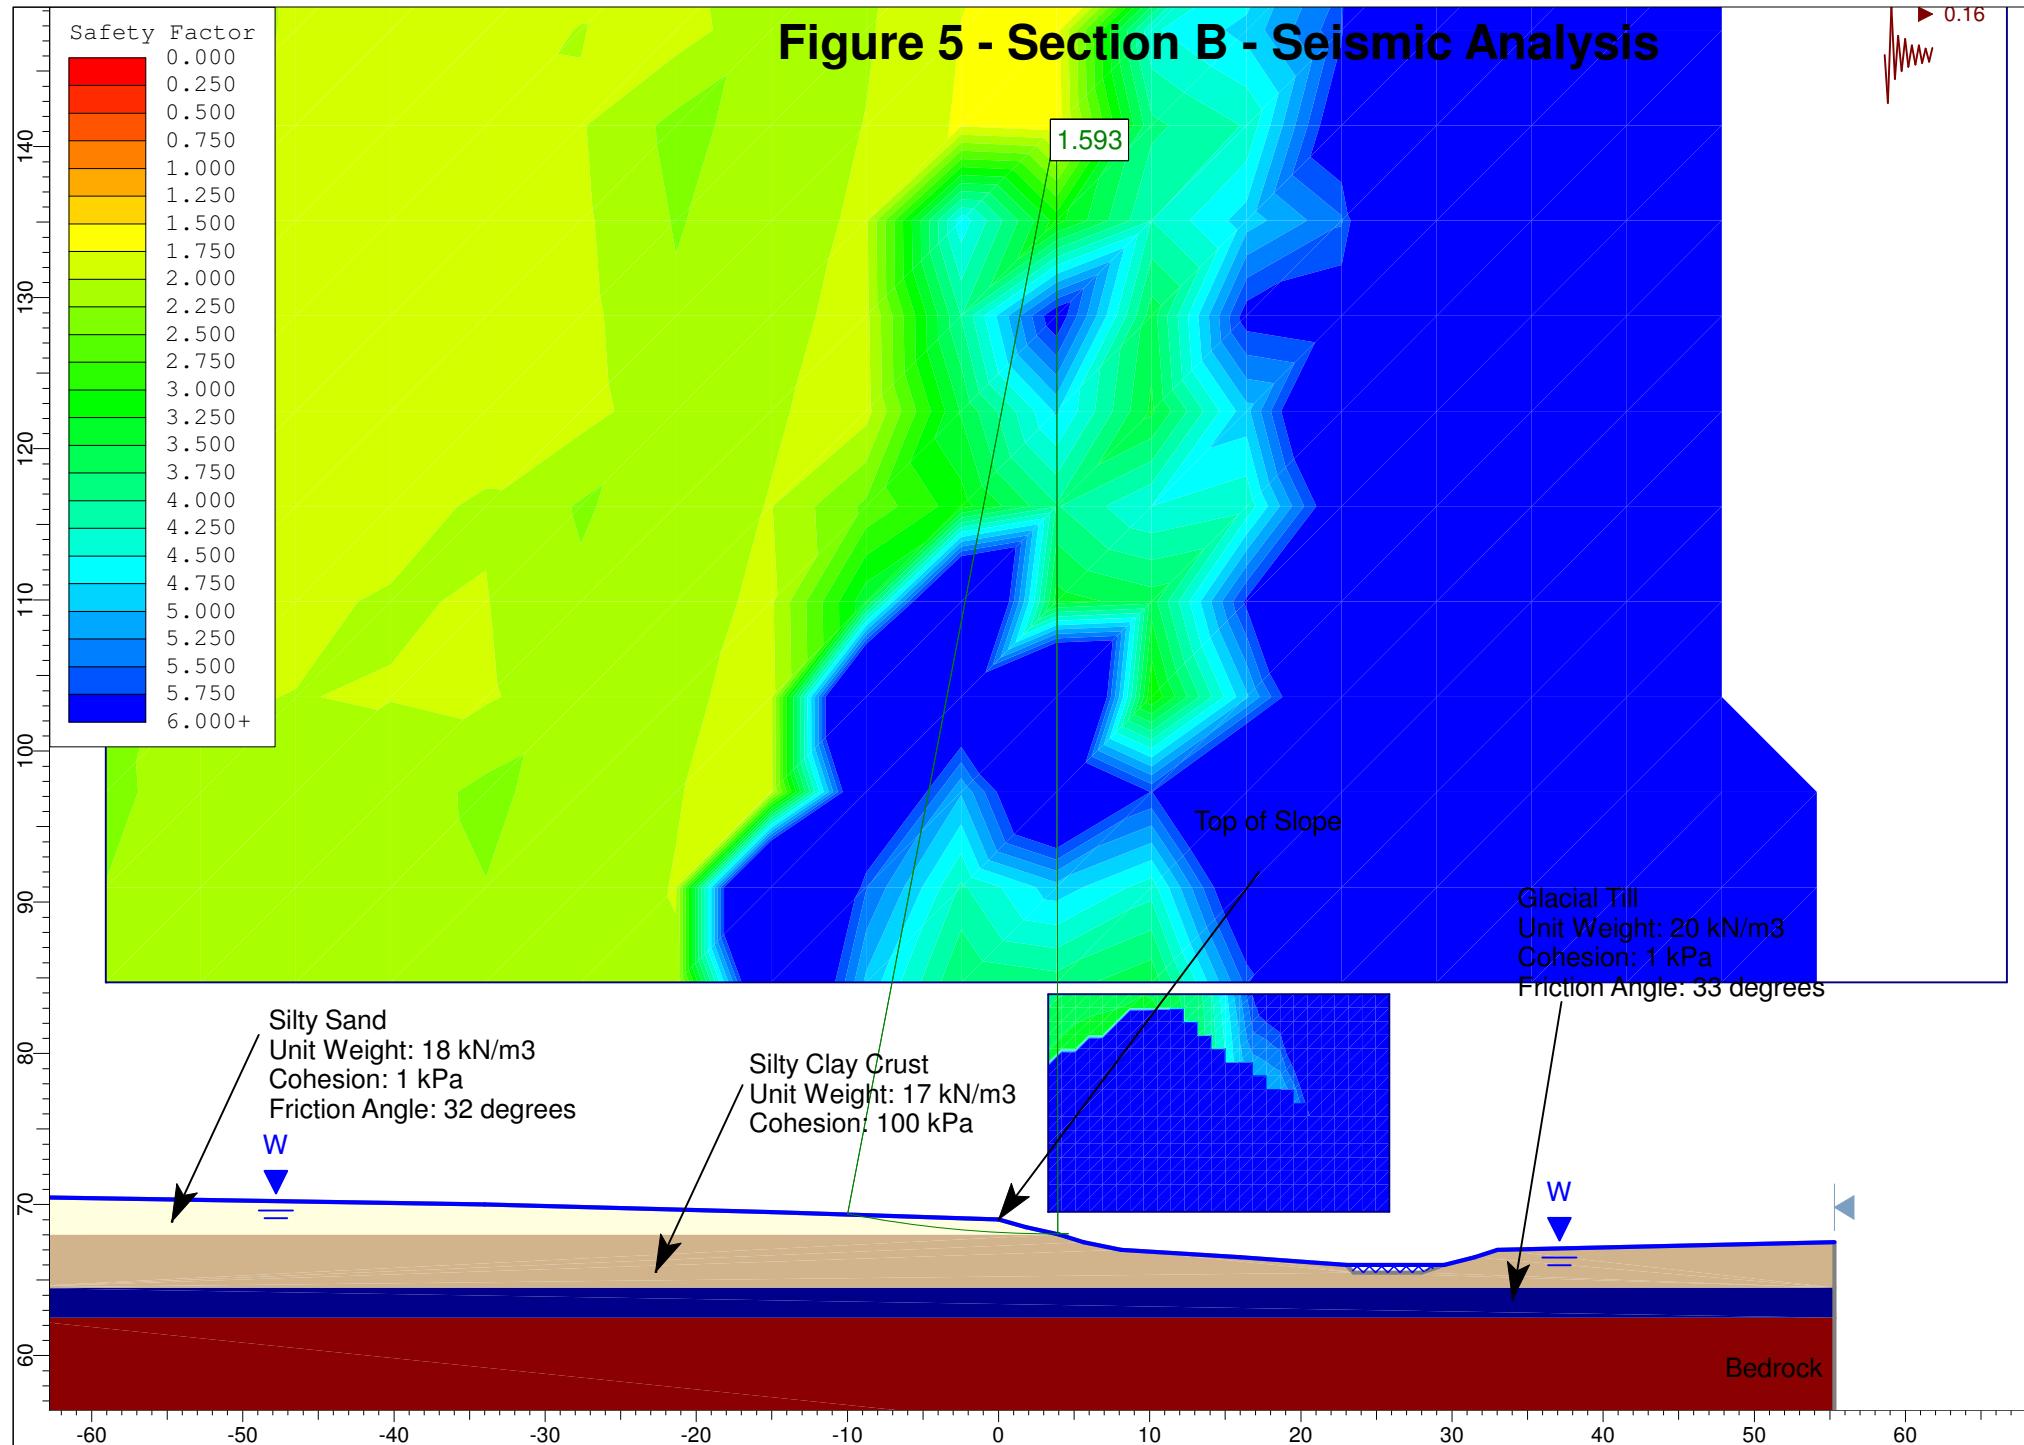
## Figure 5 - Section B - Seismic Analysis

An analysis considering seismic loading was also completed. A horizontal acceleration of 0.16g was considered for the seismic loading condition. A factor of safety of 1.1 is considered to be satisfactory for stability analyses including seismic loading.

As the slope was determined to be stable under static and seismic conditions for the section analyzed, a stable slope allowance is not considered to be required for the Limit of Hazard Lands setback.

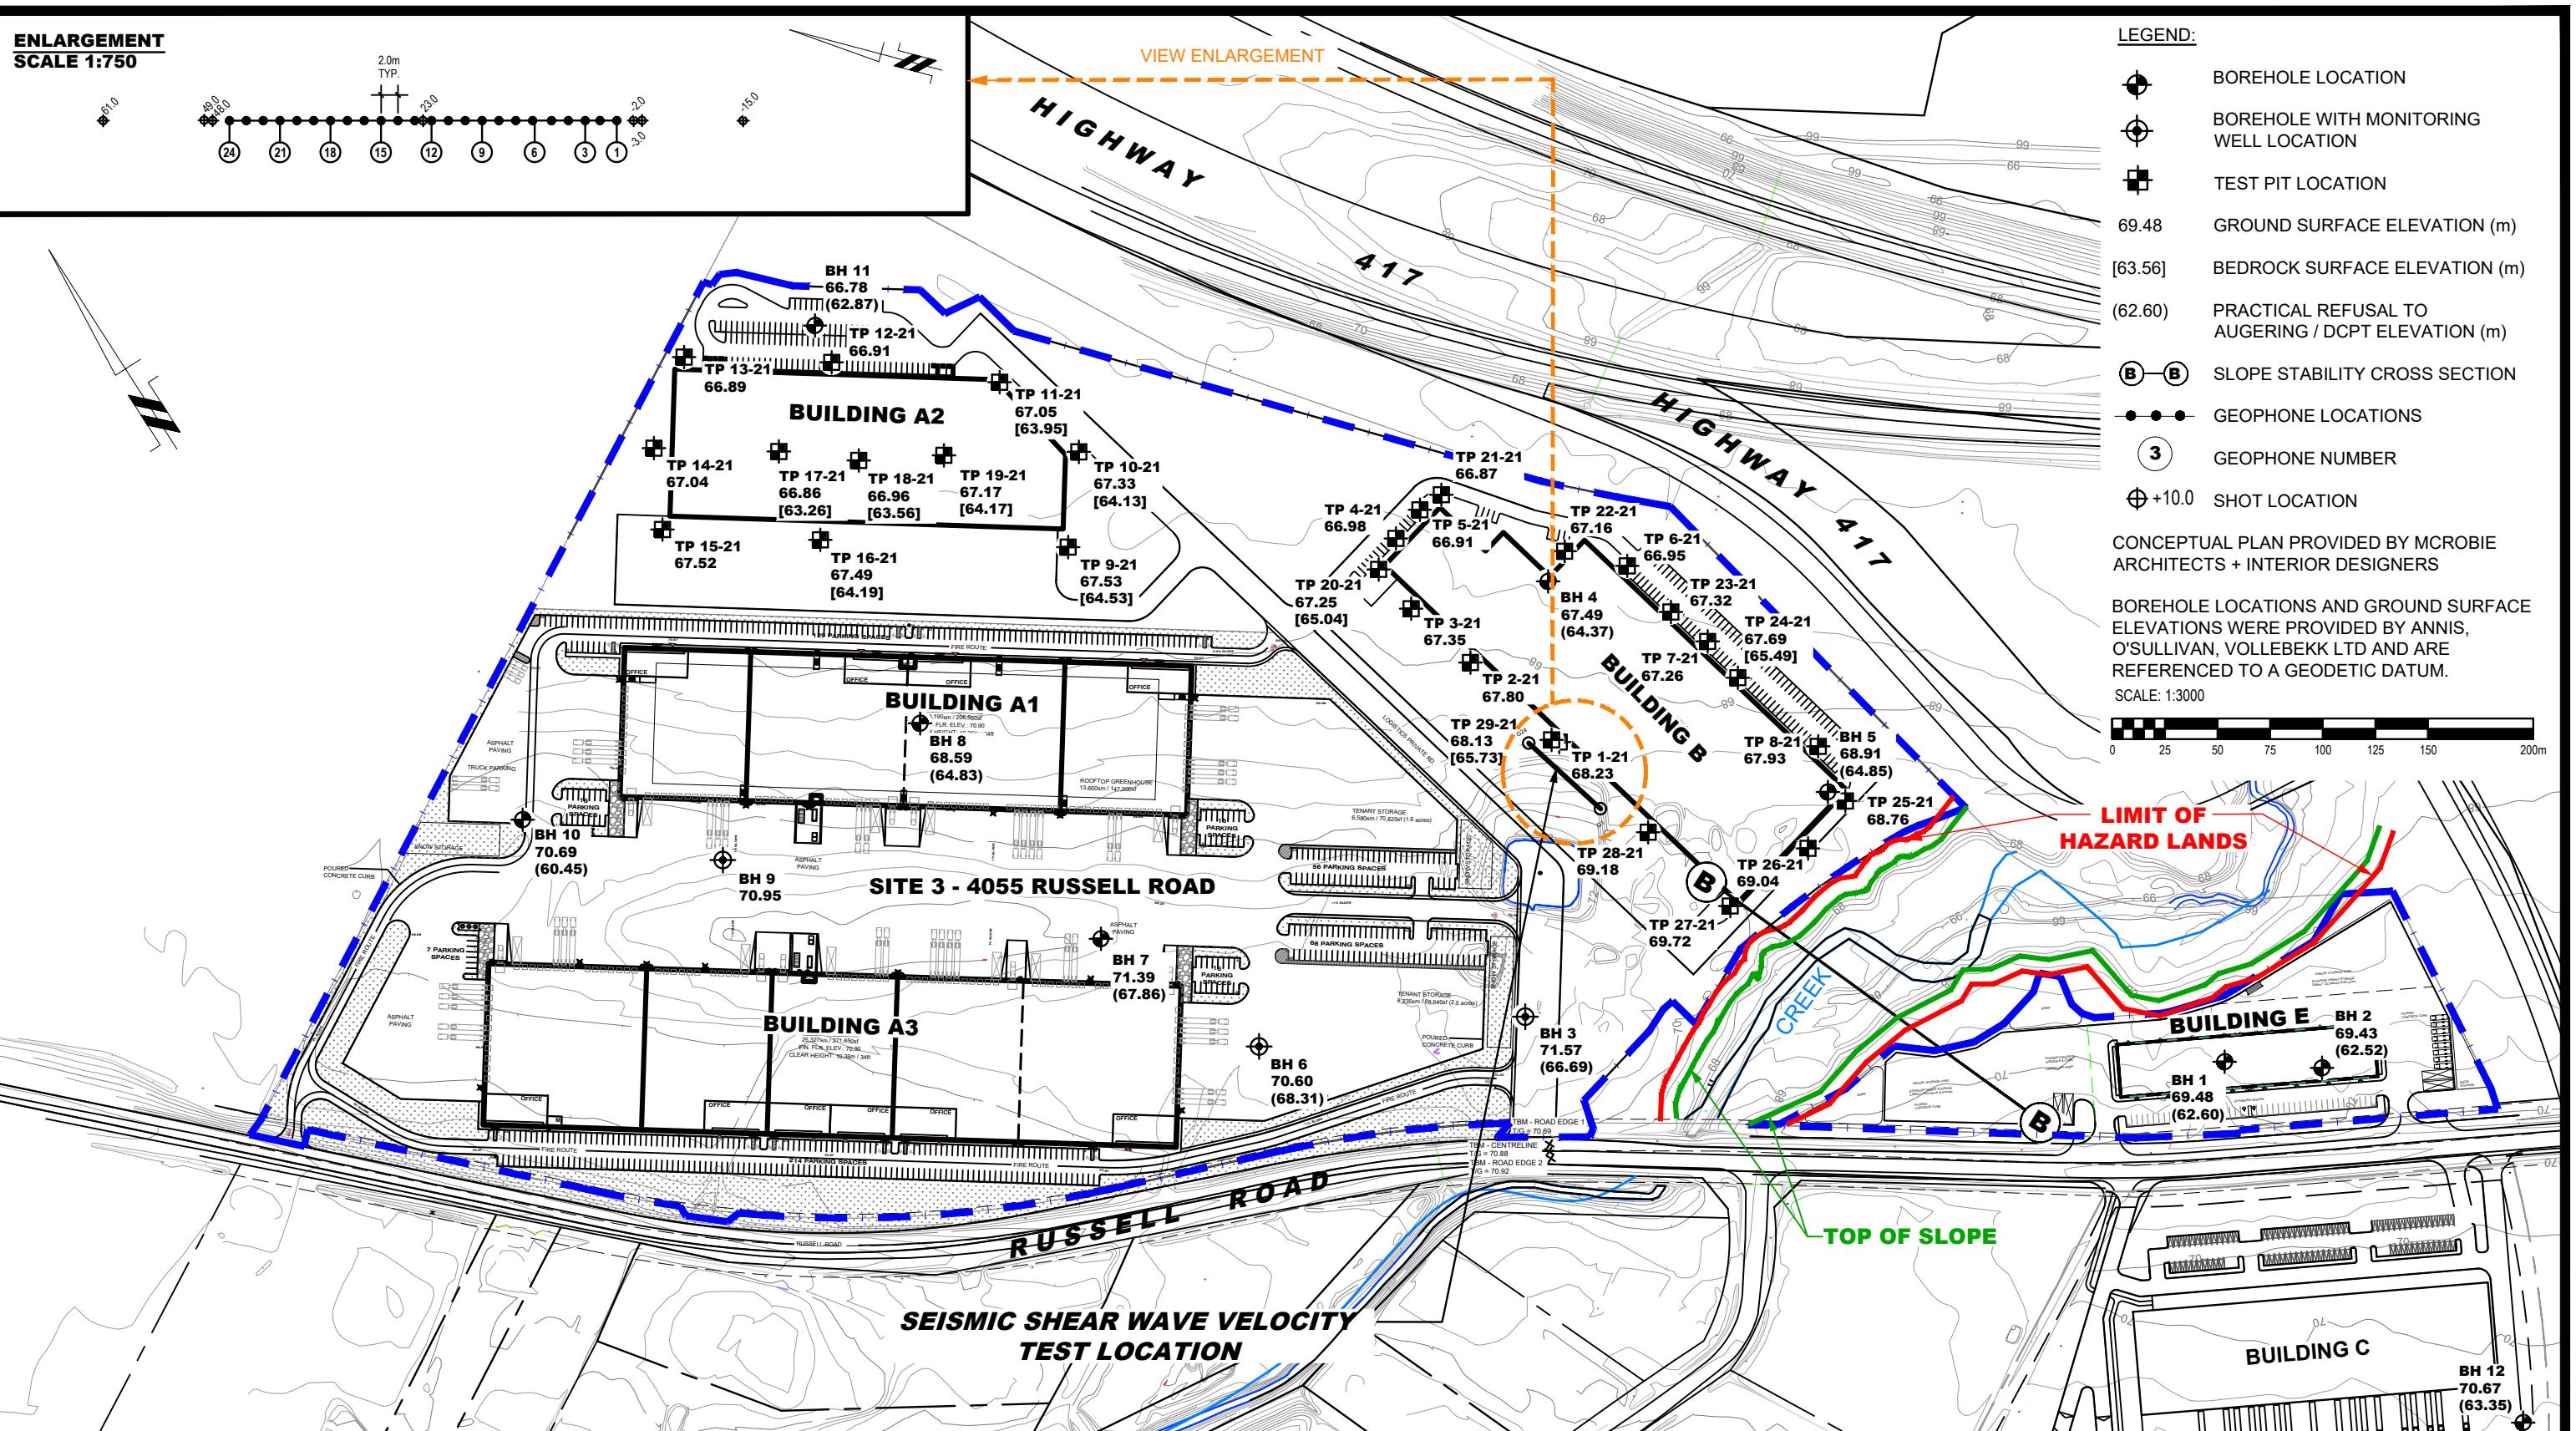
DRAWINGS PG4854-7 - TEST HOLE LOCATION PLAN

The slope conditions were reviewed by Paterson field personnel on December 5, 2019, as part of the previous investigation. One (1) slope cross-section was studied within the subject site as the worst-case scenario. The cross-section location is presented on Drawing PG4854-7 - Test Hole Location Plan attached to the current report.

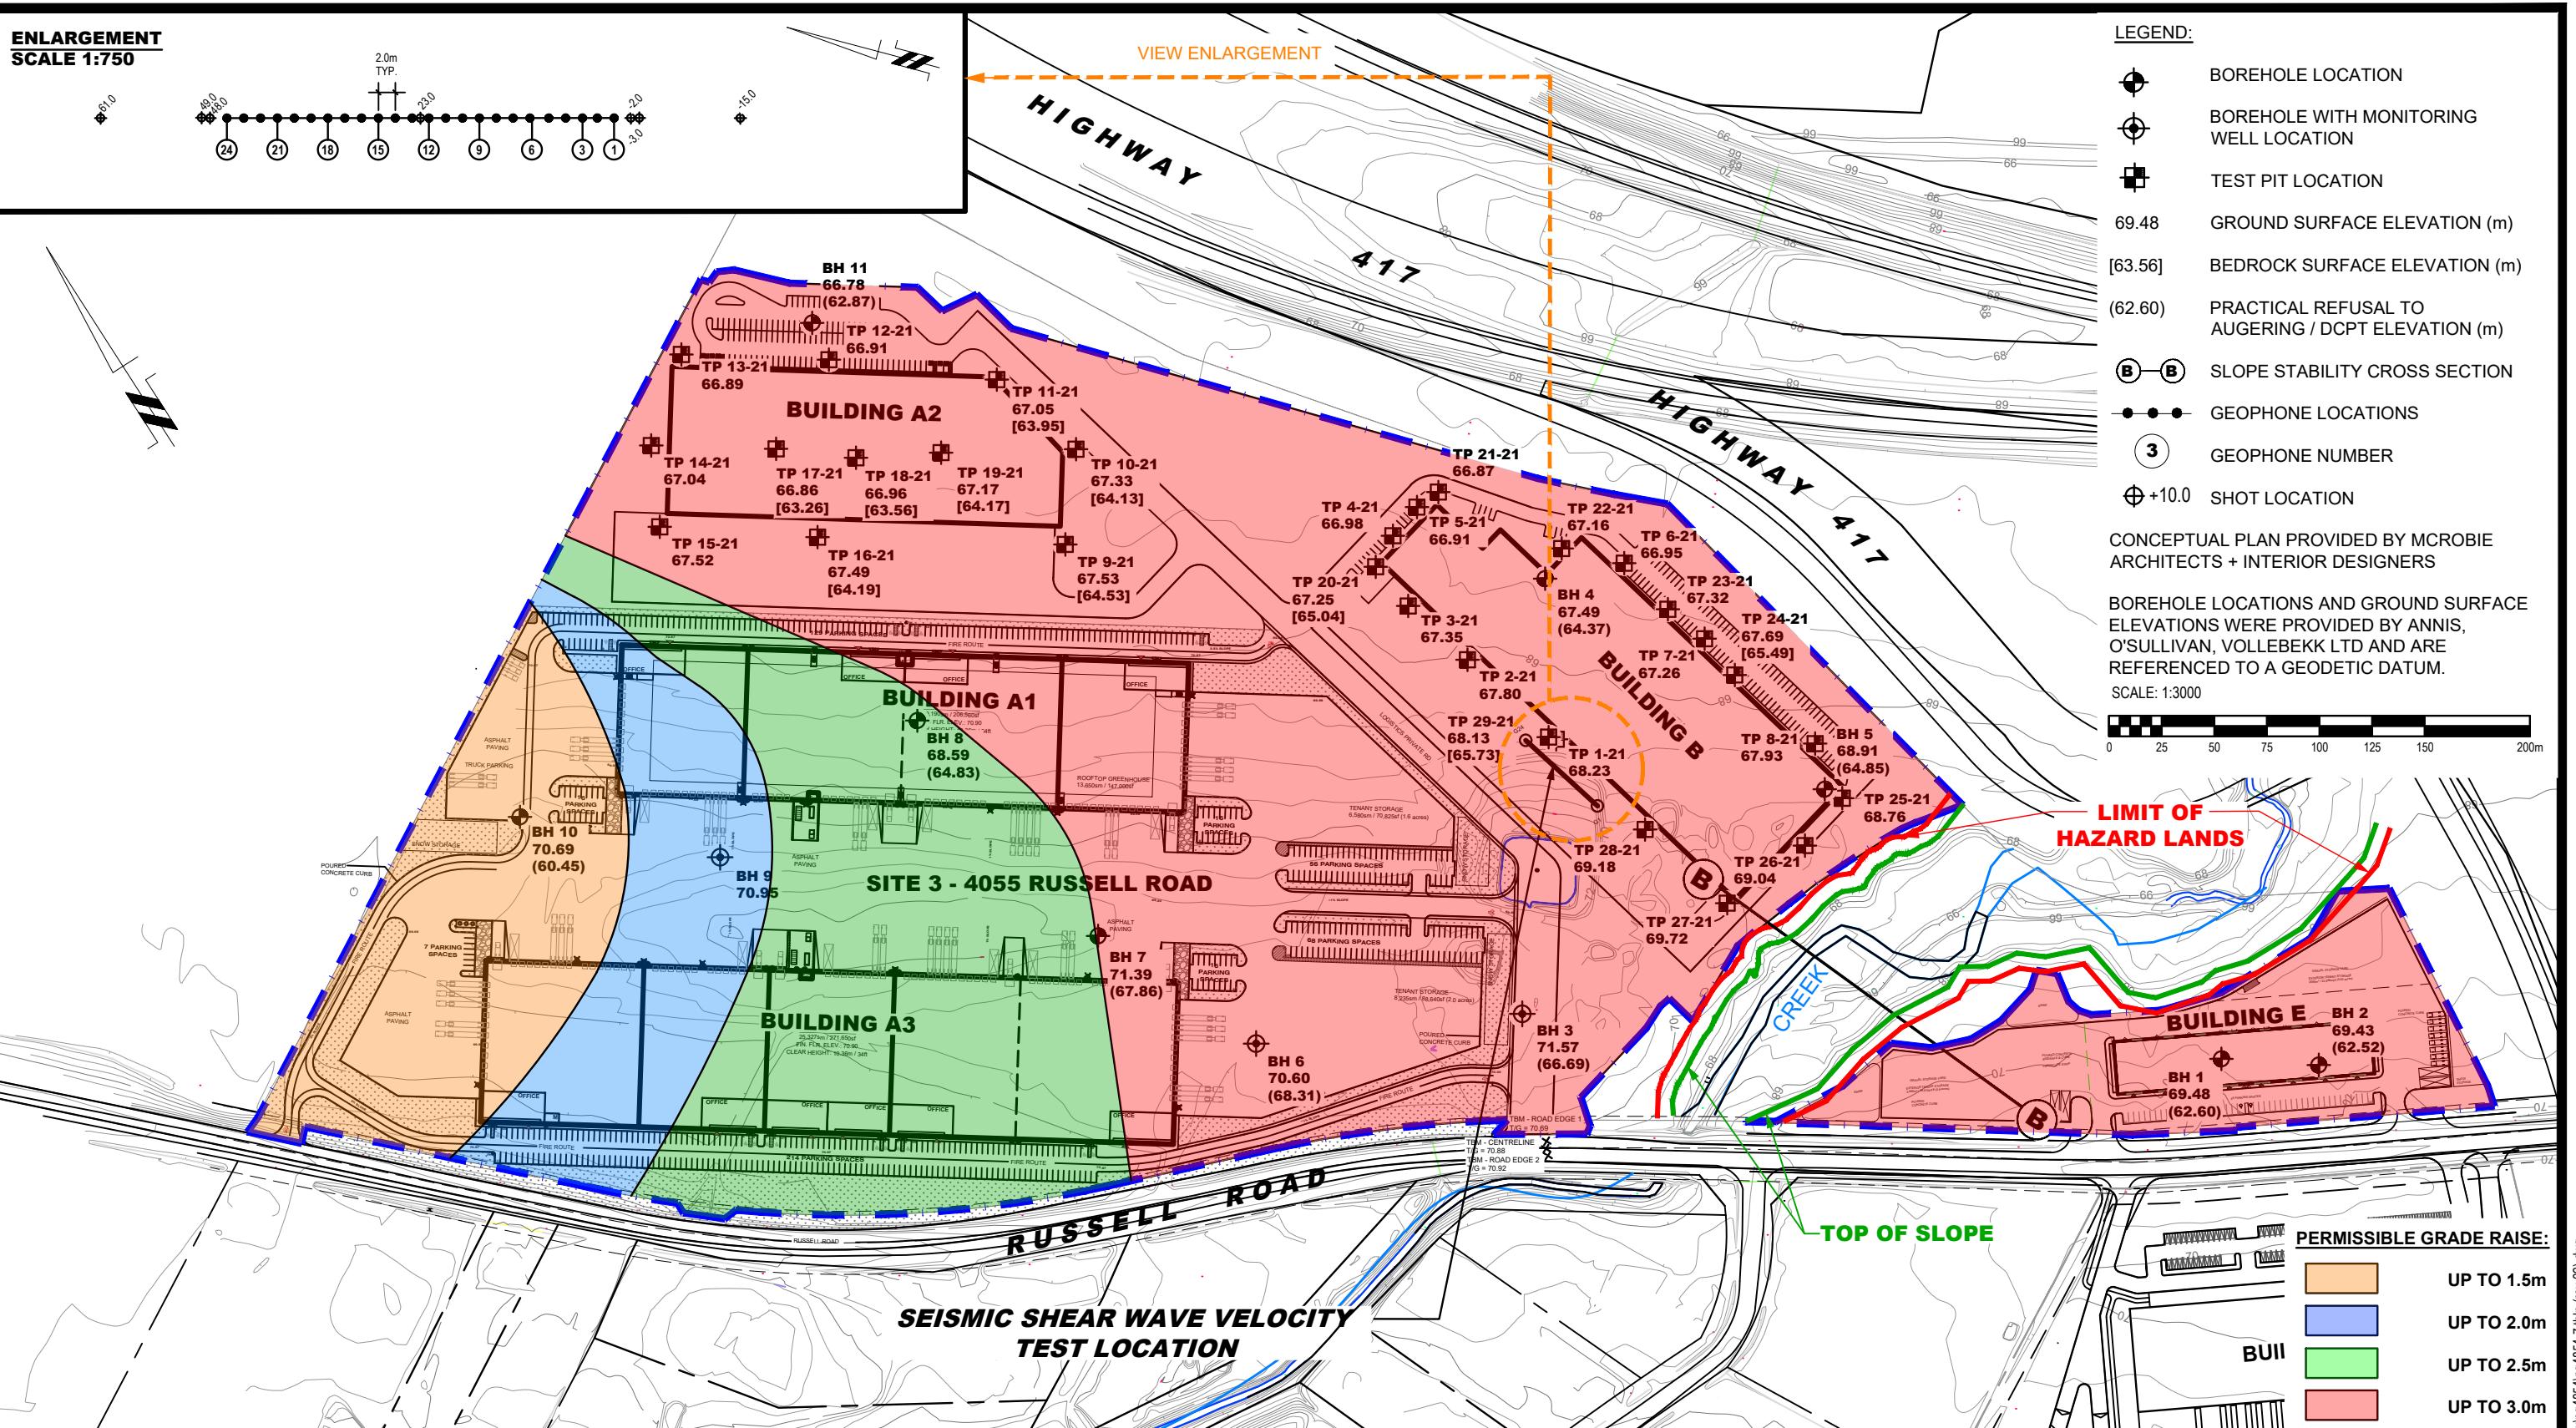
DRAWING PG4854-8 - PERMISSIBLE GRADE RAISE PLAN

Our permissible grade raise recommendations for the subject site are presented in **Drawing PG4854-8 - Permissible Grade Raise Plan** in Appendix 2. It should be noted that the permissible grade raise values provided are based on typical landscaping fill materials. If heavier fill materials such as blast rock are used, the permissible grade raise restriction would need to be reduced.

Consideration must also be given to potential settlements which could occur due to the presence of the silty clay deposit and the combined loads from the proposed footings, any groundwater lowering effects, and grade raise fill. The foundation loads to be considered for the settlement case are the continuously applied loads which consist of the unfactored dead loads and the portion of the unfactored live load that is considered to be continuously applied. For buildings, a minimum value of 50% of the live load is often recommended by Paterson. A post-development groundwater lowering of 0.5 m was assumed.
