Hydrogeological Assessment & Terrain Analysis Proposed Commercial/Industrial Subdivision 3119 Carp Road, Township of Huntley Ottawa, Ontario

> October 21, 2019 Project: 62471.01

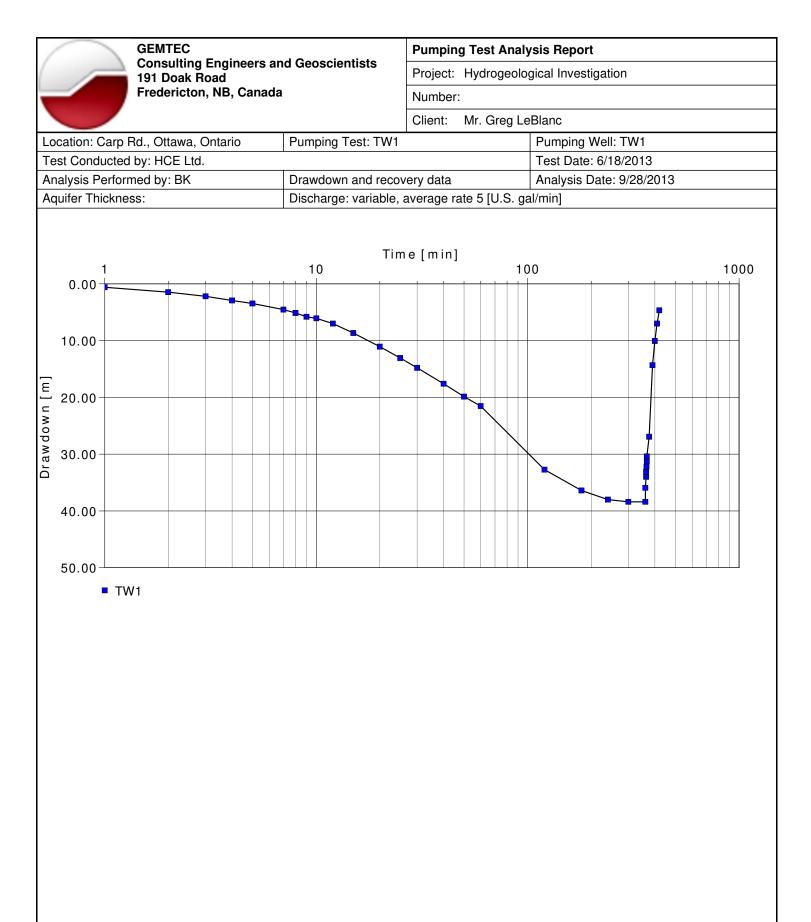
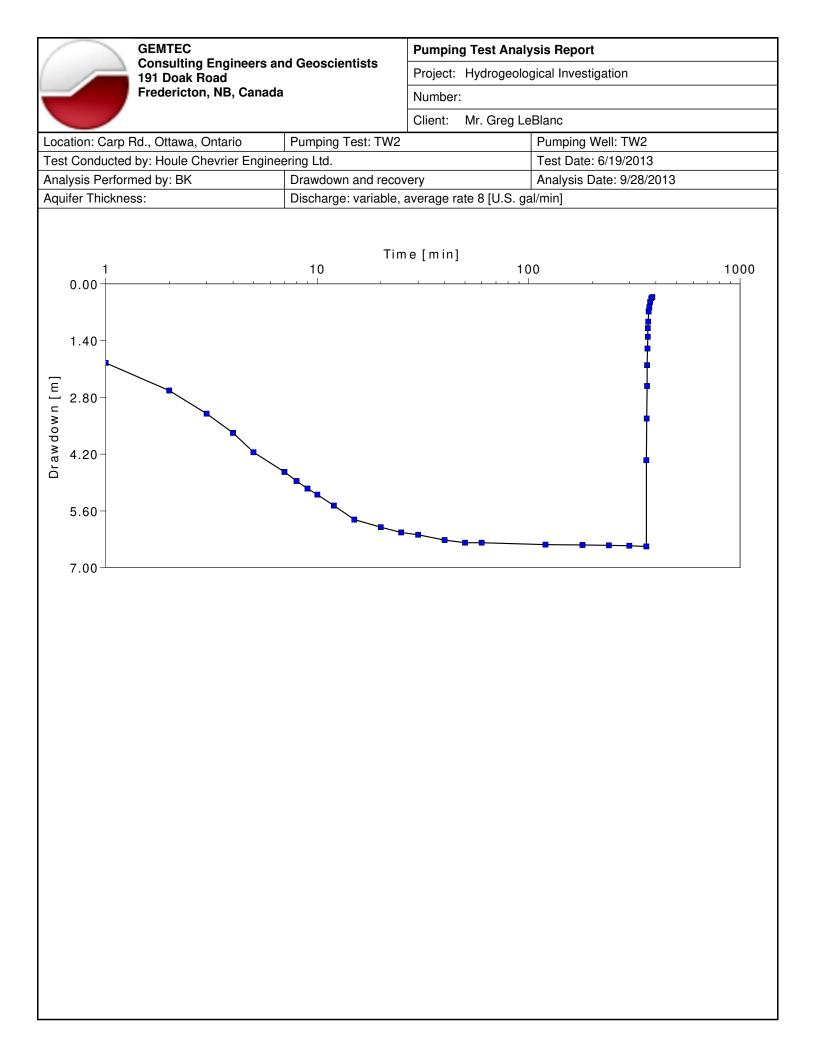
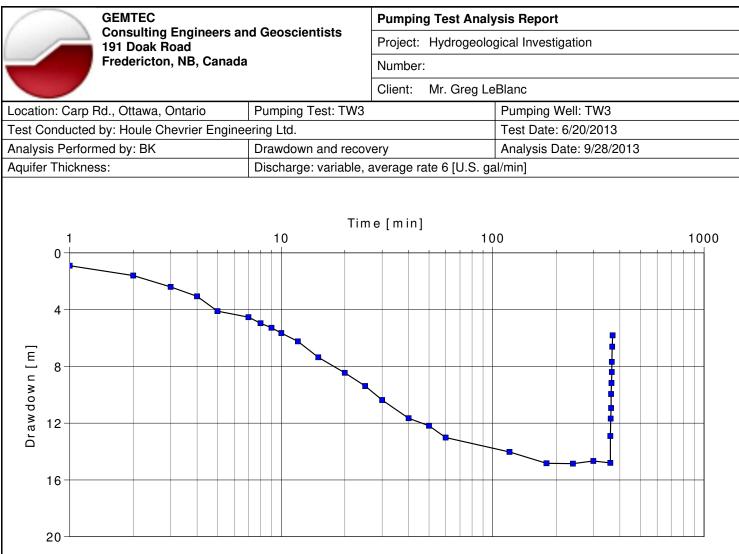
Pumping Test Drawdown and Recovery Data

The levels of turbidity measured in the field during the pumping tests (refer to Table 1) for these test wells was noted to decrease significantly during the six (6) pump test and levels will likely further decline with well use. It is noted that the field testing of turbidity for test well TW2 at six (6) hours showed an increase in turbidity after six (6) hours of pumping (refer to Table 1). However, this was not correlated with an increase in turbidity in the laboratory results for the six (6) hour water sample. The discrepancy between the field reading and the laboratory level for turbidity is unknown; however, it is our opinion that the turbidity measured by the laboratory is representative of the groundwater quality from the test well (based on the decreasing trend in turbidity concentrations in the field and laboratory results). In addition, supplemental water sampling conducted on test well TW2 in June 2015 met the ODWS aesthetic objective for turbidity (refer to laboratory Certificate of Analysis in Appendix L). Based on the June 2, 2015 supplemental water sample from TW2, the turbidity is considered to be acceptable
