Geotechnical Investigation

Proposed Development
936 March Road
Ottawa, Ontario

Minto Communities
2559688 Ontario Inc.

Report: PG4554-1
Revision 5

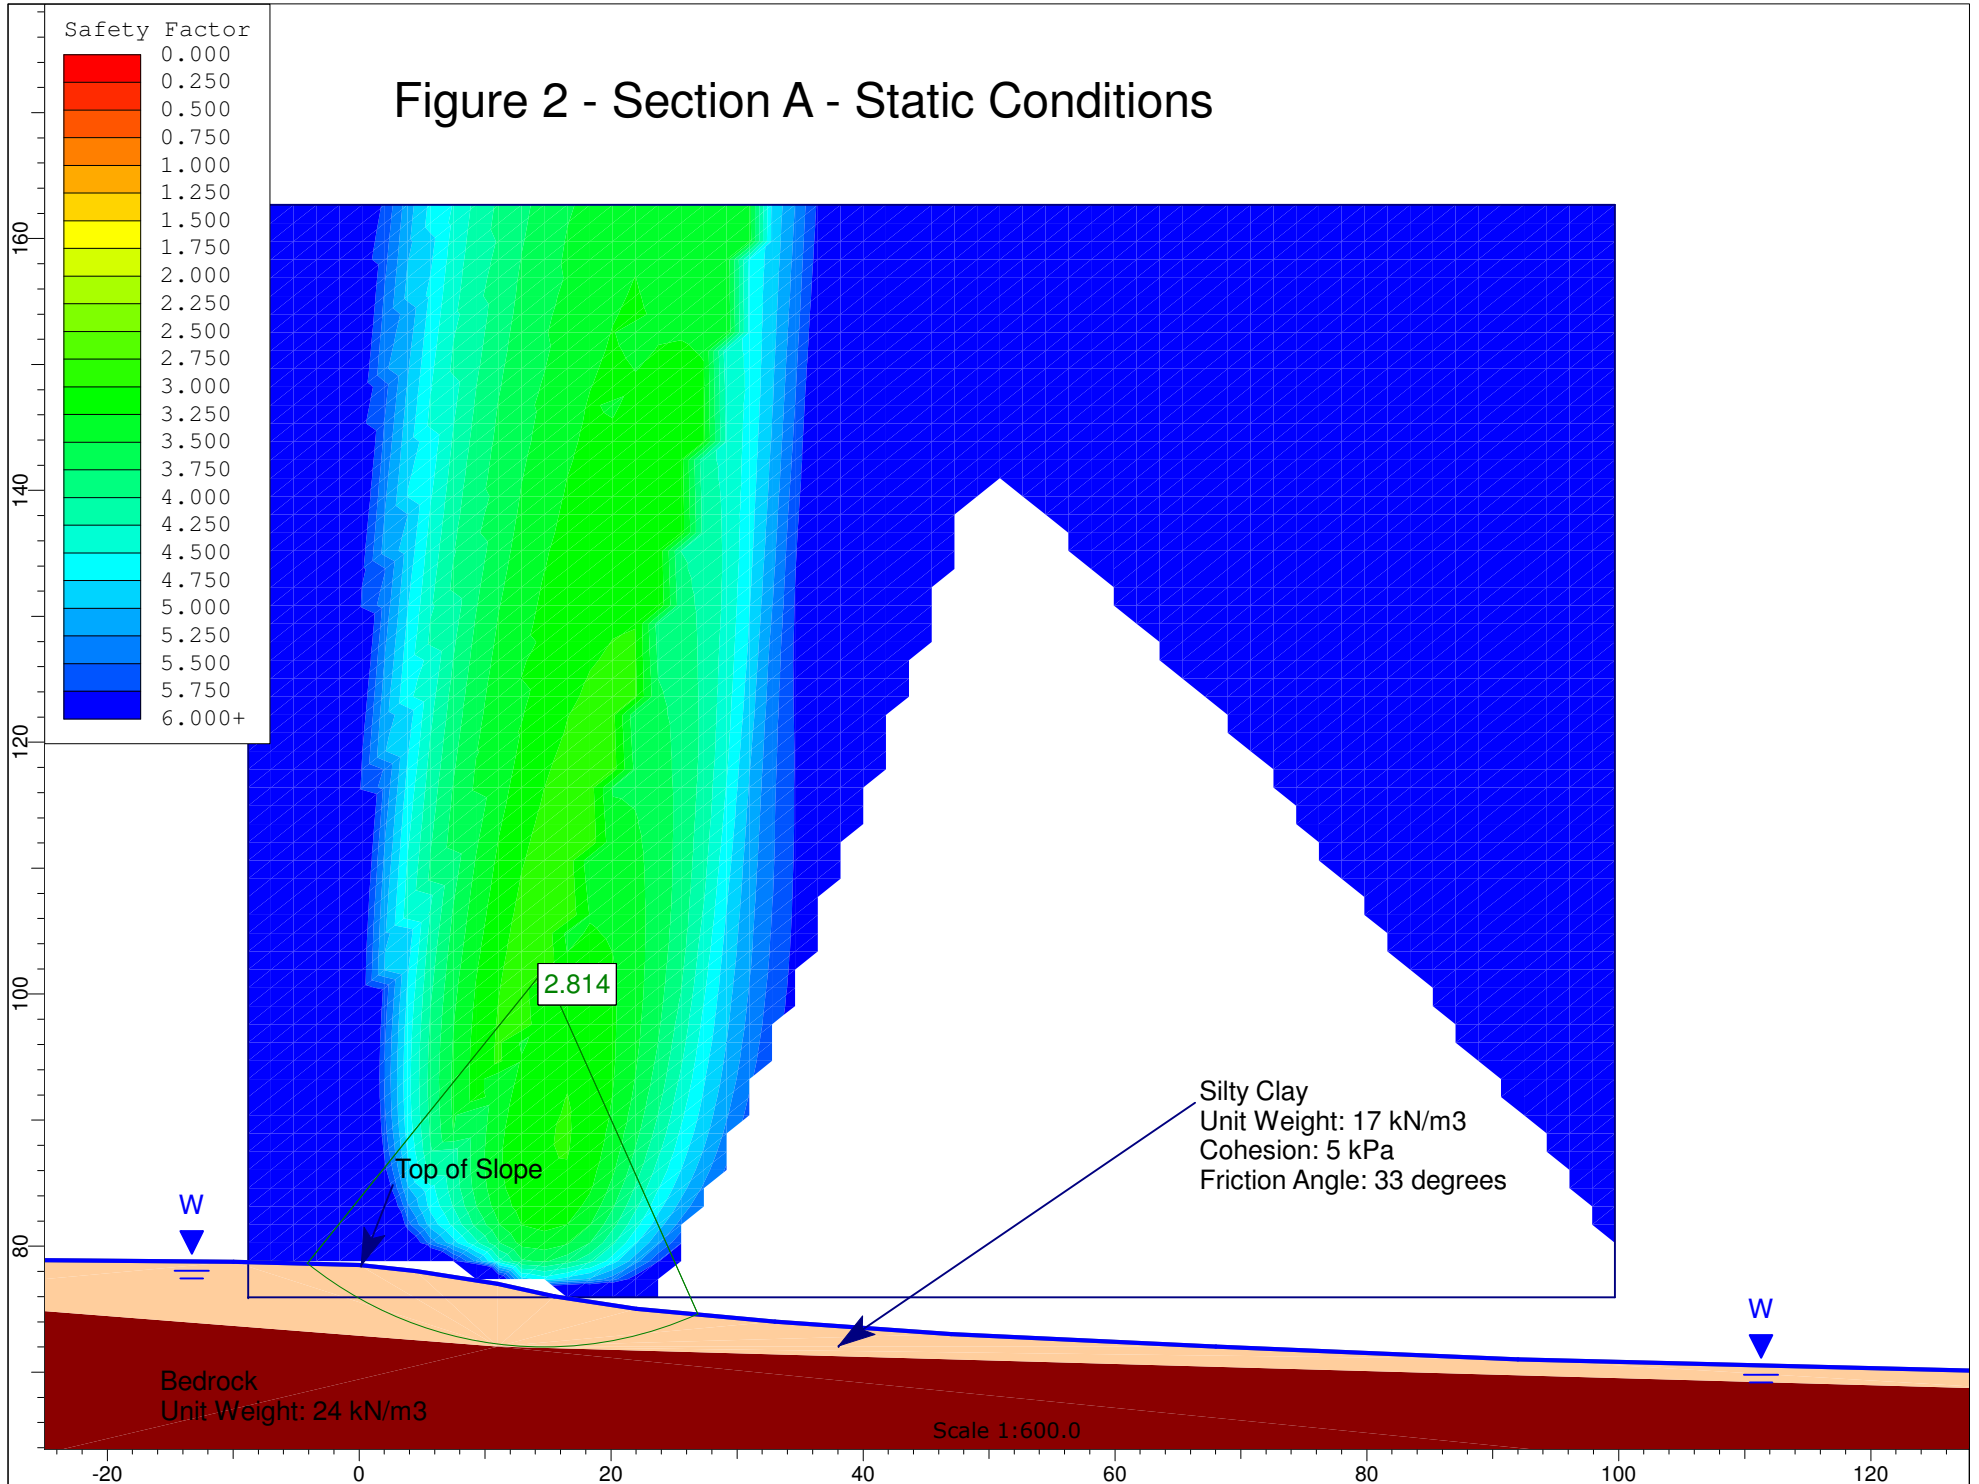
Figure 2 - Section A - Static Conditions

The slope stability analysis was modeled in SLIDE, a computer program which permits a two-dimensional slope stability analysis calculating several methods including the Bishop's method, which is a widely accepted slope analysis method. The program calculates a factor of safety, which represents the ratio of the forces resisting failure to forces favoring failure. Theoretically, a factor of safety of 1.0 represents a condition where the slope is stable. However, due to intrinsic limitations of the calculation methods and the variability of the subsurface soil and groundwater conditions, a factor of safety greater than 1.0 is generally required for the failure risk to be considered acceptable. A minimum factor of safety of 1.5 is generally recommended for conditions where the slope failure would comprise permanent structures.
