**Richmond Village Development Corporation –  
Green Lands  
Integrated Environmental Review**

**Updated Report**

**August 31, 2022**

**KILGOUR & ASSOCIATES LTD.**  
[www.kilgourassociates.com](http://www.kilgourassociates.com)  
Project Number: CAIV 1230

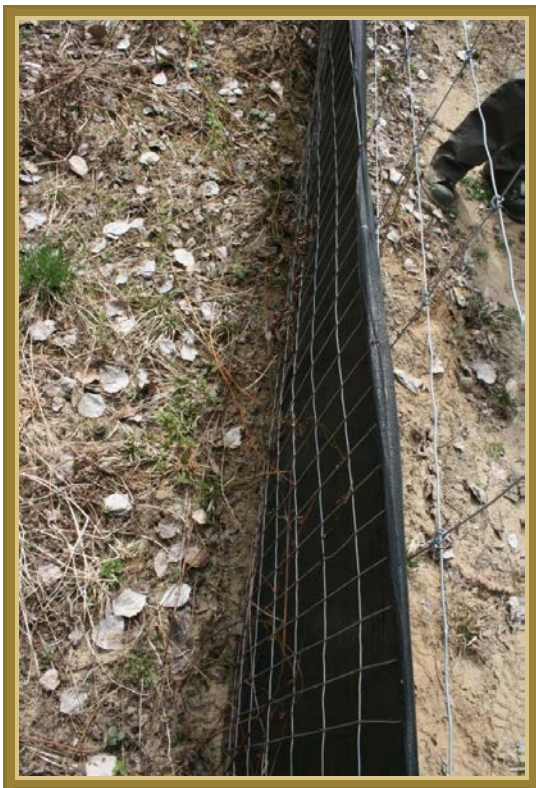
**Plate 2. Example of a heavy-duty geotextile fencing used to exclude snake species (photo credit: Jeremy Rouse).**

- The wire fence should be installed on the activity side to prevent animals from leveraging and climbing into the exclusion area while allowing the animal to escape if they find themselves on the wrong side (Figure 2).
- Geotextile fences across streams, ditches or waterways should have case-specific modifications.
- Contact your local MNR staff or experienced exclusion fencing contractor for advice.
- See light-duty geotextile section above and general best practices below for additional details.

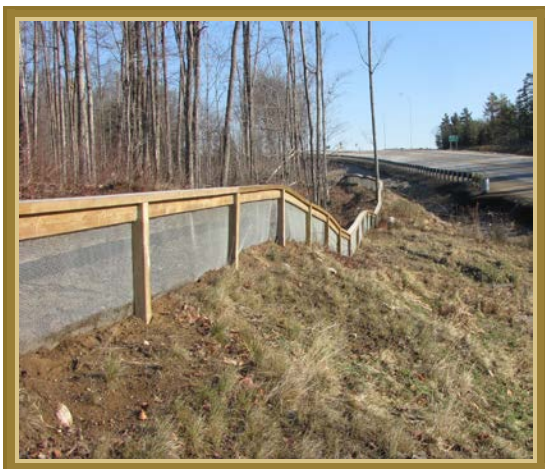
**Plate 3. Example of a galvanized mesh fencing used for the long-term exclusion of snakes and turtles from the adjacent highway (photo credit: Megan Bonenfant).**

- Secure the fence on posts placed a recommended 2.5 m apart with the stakes on the activity side (Figure 2).
- Pull the mesh taut and staple or secure with screws and a metal stripping to prevent the mesh from being ripped when pressure is applied.
- Installing a top rail or folding the mesh over a taut smooth wire reduces tearing (Plates 3 and 4).
- An outward facing lip installed on the species side ensures that snakes and amphibians are unable to climb or jump over the fence (Figure 2; Plate 4)
- Tears can be mended with 18-gauge galvanized wire.
- See general best practices section below for additional details.

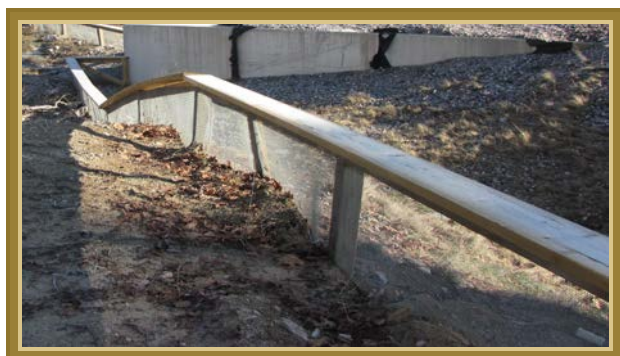
**Plate 4. Long-term to permanent exclusion fencing using galvanized mesh with over-hanging lip to prevent animals from climbing or jumping over (photo credit: Megan Bonenfant).**

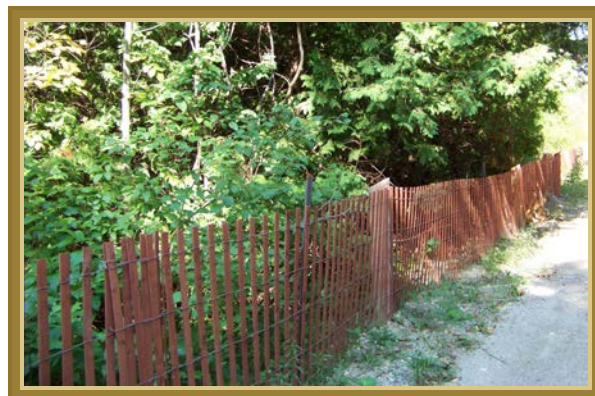
**Plate 5. Example of a wood lath snow fencing used to exclude turtles (photo credit: Karine Beriault).**

- The fencing should be attached to heavy plastic or metal stakes using heavy-duty wire staples or tie-wire.
- The stakes are recommended to be placed at 2 to 3 m intervals and securely driven into the ground 30 cm or more.
- Wood lath snow fencing across streams, ditches or waterways should have case-specific modifications.
- Wood lath snow fencing lends itself well to being combined with other types of material to ensure complete exclusion.
- See general best practices section below for additional details.

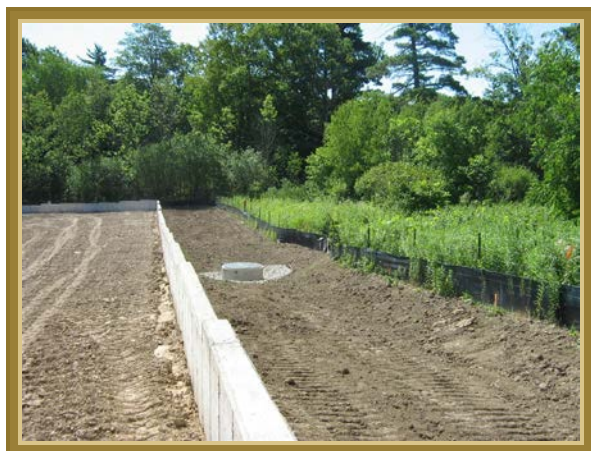
**Plate 6. Stand-alone continuous concrete wall used to exclude salamander species installed as pre-cast forms (photo credit: Steven Roorda).**

Concrete, metal or vinyl walls can stand alone or be combined with woven wire or chain link fences. They are durable, require minimal maintenance and are effective in excluding target species from high risk areas and guiding them to crossing structures or other desired locations (Plates 6 and 7). This fence type is comprised of a continuous vertical face of concrete, metal or vinyl sheeting with no gaps. Concrete walls can be installed as either pre-cast sections or pour directly in place.

The wall height depends upon the target species, but they are usually between 45 and 60 cm tall and buried 25 cm. Concrete, metal or vinyl exclusion fencing is most appropriate for salamanders, skinks, small snakes, and small turtles. For large turtle species, a chain link fence can be installed directly on top of the concrete wall for complete exclusion.

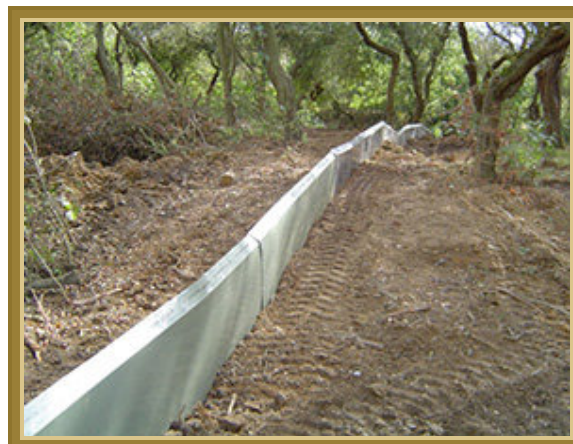
**Plate 7. Pre-formed vinyl sheeting fence intended to exclude salamanders for a construction site (photo credit: Herpetosure Ltd.)**

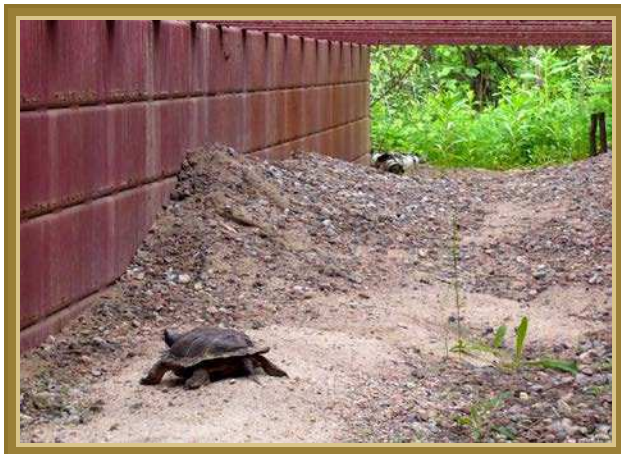
**Plate 7. A wood turtle travelling through a dry eco-passage. Ecopassages such as this help to ensure the long-term connectivity of seasonal habitat for this and other reptile and amphibian species (photo credit: Amy Mui).**

During the installation of fencing with an eco-passage, it is important that the fencing sits flush with the passage to ensure that

there are no gaps where animals can squeeze through.
