Geotechnical Investigation

Proposed Residential Development 6171 Hazeldean Road, Ottawa, Ontario

Project Number OTT-00258780-B0

May 14, 2021 (supersedes July 24, 2020)

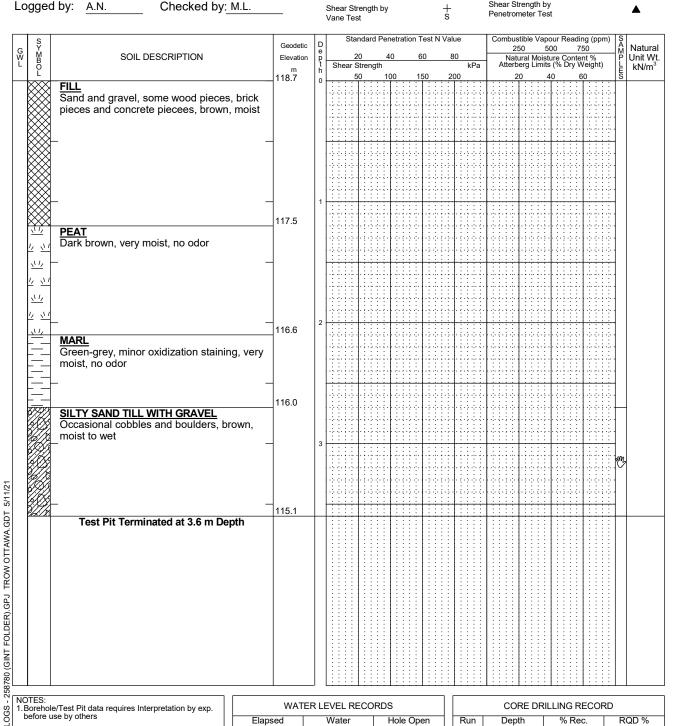
Log of Tast Dit TD-26

Log or i	COLLIL II -20			7 X
Project No:	OTT-00258780-B0				//\
Project:	Geotechnical Investigation - Proposed Residen	tial Development	Figure No. 44 Page. 1 of	 1	
_ocation:	6171 Hazeldean Road, Ottawa, Ontario		Page. <u>1</u> of _	<u>-</u>	
Date Drilled:	'November 25, 2020	Split Spoon Sample	Combustible Vapour Reading		
Orill Type:	CAT 320D Excavator	Auger Sample	Natural Moisture Content		×
onii Type.	CAT 320D Excavator	- SPT (N) Value O	Atterberg Limits	—	-
Datum:	Geodetic Elevation	Dynamic Cone Test Shelby Tube	Undrained Triaxial at % Strain at Failure		\oplus
agged by	A AL Obsessed by AAL	-	Shoar Strongth by

- 2. Test pit backfilled with excavated material and nominally compacted using excavator bucket.
- 3. Field work supervised by an EXP representative.
- 4. See Notes on Sample Descriptions
- 5. This Figure is to read with exp. Services Inc. report OTT-00258780-B0

WATER LEVEL RECORDS				
Elapsed	Water	Hole Open		
Time	Level (m)	To (m)		
November 25, 202	0 3.0			
	Elapsed Time	Elapsed Water Time Level (m)

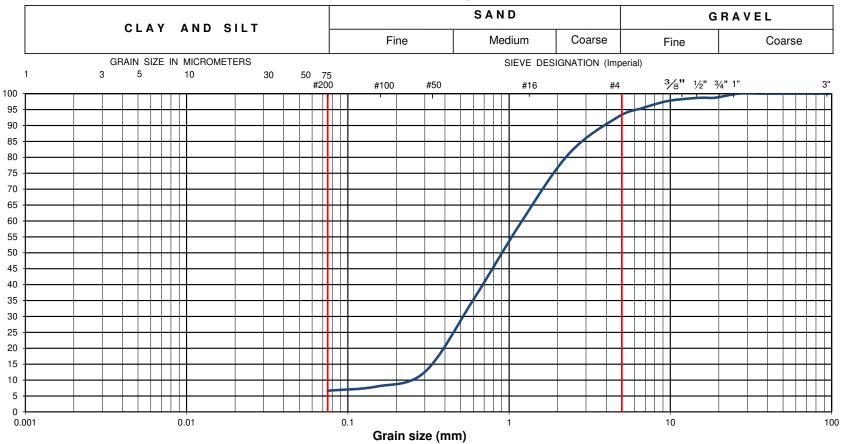
Grain-Size Distribution Curve Method of Test For Sieve Analysis of Aggregate ASTM C-136

EXP Project No.:	OTT-00258780-B0	Project Name :	oject Name : Geotechnical Investigation - Proposed Residential Development						
Client :	11654128 Canada Inc.	Project Location	oject Location : 6171 Hazeldean Rd, Ottawa, ON						
Date Sampled :	March 17, 2020	Borehole No:		TP14 Sample: Fill				Depth (m):	0-0.7
Sample Composition :		Gravel (%)	7	Sand (%)	86	Silt & Clay (%)	7	Figure :	59
Sample Description :		Fill: Well Grade	II: Well Graded Sand with Silt (SW)						อฮ

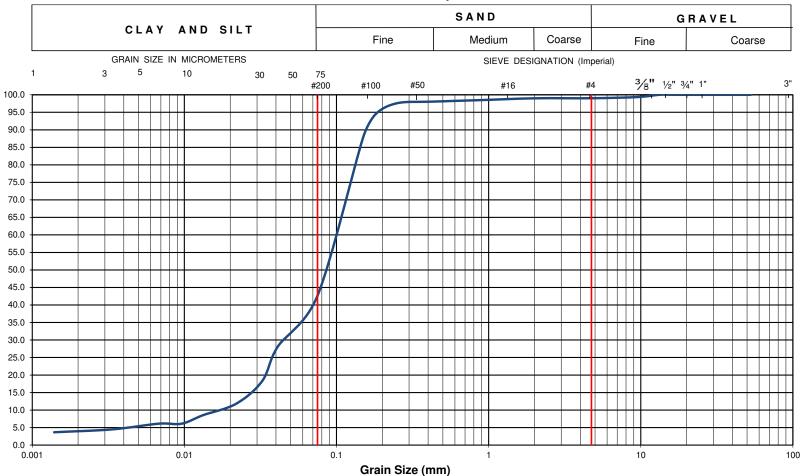
EXP Project No.:	OTT-00258780-B0	Project Name :	roject Name : Geotechnical Investigation - Proposed Residential Development								
Client :	11654128 Canada Inc.	Project Location	Project Location : 6171 Hazeldean Rd, Ottawa, ON								
Date Sampled :	March 24, 2020	Borehole No:		BH5	BH5 Sample No.: SS6 Depth (m): 3.8-4.4						
Sample Description :		% Silt and Clay	43	% Sand	56	% Gravel		1	Figure :	60	
Sample Description :							rigule .	00

The organic peat in Borehole No. 5 is underlain by a deposit of silty sand with some gravel which extends to 5.3 m depth (Elevation 111.2 m). This deposit is compact as indicated by the SPT (N values) which ranged between 15 to 24 blows per 300 mm penetration of the split spoon sampler and has a natural moisture content ranging between 9 to 20 percent, indicating moist to very moist conditions. Grain-size analyses performed on one (1) sample from this deposit is presented on Figure No. 60 and summarized in Table III below.

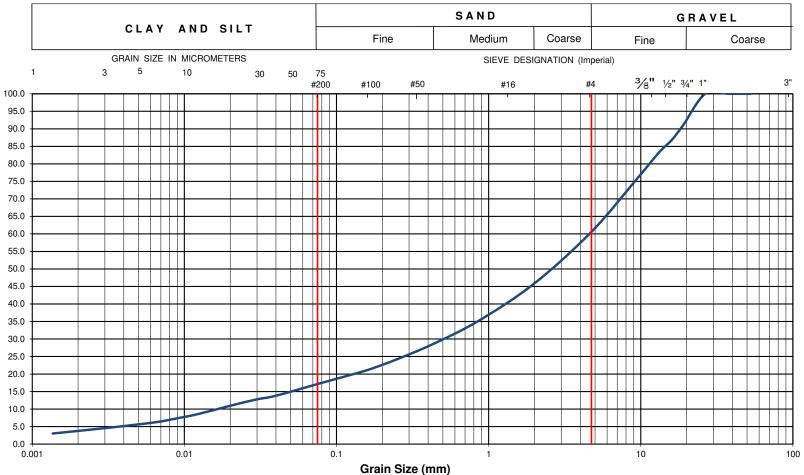
EXP Project No.:	OTT-00258780-B0	Project Name :	roject Name : Geotechnical Investigation - Proposed Residential Development								
Client :	11654128 Canada Inc.	Project Location	Project Location : 6171 Hazeldean Rd, Ottawa, ON								
Date Sampled :	March 24, 2020	Borehole No:		BH6	Sample No.: SS5 Depth (m): 3.0						
Sample Description :		% Silt and Clay	17	% Sand	44	% Gravel		39	Figure :	61	
Sample Description :		Glacial Till: Silty	Glacial Till: Silty Sand with Gravel (SM)							01

blows to greater than 50 blows per 300 mm or less of penetration of the split spoon ampler. It has a natural moisture content ranging between 3 percent to 21 percent. Grain-size analysis performed on three (3) samples from this deposit is presented on Figure No 61 to 63 and summarized in Table IV below.

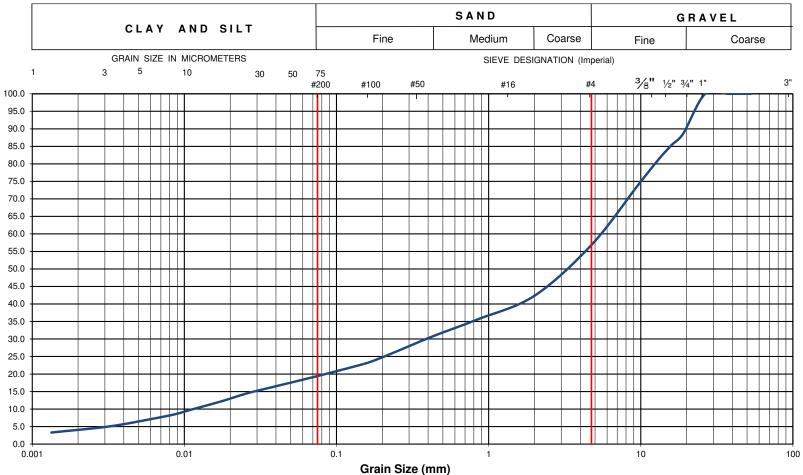
EXP Project No.:	OTT-00258780-B0	Project Name :	roject Name : Geotechnical Investigation - Proposed Residential Development							
Client :	11654128 Canada Inc.	Project Location	roject Location : 6171 Hazeldean Rd, Ottawa, ON							
Date Sampled :	December 9, 2020	Borehole No:		ВН8	Sam	ple No.:	S	Depth (m):	3.0-3.6	
Sample Description :		% Silt and Clay	19	% Sand	38	% Gravel		43	Figure :	63
Sample Description :	Glacial Till: Silty Gravel with Sand (GM)							rigule .	03

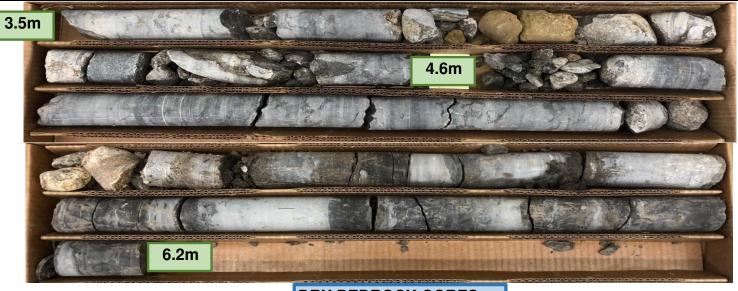
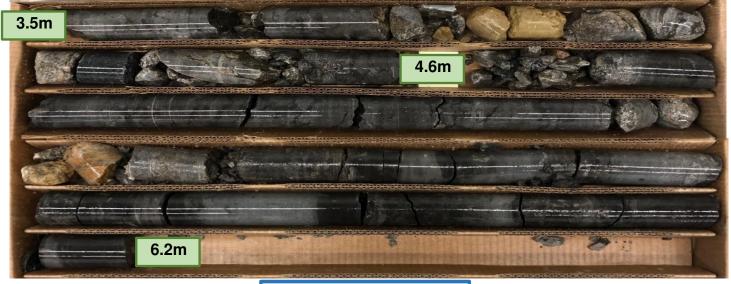
Borehole No. BH-3	Core Runs Run 3: 3.5 - 4.6 m Run 4: 4.6 - 6.2 m	Propsoed Residential Development. 6171 Hazeldean Road, Ottawa, ON	Project No:	OTT-000258780-B0
		ROCK CORE PHOTOGRAPHS	Figure No:	Fig 66

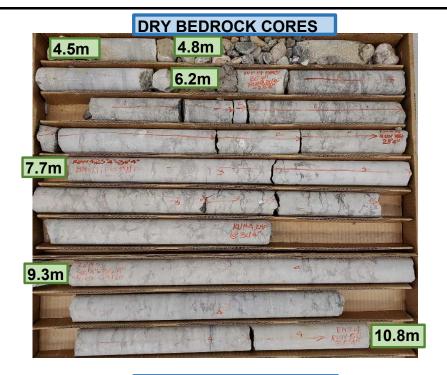
Start of Bedrock at 5.8 m Depth

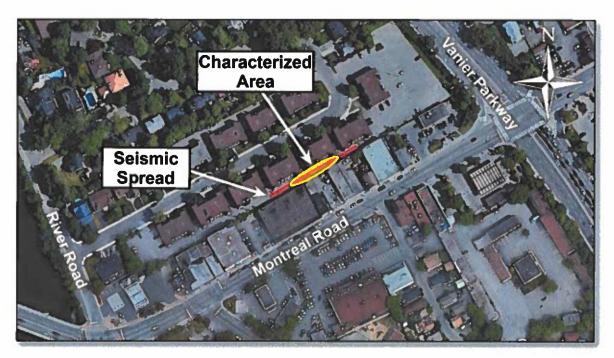
Figure 2: Location of the seismic spreads (source: Google Earth™)

The seismic acquisition spreads were laid out along the parking spaces behind the building, with geophone spacing of 3 metres for the main spread, using 24 geophones (Figure 2). Two shorter seismic spreads, with geophone spacing of 0.5 and 1.0 metre, were dedicated to the near surface materials. The seismic records were produced with a seismograph Terraloc Pro 2 (from ABEM Instrument), and the geophones were 4.5 Hz. An 8 kg sledgehammer was used as the energy source with impacts being recorded off both ends of the seismic spreads.

The surveys were carried out on April 9th, 2021, by Mrs. Karyne Faguy, B.Sc. geoph. and Mr. Timothy Ward, tech. Figure 1 shows the regional location of the site and Figure 2 illustrates the location of the seismic spreads. Both figures are presented in the Appendix.

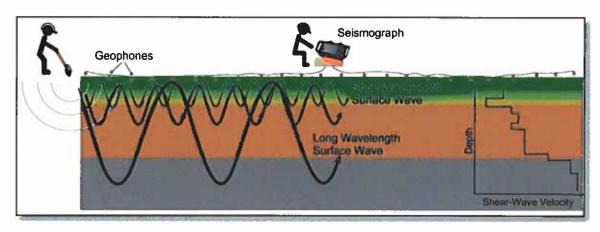
Figure 3: MASW Operating Principle

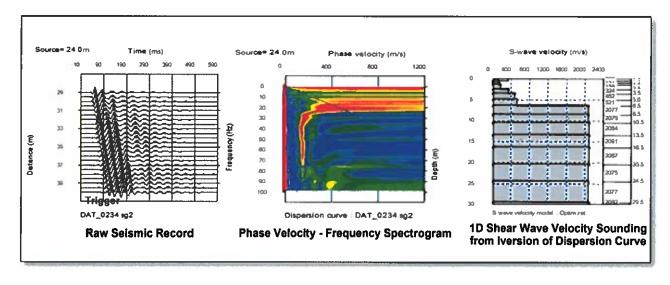
Figure 4: Example of a MASW/SPAC record, Phase Velocity - Frequency curve of the Rayleigh wave and resulting 1D Shear Wave Velocity Model

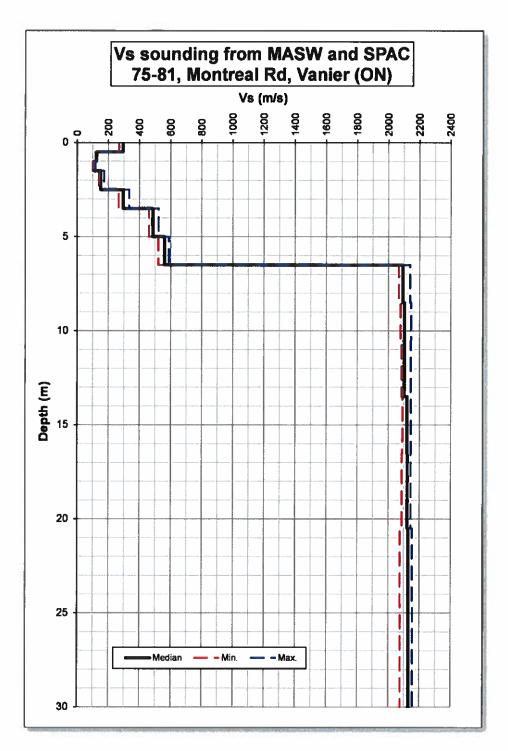
Figure 5: MASW Shear-Wave Velocity Sounding

The subject site has been classified as **Class C** for seismic site response in relation to Section 4.1.8.4 of the 2012 Ontario Building Code (OBC 2012) provided that the foundations are placed on engineering fill pads or on glacial till with more than 3 m of soils exist between the underside of footings and bedrock surface. A **Class A** seismic site class can be used for footings placed directly on bedrock or in areas where the depth of overburden between the underside of footings and bedrock is less than 3 m.
