Phase II – Environmental Site Assessment

Trail's Edge: Phase 5 (North)
Ottawa, Ontario

Richcraft Group of Companies

Report: PE5000-1

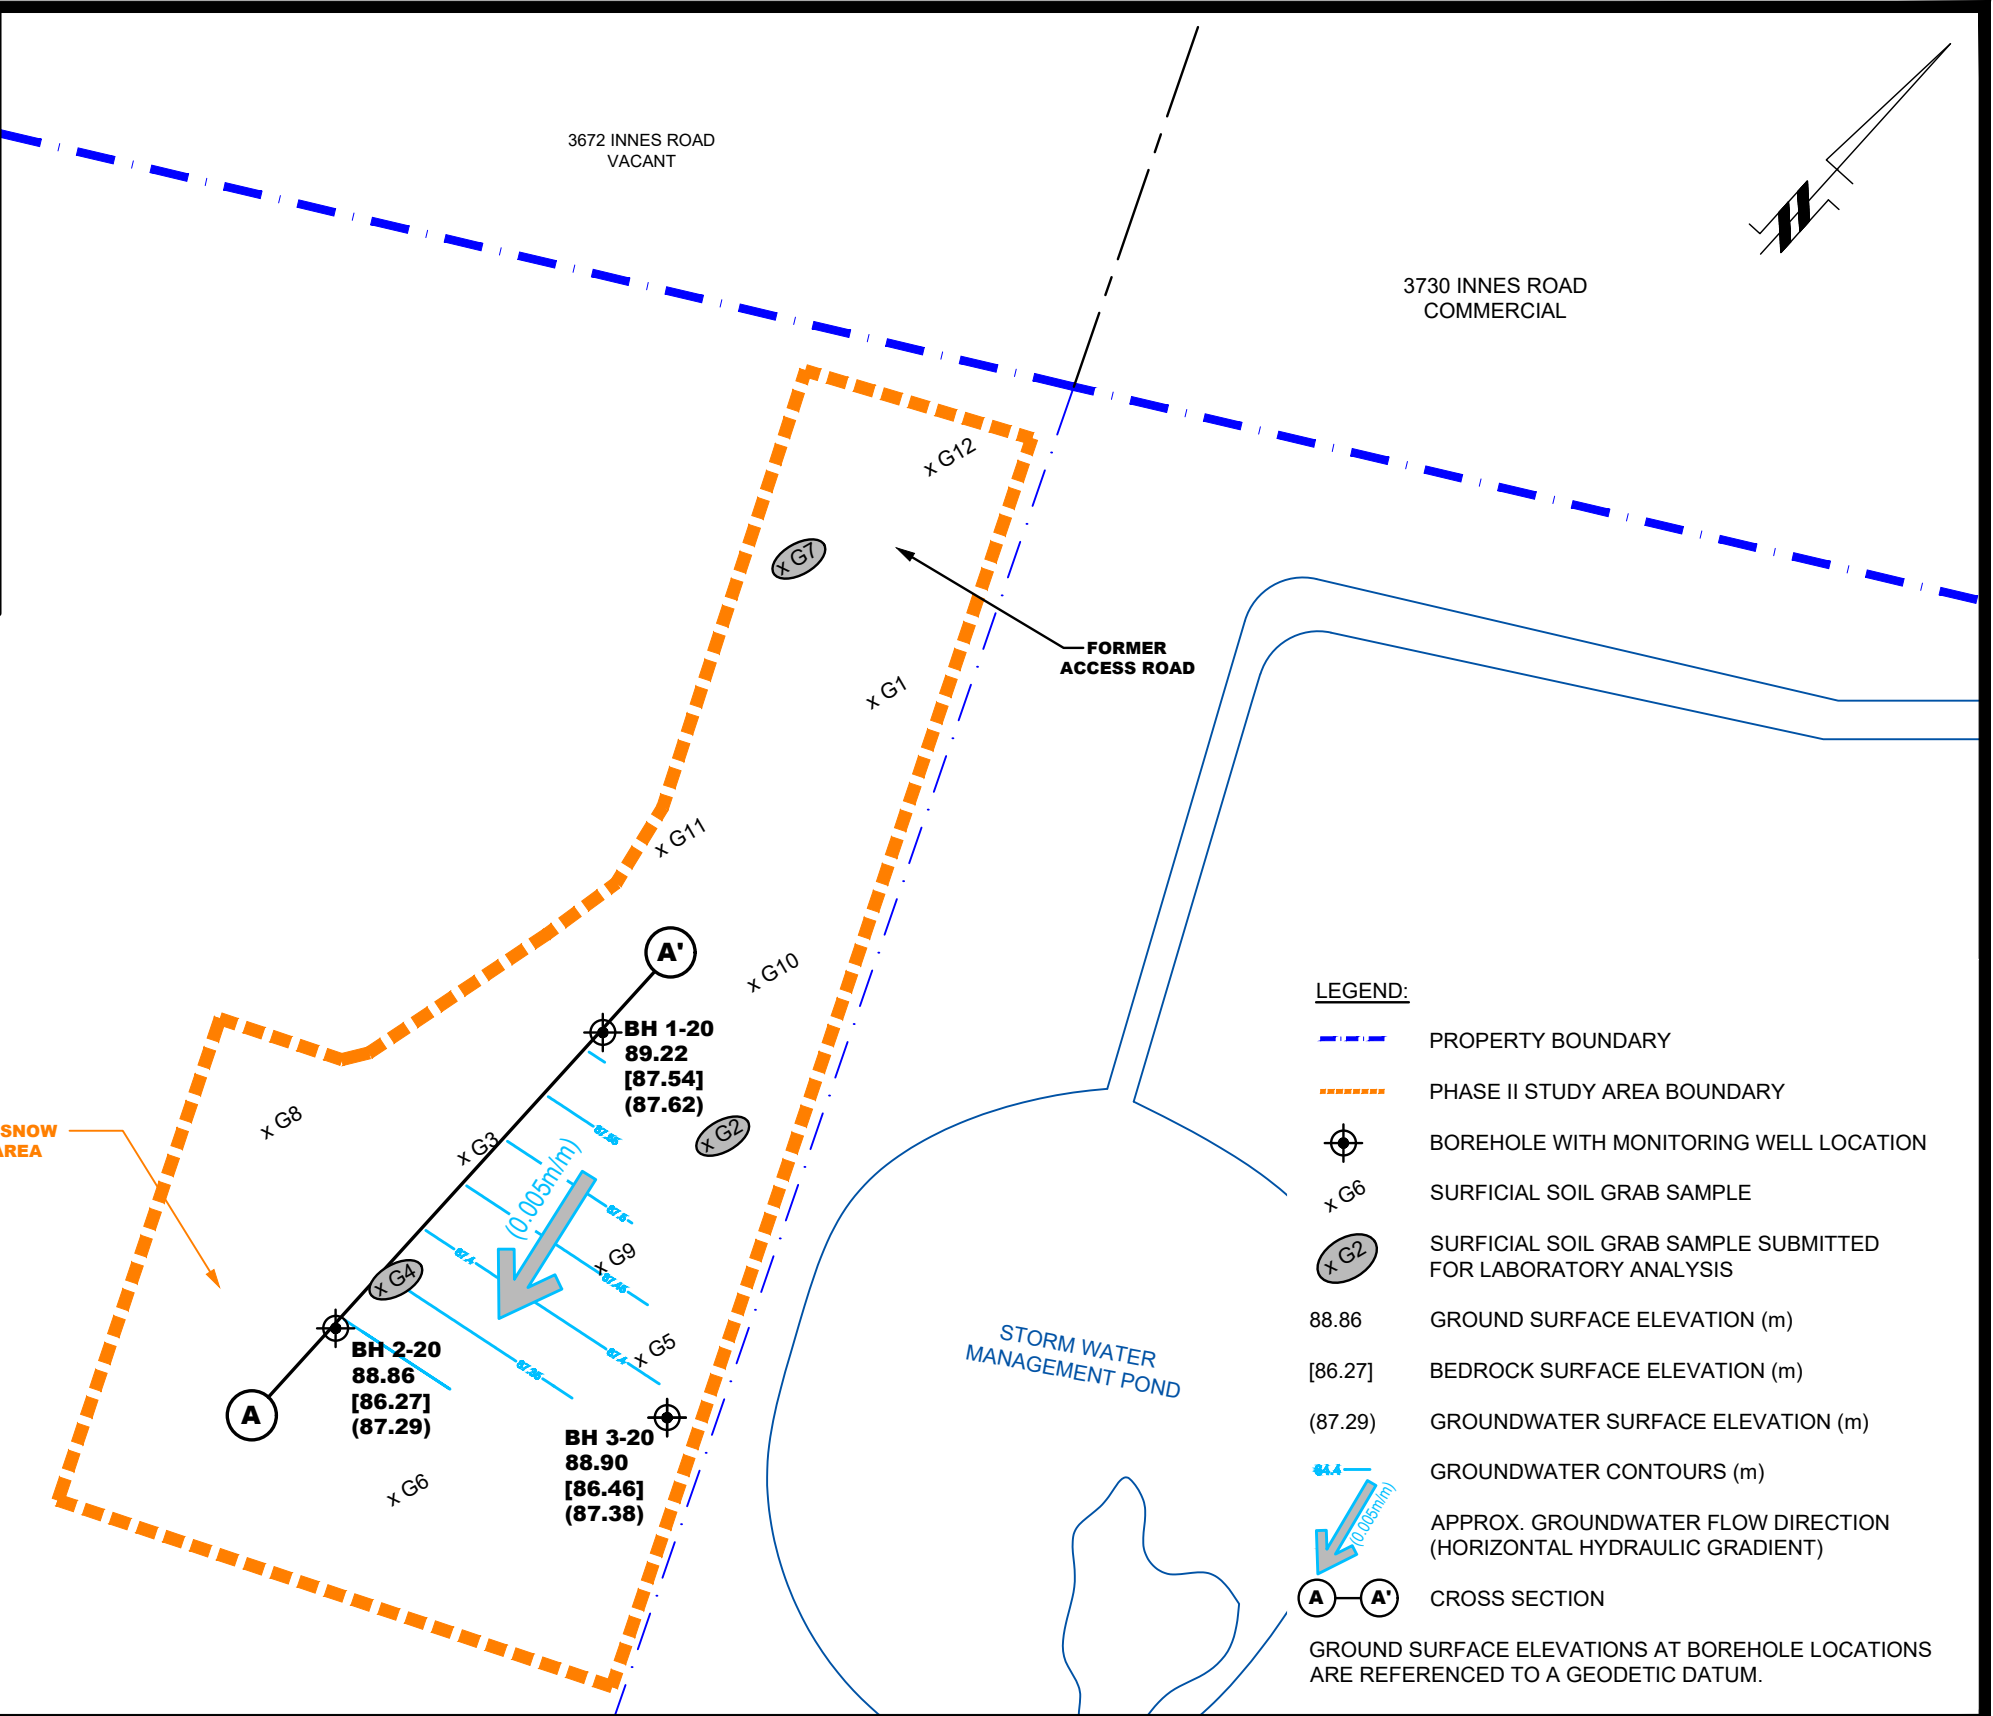
Drawing PE5000-3 – Test Hole Location Plan

Refer to Drawing PE5000-3 Test Hole Location Plan for the location of all boreholes and surficial grab samples.

An additional twelve (12) soil samples were obtained via grab sampling of surficial soils. The location at which grab samples were obtained from the subject site are shown as “**G**”, on Drawing PE5000-3 Test Hole Location Plan.

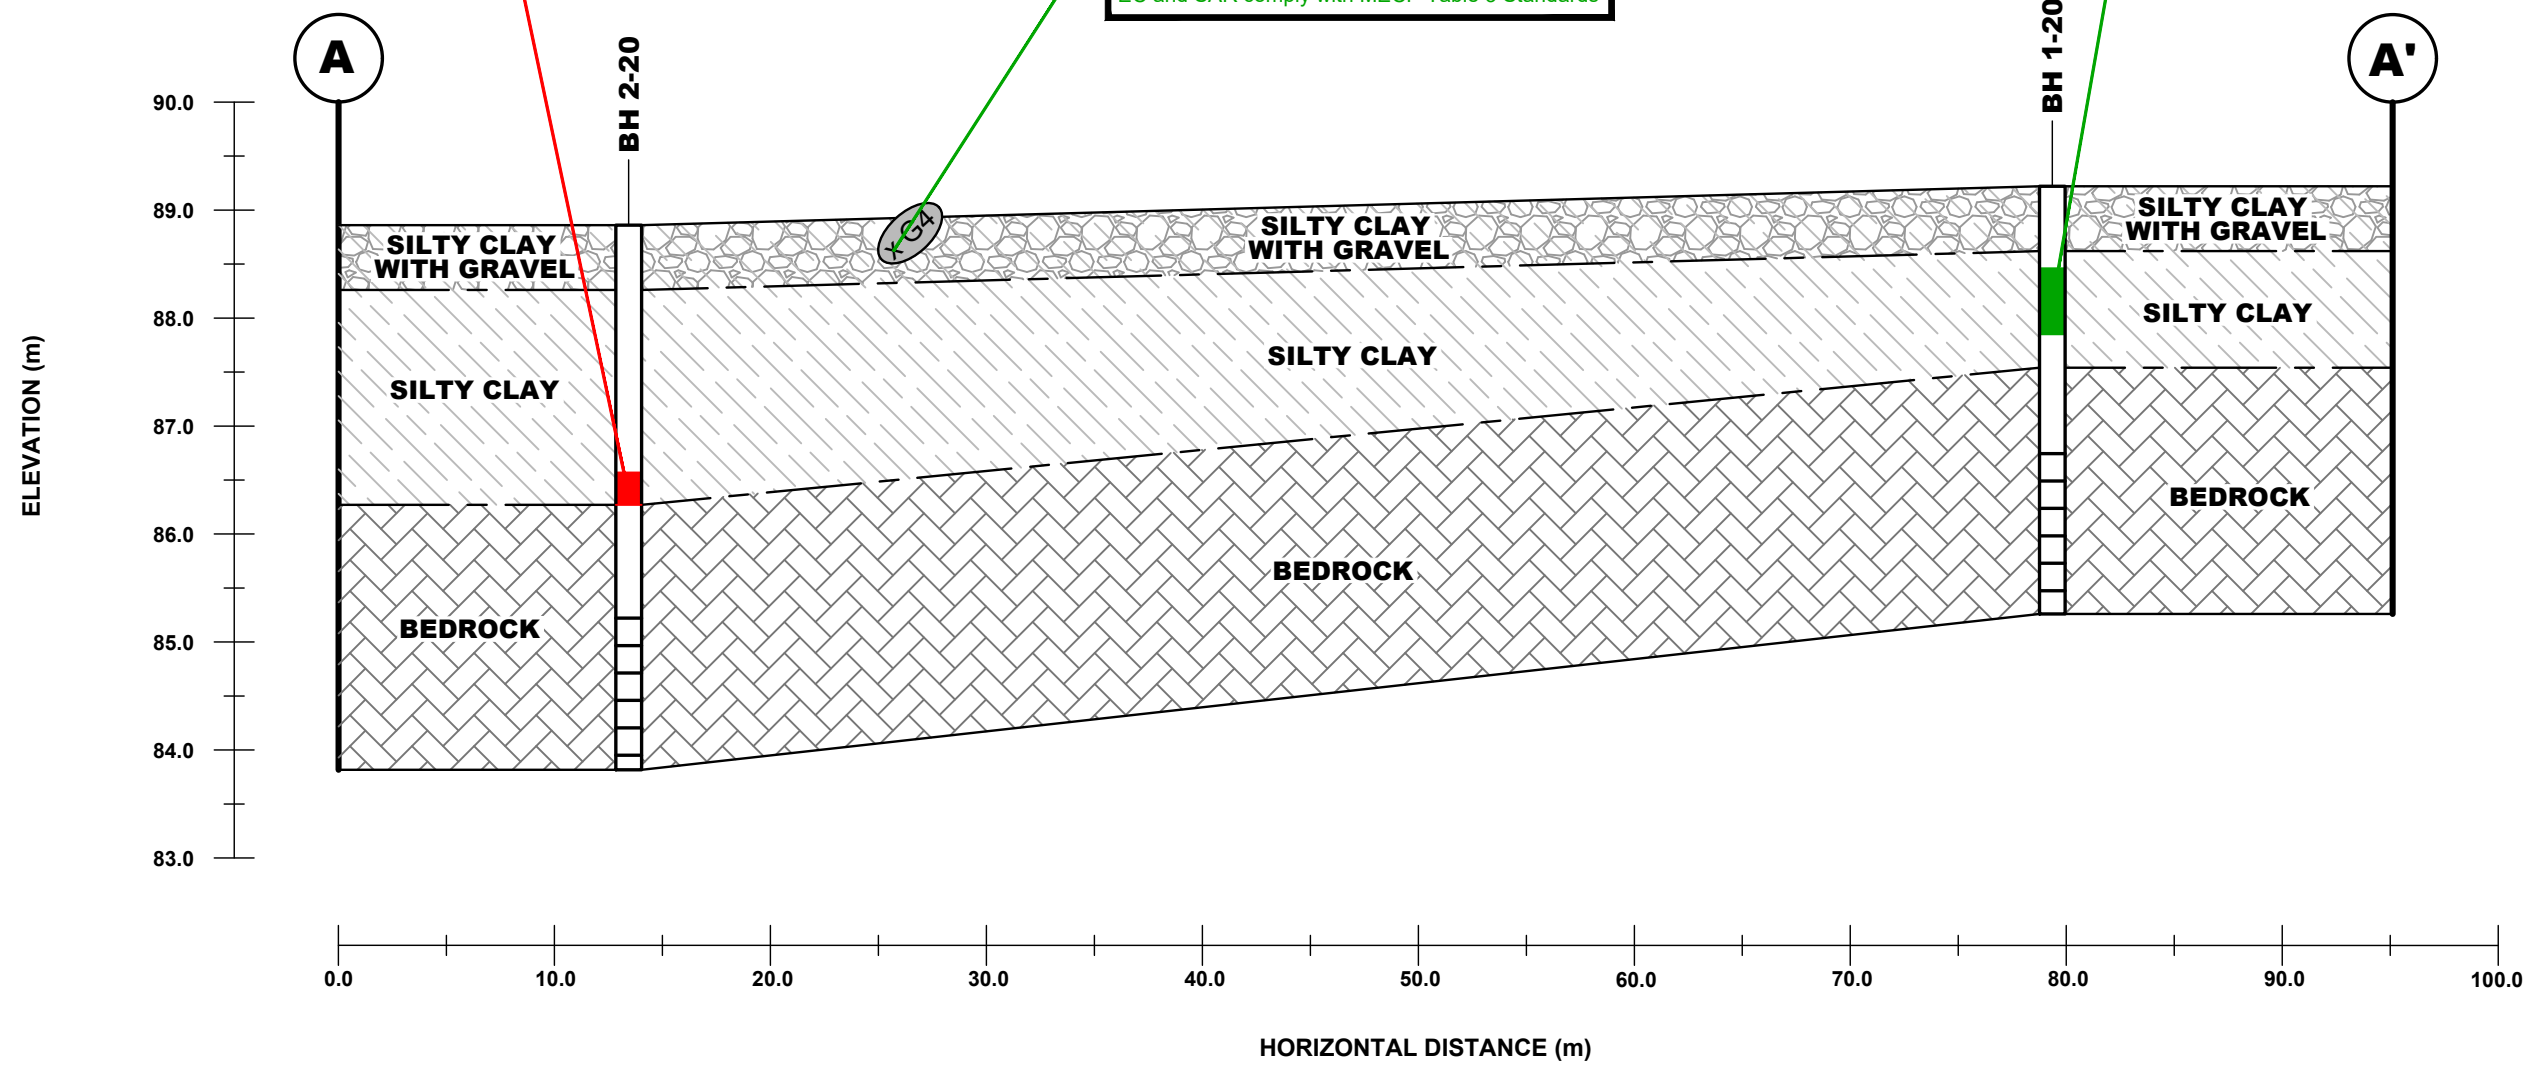
CROSS SECTION A-A' - SOIL (EC, SAR)

SOIL RESULT COMPLIES WITH MECP TABLE 3 STANDARDS

SOIL RESULT EXCEEDS MECP TABLE 3 STANDARDS
