## Phase II – Environmental Site Assessment

Trail's Edge: Phase 5 (North)  
Ottawa, Ontario

October 27, 2020

Report: PE5000-1

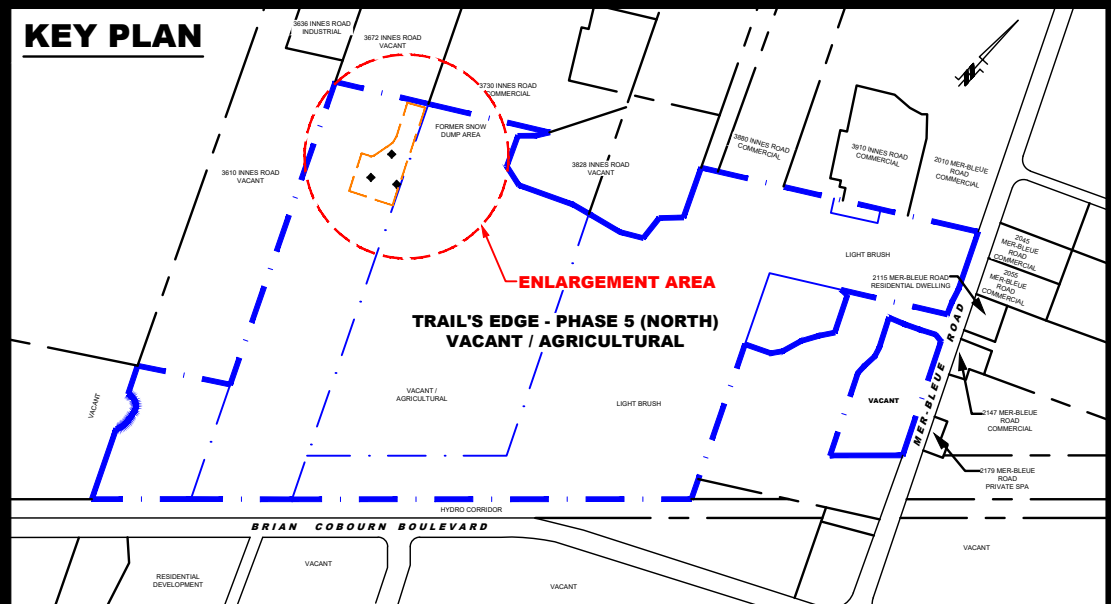
Scale:	1:1250	Date:	11/2020
Drawn by:	YA	Report No.:	PE5000-1
Checked by:	NS	Dwg. No.:	<b>PE5000-3</b>
Approved by:	MSD	Revision No.:

Refer to Drawing PE5000-3 Test Hole Location Plan for the location of all boreholes and surficial grab samples.

An additional twelve (12) soil samples were obtained via grab sampling of surficial soils. The location at which grab samples were obtained from the subject site are shown as “**G**”, on Drawing PE5000-3 Test Hole Location Plan.
