# Phase Two Environmental Site Assessment

*Northwest 0.47-Hectare Parcel at 933 Gladstone Avenue, Ottawa, Ontario*

**Golder Associates Ltd.**

21470873-003-R-Rev1

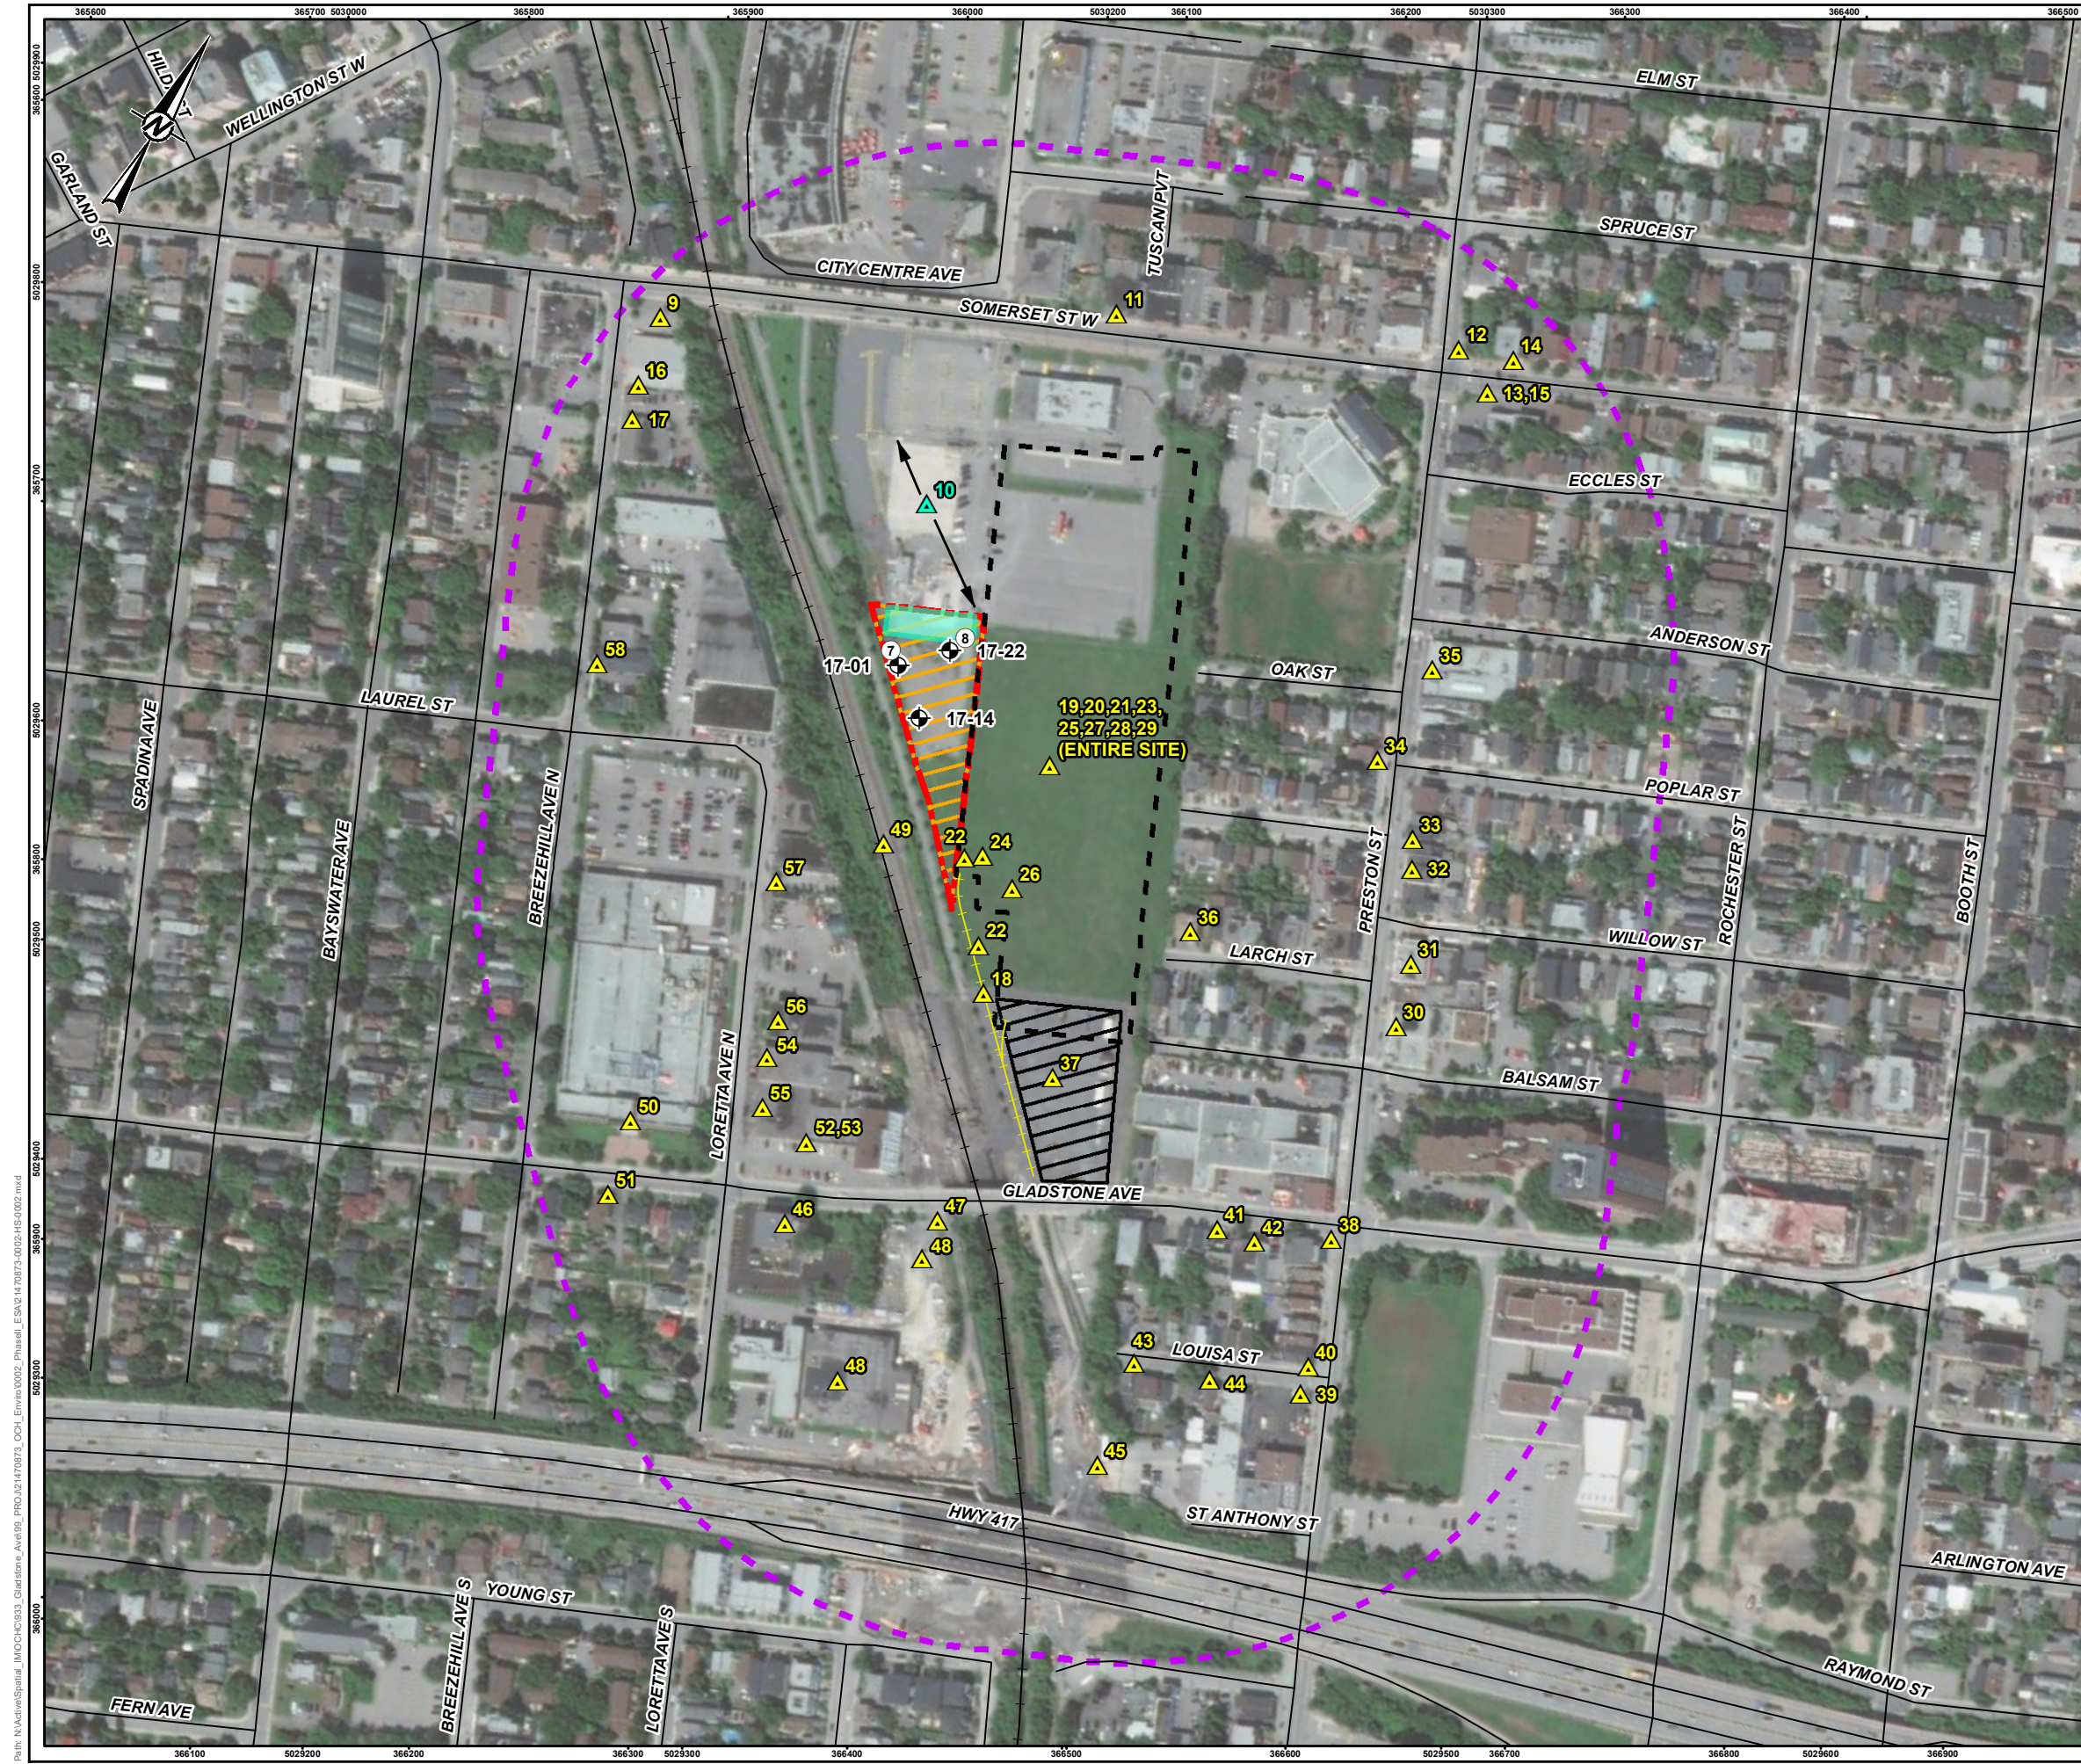
- PCA NOT RESULTING IN APEC FOR THE SITE
- OFF-SITE PCA RESULTING IN APEC FOR THE SITE
- APEC LOCATION
- APPROXIMATE MONITORING WELL LOCATION
- ROADWAY
- RAILWAY
- PCA 18 - FORMER RAILWAY
- APEC 9 - RESULTING FROM OFF-SITE PCA
- LOCATION OF APEC 1, 2, 3, 4, 5, 6 (ENTIRE SITE)
- PCA 37 - LRT STAGING AREA
- FORMER WAREHOUSE BUILDING FOOTPRINT
- APPROXIMATE SITE BOUNDARY
- APPROXIMATE STUDY AREA

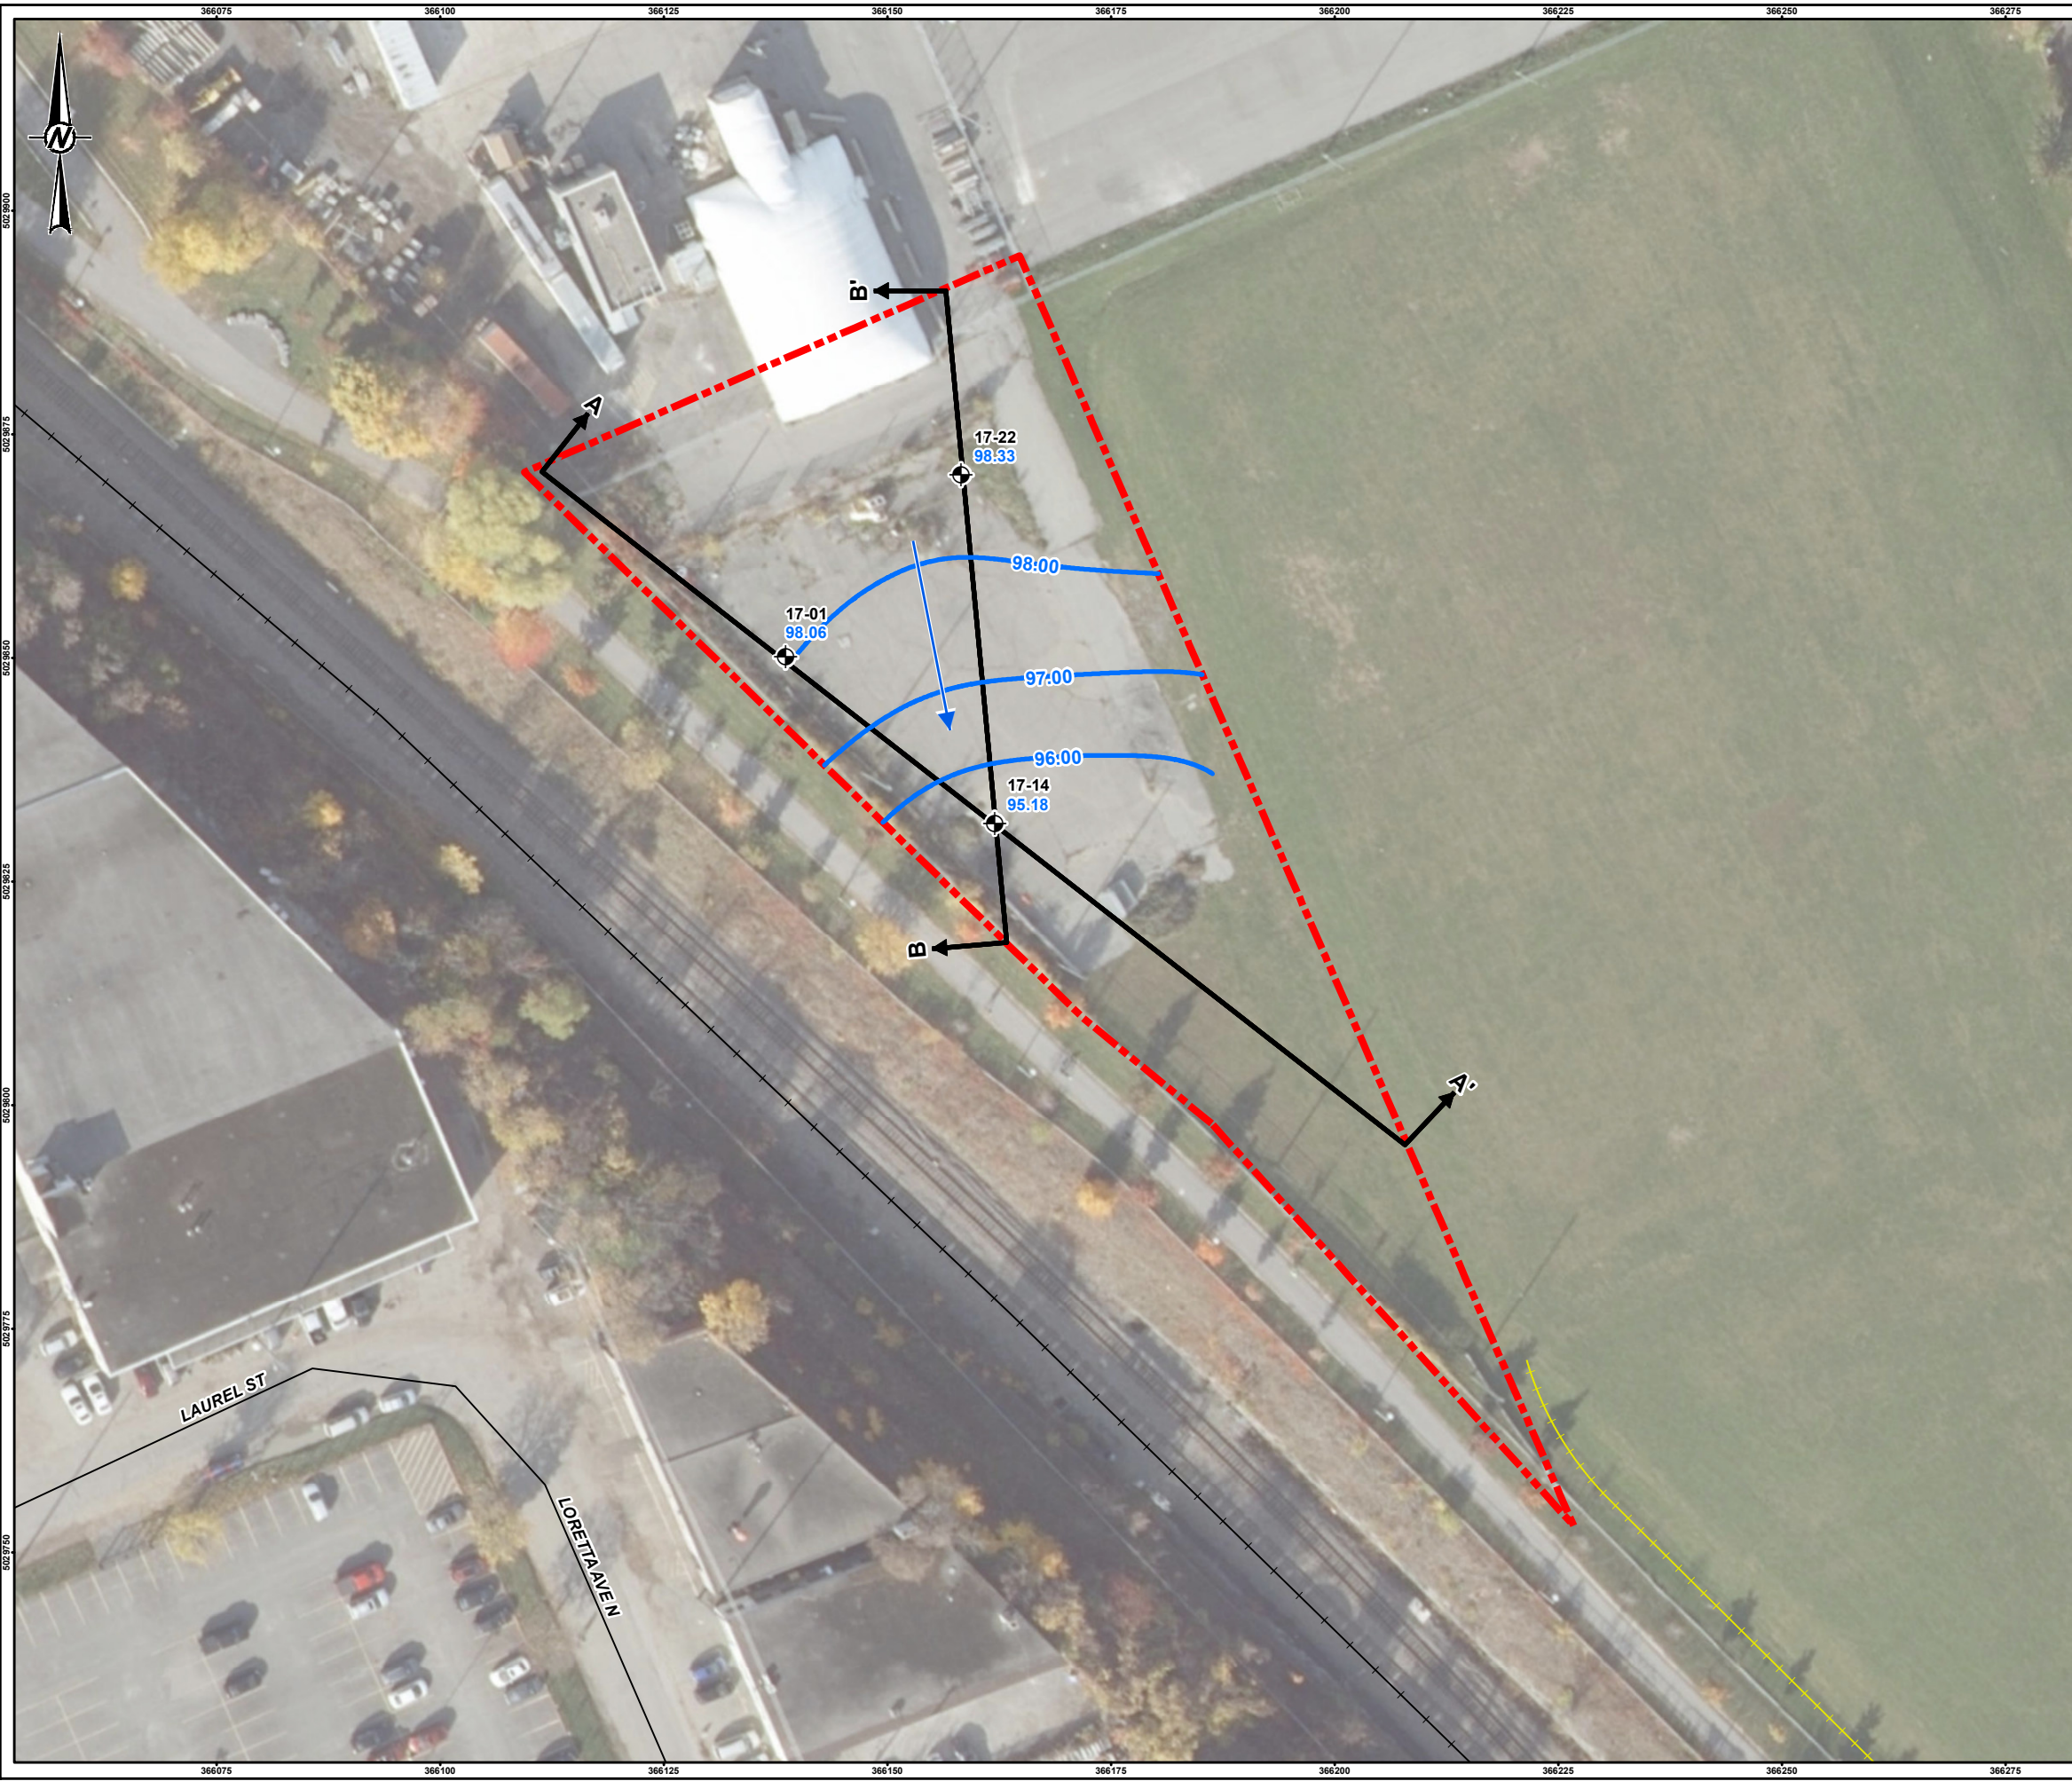
- SCALE 1:25,000
- LEGEND**
- APPROXIMATE MONITORING WELL LOCATION
  - ROADWAY
  - RAILWAY
  - FORMER RAILWAY
  - APPROXIMATE SITE BOUNDARY
  - GROUNDWATER ELEVATION, mASL (August 11, 2021)
  - GROUNDWATER ELEVATION CONTOUR, mASL
  - INTERPRETED GROUNDWATER FLOW DIRECTION
  - CROSS-SECTION LOCATION

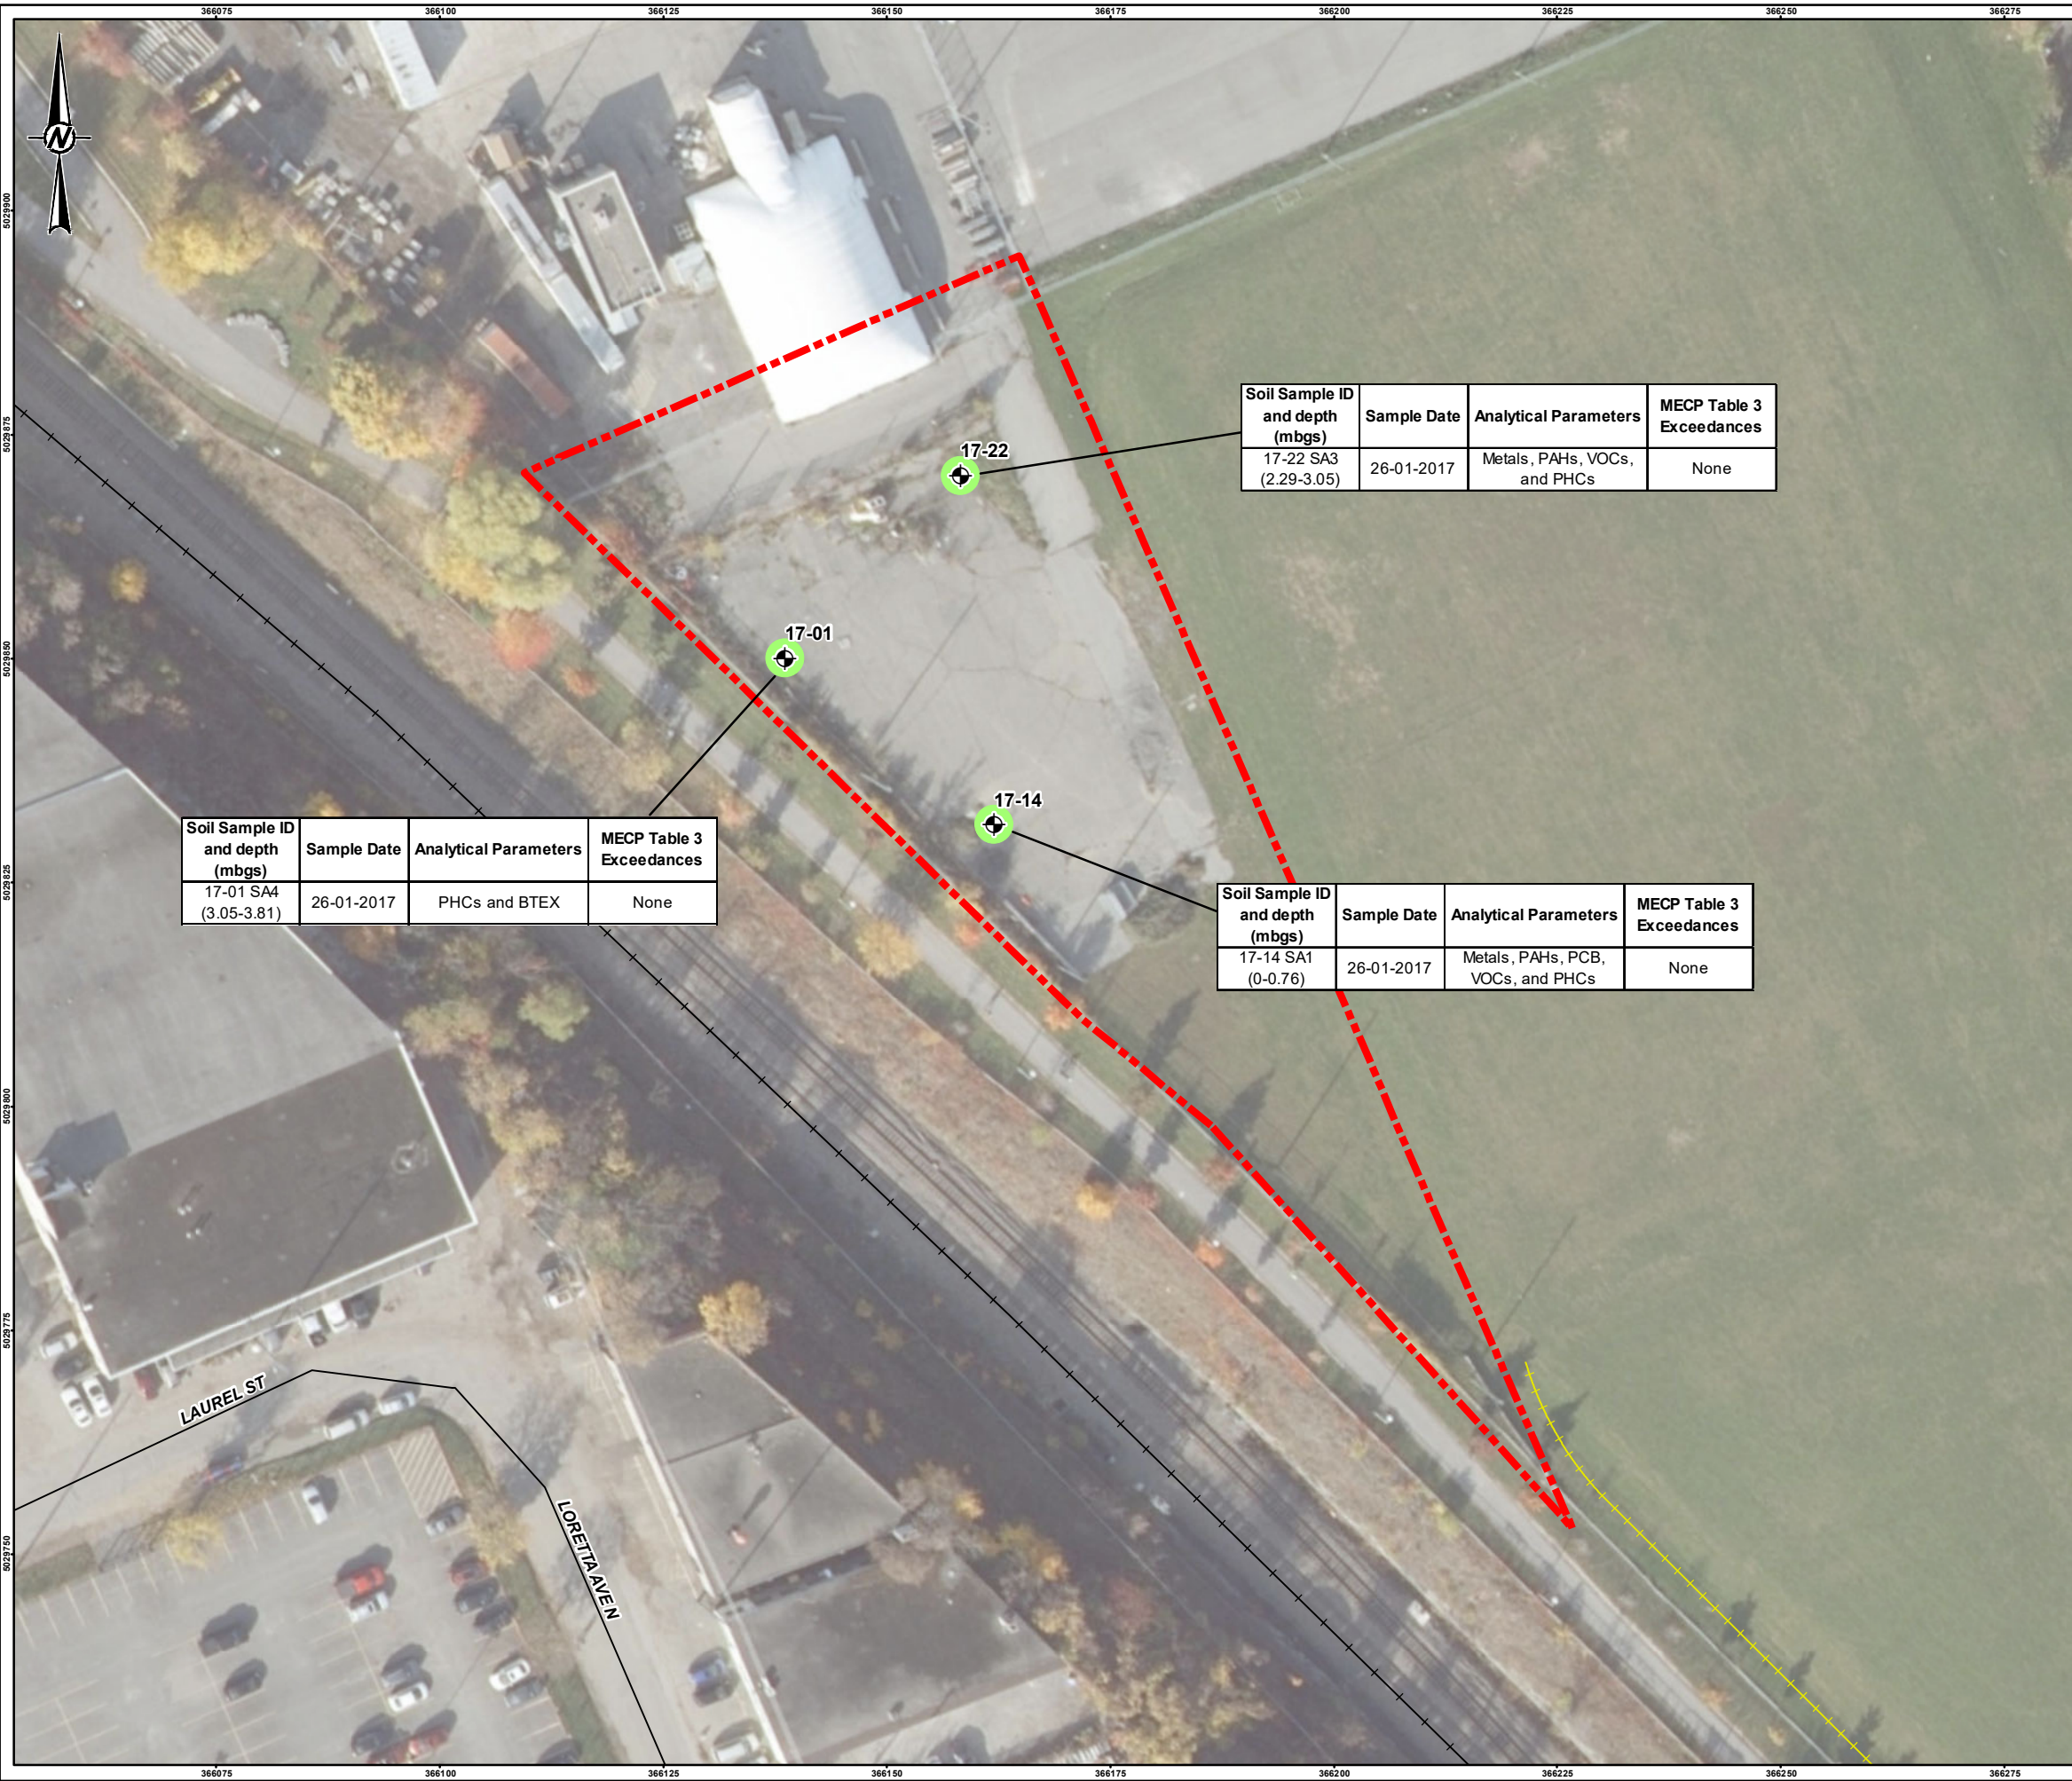
Soil Sample ID and depth (mbgs)	Sample Date	Analytical Parameters	MECP Table 3 Exceedances
17-22 SA3 (2.29-3.05)	26-01-2017	Metals, PAHs, VOCs, and PHCs	None

Soil Sample ID and depth (mbgs)	Sample Date	Analytical Parameters	MECP Table 3 Exceedances
17-01 SA4 (3.05-3.81)	26-01-2017	PHCs and BTEX	None

Soil Sample ID and depth (mbgs)	Sample Date	Analytical Parameters	MECP Table 3 Exceedances
17-14 SA1 (0-0.76)	26-01-2017	Metals, PAHs, PCB, VOCs, and PHCs	None

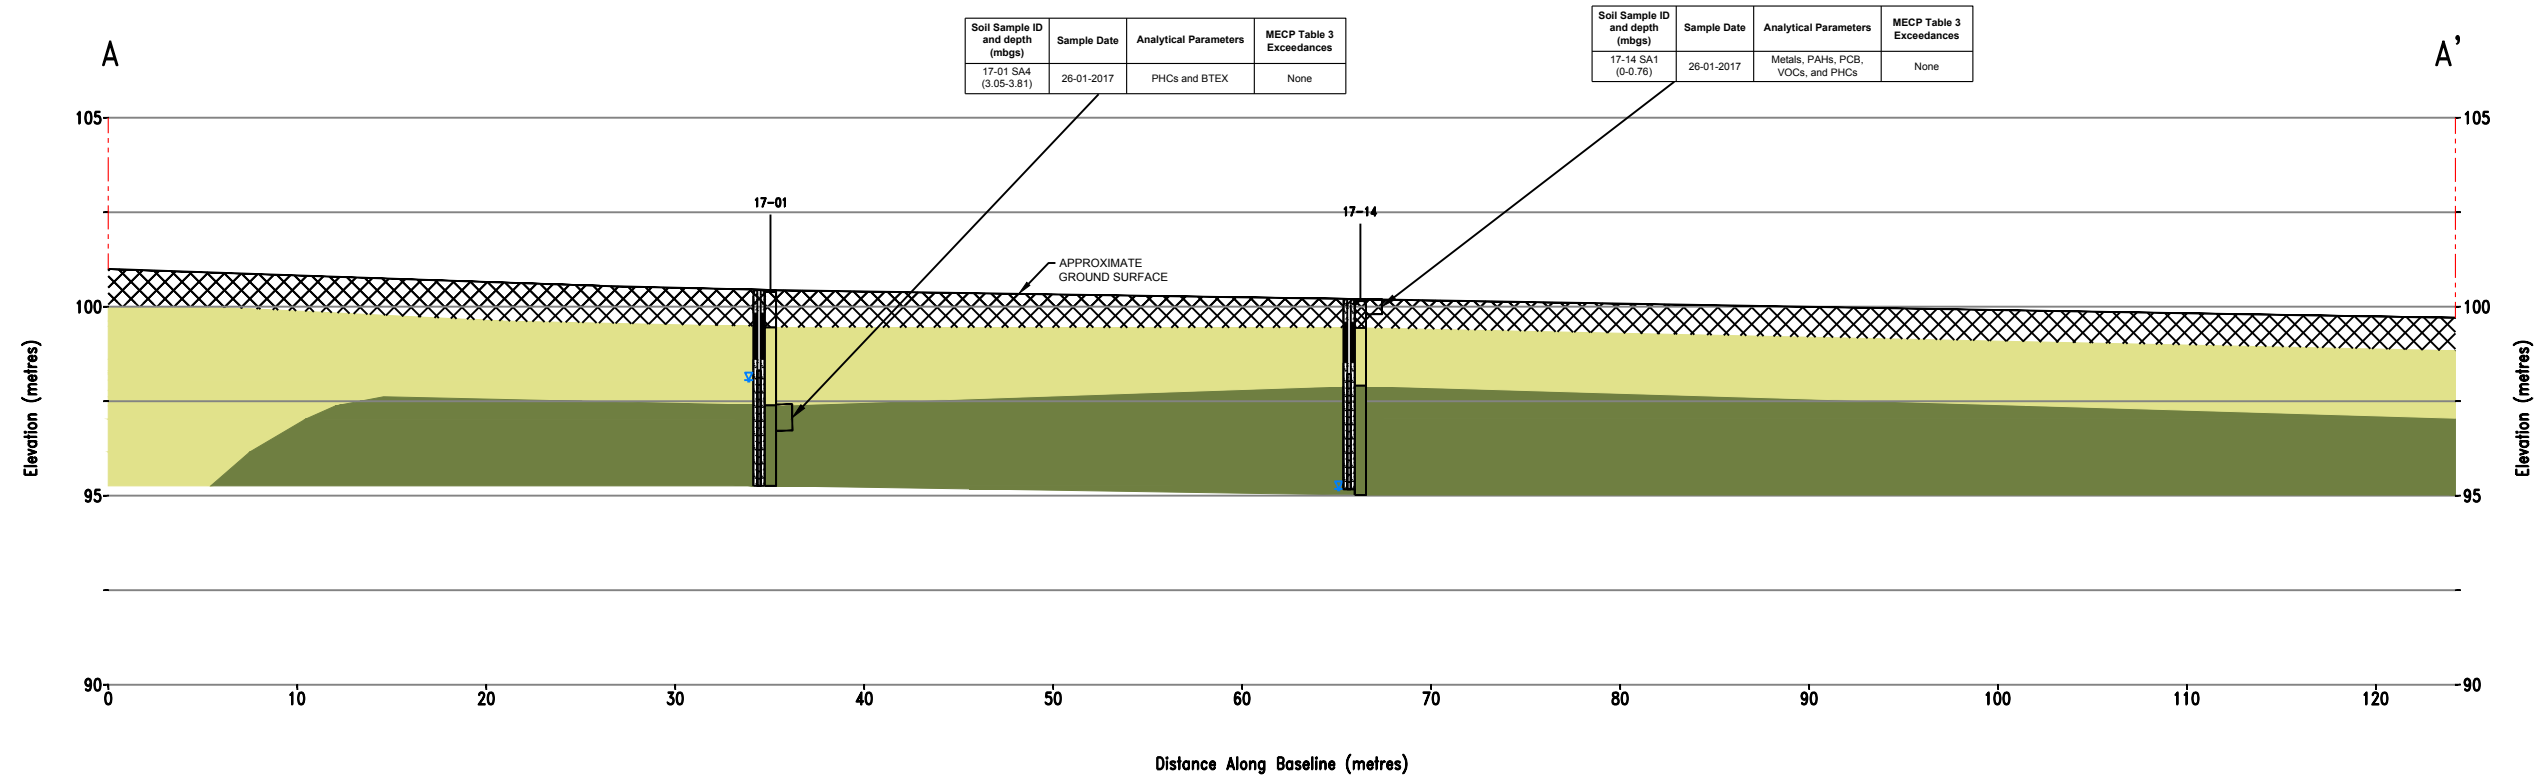
1. ALL LOCATIONS ARE APPROXIMATE
2. FOR DETAILED STRATIGRAPHY SEE RECORD OF BOREHOLE LOGS
3. FOR CROSS-SECTION LOCATION SEE FIGURE 3

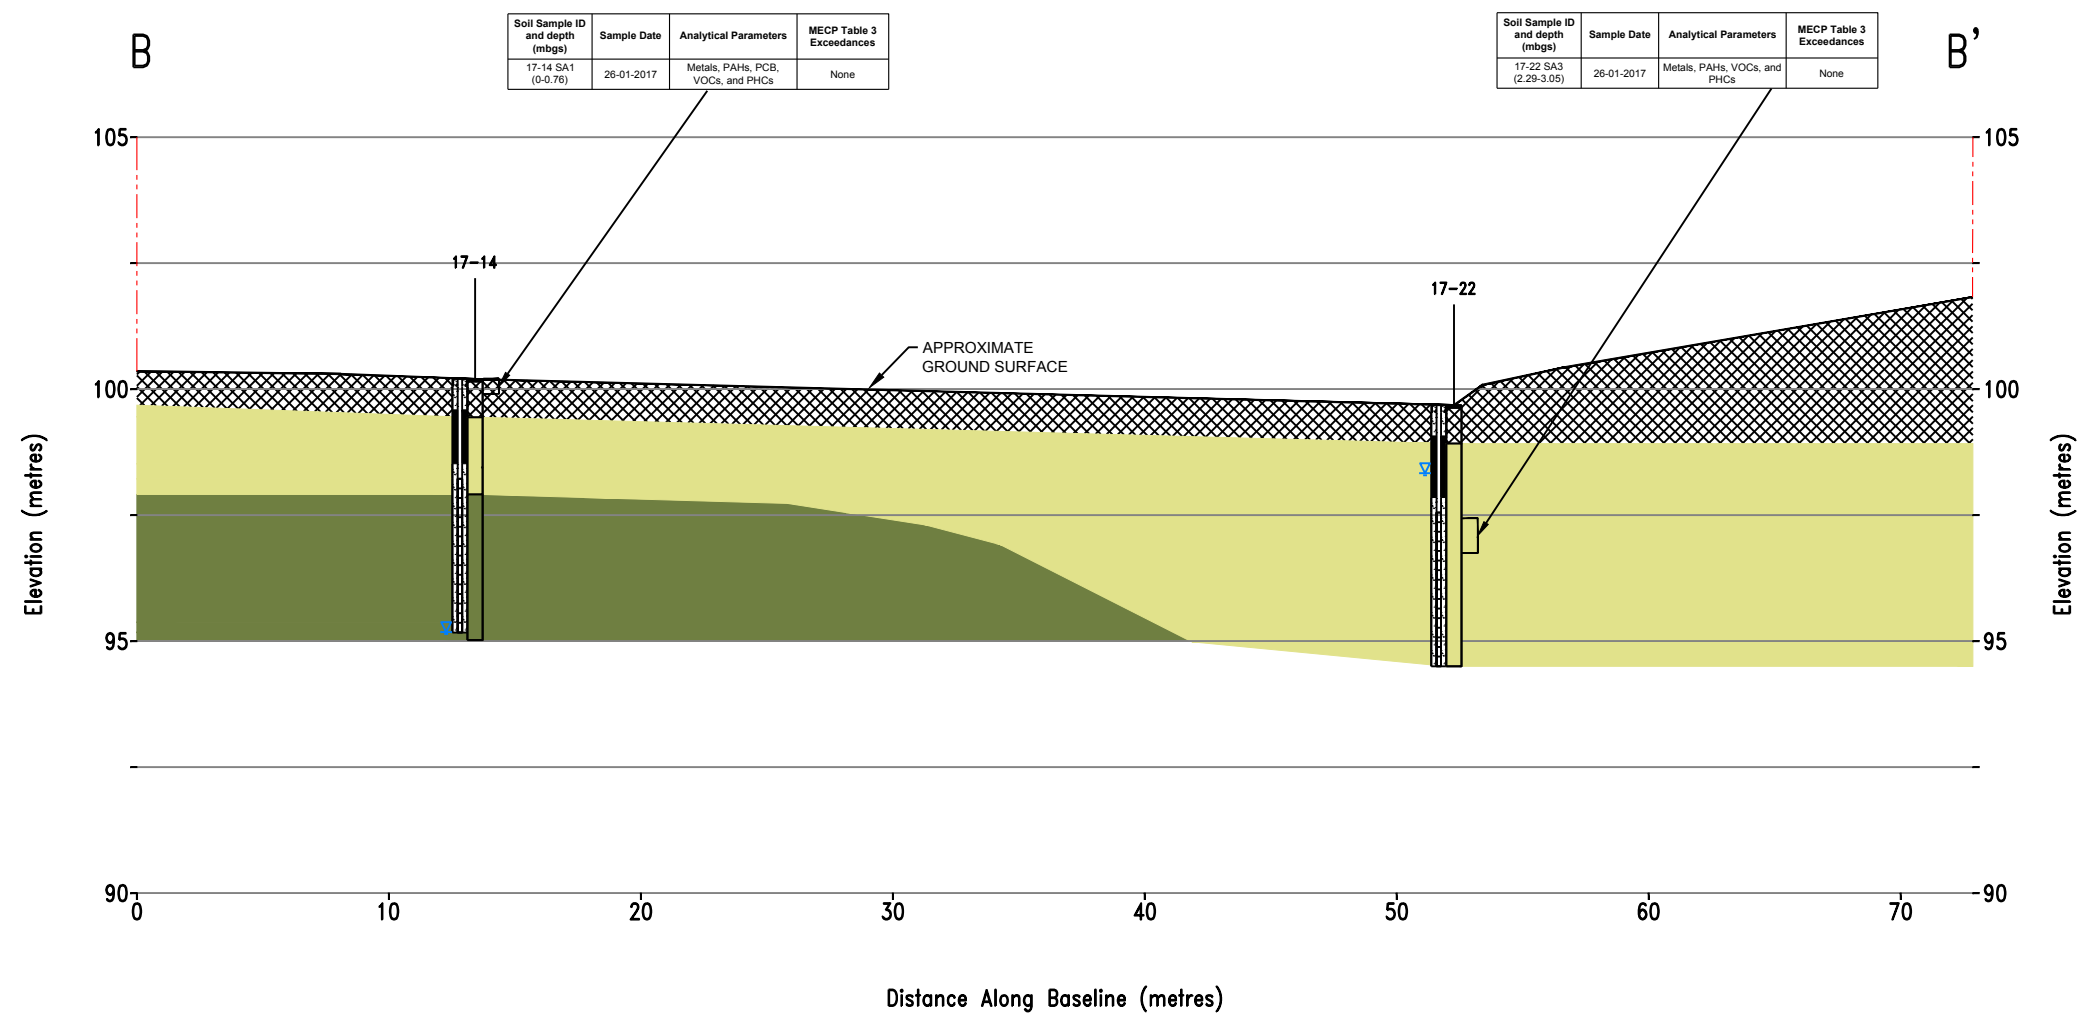
ASPHALTIC CONCRETE
	FILL
	SANDY CLAY
	CLAY

- NOTE(S)**
1. ALL LOCATIONS ARE APPROXIMATE
  2. FOR DETAILED STRATIGRAPHY SEE RECORD OF BOREHOLE LOGS
  3. FOR CROSS-SECTION LOCATION SEE FIGURE 3

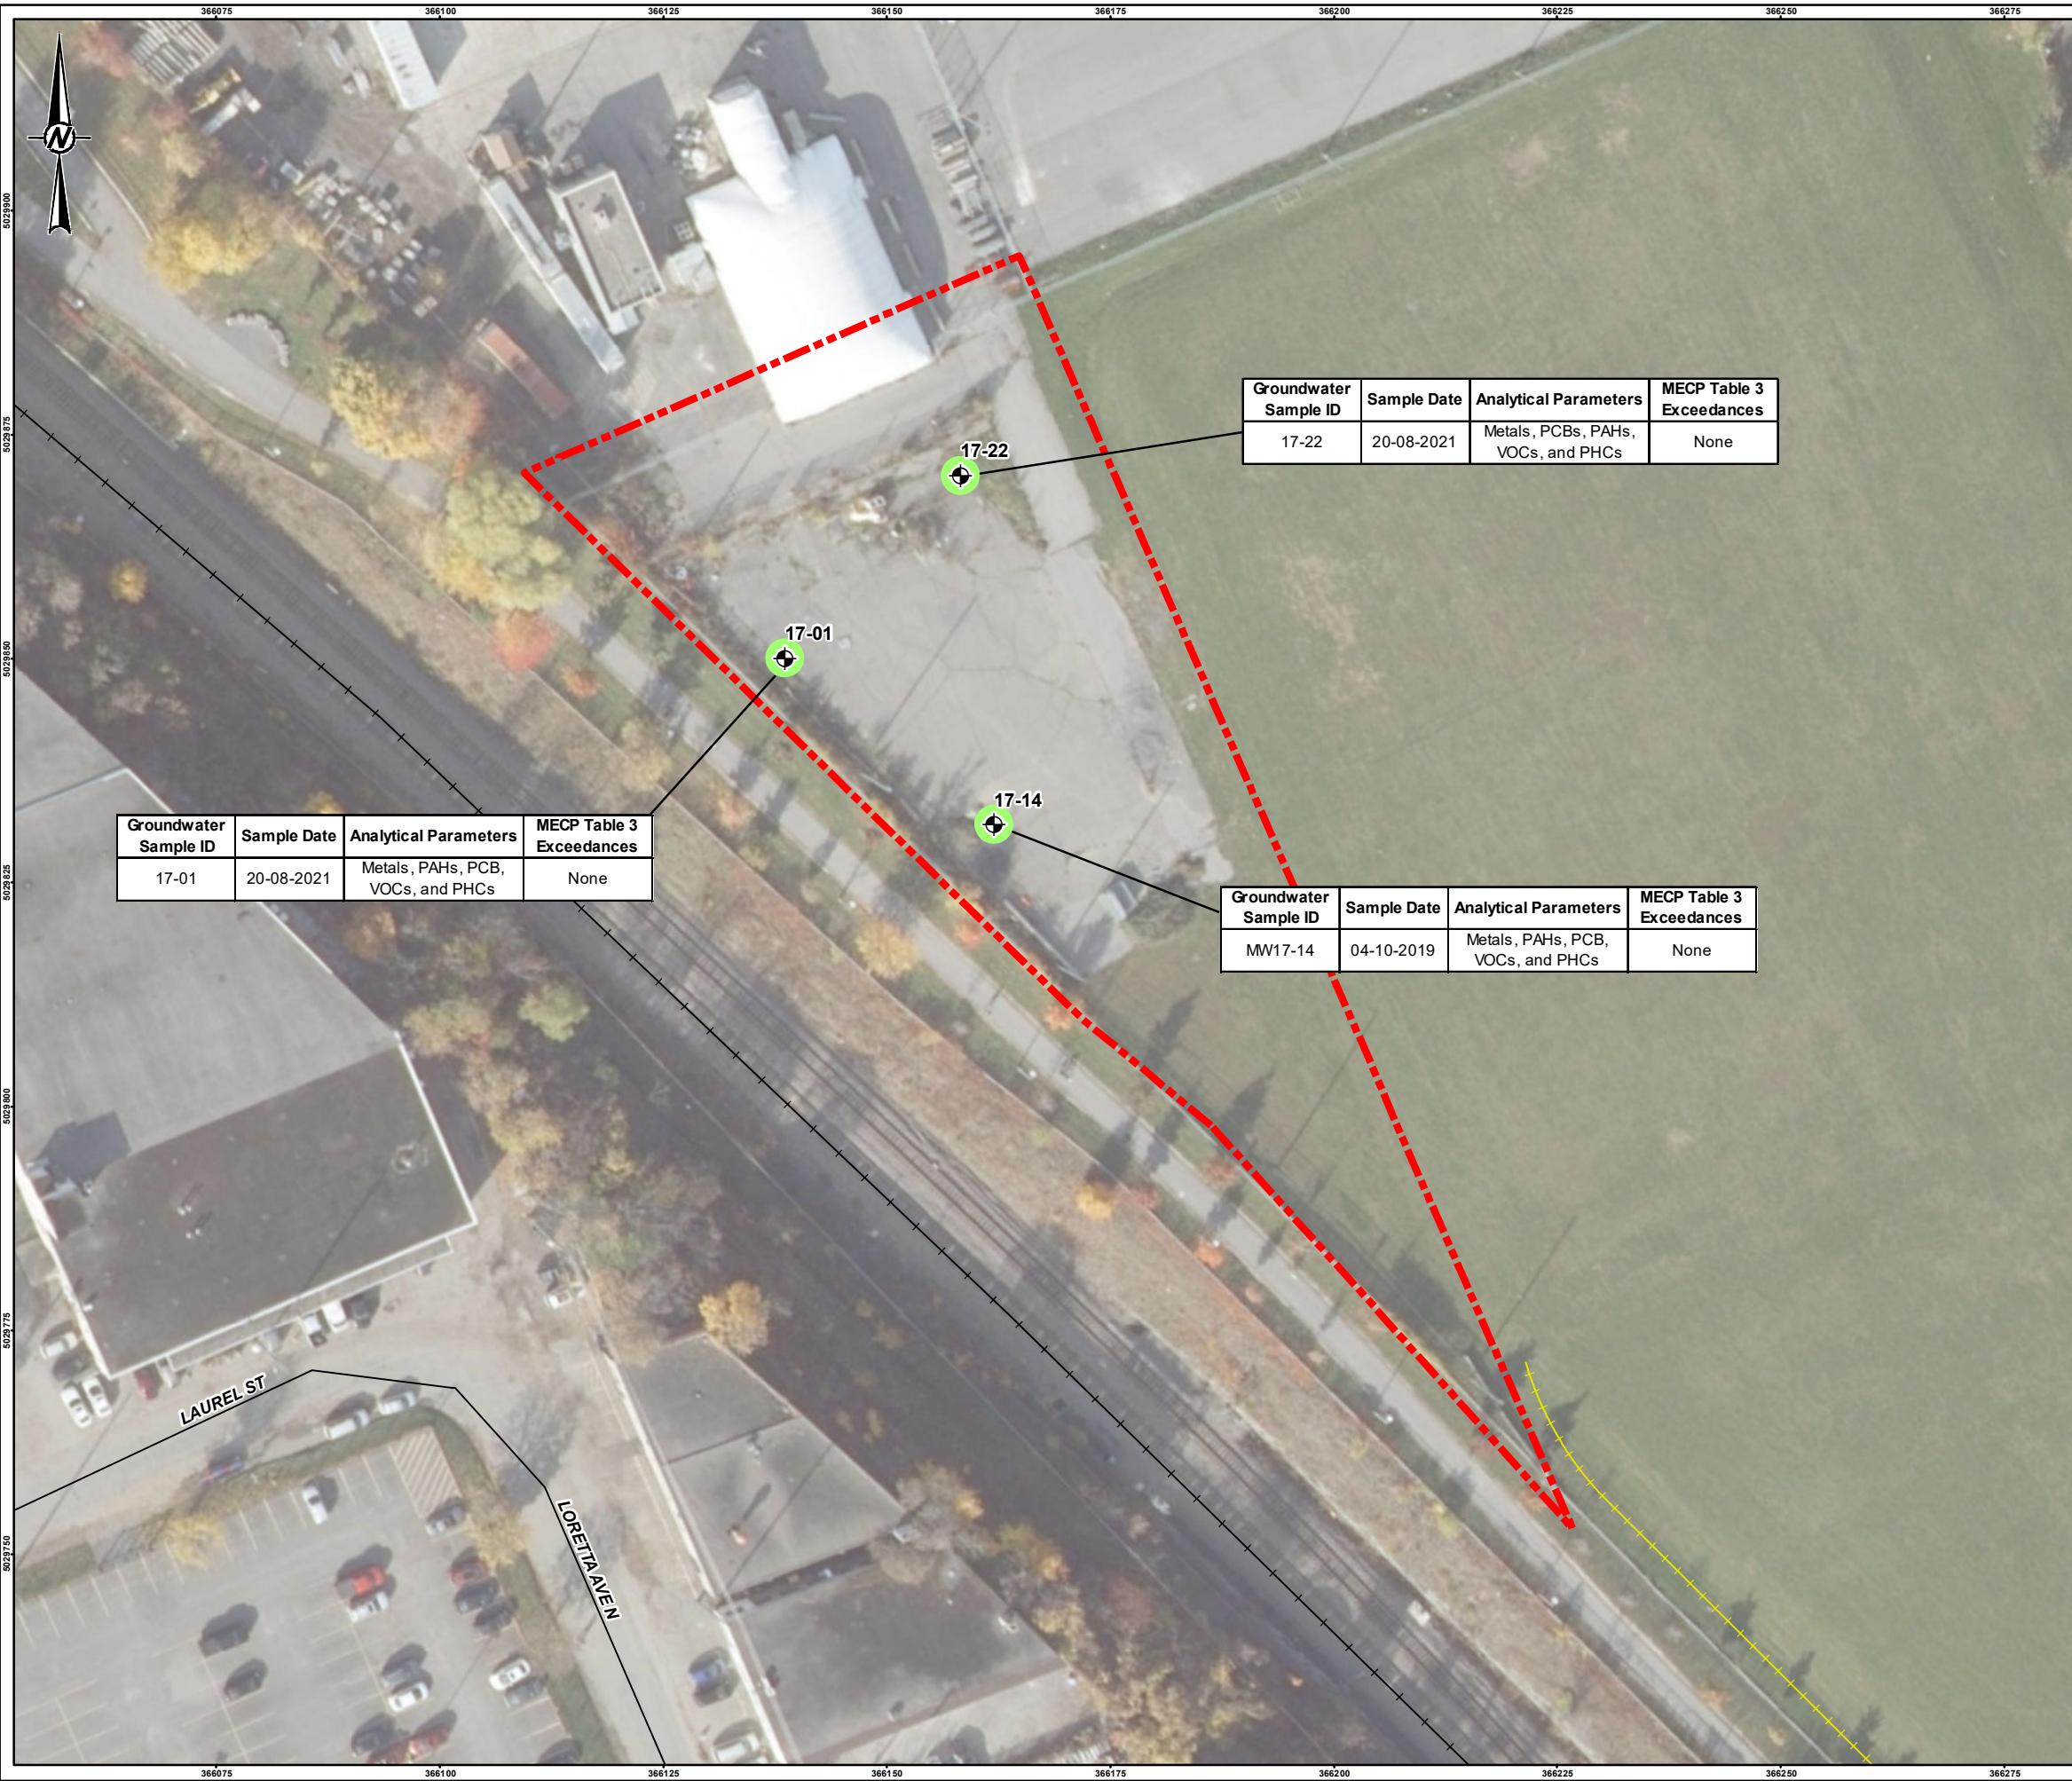
Groundwater Sample ID	Sample Date	Analytical Parameters	MECP Table 3 Exceedances
17-01	20-08-2021	Metals, PAHs, PCB, VOCs, and PHCs	None

Groundwater Sample ID	Sample Date	Analytical Parameters	MECP Table 3 Exceedances
MW17-14	04-10-2019	Metals, PAHs, PCB, VOCs, and PHCs	None

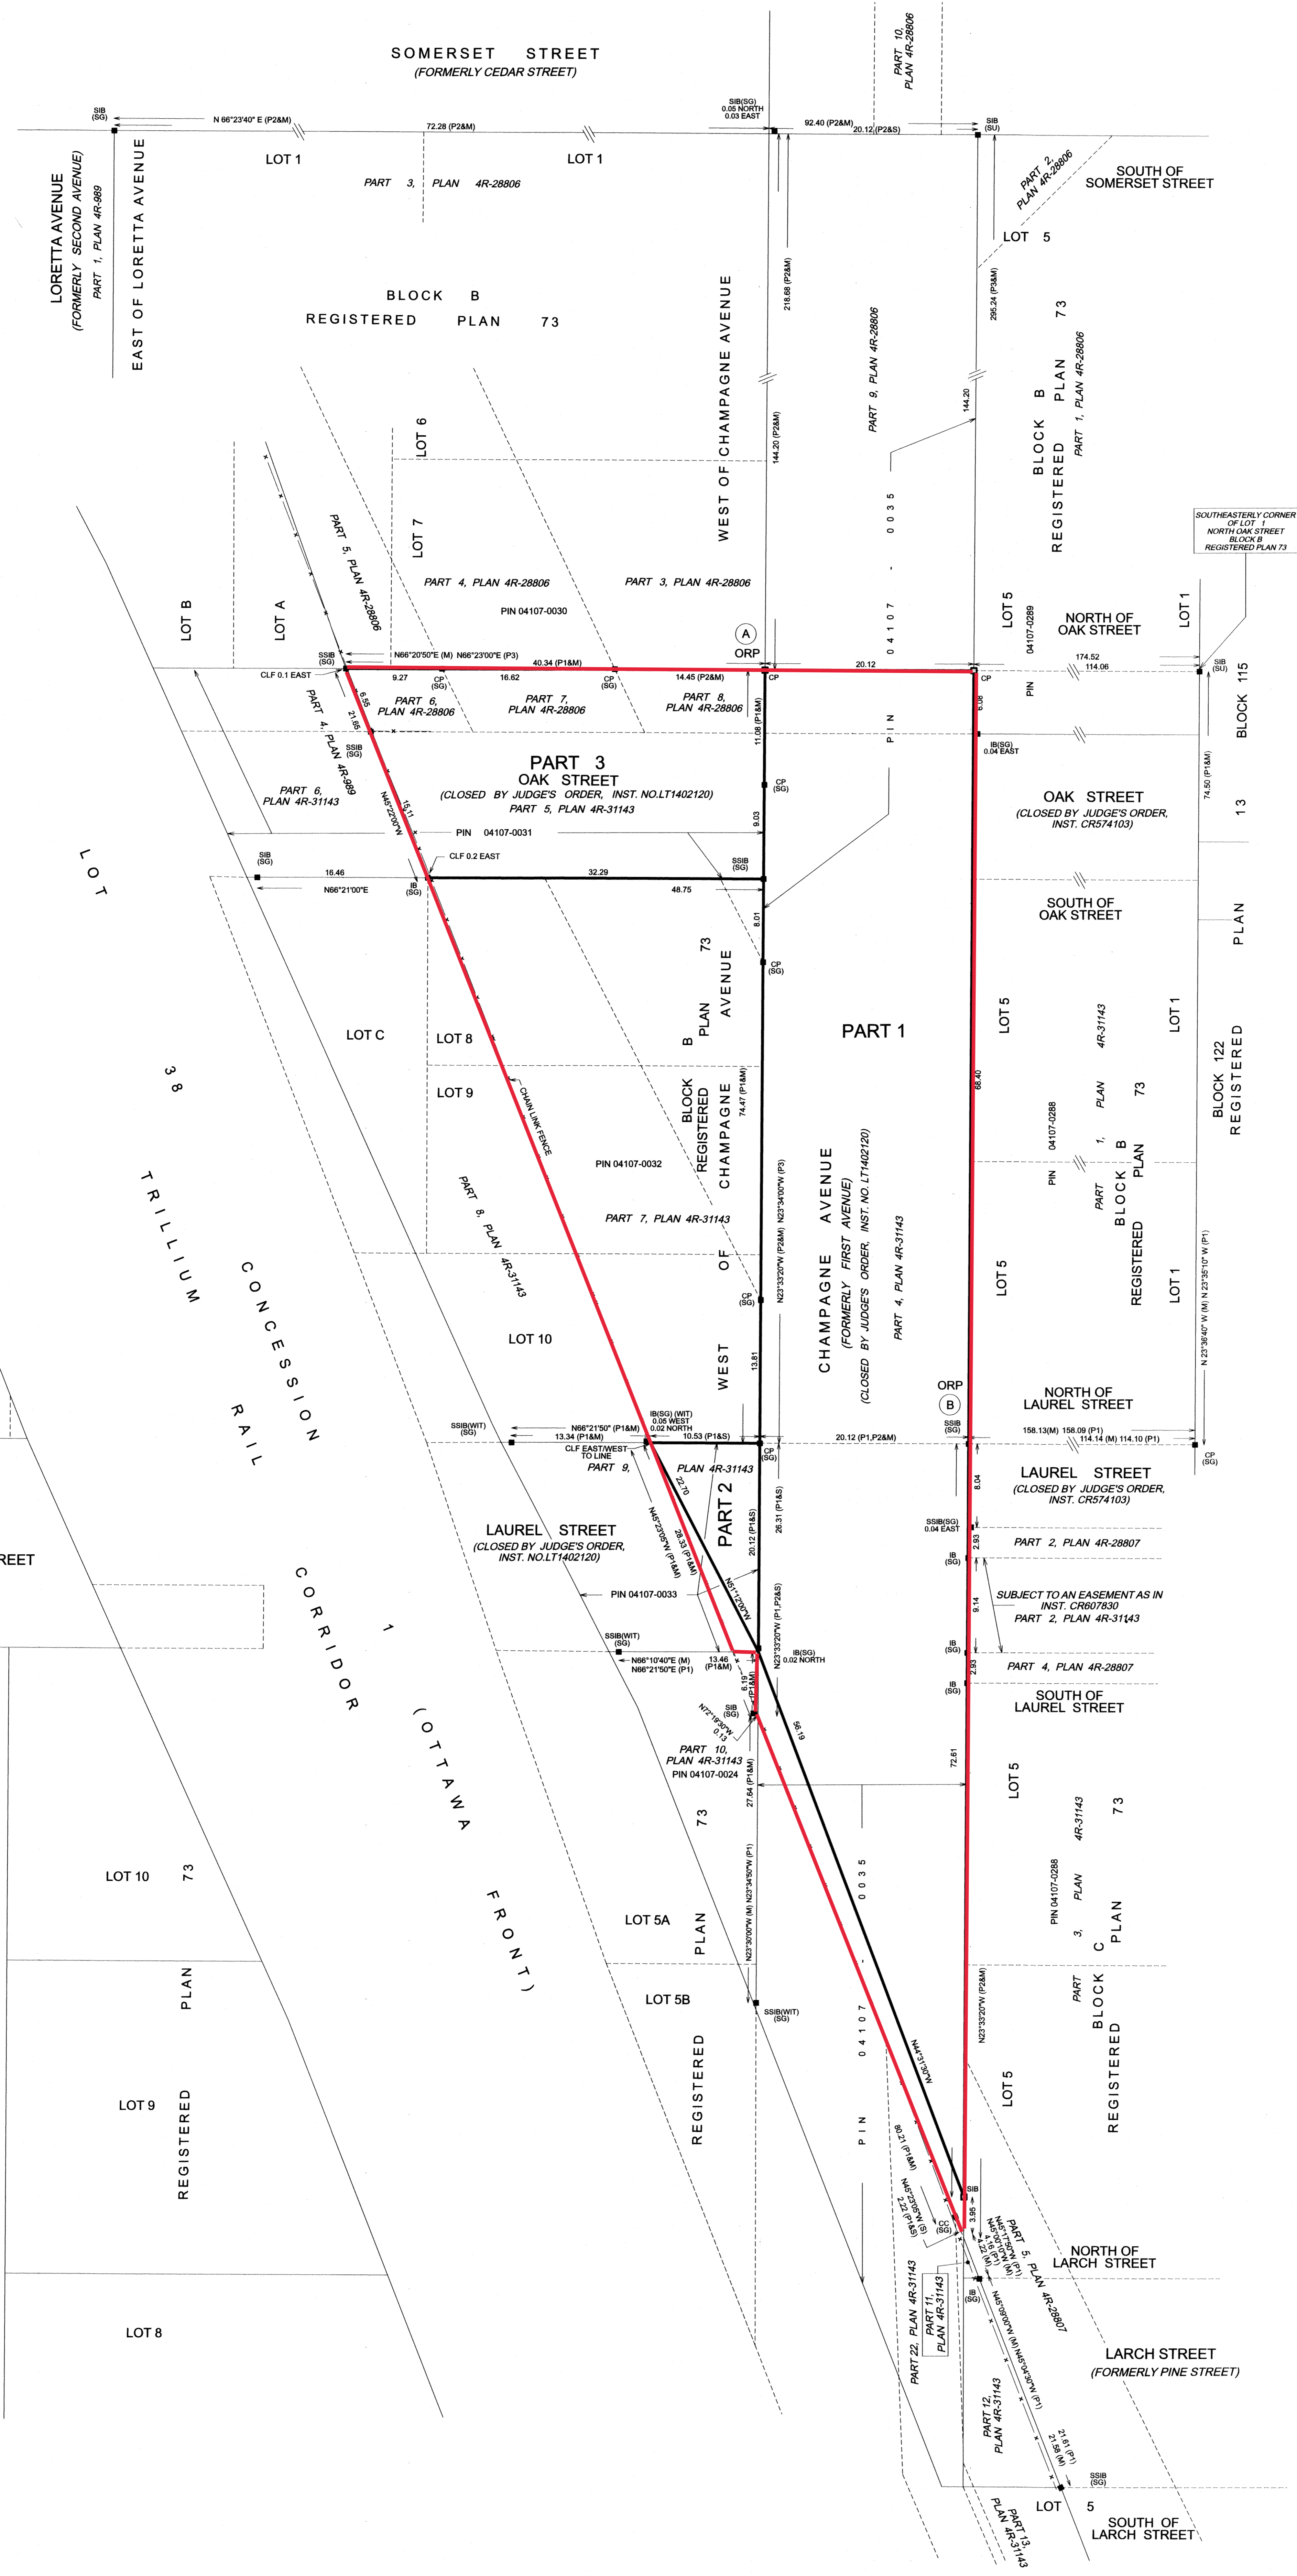
**METRIC**  
DISTANCES AND COORDINATES SHOWN ON THIS PLAN ARE IN METRES AND CAN BE CONVERTED TO FEET BY DIVIDING BY 0.3048

COORDINATES WERE DERIVED FROM GPS OBSERVATIONS USING THE CAN-NET 2016 REAL TIME NETWORK AND ARE REFERENCED TO SPECIFIED CONTROL POINTS 1980105 AND 19880091, MTM ZONE 9 (76°30' WEST LONGITUDE) NAD-83 (ORIGINAL.)
