**HYDROGEOLOGICAL INVESTIGATION
AND TERRAIN EVALUATION
PROPOSED RESIDENTIAL SUBDIVISION
3200 REIDS LANE
OSGOODE WARD, CITY OF OTTAWA
ONTARIO**

FILE # 210064

DATE September 1, 2021

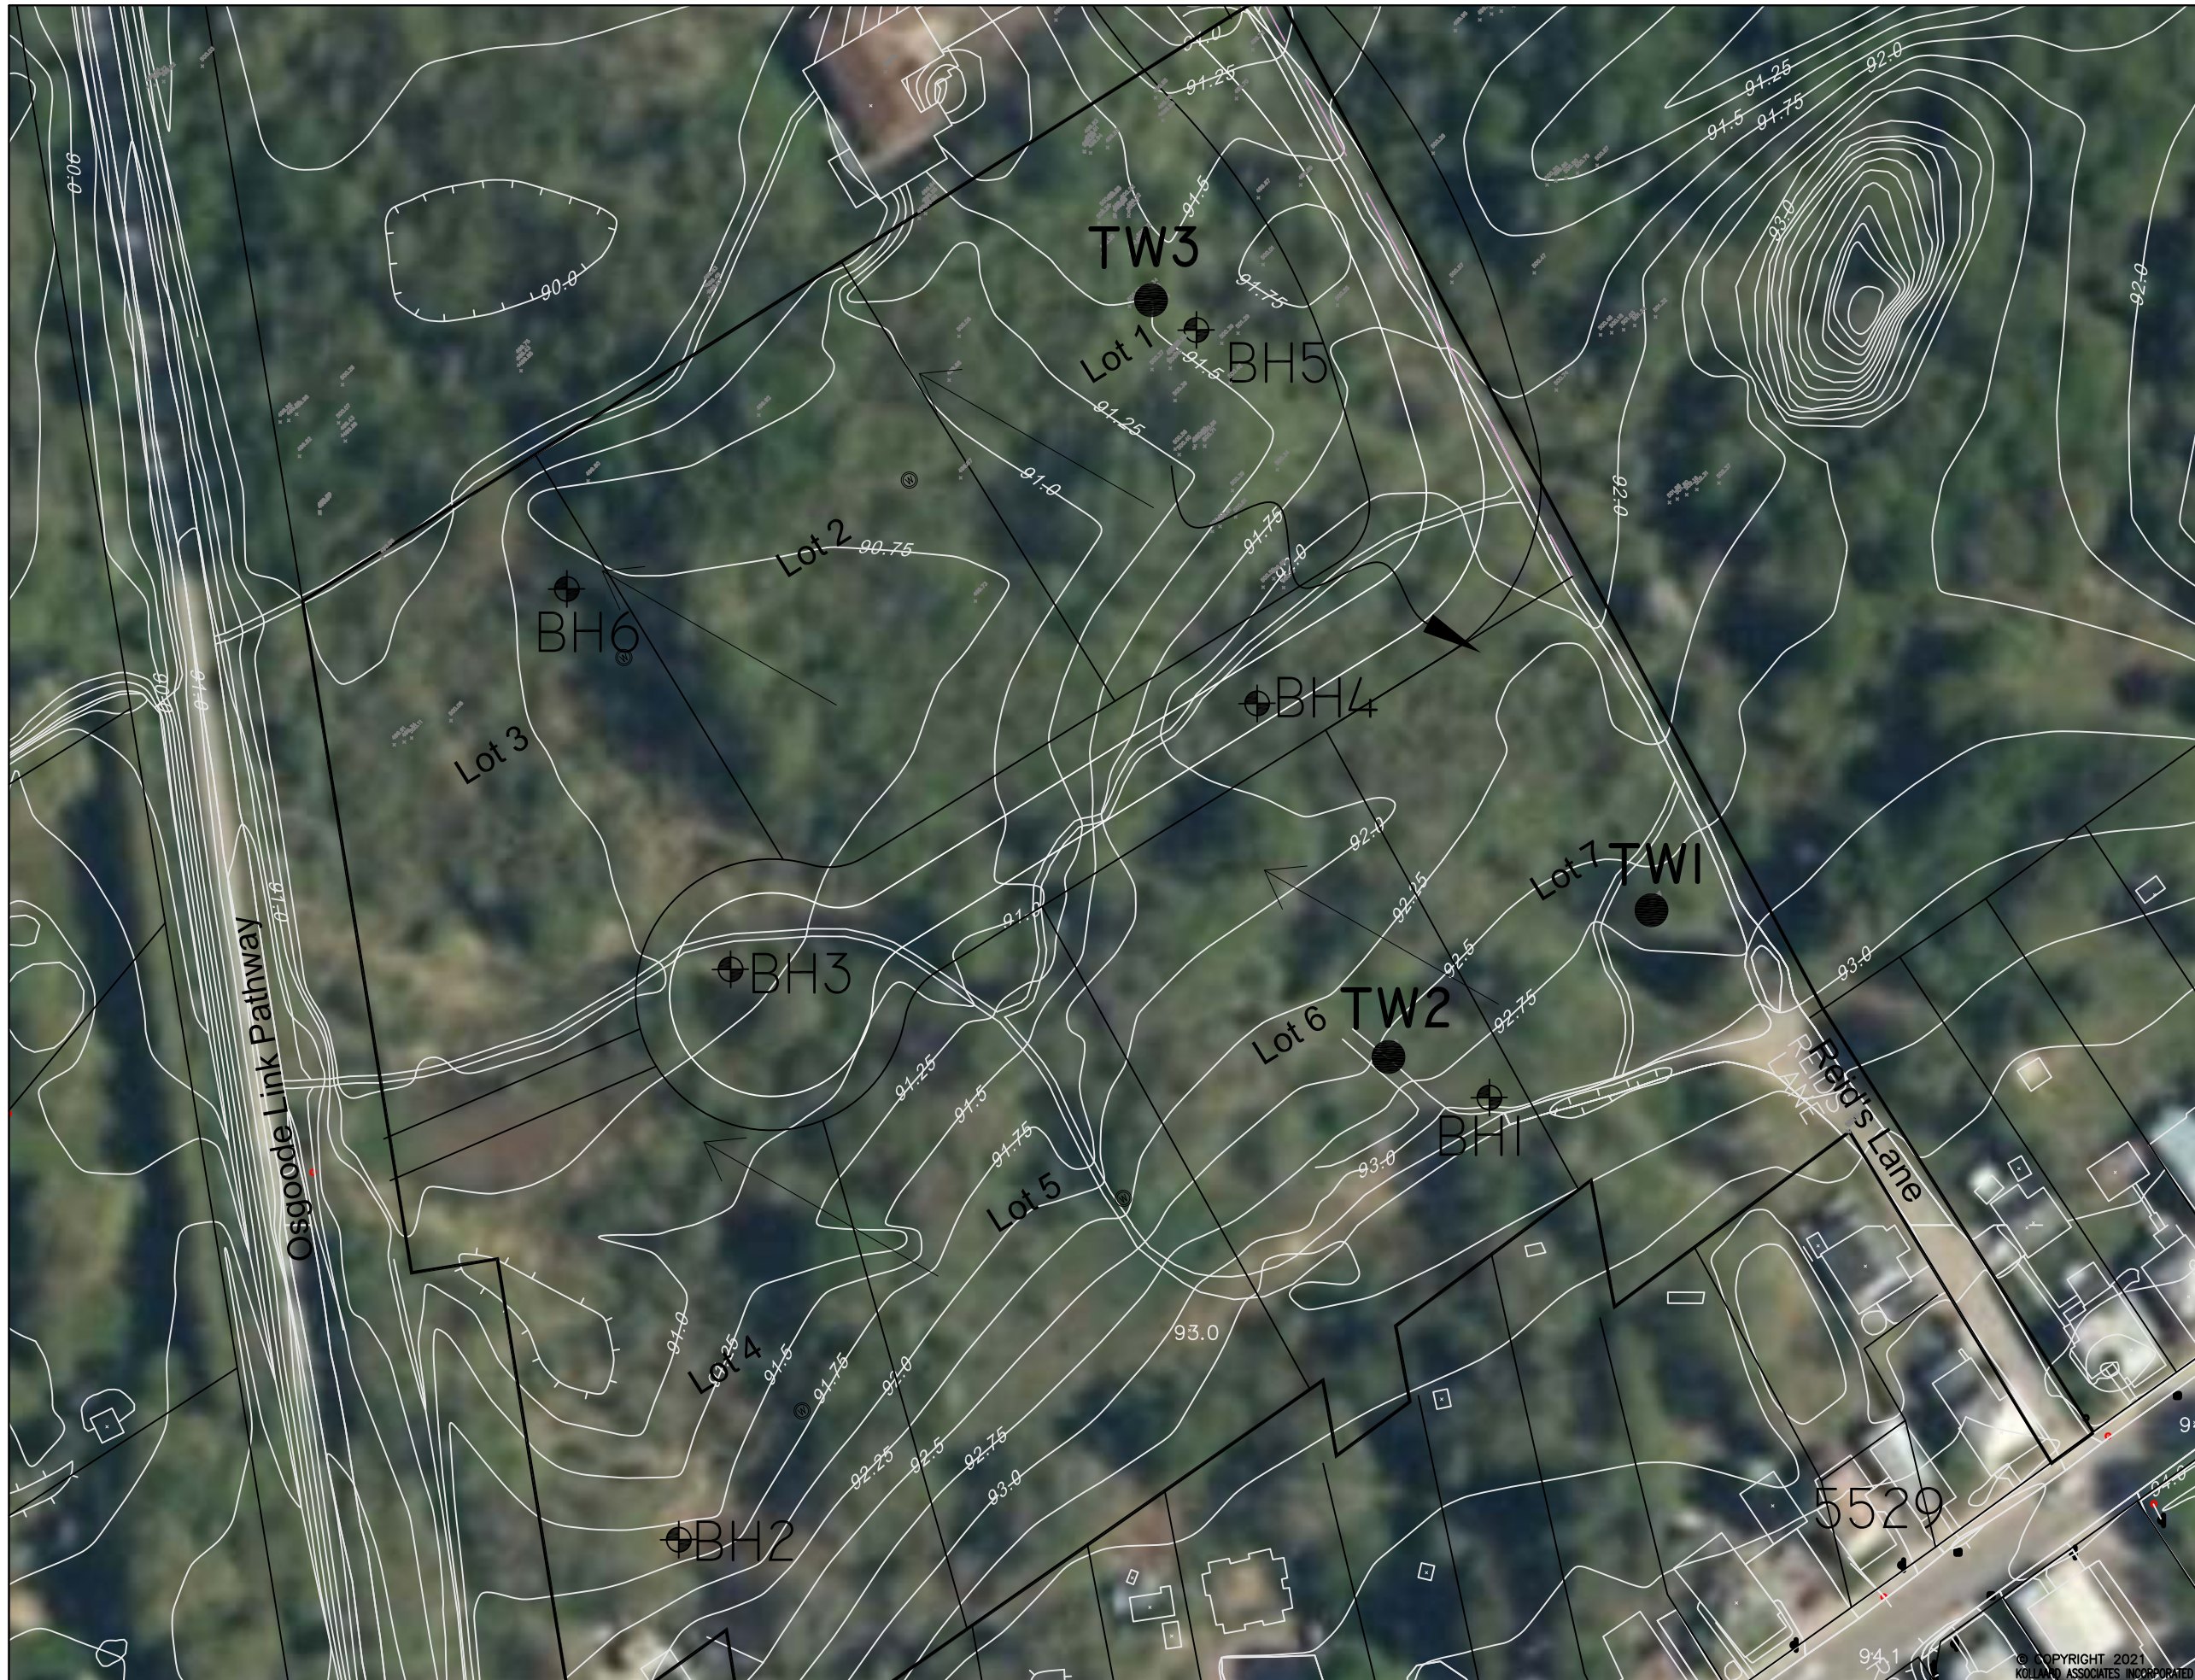
FIGURE 2

- TW1
- Approximate Water Well Location
 - ⊕ Approximate Borehole Location
 - BH1
 - ↖ Approximate Receiving Aquifer Flow Direction
 - ⤵ Approximate Water Supply Aquifer Flow Direction

In order to evaluate the background water quality conditions in the receiving aquifer, three shallow monitoring wells were installed at the site and tested for nitrogen species. The construction details are provided in Section 2.1, the Records of Boreholes are appended to the report and groundwater levels are reported in Section 3.1. Background nitrogen concentrations from the shallow groundwater receiving effluent were reported (Section 3.1.1) and the original laboratory testing results are in Attachment D. The Site Plan, Figure 2, shows the locations of the monitoring wells.

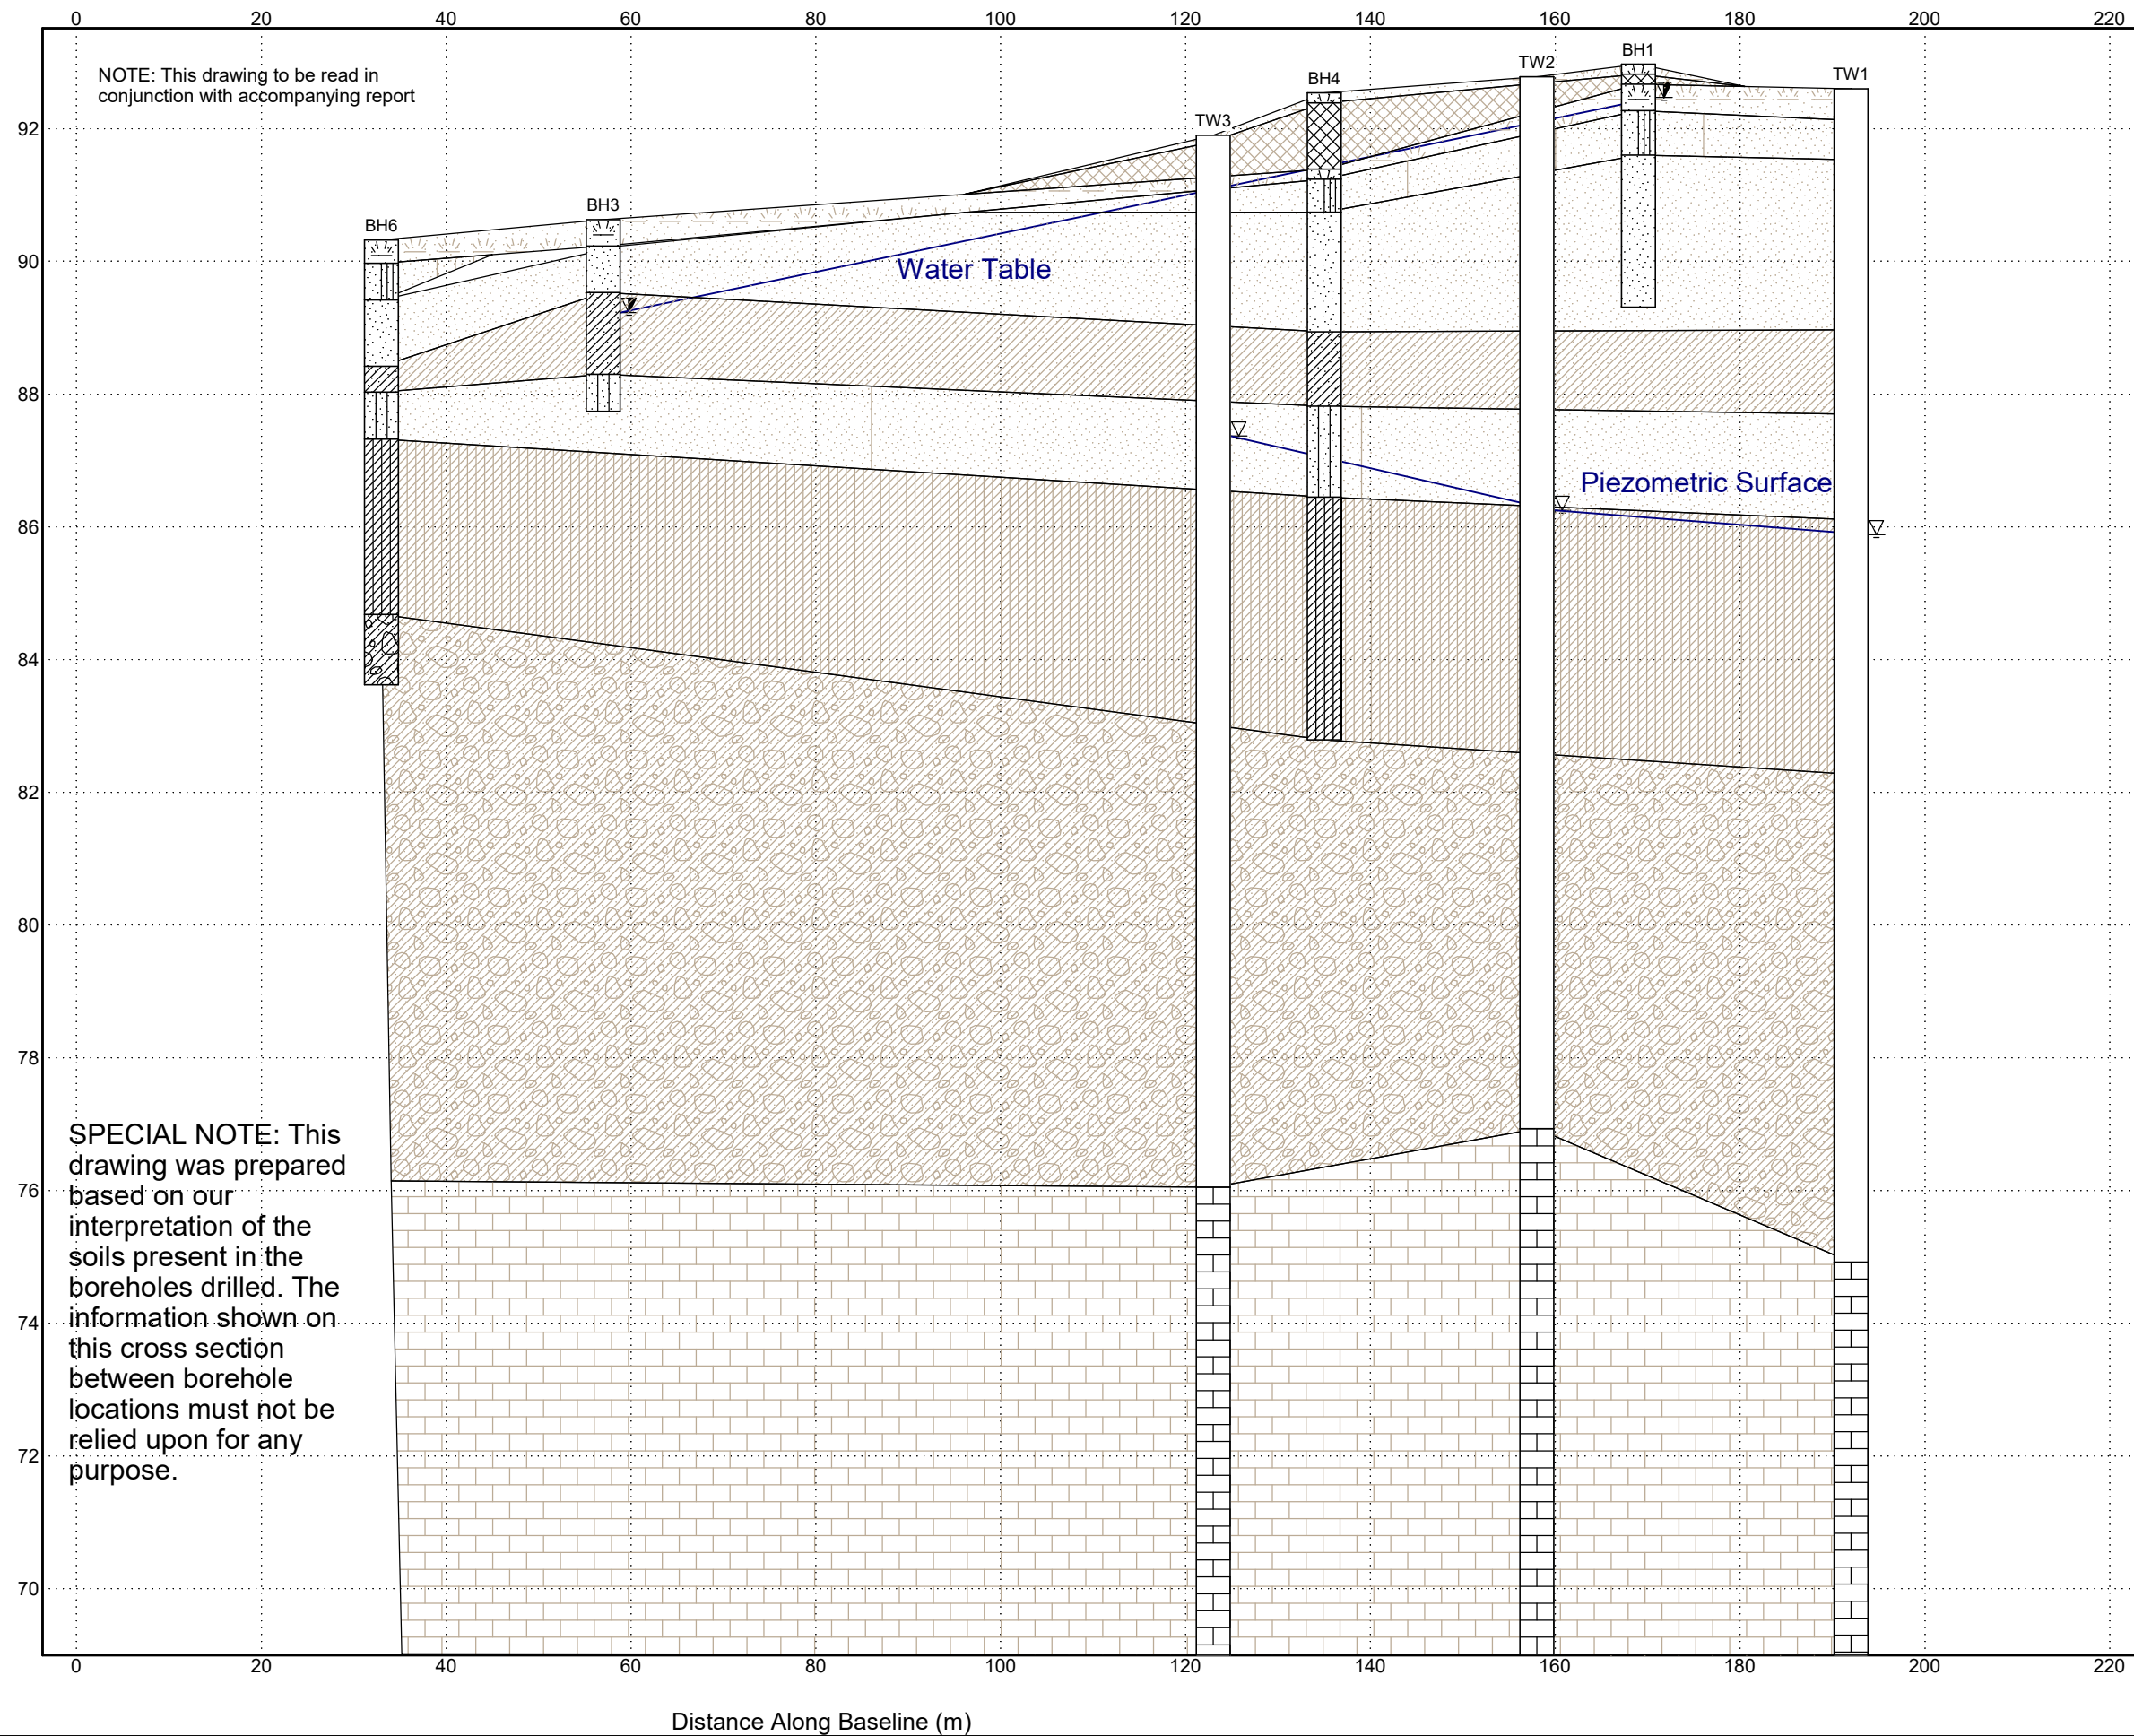
SPECIAL NOTE: This drawing was prepared based on our interpretation of the soils present in the boreholes drilled. The information shown on this cross section between borehole locations must not be relied upon for any purpose.

- The piezometric surfaces in the three water supply wells (see cross sections, Figures 4 and 5) are above the top of the aquifer (bedrock elevation); and
- the shape of the drawdown response curve observed in the pumping tests closely resembles the ideal response of a confined aquifer; and
- the storativity coefficient calculated using the drawdown response in adjacent wells is $\sim 2.0 \times 10^{-4}$, whereas specific yield in an unconfined aquifer is typically orders of magnitude higher

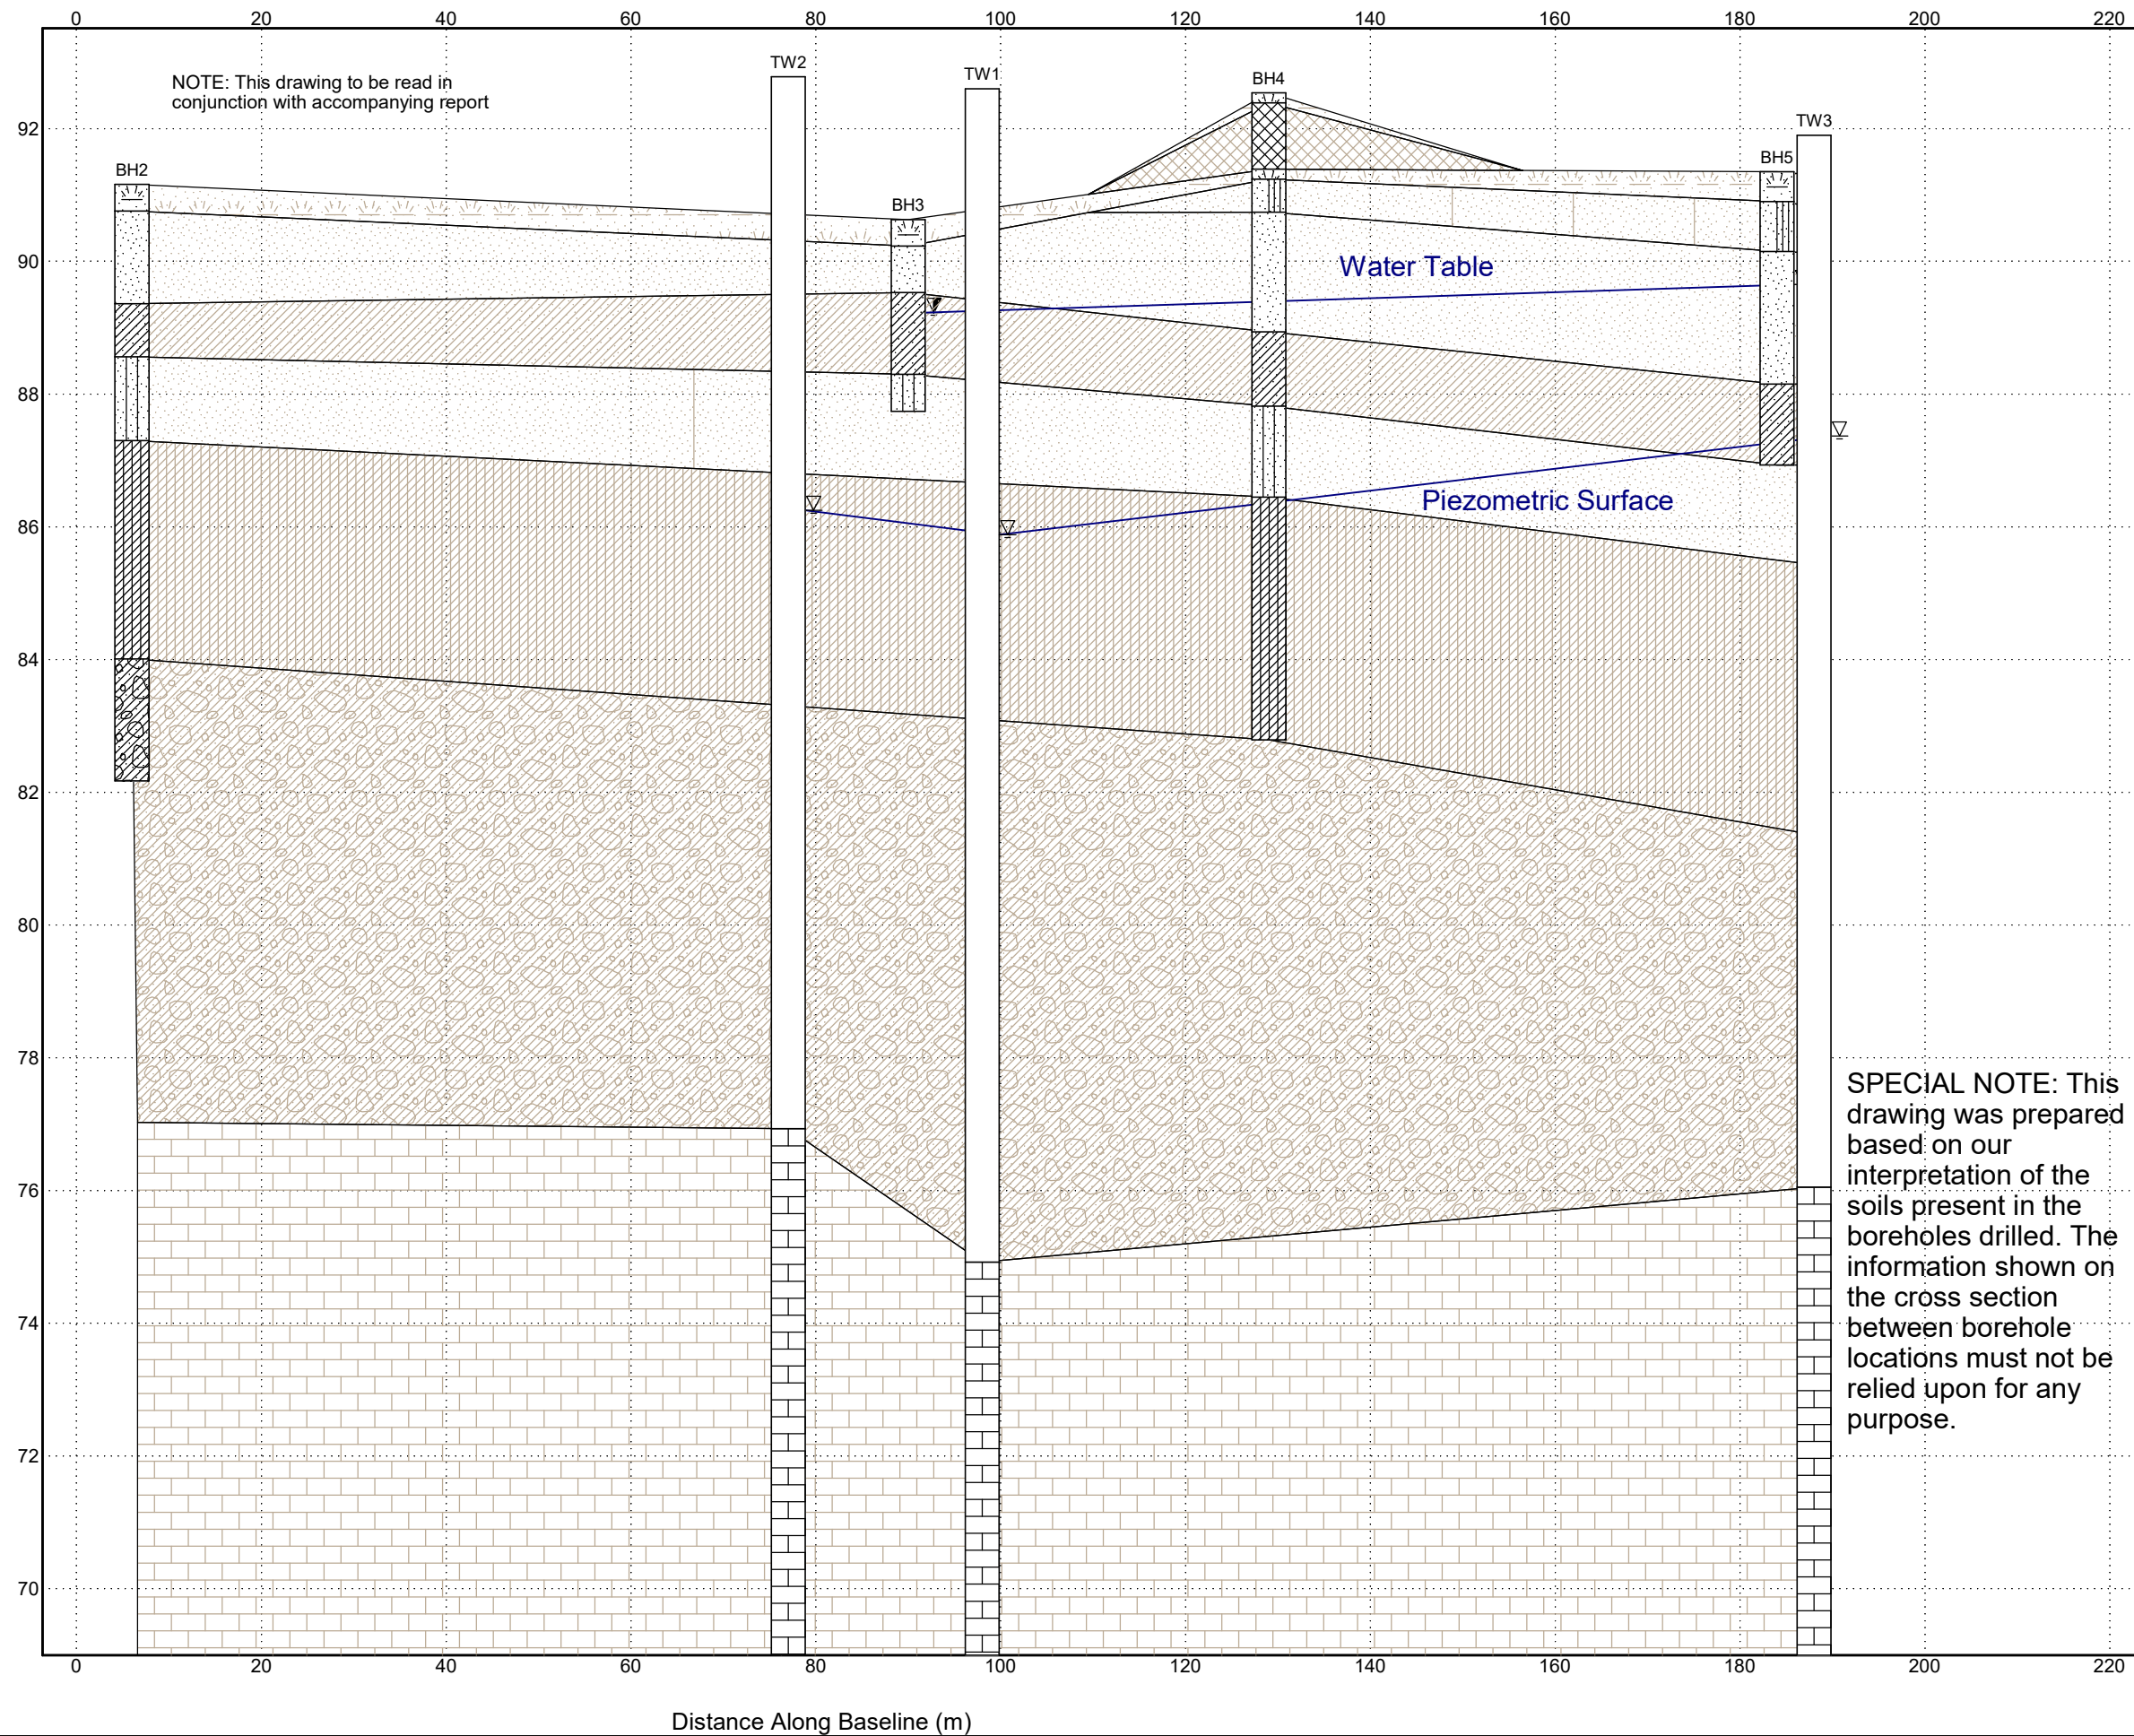
FIGURE 5

- TOPSOIL**
- Yellow brown sand and gravel (FILL)**
- Red brown fine to medium SAND, trace silt**
- Grey fine to medium SAND**
- Grey sandy CLAY, trace silt**
- Grey SILTY SAND**
- Grey SILTY CLAY**
- Grey silty sand, trace to some gravel, cobbles and boulders, trace clay (GLACIAL TILL)**
- LIMESTONE BEDROCK**

SPECIAL NOTE: This drawing was prepared based on our interpretation of the soils present in the boreholes drilled. The information shown on the cross section between borehole locations must not be relied upon for any purpose.

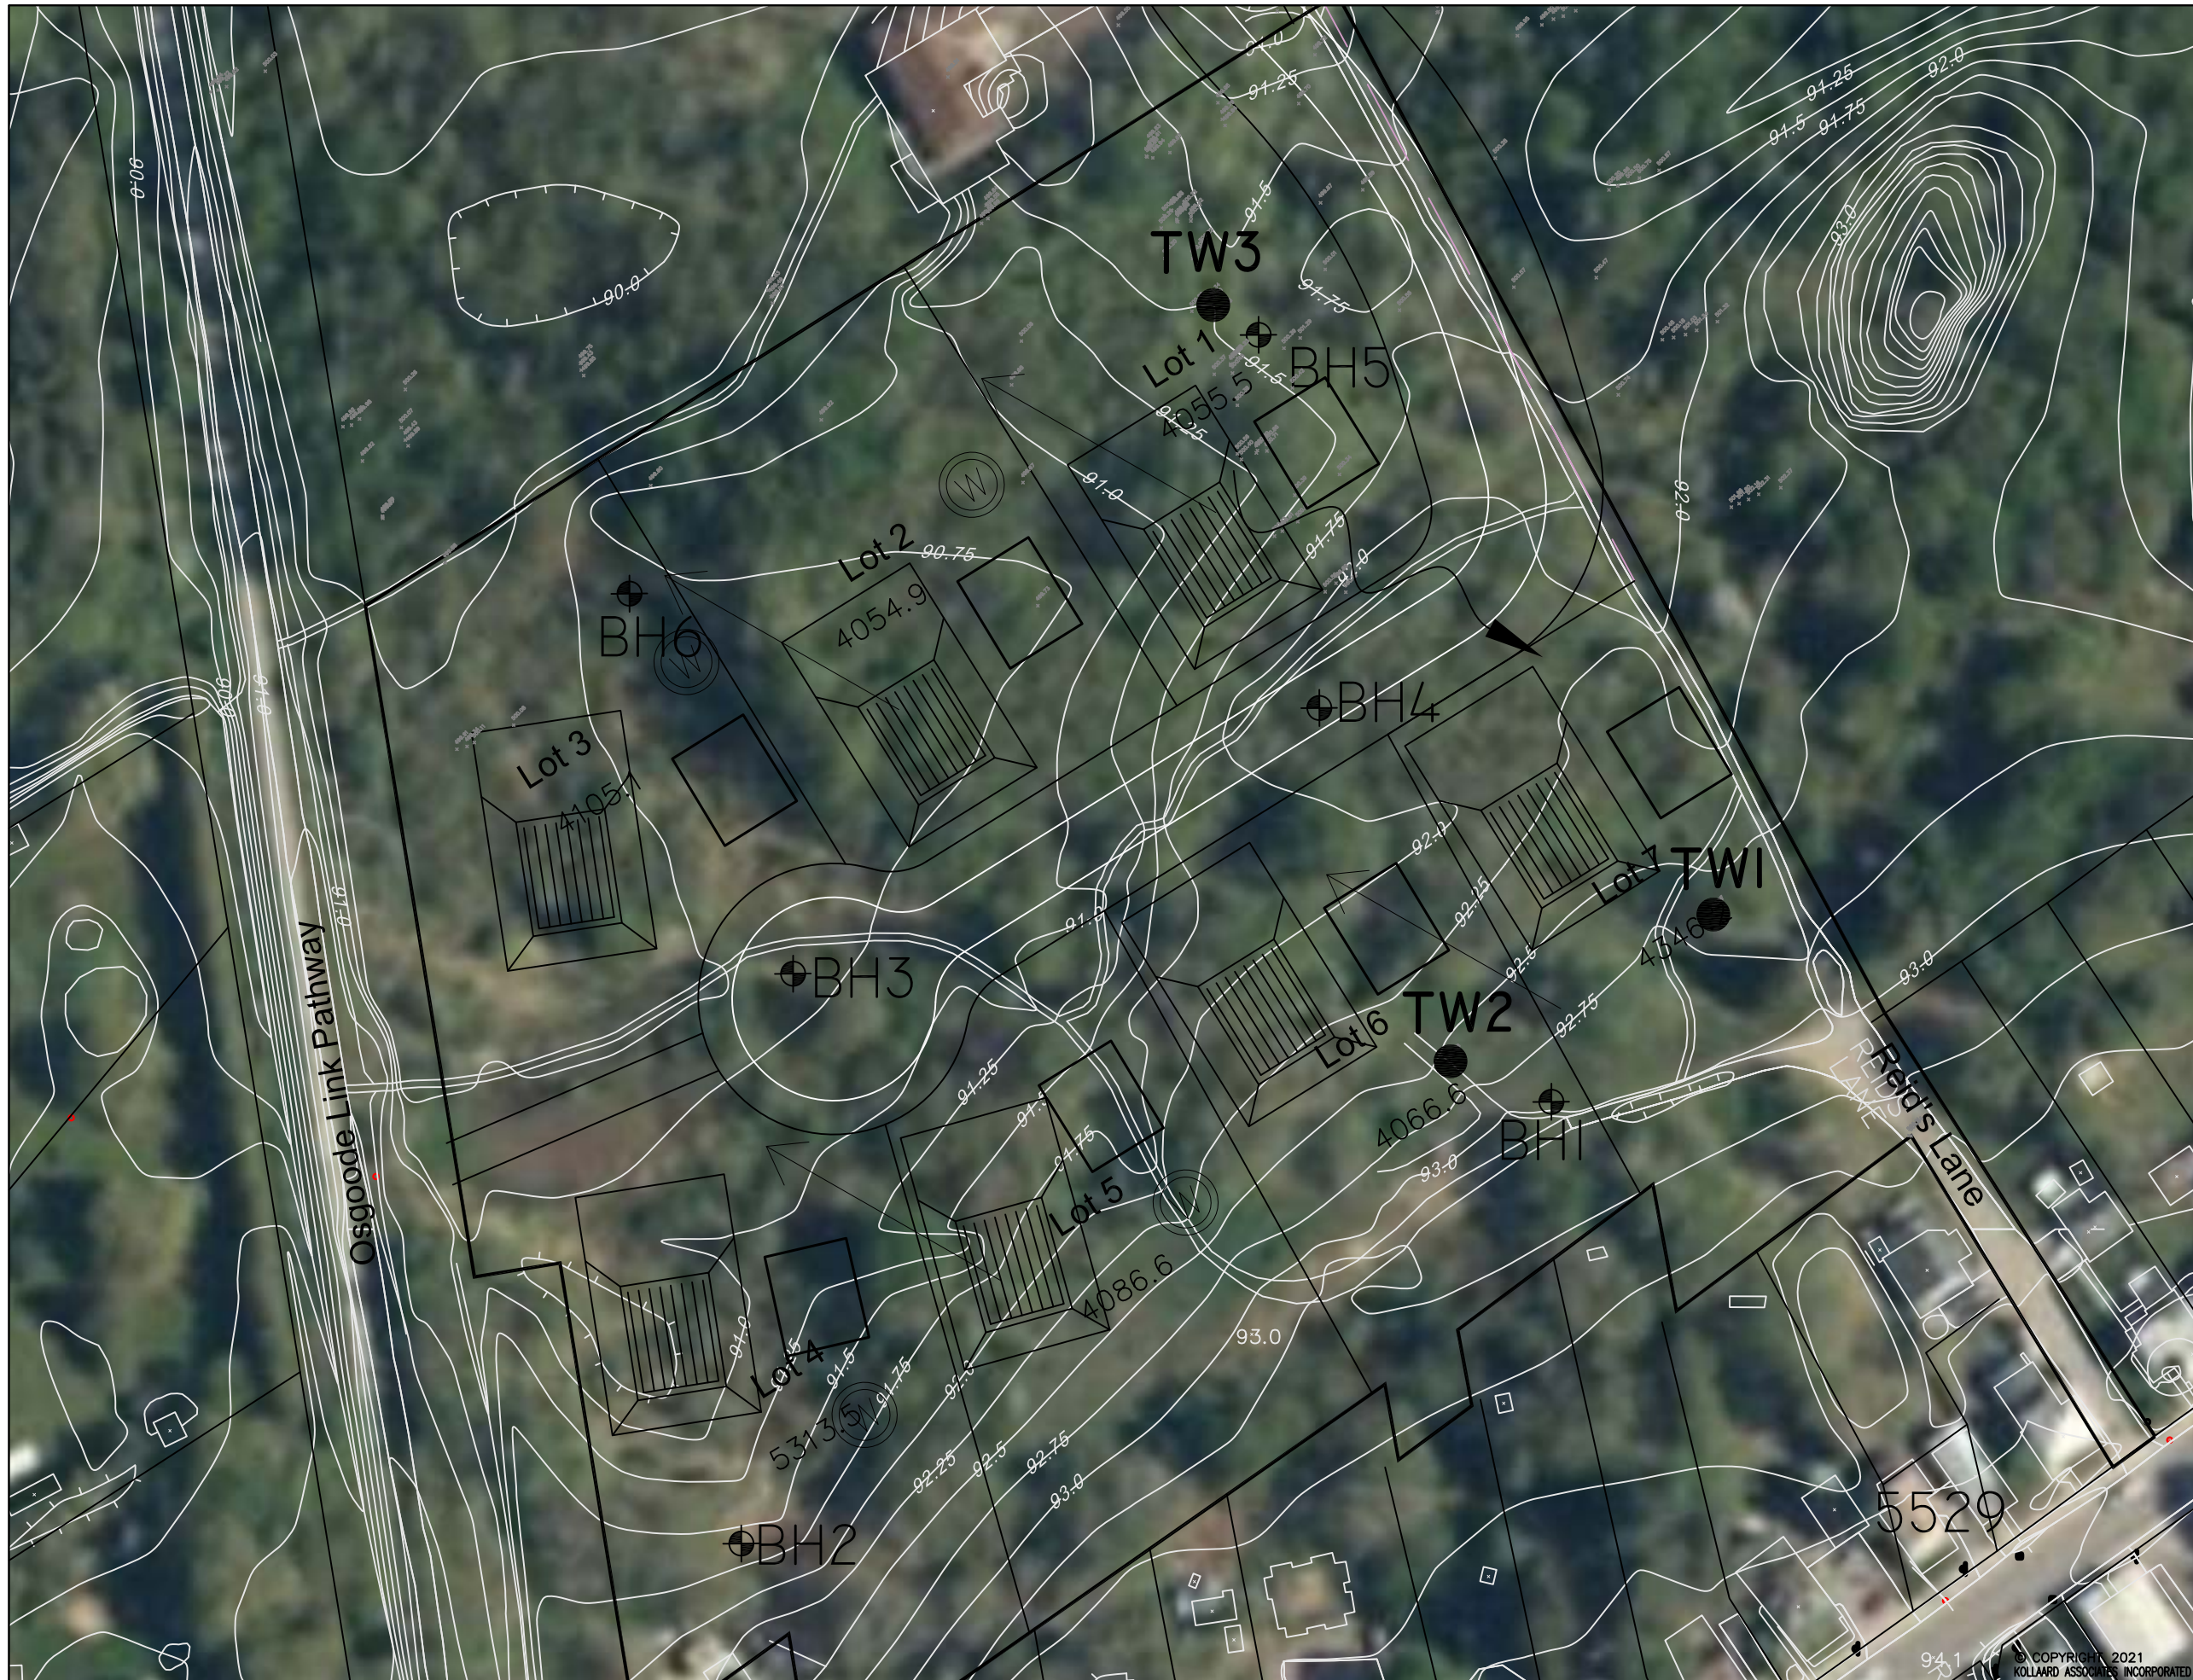
FIGURE 6

- TW1
- Approximate Water Well Location
- ⊕ Approximate Borehole Location
- BH1
- ⊕ (W) Proposed Water Well Location
- ▭ (with hatching) Proposed sewage system
- ▭ Proposed house

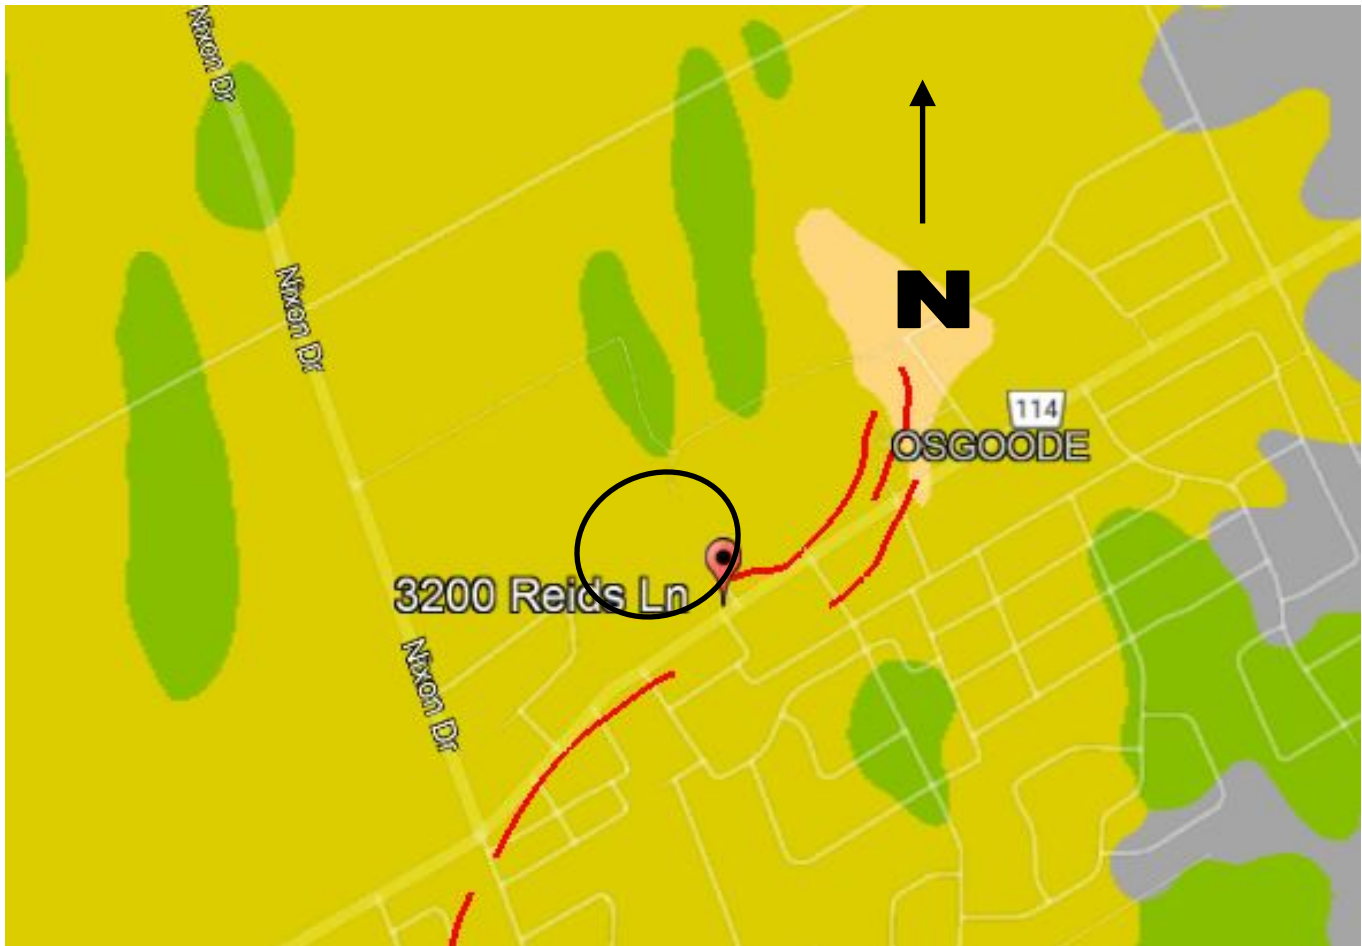
SURFICIAL GEOLOGY MAP

- 12** Older alluvial deposits: clay, silt, sand, gravel, may contain organic remains
- 11** Coarse-textured glaciomarine deposits: sand, gravel, minor silt and clay
 - 11a Deltaic deposits
 - 11b Littoral deposits
 - 11c Foreshore and basinal deposits

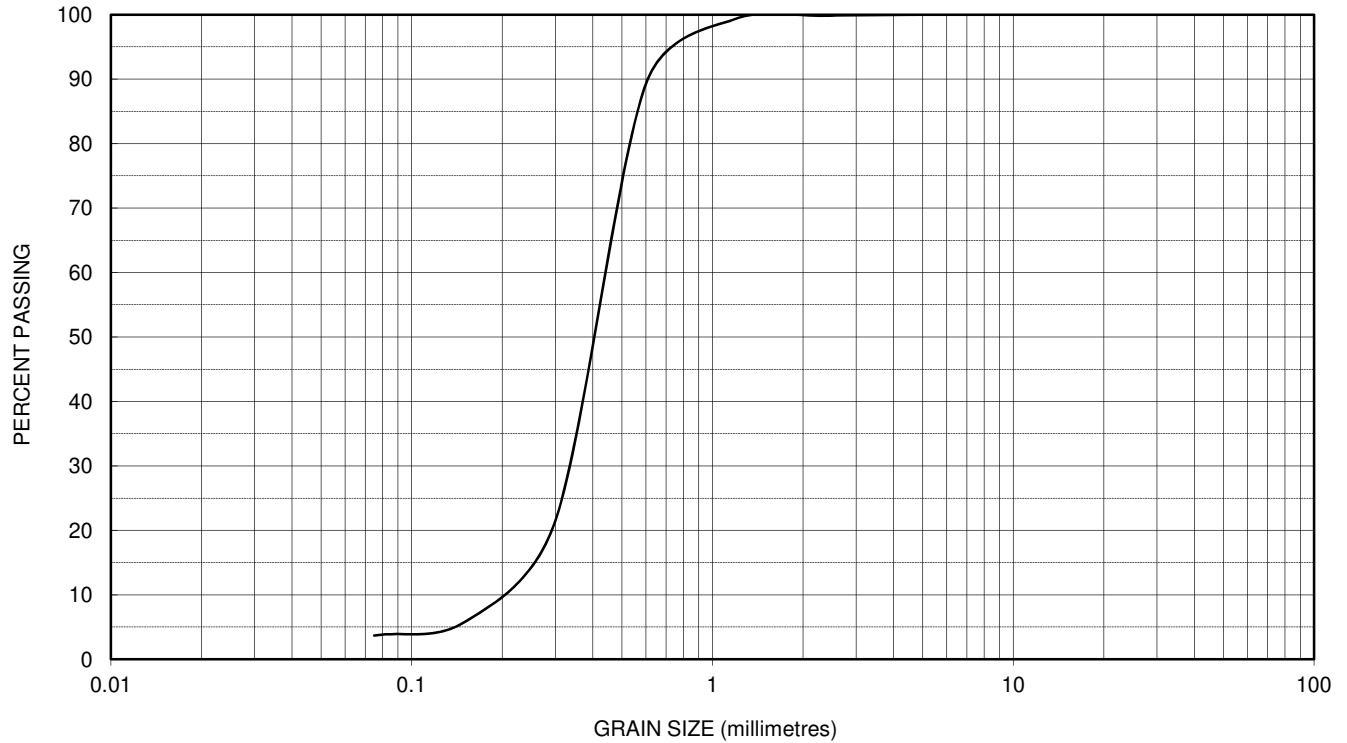
SIEVE SIZE (mm)	76.2	53	26.5	19.0	16	13.2	9.5	4.75	2.36	1.180	0.600	0.300	0.15	0.075
SAMPLE PASSING								100.0	99.8	99.3	89.2	21.4	5.8	3.7

CLIENT: Crestview Innovations Inc.	
PROJECT: 3200 Reids Lane, Ossgoode	OUR REF.: 210064
TYPE OF MATERIAL: Sand	INTENDED USE: Residential
DATE SAMPLED: February 3, 2021	DATE TESTED: February 11, 2021
SOURCE: BH1 - 0.76-1.37	SAMPLE NO: SS2
REMARKS:

Based on the above noted information, the hydraulic conductivity of the soil is expected to be $\sim 2.6 \times 10^{-2}$ cm/s. The soil can be characterized as poorly graded sand. This is considered to be a soil of medium permeability.

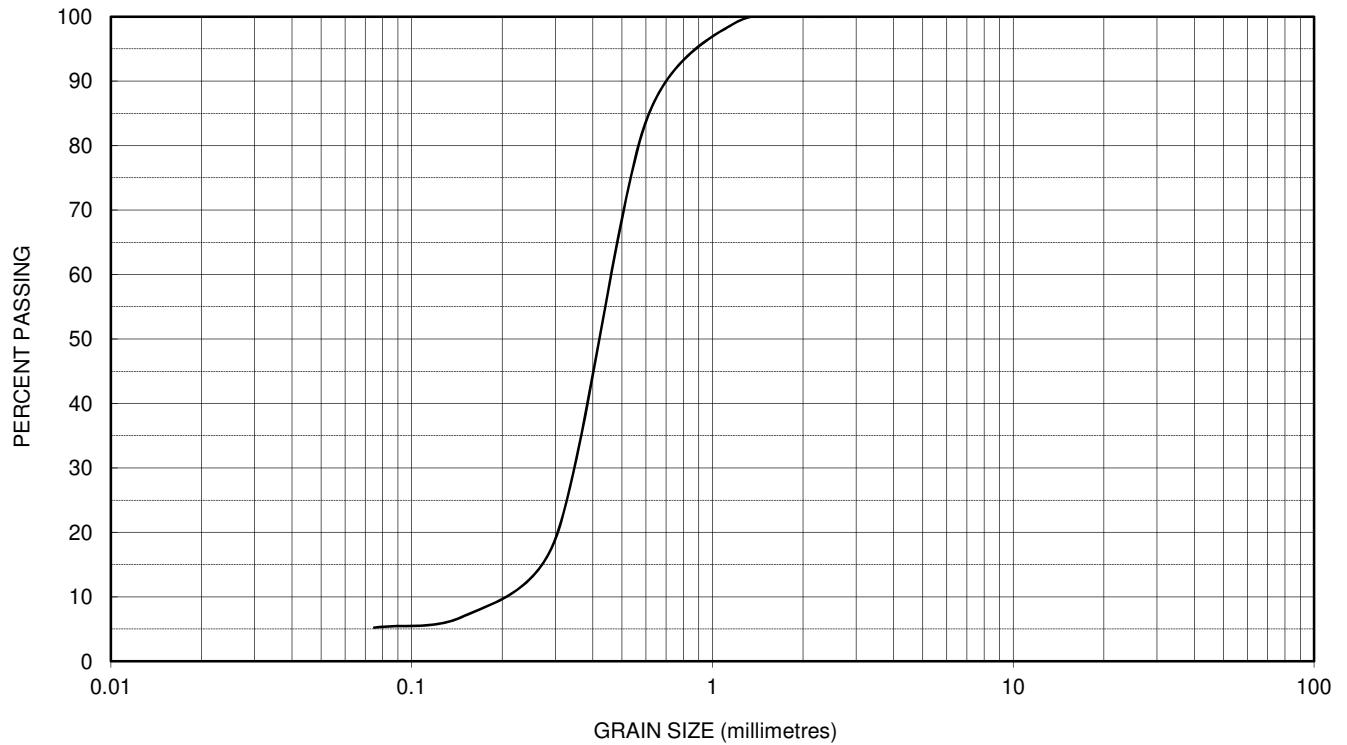
SIEVE SIZE (mm)	76.2	53	26.5	19.0	16	13.2	9.5	4.75	2.36	1.180	0.600	0.300	0.15	0.075
SAMPLE PASSING									100.0	99.0	83.7	19.0	7.1	5.2

CLIENT: Crestview Innovations Inc.	
PROJECT: 3200 Reids Lane, Ossgoode	OUR REF.: 210064
TYPE OF MATERIAL: Sand	INTENDED USE: Residential
DATE SAMPLED: February 3, 2021	DATE TESTED: February 11, 2021
SOURCE: BH3 - 0.76 - 1.37	SAMPLE NO: SS2
REMARKS:

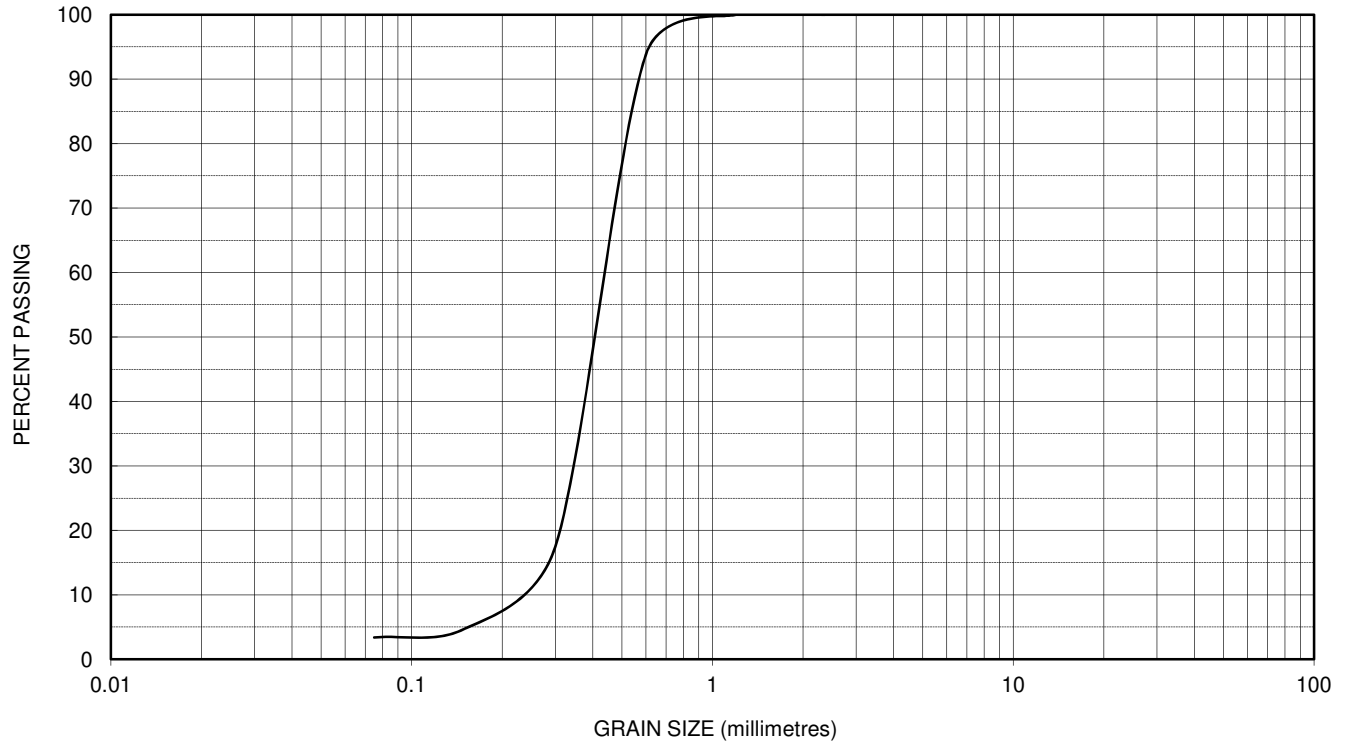
SIEVE SIZE (mm)	76.2	53	26.5	19.0	16	13.2	9.5	4.75	2.36	1.180	0.600	0.300	0.15	0.075
SAMPLE PASSING									100.0	99.9	93.8	17.5	4.7	3.4

CLIENT: Crestview Innovations Inc.	
PROJECT: 3200 Reids Lane, Ossgoode	OUR REF.: 210064
TYPE OF MATERIAL: Sand	INTENDED USE: Residential
DATE SAMPLED: February 3, 2021	DATE TESTED: February 11, 2021
SOURCE: BH5 - 0.76 - 1.37	SAMPLE NO: SS2
REMARKS:

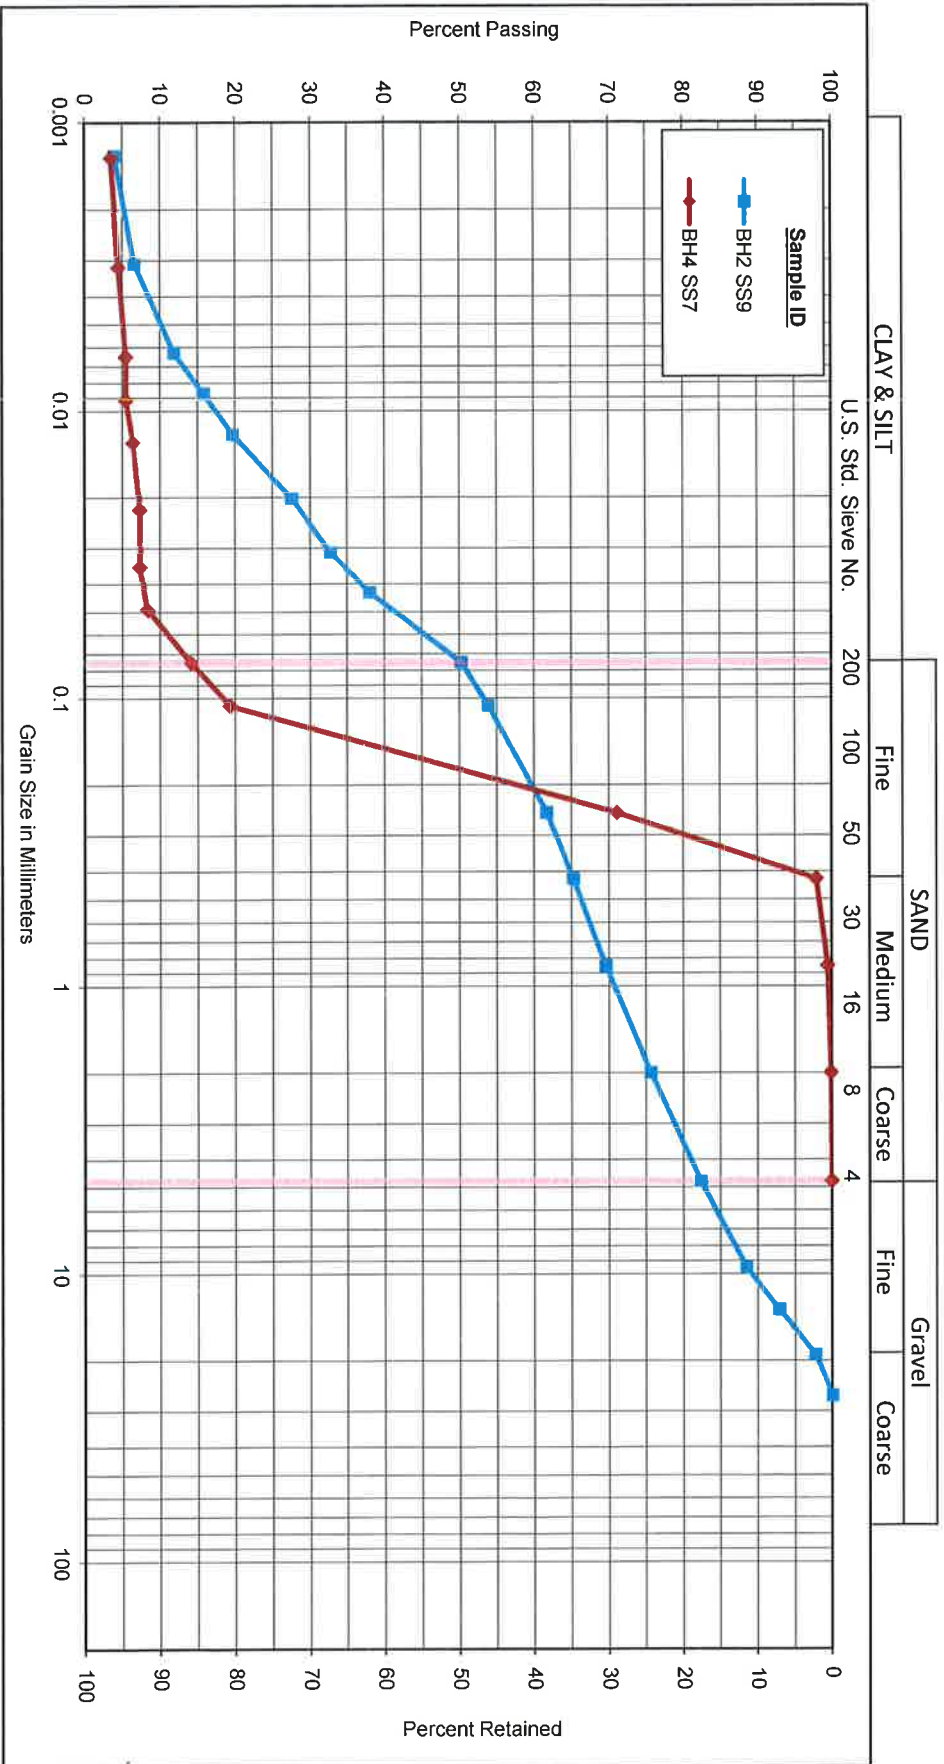
Unified Soil Classification System

Sample ID	Depth	% Gravel	% Sand	% Silt	% Clay
BH2 SS9	7.62-8.22 m	17.7	32.1	45.2	5.0
BH4 SS7	4.52-5.18 m	0.0	85.9	10.1	4.0
