**HYDROGEOLOGICAL INVESTIGATION
AND TERRAIN EVALUATION
PROPOSED RESIDENTIAL SUBDIVISION
3200 REIDS LANE
OSGOODE WARD, CITY OF OTTAWA
ONTARIO**

FILE # 210064

DATE September 1, 2021

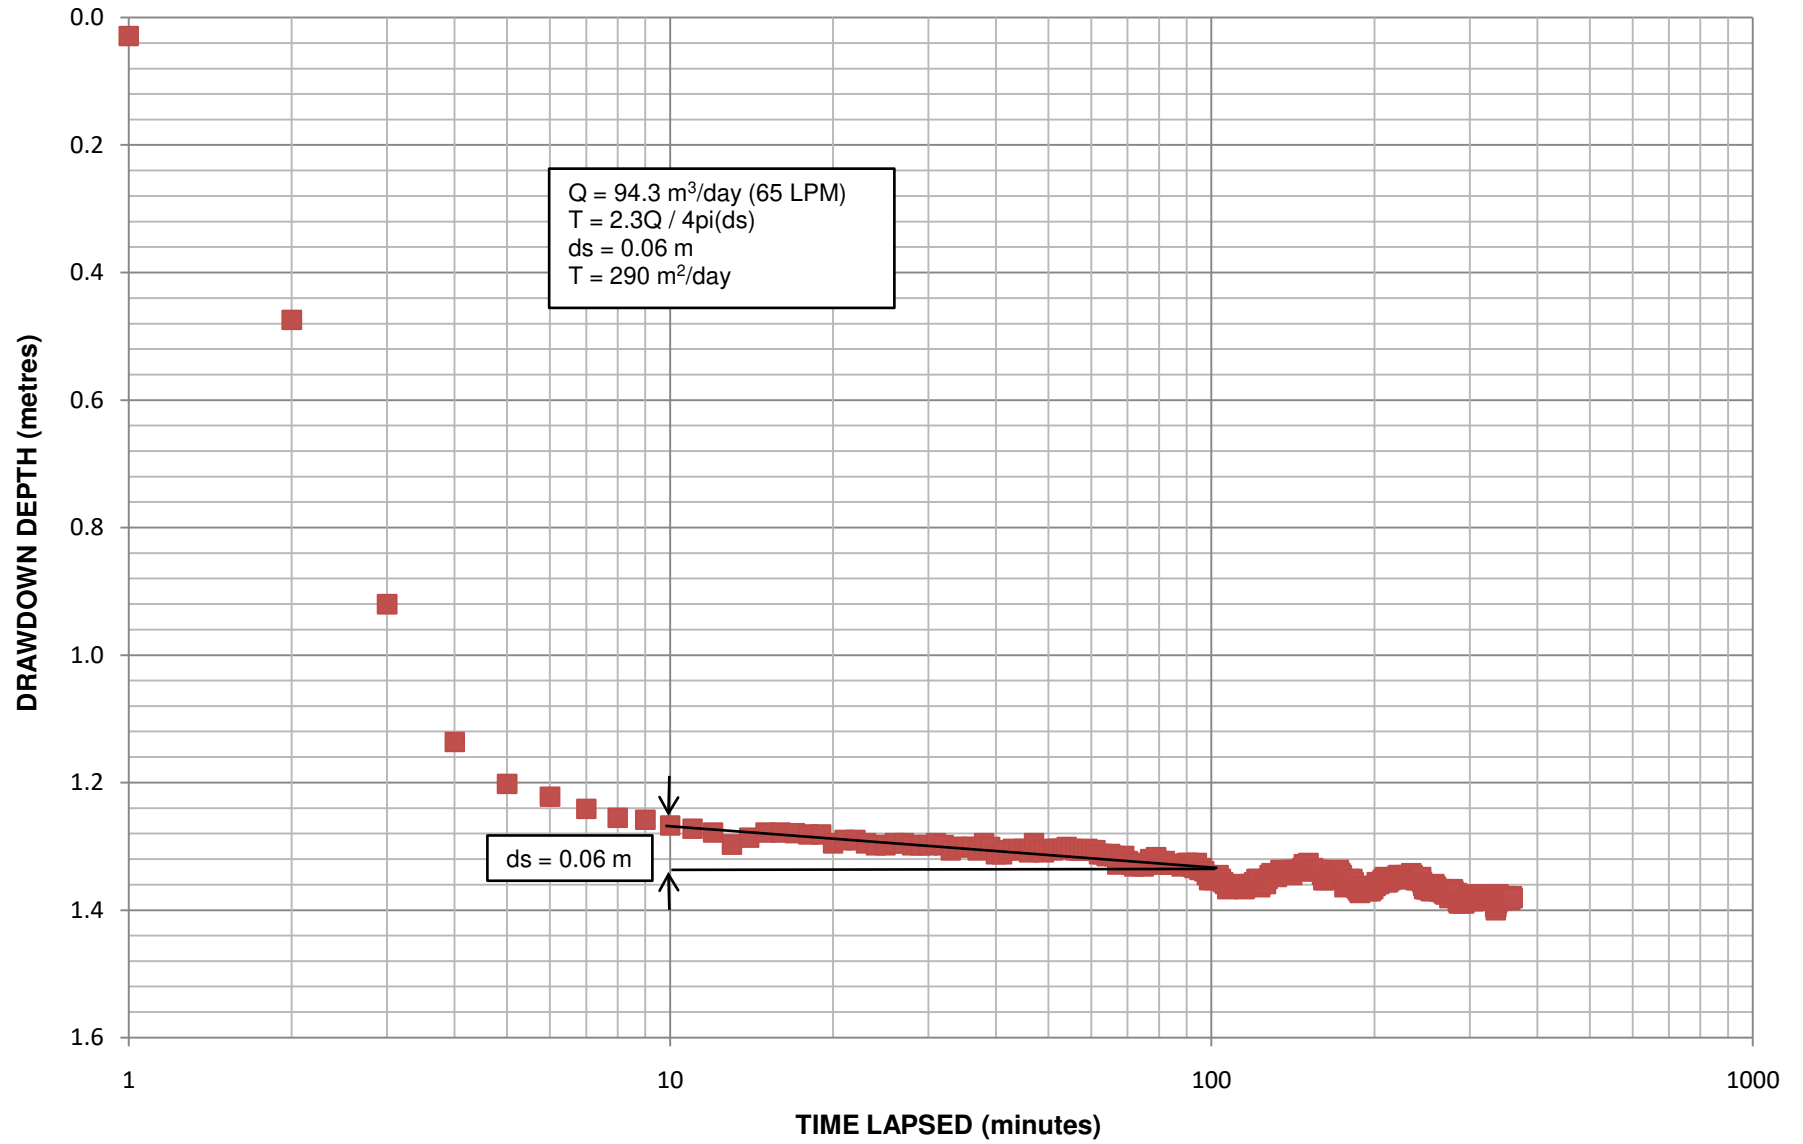
TW1-WELL DRAWDOWN VS. TIME-KOLLAARD FILE 210064

Time Lapsed (minutes)	Abs Pres (kPa)	Temp (°C)	Water Level (m)	Drawdown (m)
0	388.094	8.382	-6.86	0.00
1	387.814	8.282	-6.889	0.03
2	383.442	8.282	-7.334	0.47
3	379.072	8.282	-7.78	0.92
4	376.956	8.282	-7.996	1.14
5	376.305	8.282	-8.062	1.20
6	376.115	8.282	-8.082	1.22
7	375.925	8.282	-8.101	1.24
8	375.789	8.282	-8.115	1.26
9	375.754	8.182	-8.118	1.26
10	375.672	8.182	-8.127	1.27
11	375.618	8.182	-8.132	1.27
12	375.564	8.182	-8.138	1.28
13	375.374	8.182	-8.157	1.30
14	375.483	8.182	-8.146	1.29
15	375.564	8.182	-8.138	1.28
16	375.564	8.182	-8.138	1.28
17	375.555	8.082	-8.139	1.28
18	375.528	8.082	-8.141	1.28
19	375.528	8.082	-8.141	1.28
20	375.393	8.082	-8.155	1.30
21	375.447	8.082	-8.15	1.29
22	375.447	8.082	-8.15	1.29
23	375.393	8.082	-8.155	1.30
24	375.366	8.082	-8.158	1.30
25	375.366	8.082	-8.158	1.30
26	375.393	8.082	-8.155	1.30
27	375.393	8.082	-8.155	1.30
28	375.366	8.082	-8.158	1.30
29	375.366	8.082	-8.158	1.30

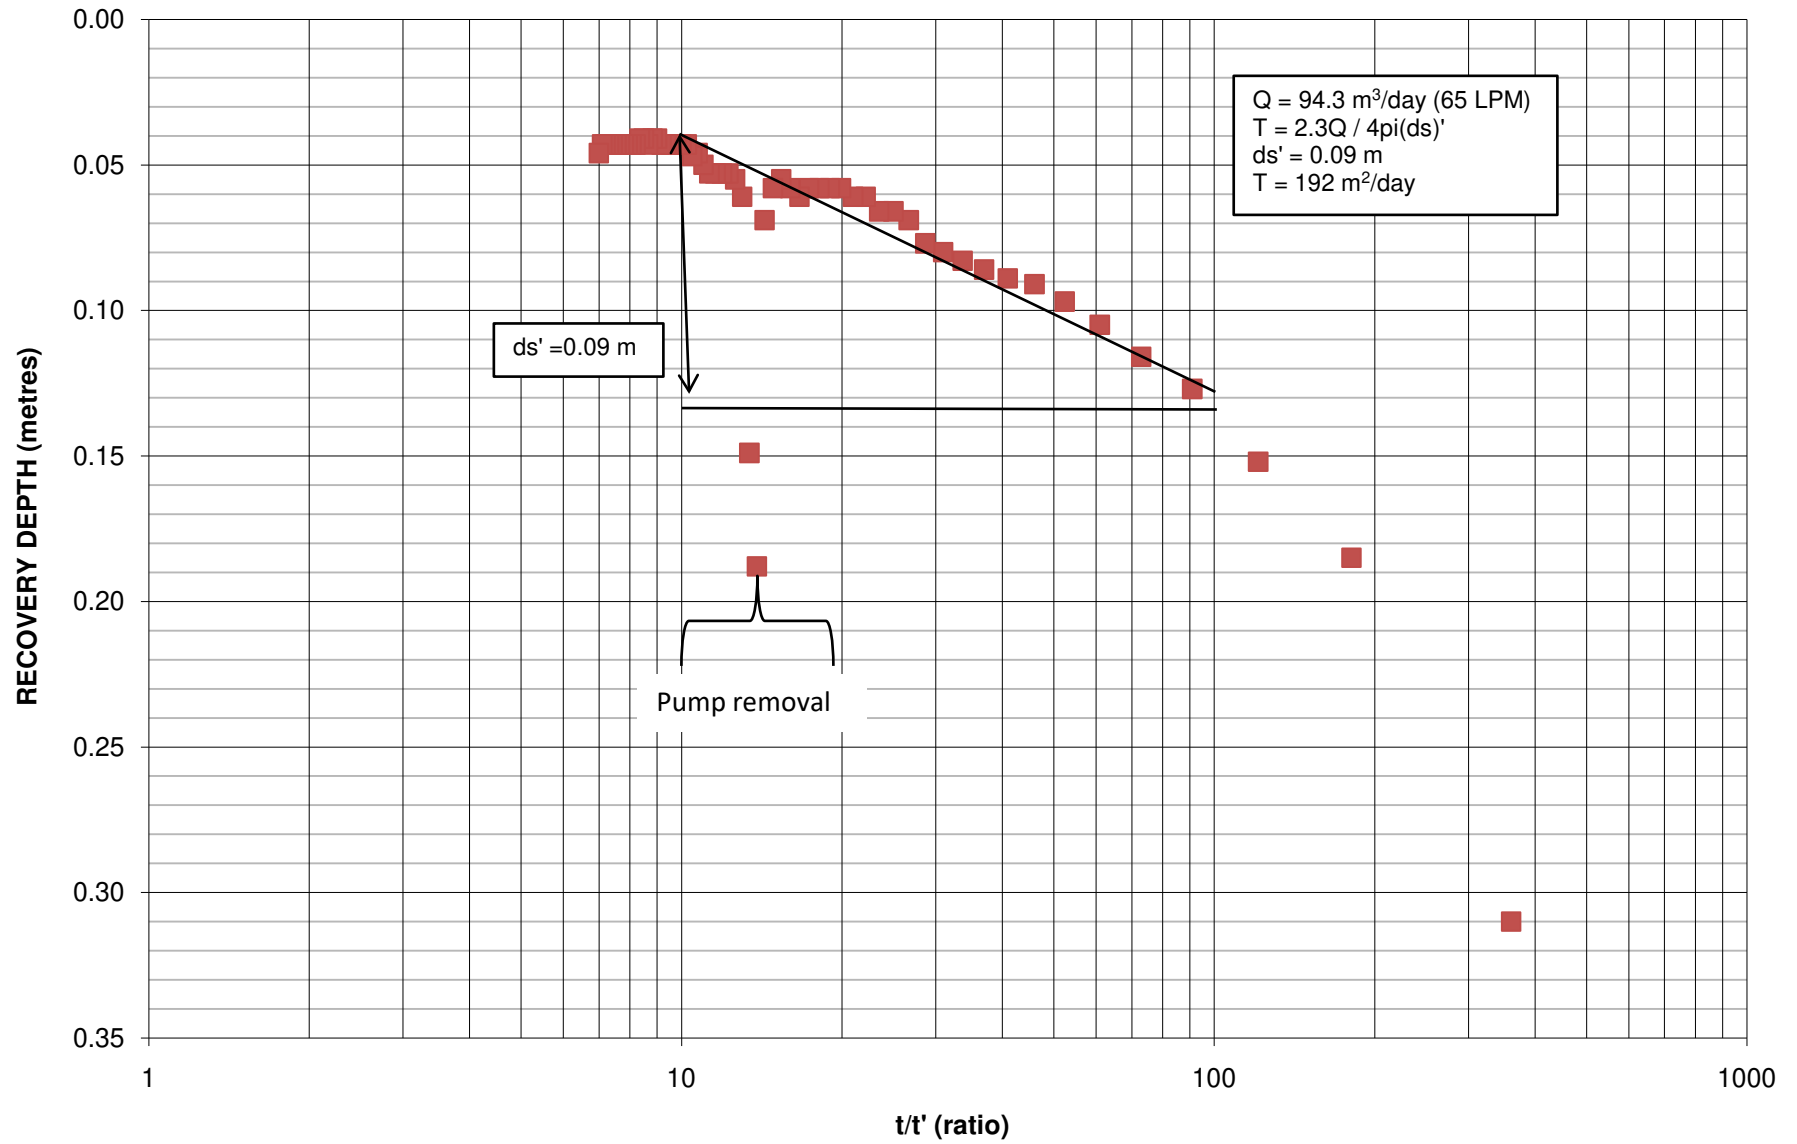
TW1- WELL RECOVERY VS. TIME - KOLLAARD FILE 210064

t'	t / t'	Abs Pres (kPa)	Temp (°C)	Water Level (m)	Drawdown (m)	Recovery (%)
1	361	385.053	8.082	-7.17	0.31	78%
2	181.0	386.275	8.082	-7.045	0.19	87%
3	121.0	386.601	8.082	-7.012	0.15	89%
4	91.0	386.846	8.082	-6.987	0.13	91%
5	73.0	386.954	8.082	-6.976	0.12	92%
6	61.0	387.063	8.082	-6.965	0.11	92%
7	52.4	387.144	8.082	-6.957	0.10	93%
8	46.0	387.199	8.082	-6.951	0.09	93%
9	41.0	387.226	8.082	-6.949	0.09	94%
10	37.0	387.253	8.082	-6.946	0.09	94%
11	33.7	387.28	8.082	-6.943	0.08	94%
12	31.0	387.307	8.082	-6.94	0.08	94%
13	28.7	387.335	8.082	-6.937	0.08	94%
14	26.7	387.416	8.082	-6.929	0.07	95%
15	25.0	387.443	8.082	-6.926	0.07	95%
16	23.5	387.443	8.082	-6.926	0.07	95%
17	22.2	387.498	8.082	-6.921	0.06	96%
18	21.0	387.498	8.082	-6.921	0.06	96%
19	19.9	387.525	8.082	-6.918	0.06	96%
20	19.0	387.525	8.082	-6.918	0.06	96%
21	18.1	387.525	8.082	-6.918	0.06	96%
22	17.4	387.525	8.082	-6.918	0.06	96%
23	16.7	387.498	8.082	-6.921	0.06	96%

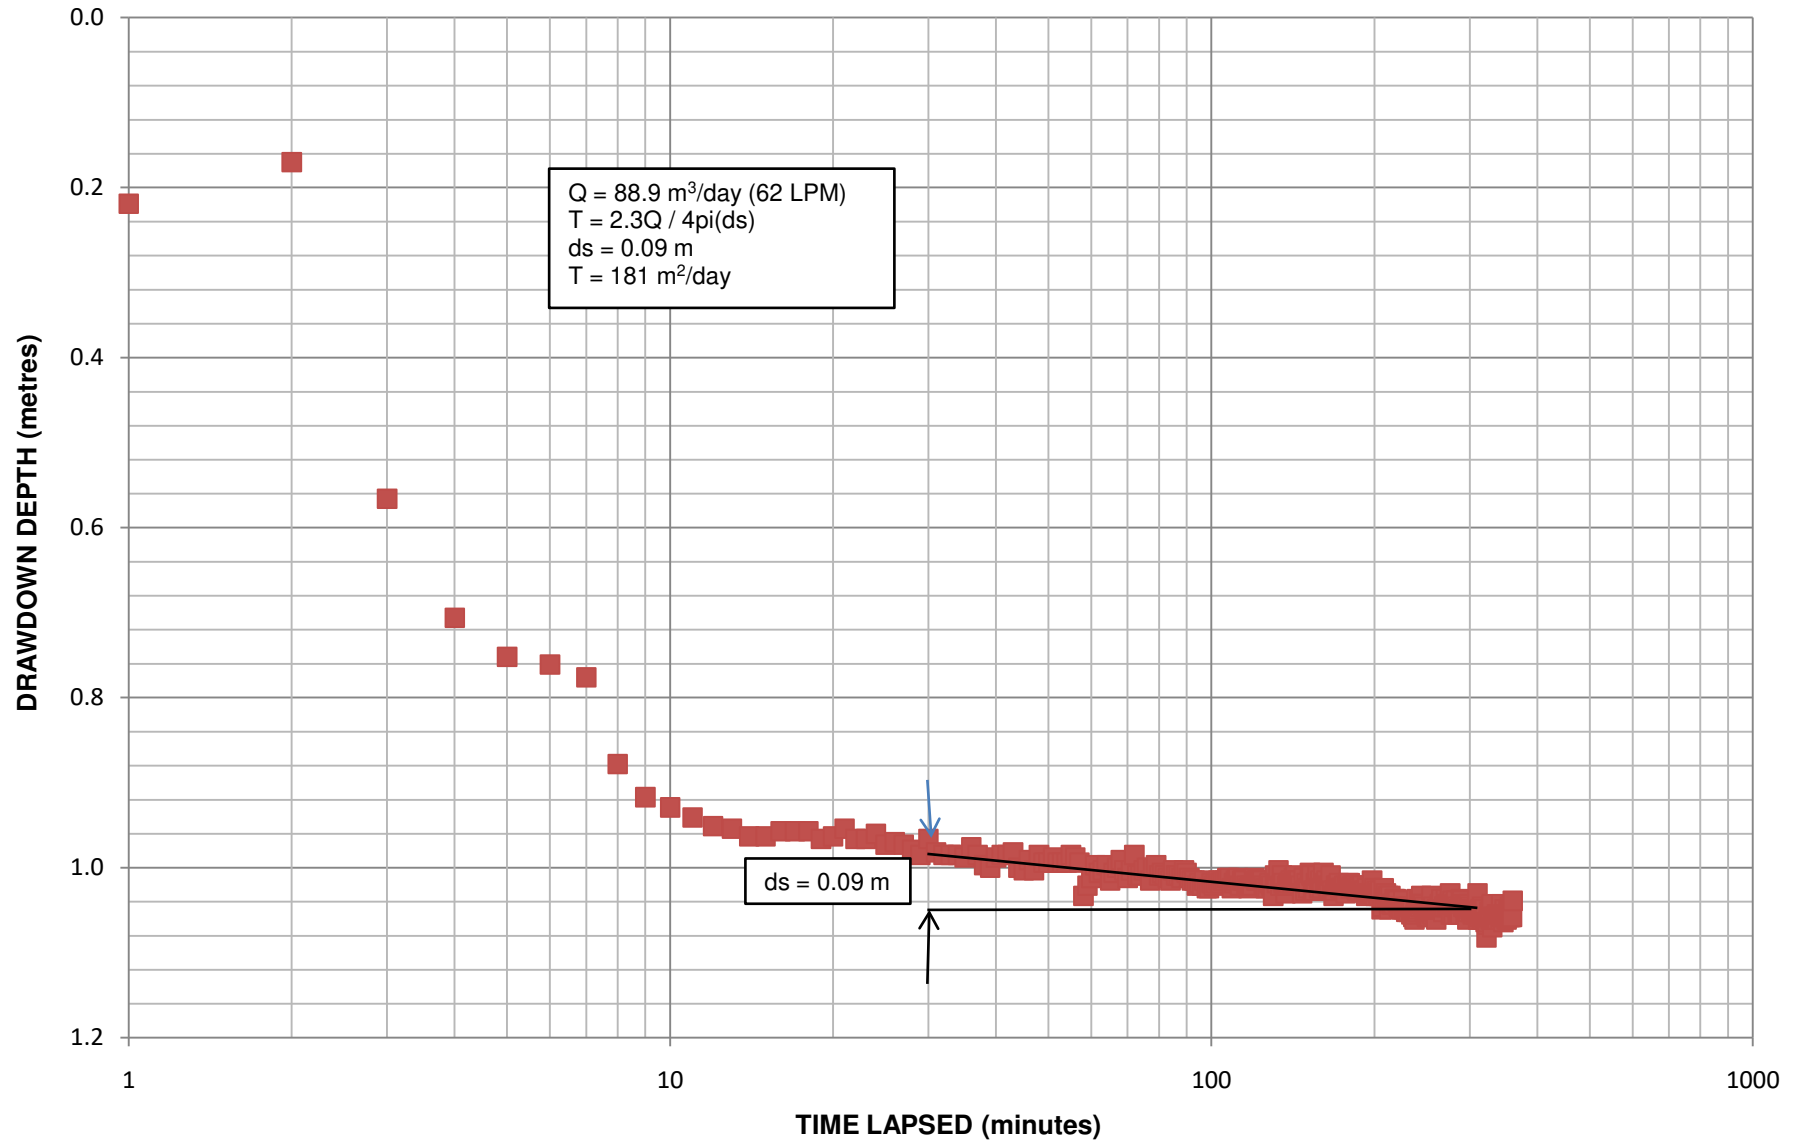
TW2-WELL DRAWDOWN VS. TIME-KOLLAARD FILE 210064

Time Lapsed (minutes)	Abs Pres (kPa)	Temp (°C)	Water Level (m)	Drawdown (m)
0	392.344	8.182	-6.68	0.00
1	390.194	8.182	-6.899	0.22
2	390.672	8.182	-6.85	0.17
3	386.79	8.182	-7.246	0.57
4	385.417	8.182	-7.386	0.71
5	384.969	8.182	-7.432	0.75
6	384.88	8.182	-7.441	0.76
7	384.73	8.182	-7.456	0.78
8	383.738	8.082	-7.558	0.88
9	383.35	8.082	-7.597	0.92
10	383.231	8.082	-7.609	0.93
11	383.112	8.082	-7.621	0.94
12	383.022	8.082	-7.631	0.95
13	382.992	8.082	-7.634	0.95
14	382.903	8.082	-7.643	0.96
15	382.903	8.082	-7.643	0.96
16	382.962	8.082	-7.637	0.96
17	382.955	7.983	-7.637	0.96
18	382.955	7.983	-7.637	0.96
19	382.866	7.983	-7.646	0.97
20	382.896	7.983	-7.643	0.96
21	382.985	7.983	-7.634	0.95
22	382.866	7.983	-7.646	0.97
23	382.866	7.983	-7.646	0.97
24	382.926	7.983	-7.64	0.96
25	382.806	7.983	-7.653	0.97
26	382.836	7.983	-7.65	0.97
27	382.806	7.983	-7.653	0.97
28	382.746	7.983	-7.659	0.98
29	382.687	7.983	-7.665	0.99
30	382.866	7.983	-7.646	0.97

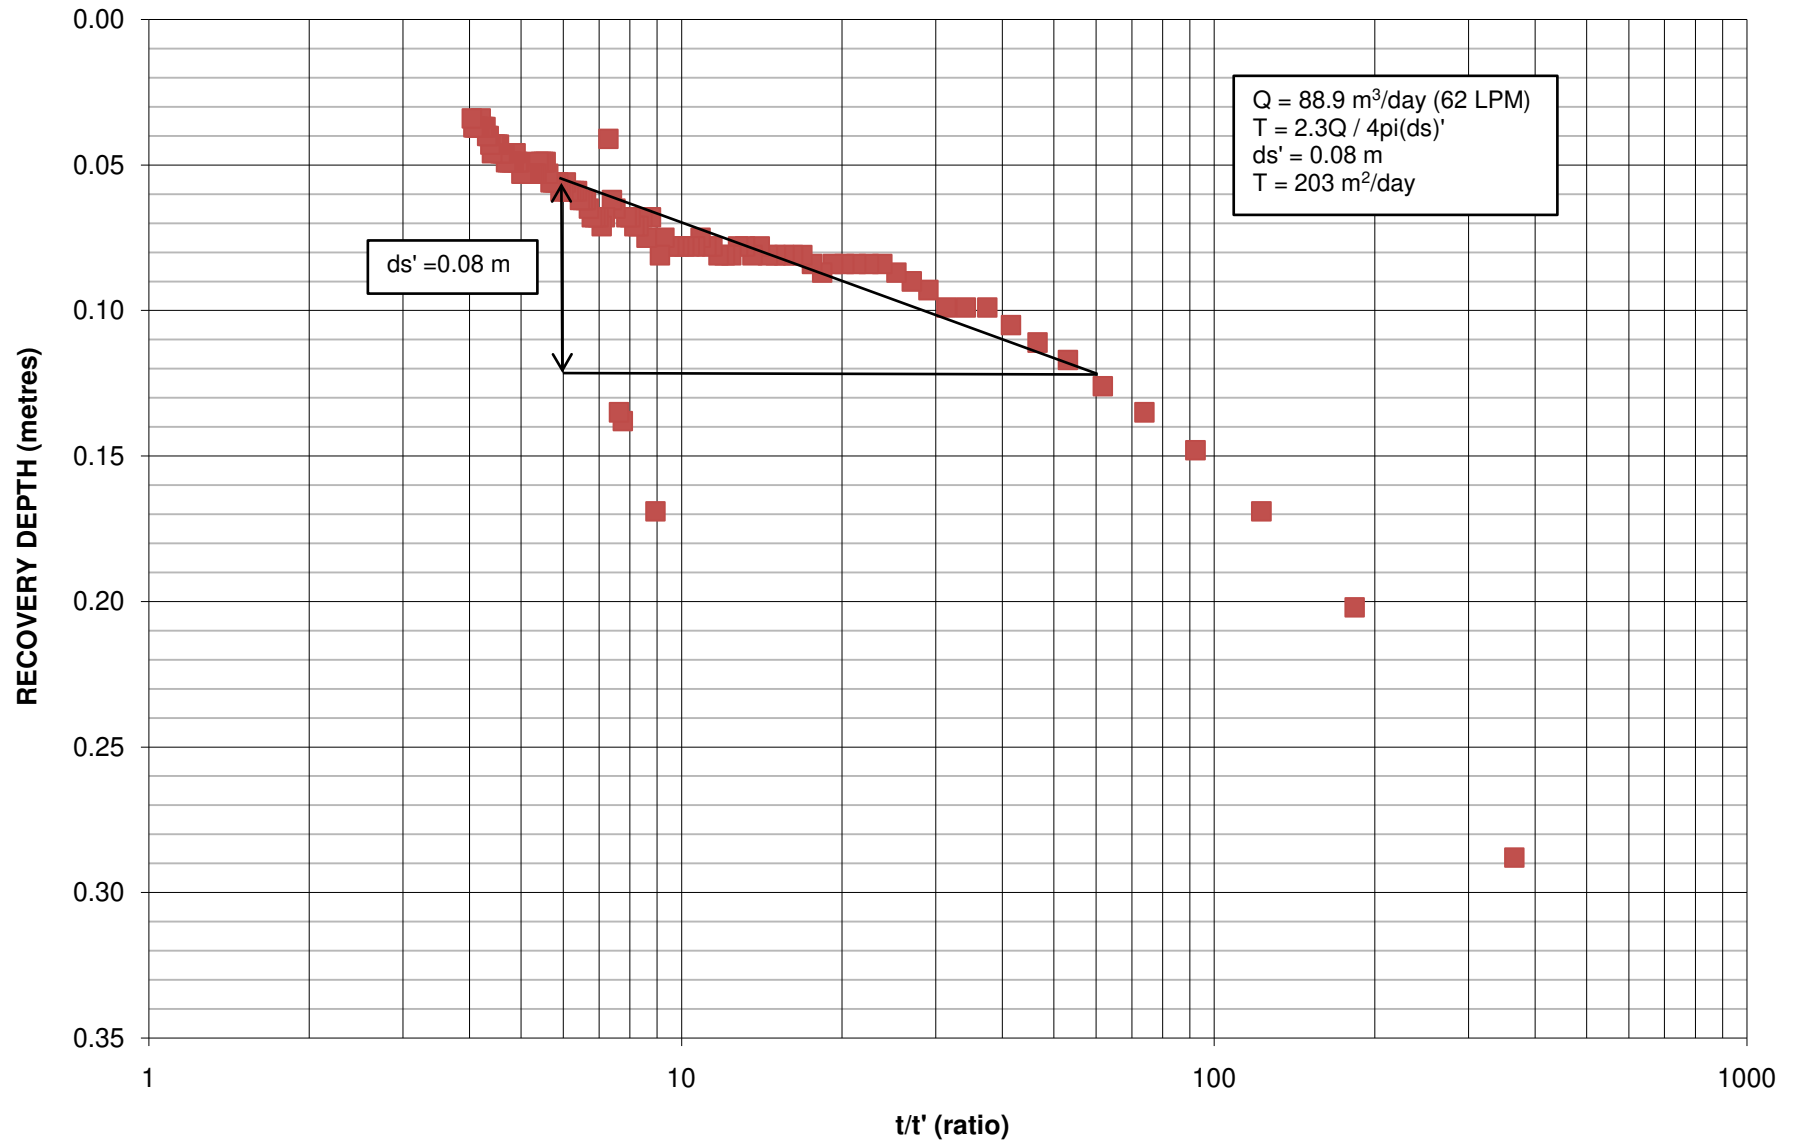
TW2- WELL RECOVERY VS. TIME - KOLLAARD FILE 210064

t'	t / t'	Abs Pres (kPa)	Temp (°C)	Water Level (m)	Drawdown (m)	Recovery (%)
1	366.0	389.523	7.983	-6.968	0.29	73%
2	183.5	390.359	7.983	-6.882	0.20	81%
3	122.7	390.687	7.983	-6.849	0.17	84%
4	92.3	390.896	7.983	-6.828	0.15	86%
5	74.0	391.016	7.983	-6.815	0.14	87%
6	61.8	391.105	7.983	-6.806	0.13	88%
7	53.1	391.195	7.983	-6.797	0.12	89%
8	46.6	391.255	7.983	-6.791	0.11	90%
9	41.6	391.314	7.983	-6.785	0.11	90%
10	37.5	391.374	7.983	-6.779	0.10	91%
11	34.2	391.374	7.983	-6.779	0.10	91%
12	31.4	391.374	7.983	-6.779	0.10	91%
13	29.1	391.434	7.983	-6.773	0.09	91%
14	27.1	391.464	7.983	-6.77	0.09	91%
15	25.3	391.494	7.983	-6.767	0.09	92%
16	23.8	391.523	7.983	-6.764	0.08	92%
17	22.5	391.523	7.983	-6.764	0.08	92%
18	21.3	391.523	7.983	-6.764	0.08	92%
19	20.2	391.523	7.983	-6.764	0.08	92%
20	19.3	391.523	7.983	-6.764	0.08	92%
21	18.4	391.494	7.983	-6.767	0.09	92%
22	17.6	391.523	7.983	-6.764	0.08	92%
23	16.9	391.553	7.983	-6.761	0.08	92%

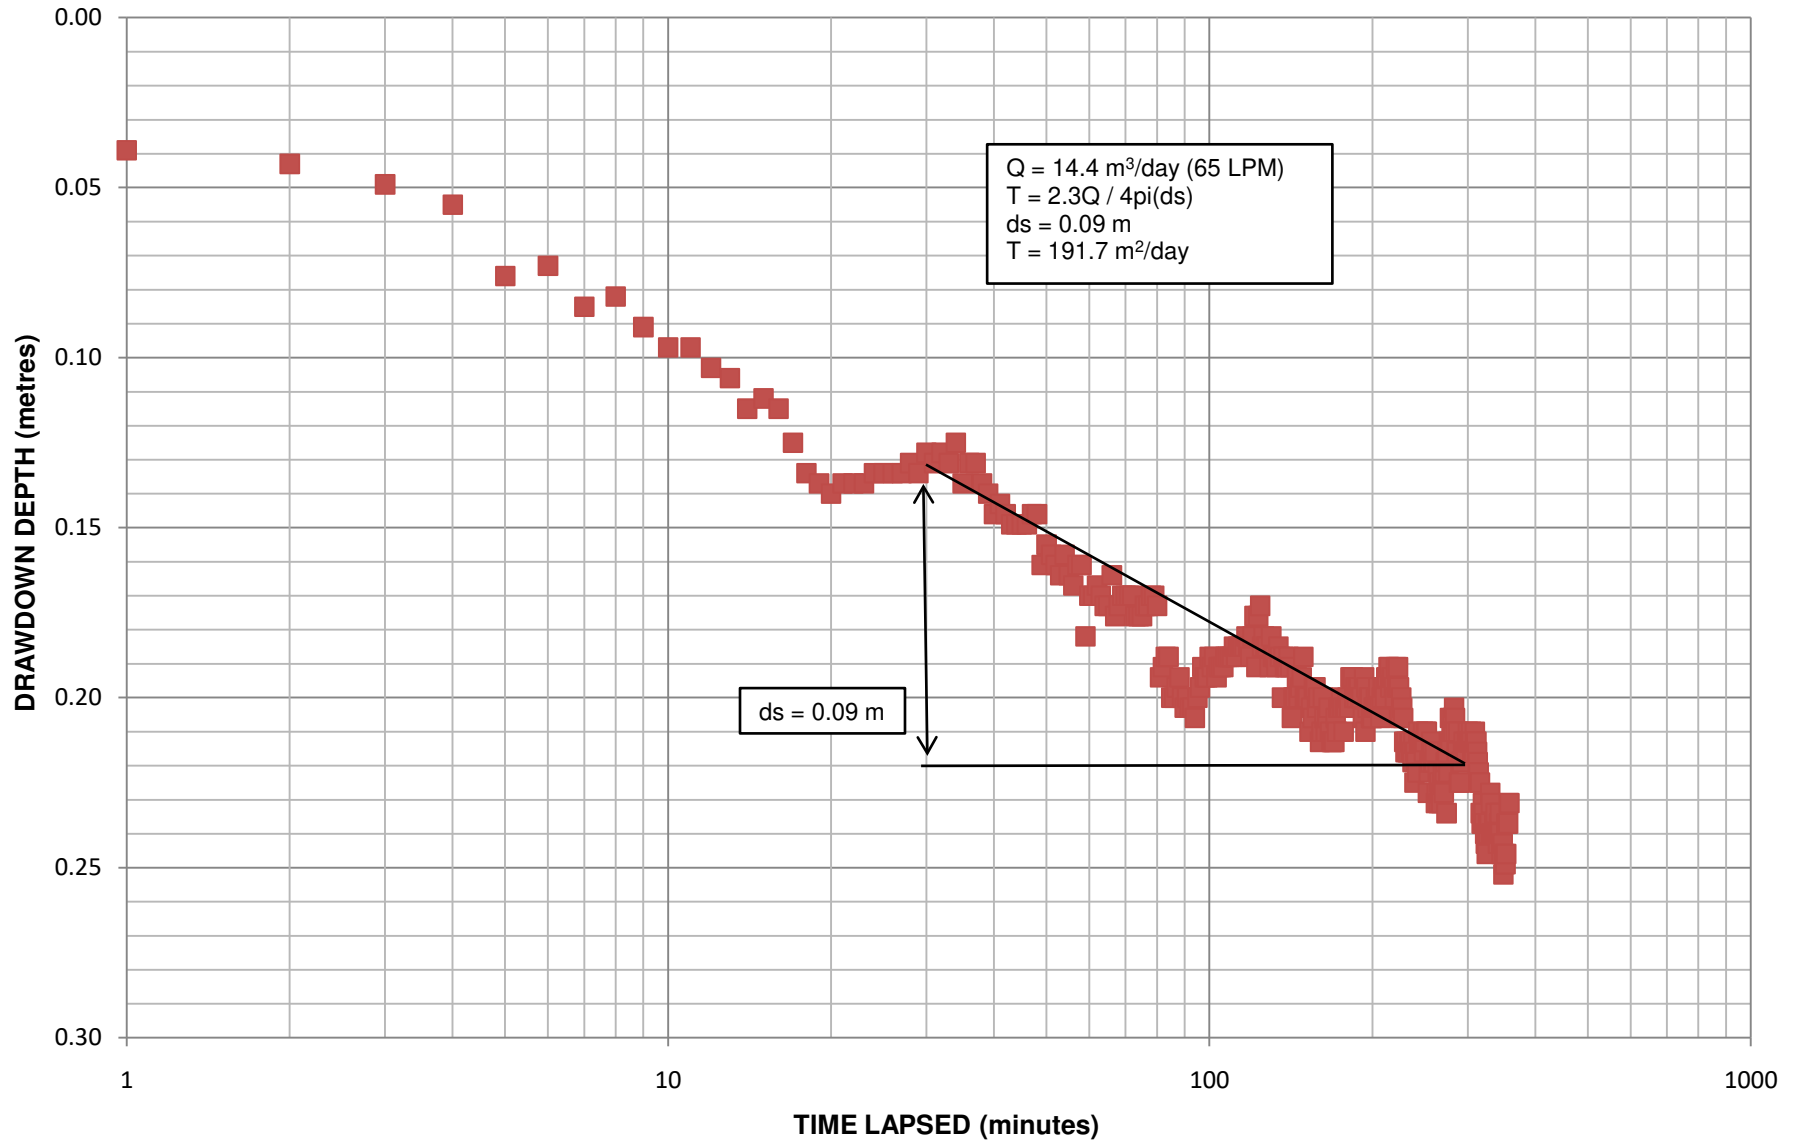
TW3-WELL DRAWDOWN VS. TIME-KOLLAARD FILE 210064

Time Lapsed (minutes)	Abs Pres (kPa)	Temp (°C)	Water Level (m)	Drawdown (m)
0	359.25	7.983	-4.53	0.00
1	358.863	7.983	-4.569	0.04
2	358.833	7.983	-4.573	0.04
3	358.774	7.983	-4.579	0.05
4	358.714	7.983	-4.585	0.05
5	358.506	7.983	-4.606	0.08
6	358.535	7.983	-4.603	0.07
7	358.416	7.983	-4.615	0.09
8	358.446	7.983	-4.612	0.08
9	358.357	7.983	-4.621	0.09
10	358.297	7.983	-4.627	0.10
11	358.297	7.983	-4.627	0.10
12	358.238	7.983	-4.633	0.10
13	358.208	7.983	-4.636	0.11
14	358.118	7.983	-4.645	0.11
15	358.148	7.983	-4.642	0.11
16	358.118	7.983	-4.645	0.11
17	358.029	7.983	-4.655	0.13
18	357.94	7.983	-4.664	0.13
19	357.91	7.983	-4.667	0.14
20	357.88	7.983	-4.67	0.14
21	357.91	7.983	-4.667	0.14
22	357.91	7.983	-4.667	0.14
23	357.91	7.983	-4.667	0.14
24	357.94	7.983	-4.664	0.13
25	357.94	7.983	-4.664	0.13
26	357.94	7.983	-4.664	0.13
27	357.94	7.983	-4.664	0.13
28	357.969	7.983	-4.661	0.13
29	357.94	7.983	-4.664	0.13
30	357.999	7.983	-4.658	0.13

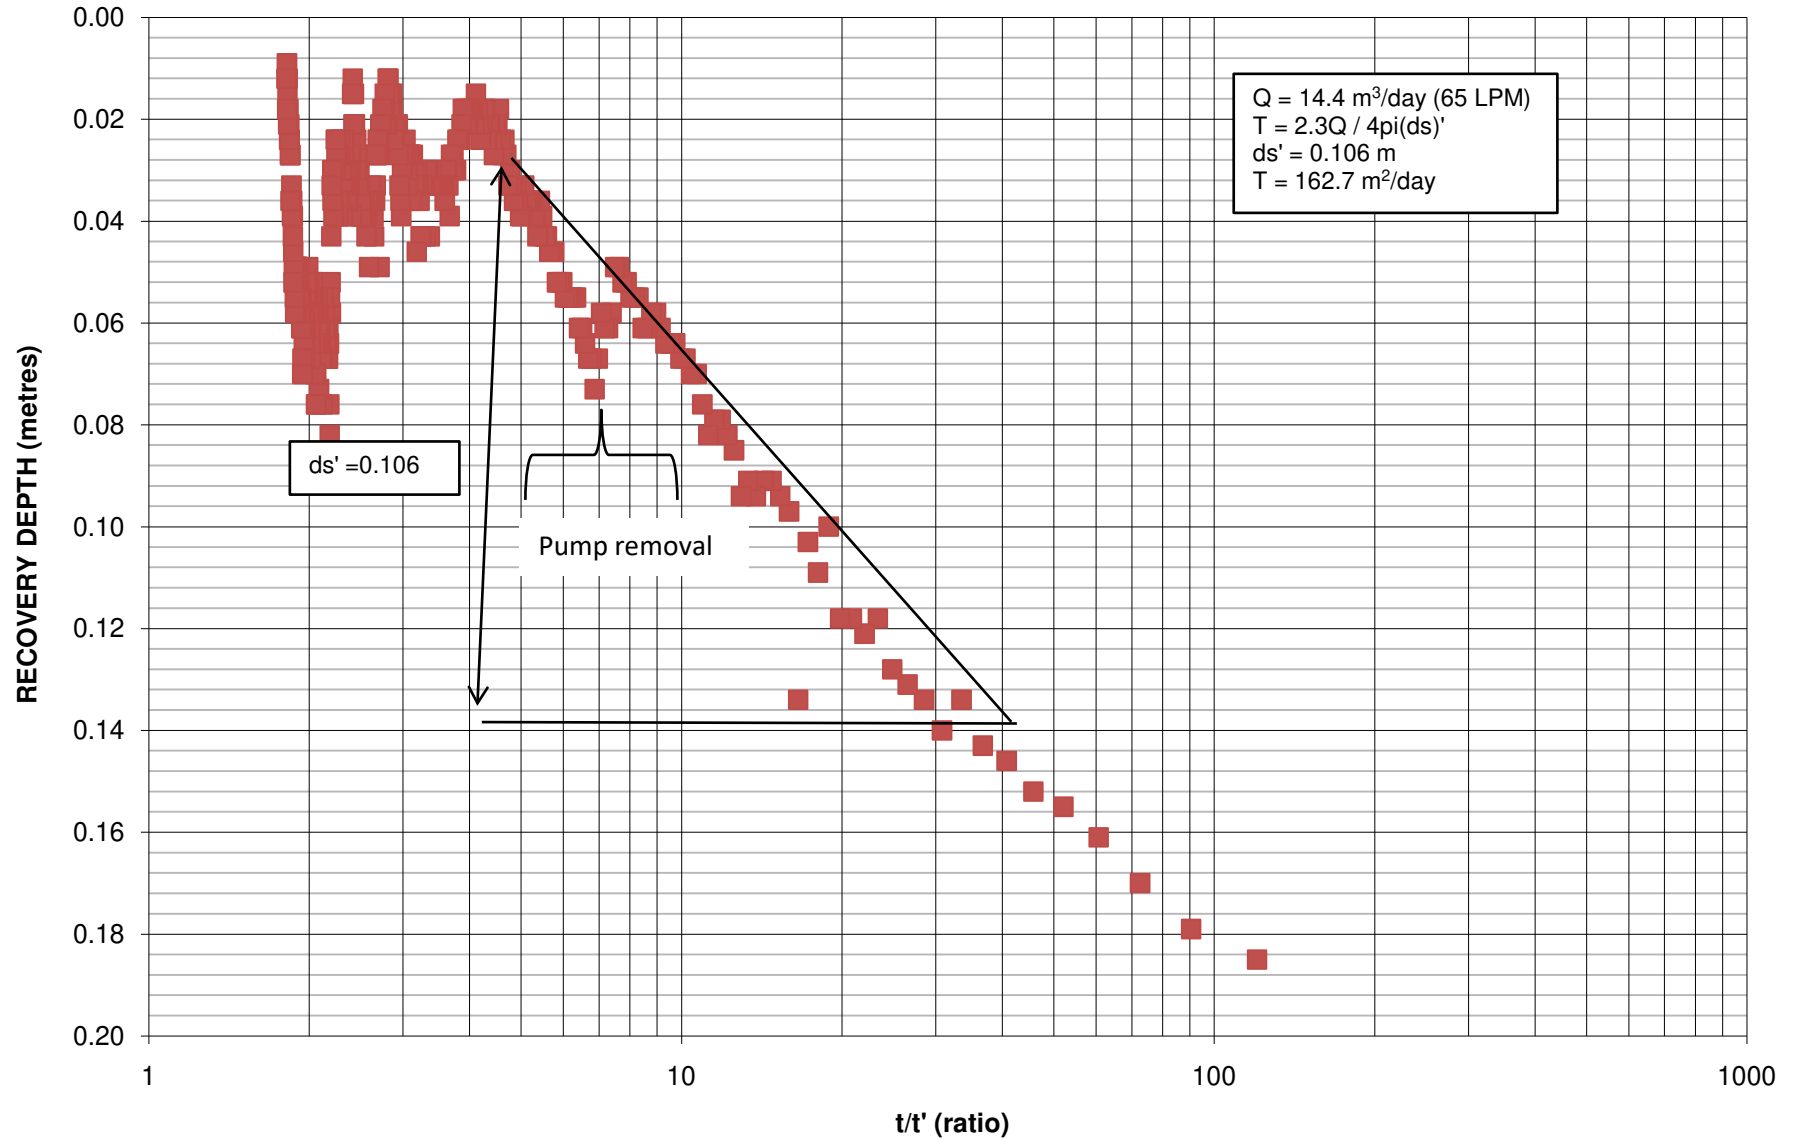
TW3- WELL RECOVERY VS. TIME - KOLLAARD FILE 210064

t'	t / t'	Abs Pres (kPa)	Temp (°C)	Water Level (m)	Drawdown (m)	Recovery (%)
1	359.0	357.195	7.983	-4.74	95.24	
2	180.0	357.344	7.983	-4.724	95.22	
3	120.3	357.433	7.983	-4.715	0.19	12%
4	90.5	357.493	7.983	-4.709	0.18	15%
5	72.6	357.582	7.983	-4.7	0.17	19%
6	60.7	357.672	7.983	-4.691	0.16	23%
7	52.1	357.731	7.983	-4.685	0.15	26%
8	45.8	357.761	7.983	-4.682	0.15	28%
9	40.8	357.82	7.983	-4.676	0.15	30%
10	36.8	357.85	7.983	-4.673	0.14	32%
11	33.5	357.94	7.983	-4.664	0.13	36%
12	30.8	357.88	7.983	-4.67	0.14	33%
13	28.5	357.94	7.983	-4.664	0.13	36%
14	26.6	357.969	7.983	-4.661	0.13	38%
15	24.9	357.999	7.983	-4.658	0.13	39%
16	23.4	358.089	7.983	-4.648	0.12	44%
17	22.1	358.059	7.983	-4.651	0.12	42%
18	20.9	358.089	7.983	-4.648	0.12	44%
19	19.8	358.089	7.983	-4.648	0.12	44%
20	18.9	358.267	7.983	-4.63	0.10	52%
21	18.0	358.178	7.983	-4.639	0.11	48%
22	17.3	358.238	7.983	-4.633	0.10	51%
23	16.6	357.94	7.983	-4.664	0.13	36%
