Re: OTT-00263154-A0 Percolation Tests at 37 Wildpine Court, Stittsville site

*Percolation Test
37 Wildpine Court, Stittsville, Ontario
OTT-00263154-A0
November 7, 2023*

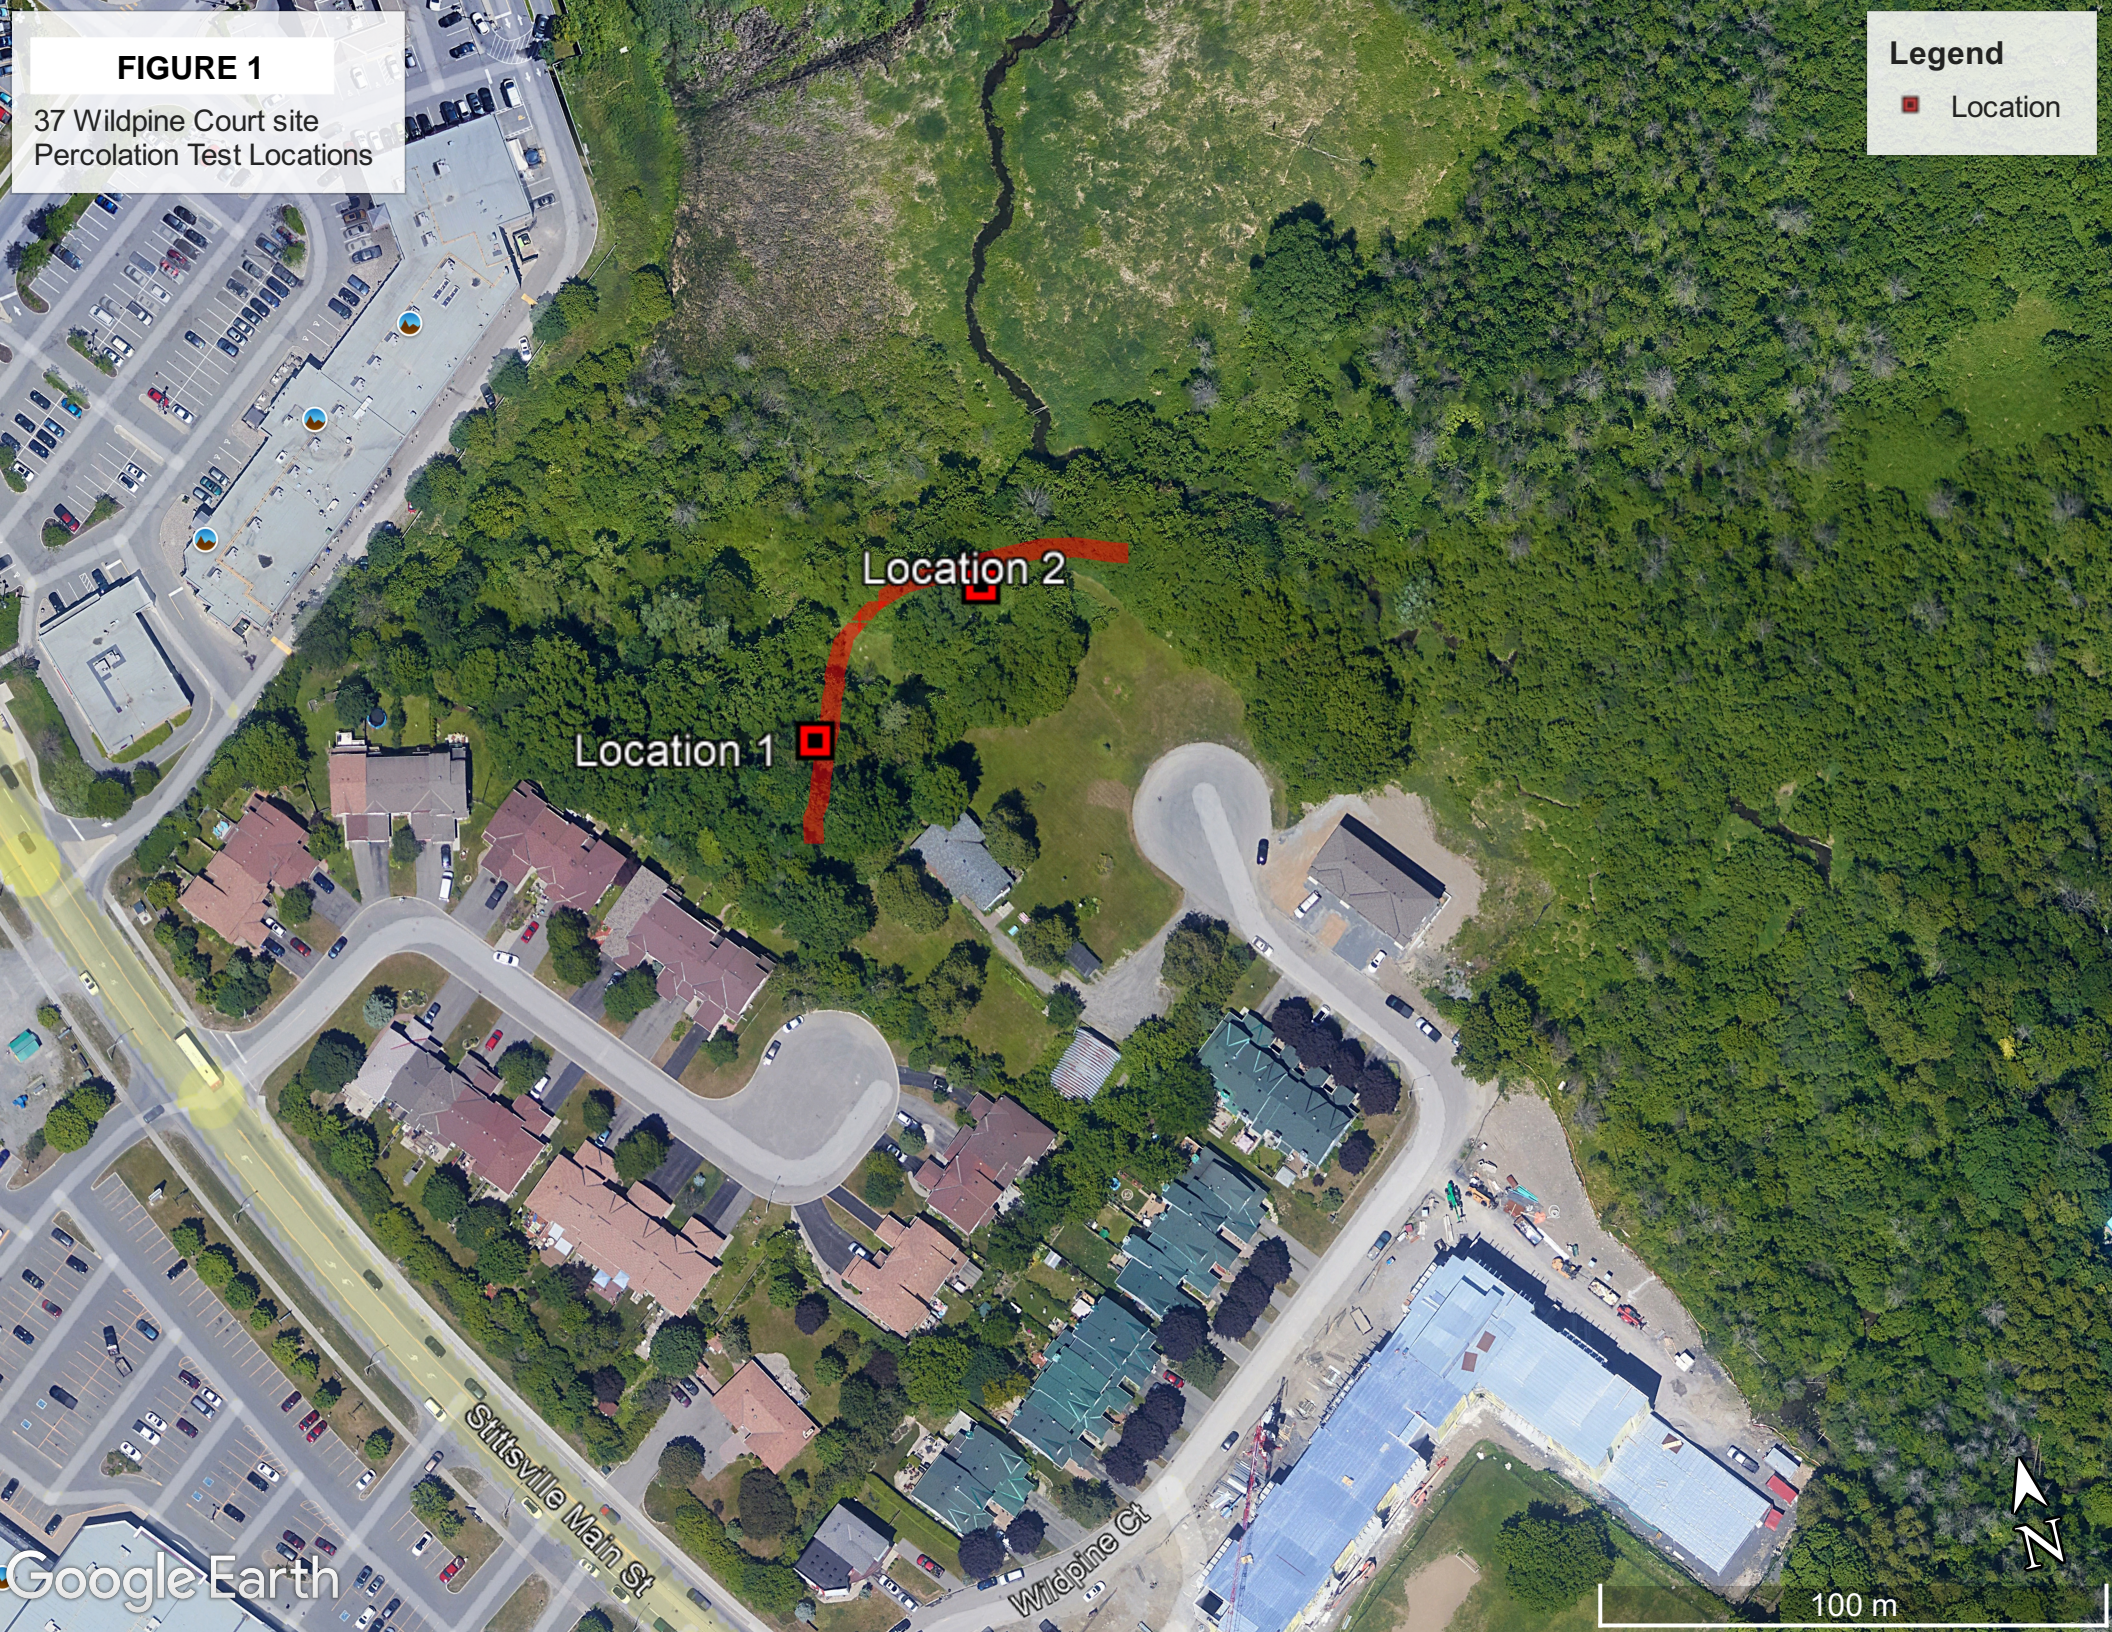
FIGURE 1

37 Wildpine Court site
Percolation Test Locations

We understand that this was completed to address City of Ottawa comment about the previously performed percolation test. The test on November 2, 2023 was performed using Guelph Permeameter. The test locations are presented in Figure 1. Three (3) tests were performed (two at Location 1 and one at Location 2). Guelph Permeameter (GP) was used for the tests.
