## Geotechnical Investigation

Proposed Residential Development  
Mer Bleue Expansion Area  
Mer Bleue Road - Ottawa

Claridge Homes

Report: PG5072-1

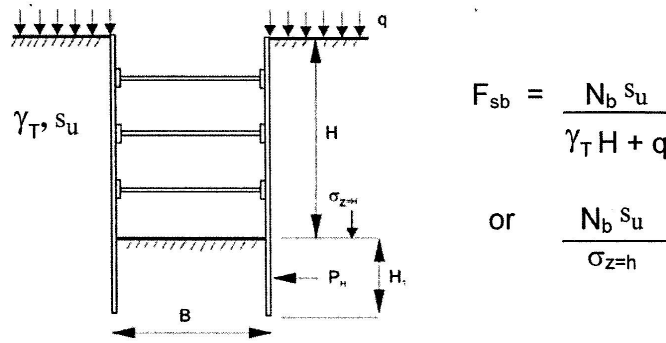
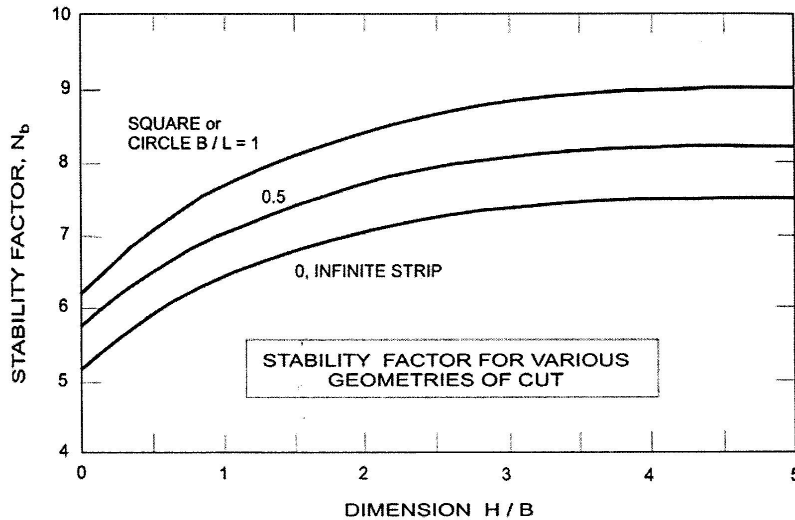
Figure 1 - Stability Factor for Various Geometries of Cut

In the case of soft to firm clays, a factor of safety of 2 is recommended for base stability.

The base of supported excavations can fail by three (3) general modes:

- Shear failure within the ground caused by inadequate resistance to loads imposed by grade difference inside and outside of the excavation,
- Piping from water seepage through granular soils, and
- Heave of layered soils due to water pressures confined by intervening low permeability soils.

Shear failure of excavation bases is typically rare in granular soils if adequate lateral support is provided. Inadequate dewatering can cause instability in excavations made through granular or layered soils. The potential for base heave in cohesive soils should be determined for stability of flexible retaining systems.

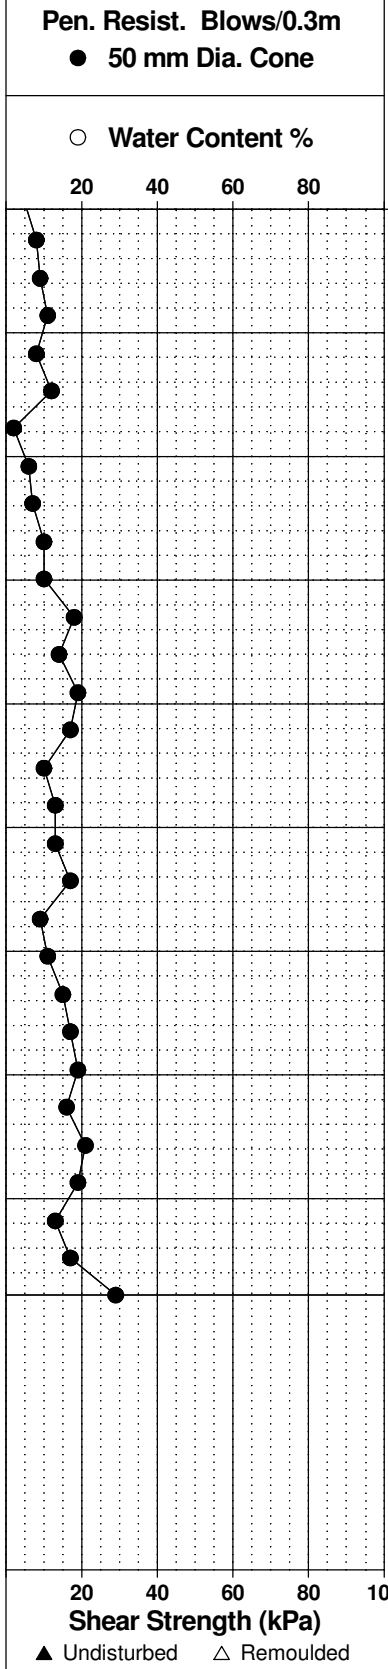
HOLE NO. **BH19**

SOIL DESCRIPTION	STRATA PLOT	SAMPLE				DEPTH (m)	ELEV. (m)	Pen. Resist. Blows/0.3m ● 50 mm Dia. Cone		Piezometer Construction
		TYPE	NUMBER	RECOVERY	N VALUE or RQD			○ Water Content %		
GROUND SURFACE						22	64.81			
						23	63.81			
						24	62.81			
						25	61.81			
						26	60.81			
						27	59.81			
						28	58.81			
						29	57.81			
						30	56.81			
							30.78			
End of Borehole  (Piezometer dry/blocked at 1.3m depth - Dec. 9, 2019)

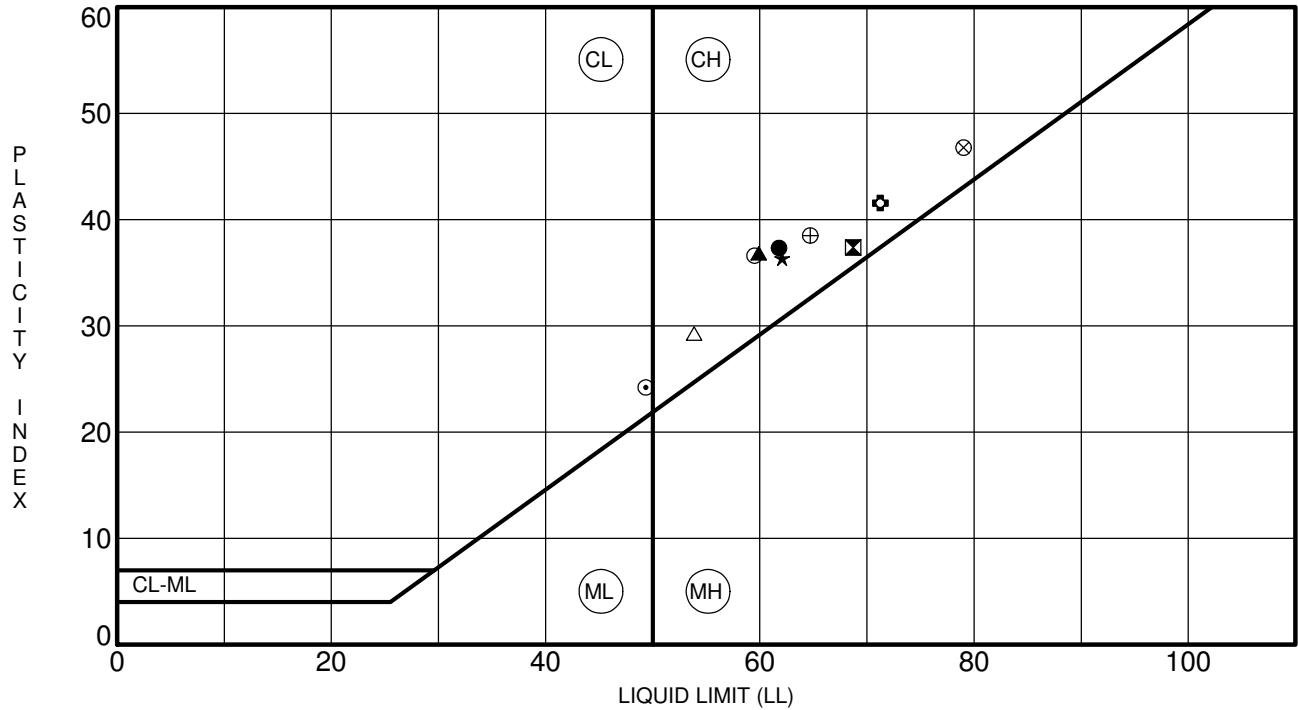
Specimen Identification	LL	PL	PI	Fines	Classification
● BH16 SS 2	62	24	37		CH - Inorganic clay of high plasticity
⊠ BH17 SS 2	69	31	37		CH - Inorganic clay of high plasticity
▲ BH19 SS 3	60	23	37		CH - Inorganic clay of high plasticity
★ BH20 SS 2	62	26	36		CH - Inorganic clay of high plasticity
⊙ BH21 SS 2	49	25	24		CL - Inorganic clay of low plasticity
⊕ BH22 SS 2	71	30	42		CH - Inorganic clay of high plasticity
○ BH24 SS 2	60	23	37		CH - Inorganic clay of high plasticity
△ BH25 SS 3	54	25	29		CH - Inorganic clay of high plasticity
⊗ BH26 SS 2	79	32	47		CH - Inorganic clay of high plasticity
⊕ BH27 SS 2	65	26	39		CH - Inorganic clay of high plasticity

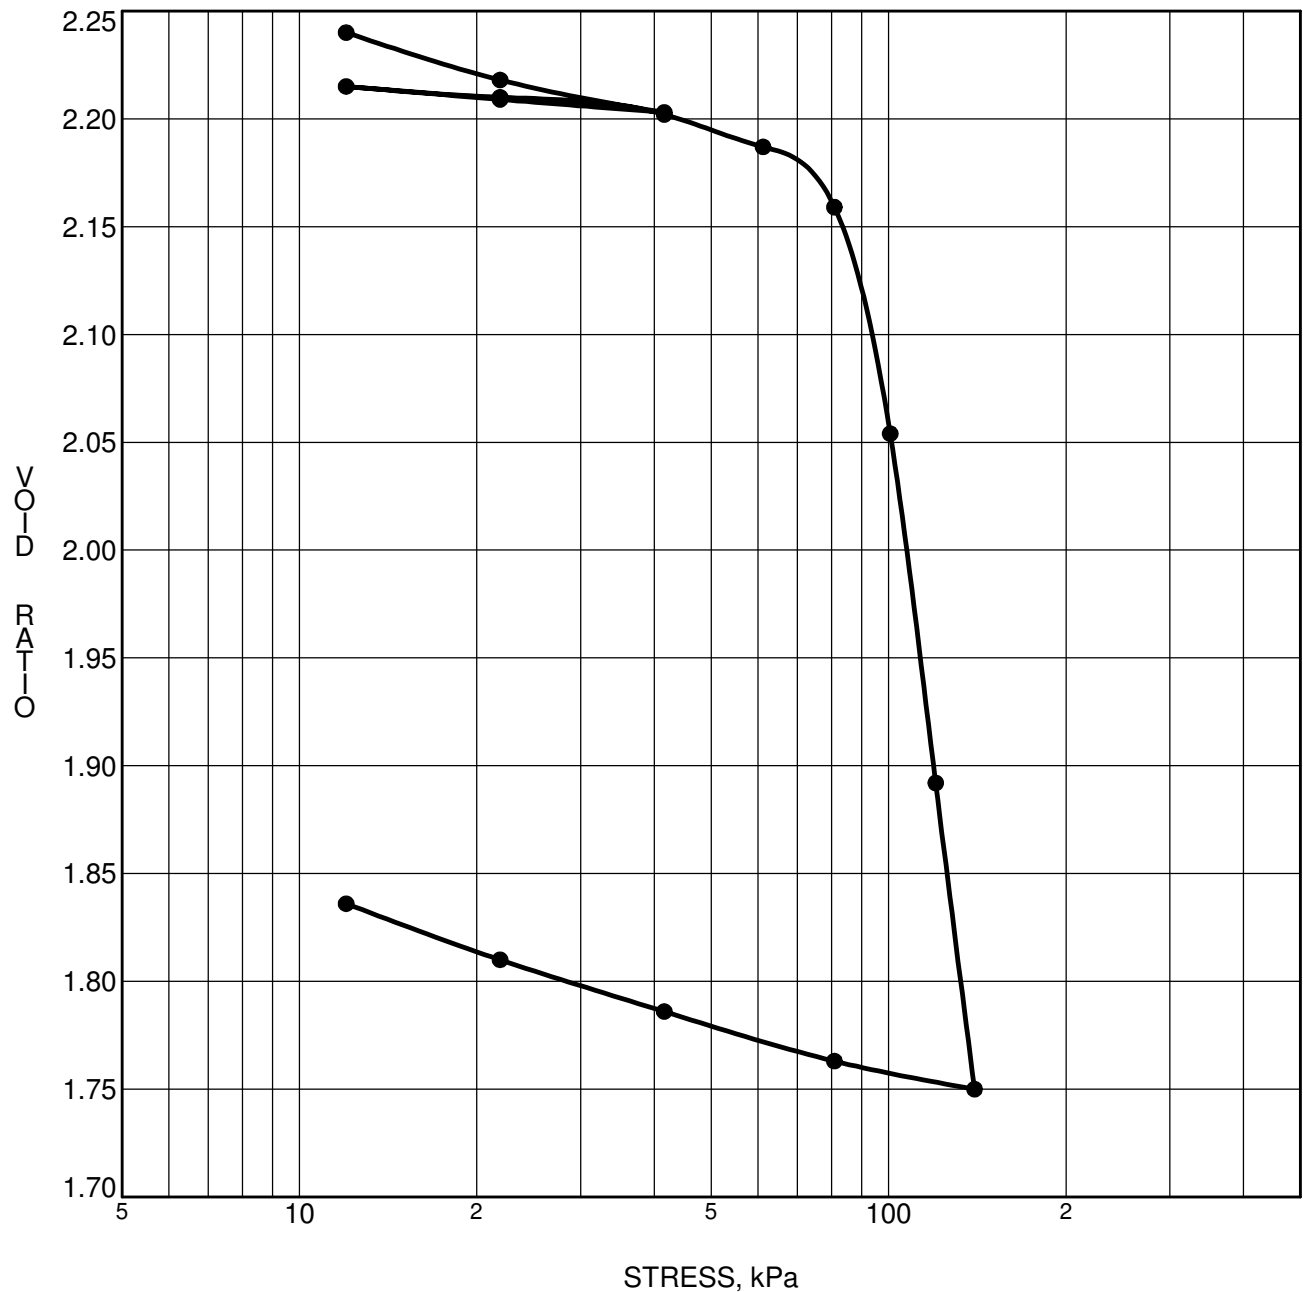
CONSOLIDATION TEST DATA SUMMARY					
Borehole No.	<b>BH 4</b>	$p'_o$	<b>58.4 kPa</b>	$C_{cr}$	<b>0.026</b>
Sample No.	<b>TW 4</b>	$p'_c$	<b>90 kPa</b>	$C_c$	<b>2.158</b>
Sample Depth	<b>4.98 m</b>	OC Ratio	<b>1.5</b>	$W_o$	<b>81.4 %</b>
Sample Elev.	<b>80.34 m</b>	Void Ratio	<b>2.237</b>	Unit Wt.	<b>15.1 kN/m<sup>3</sup></b>

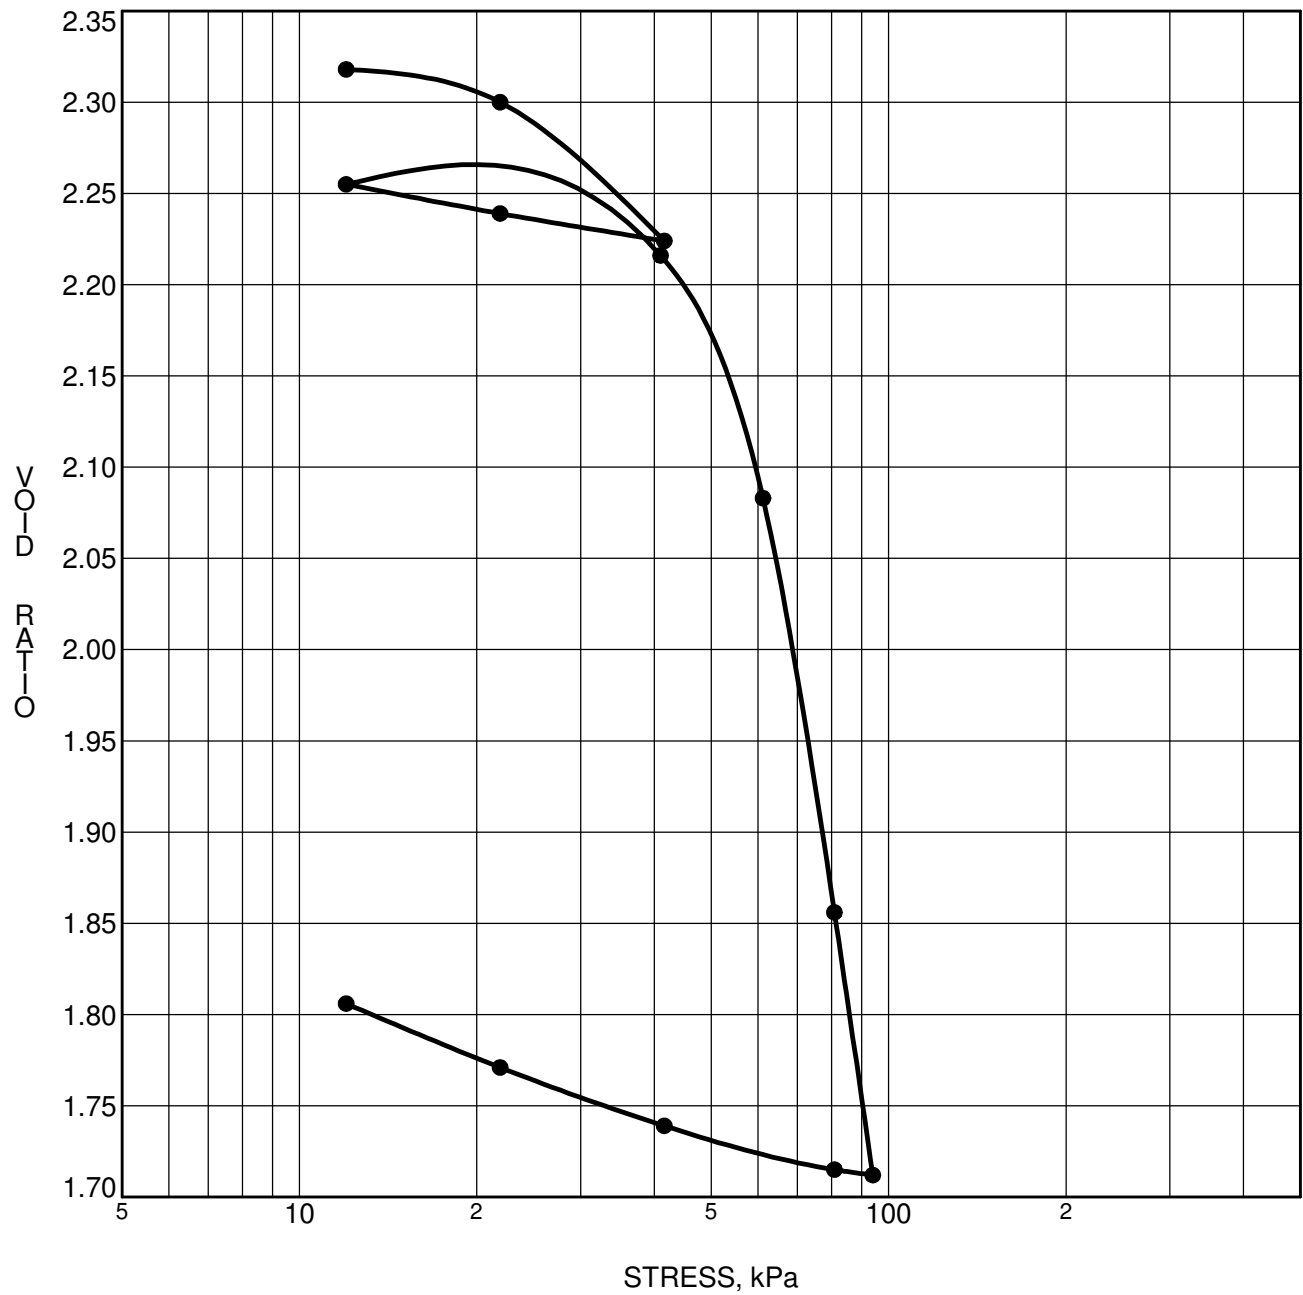
CONSOLIDATION TEST DATA SUMMARY					
Borehole No.	<b>BH 7</b>	$p'_o$	<b>31.5 kPa</b>	$C_{cr}$	<b>0.072</b>
Sample No.	<b>TW 4</b>	$p'_c$	<b>57.9 kPa</b>	$C_c$	<b>2.308</b>
Sample Depth	<b>3.25 m</b>	OC Ratio	<b>1.8</b>	$W_o$	<b>85.4 %</b>
Sample Elev.	<b>82.78 m</b>	Void Ratio	<b>2.349</b>	Unit Wt.	<b>14.9 kN/m<sup>3</sup></b>

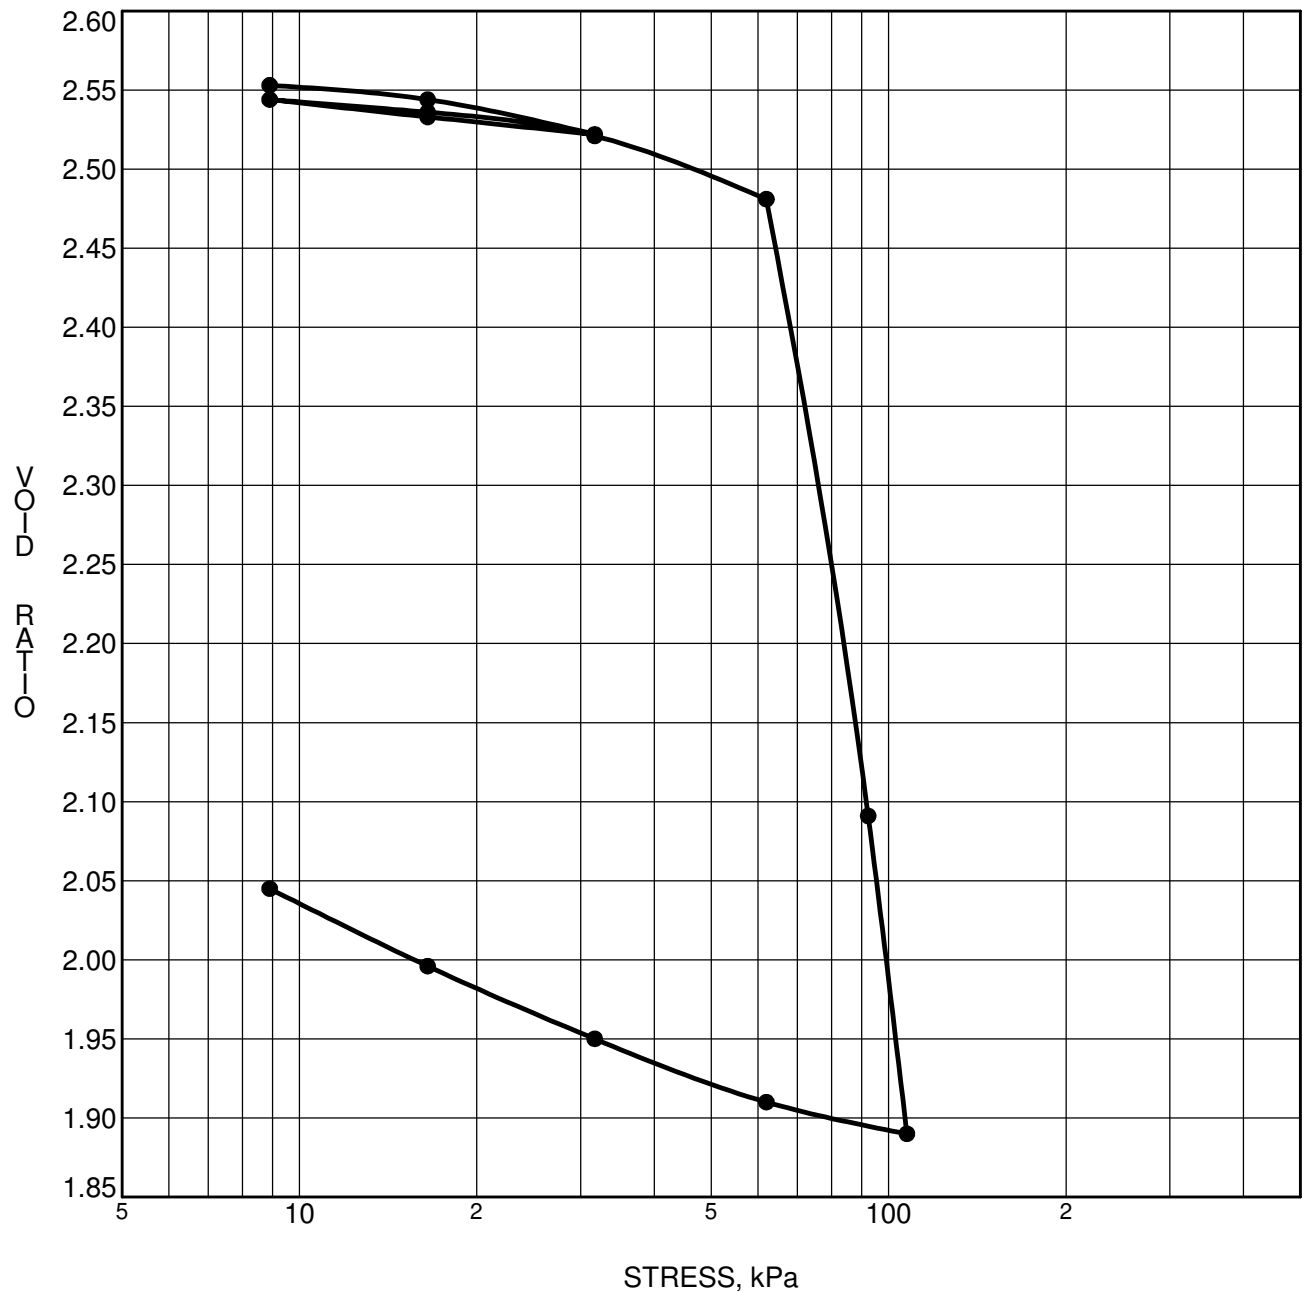
CONSOLIDATION TEST DATA SUMMARY					
Borehole No.	<b>BH12</b>	$p'_o$	<b>50.6 kPa</b>	$C_{cr}$	<b>0.040</b>
Sample No.	<b>TW 5</b>	$p'_c$	<b>68.9 kPa</b>	$C_c$	<b>3.077</b>
Sample Depth	<b>4.22 m</b>	OC Ratio	<b>1.4</b>	$W_o$	<b>92.9 %</b>
Sample Elev.	<b>81.13 m</b>	Void Ratio	<b>2.556</b>	Unit Wt.	<b>2.6 kN/m<sup>3</sup></b>

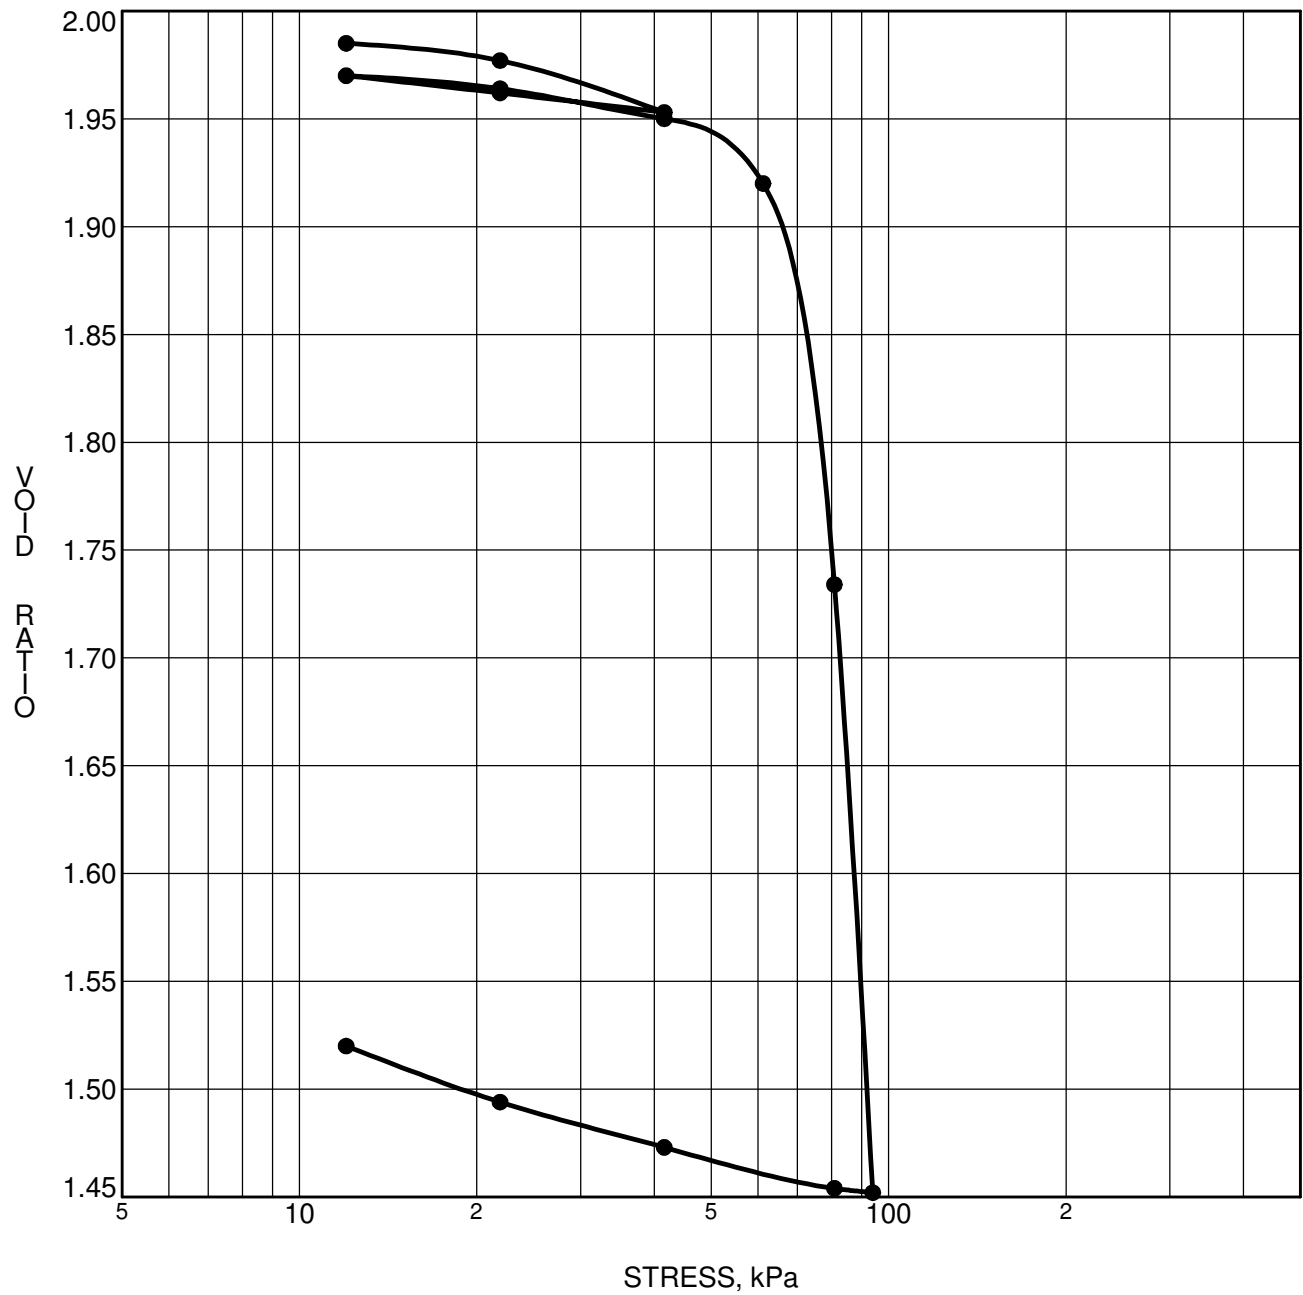
CONSOLIDATION TEST DATA SUMMARY					
Borehole No.	<b>BH15</b>	p' <sub>o</sub>	<b>53.7 kPa</b>	C <sub>cr</sub>	<b>0.038</b>
Sample No.	<b>TW 3</b>	p' <sub>c</sub>	<b>73.6 kPa</b>	C <sub>c</sub>	<b>4.370</b>
Sample Depth	<b>4.22 m</b>	OC Ratio	<b>1.4</b>	W <sub>o</sub>	<b>72.8 %</b>
Sample Elev.	<b>81.43 m</b>	Void Ratio	<b>2.001</b>	Unit Wt.	<b>155.0 kN/m<sup>3</sup></b>

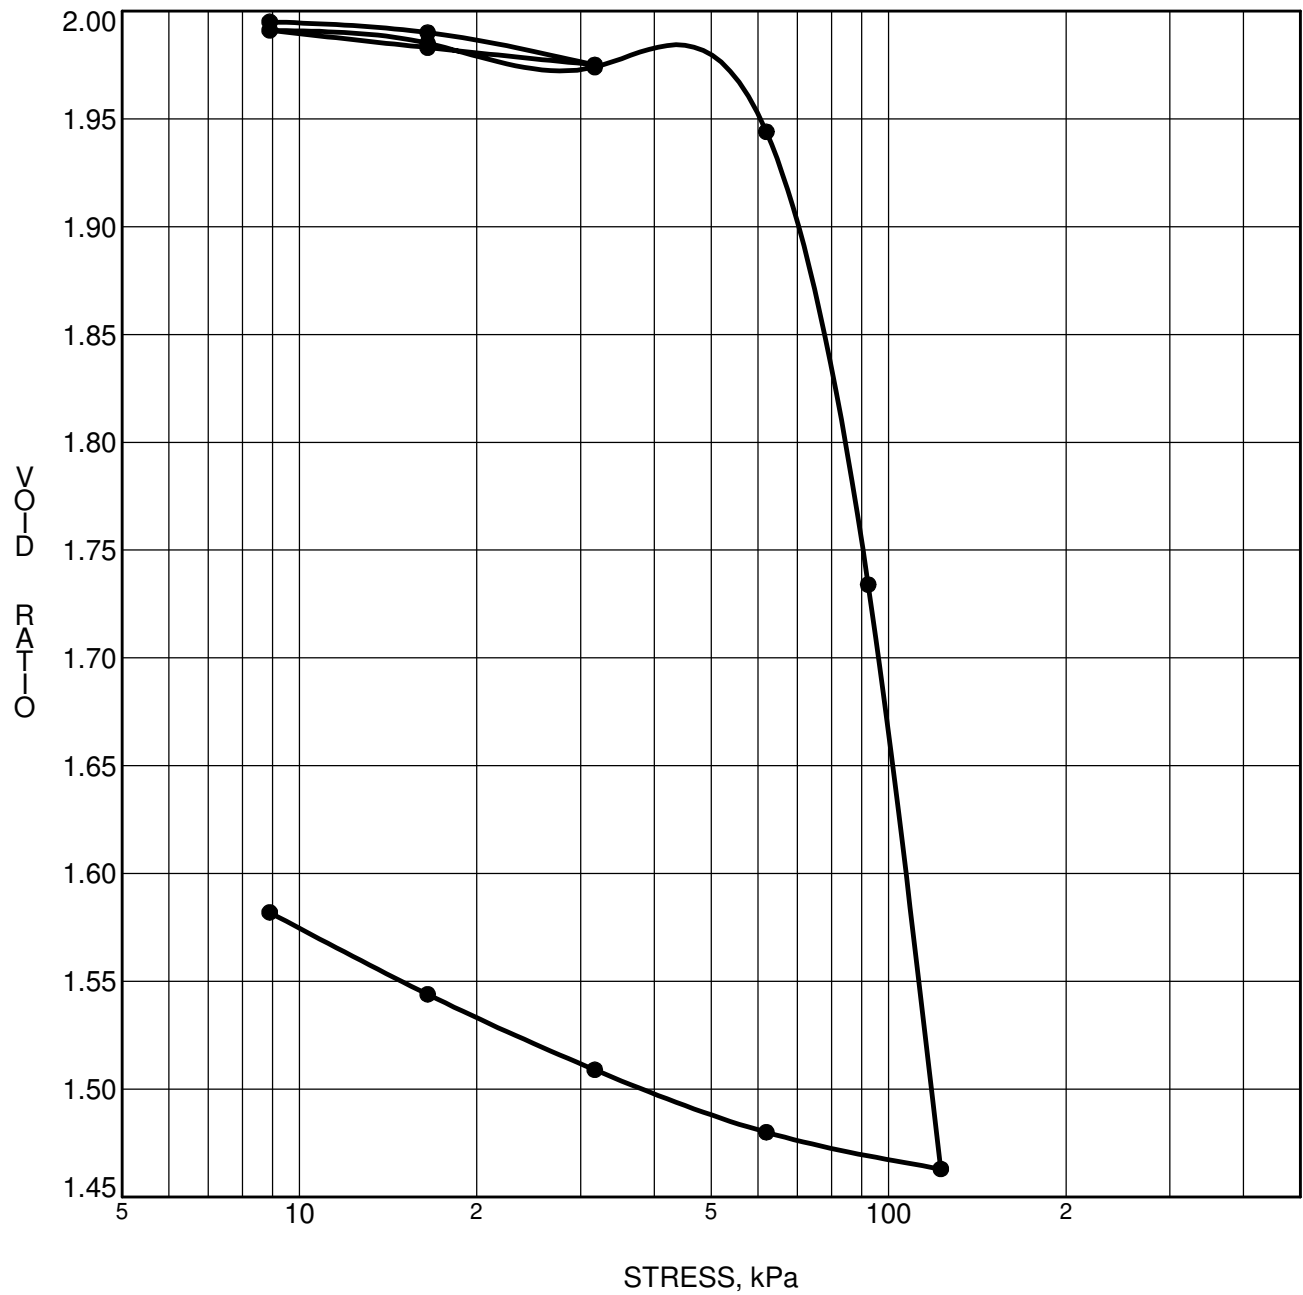
CONSOLIDATION TEST DATA SUMMARY					
Borehole No.	<b>BH16</b>	$p'_o$	<b>46 kPa</b>	$C_{cr}$	<b>0.028</b>
Sample No.	<b>TW 3</b>	$p'_c$	<b>73.1 kPa</b>	$C_c$	<b>2.174</b>
Sample Depth	<b>4.29 m</b>	OC Ratio	<b>1.6</b>	$W_o$	<b>72.6 %</b>
Sample Elev.	<b>80.90 m</b>	Void Ratio	<b>1.995</b>	Unit Wt.	<b>15.5 kN/m<sup>3</sup></b>

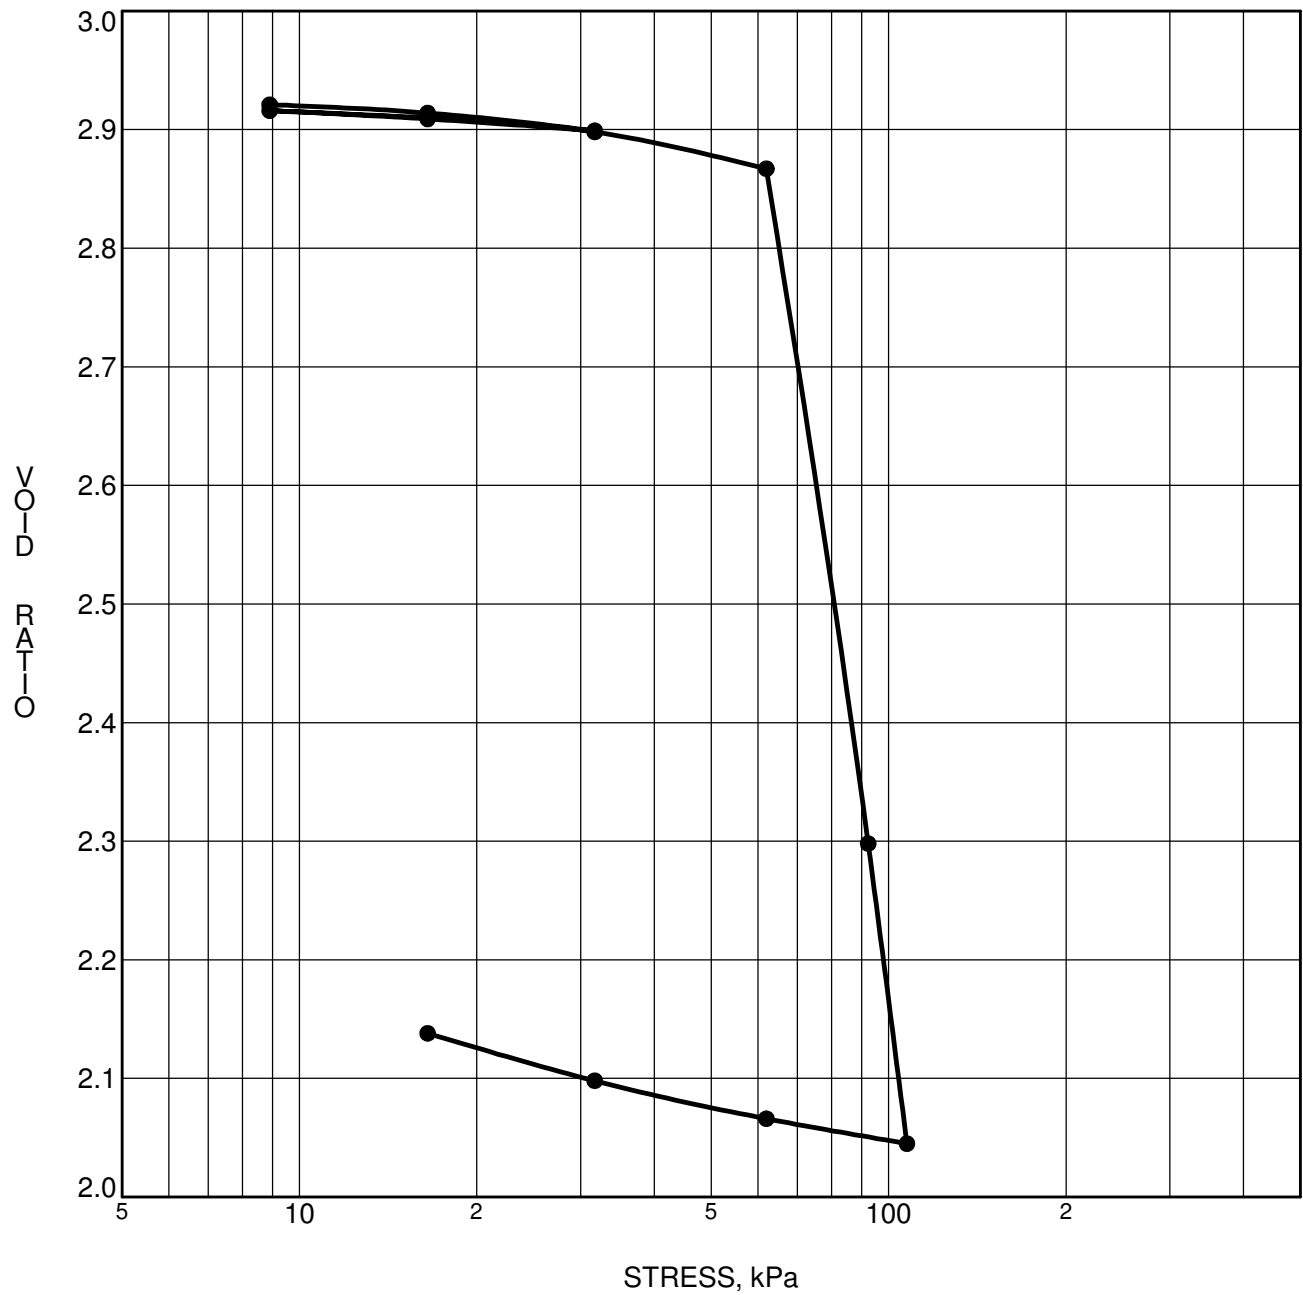
CONSOLIDATION TEST DATA SUMMARY					
Borehole No.	<b>BH17</b>	$p'_o$	<b>58.2 kPa</b>	$C_{cr}$	<b>0.033</b>
Sample No.	<b>TW 4</b>	$p'_c$	<b>65.5 kPa</b>	$C_c$	<b>3.875</b>
Sample Depth	<b>4.95 m</b>	OC Ratio	<b>1.1</b>	$W_o$	<b>106.3%</b>
Sample Elev.	<b>80.31 m</b>	Void Ratio	<b>2.924</b>	Unit Wt.	<b>14.2 kN/m<sup>3</sup></b>

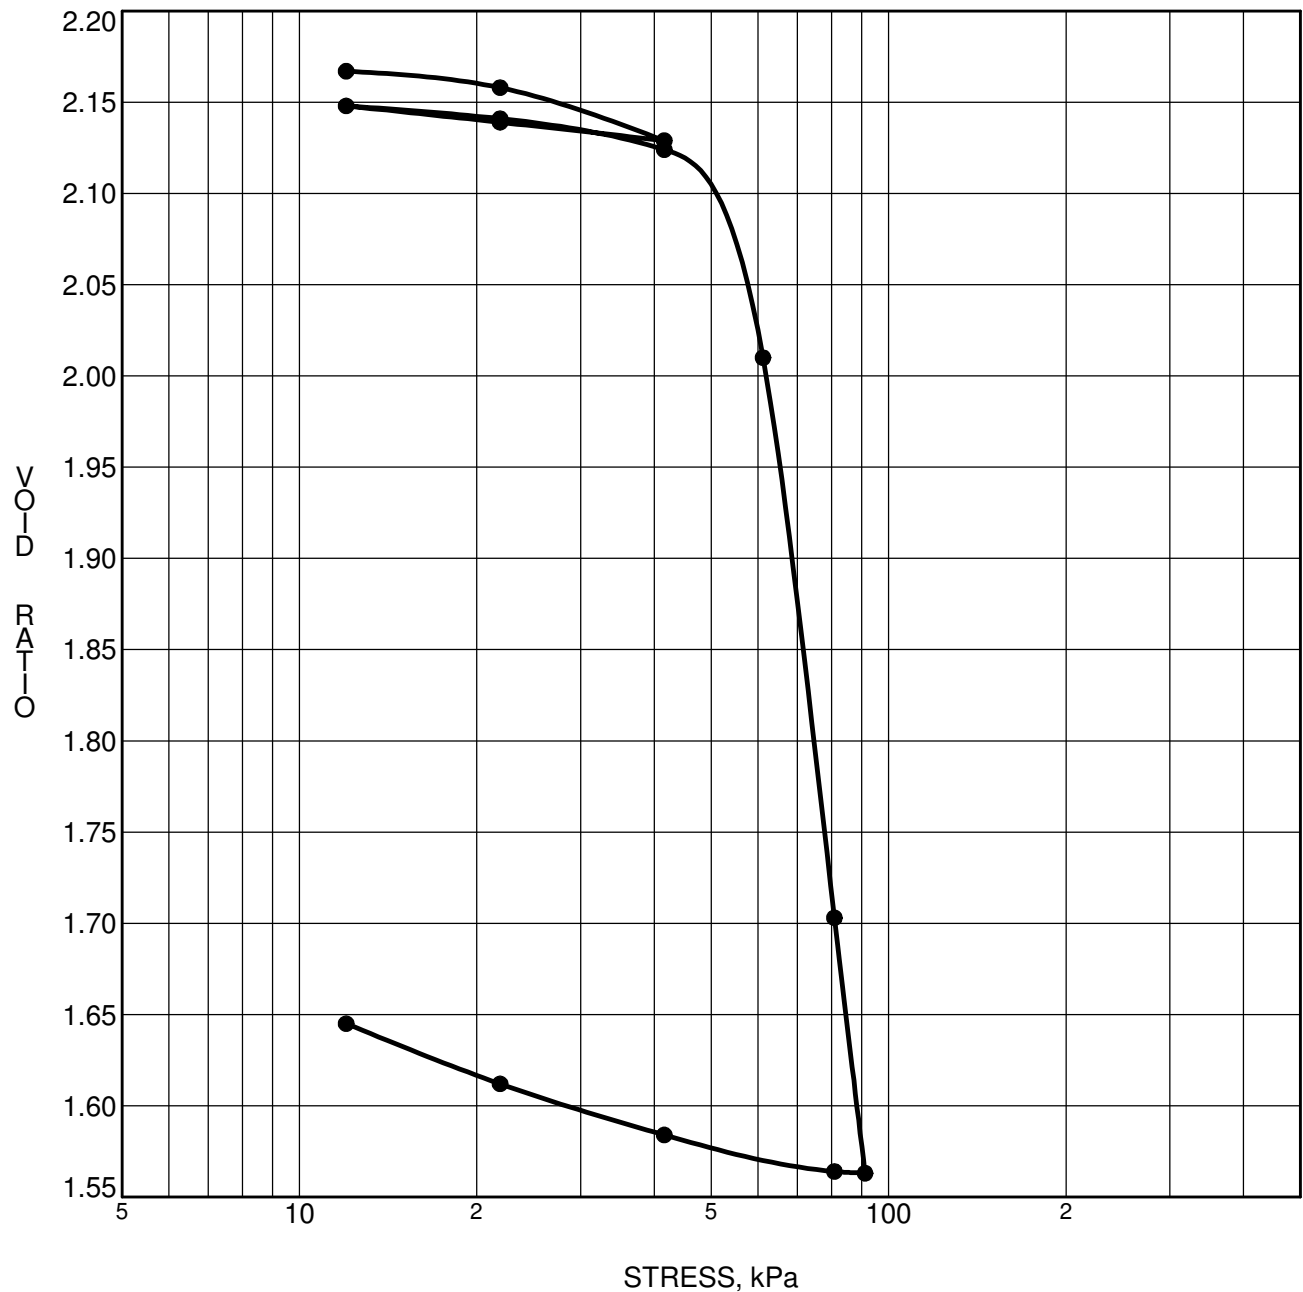
CONSOLIDATION TEST DATA SUMMARY					
Borehole No.	<b>BH19</b>	$p'_o$	<b>41.7 kPa</b>	$C_{cr}$	<b>0.044</b>
Sample No.	<b>TW 4</b>	$p'_c$	<b>55.5 kPa</b>	$C_c$	<b>2.524</b>
Sample Depth	<b>3.38 m</b>	OC Ratio	<b>1.3</b>	$W_o$	<b>79.4 %</b>
Sample Elev.	<b>83.43 m</b>	Void Ratio	<b>2.183</b>	Unit Wt.	<b>15.2 kN/m<sup>3</sup></b>

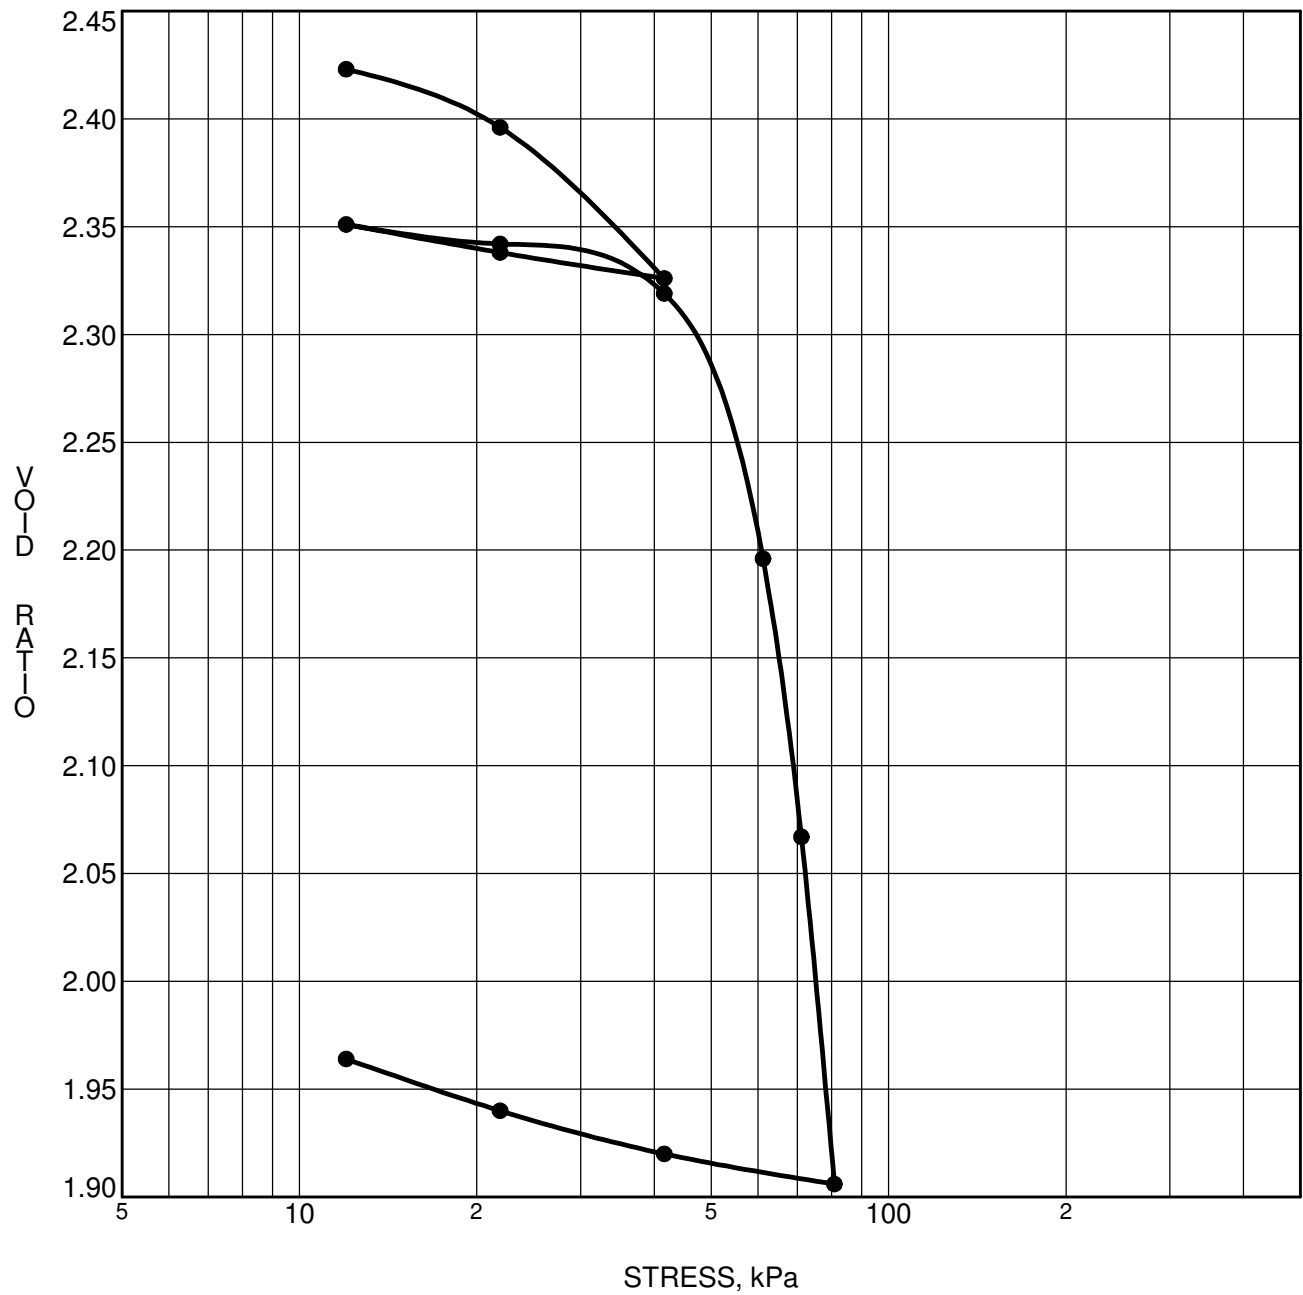
CONSOLIDATION TEST DATA SUMMARY					
Borehole No.	<b>BH22</b>	$p'_o$	<b>58.6 kPa</b>	$C_{cr}$	<b>0.058</b>
Sample No.	<b>TW 4</b>	$p'_c$	<b>59 kPa</b>	$C_c$	<b>2.869</b>
Sample Depth	<b>5.00 m</b>	OC Ratio	<b>1.0</b>	$W_o$	<b>89.5 %</b>
Sample Elev.	<b>80.94 m</b>	Void Ratio	<b>2.461</b>	Unit Wt.	<b>14.8 kN/m<sup>3</sup></b>

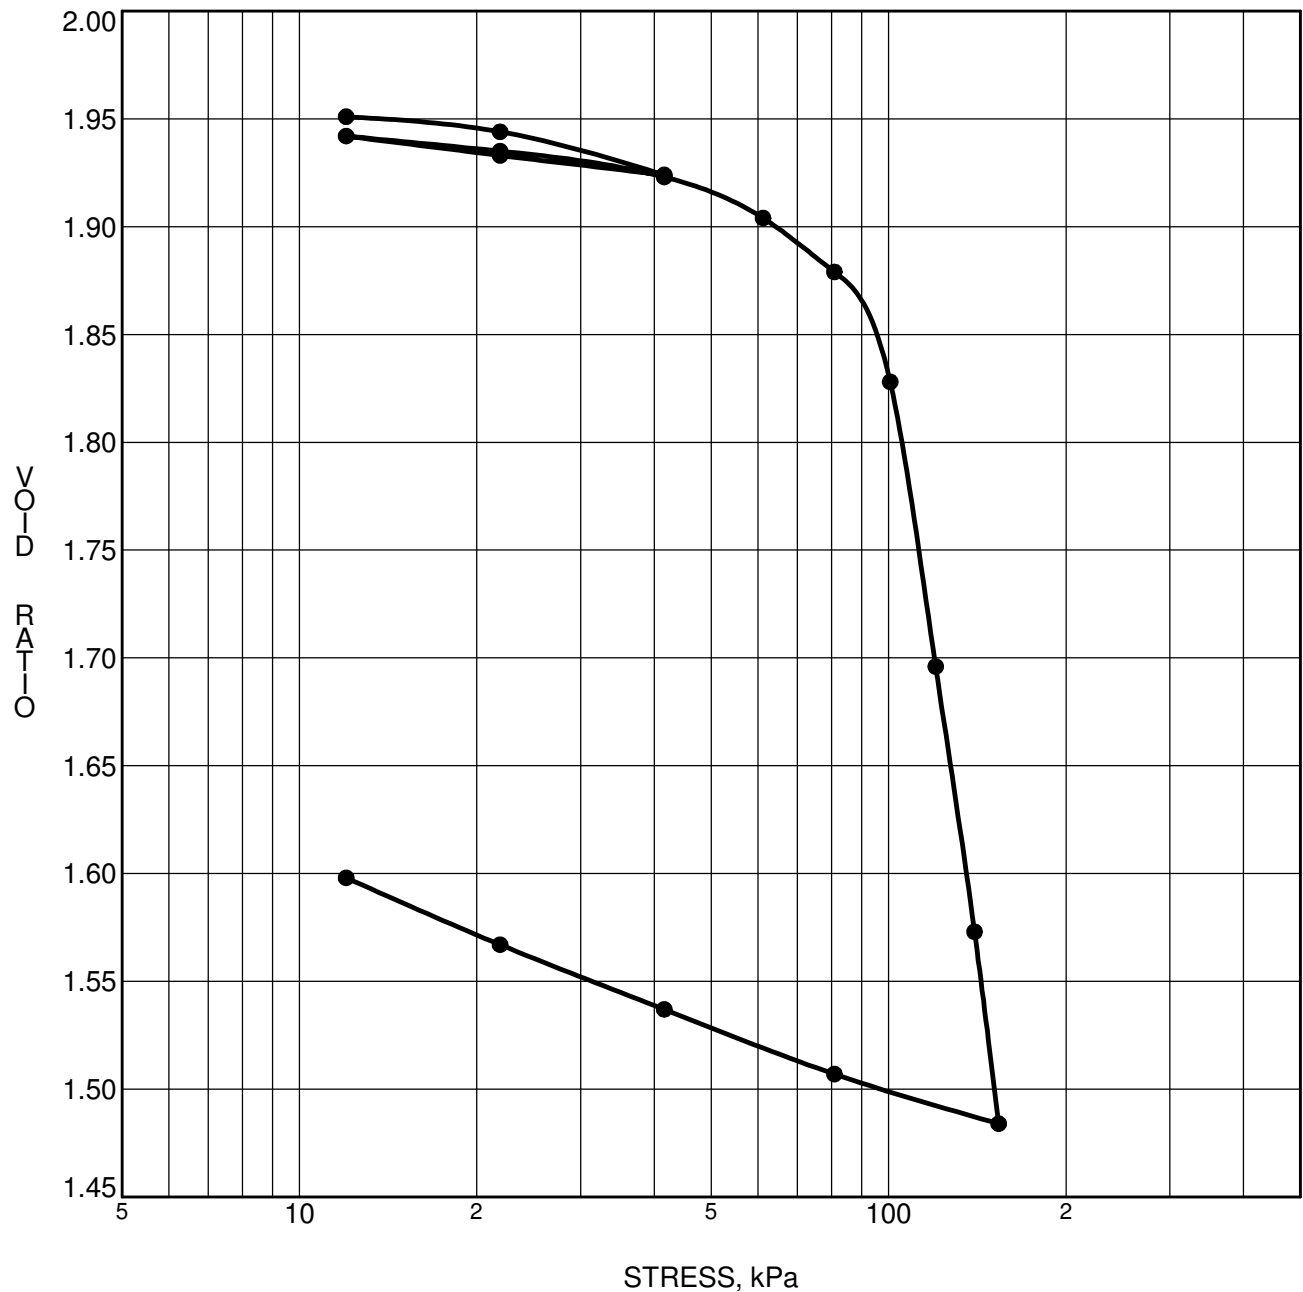
CONSOLIDATION TEST DATA SUMMARY					
Borehole No.	<b>BH26</b>	$p'_o$	<b>53.4 kPa</b>	$C_{cr}$	<b>0.036</b>
Sample No.	<b>TW 5</b>	$p'_c$	<b>97 kPa</b>	$C_c$	<b>1.916</b>
Sample Depth	<b>4.16 m</b>	OC Ratio	<b>1.8</b>	$W_o$	<b>71.6 %</b>
Sample Elev.	<b>83.10 m</b>	Void Ratio	<b>1.969</b>	Unit Wt.	<b>15.6 kN/m<sup>3</sup></b>
