## Geotechnical Investigation

Proposed Residential Development  
2009-2013 Prince of Wales Drive  
Ottawa, Ontario  
*Revision 3*

LRL File No.: 220528

December 2022, *Revised: April 2024*

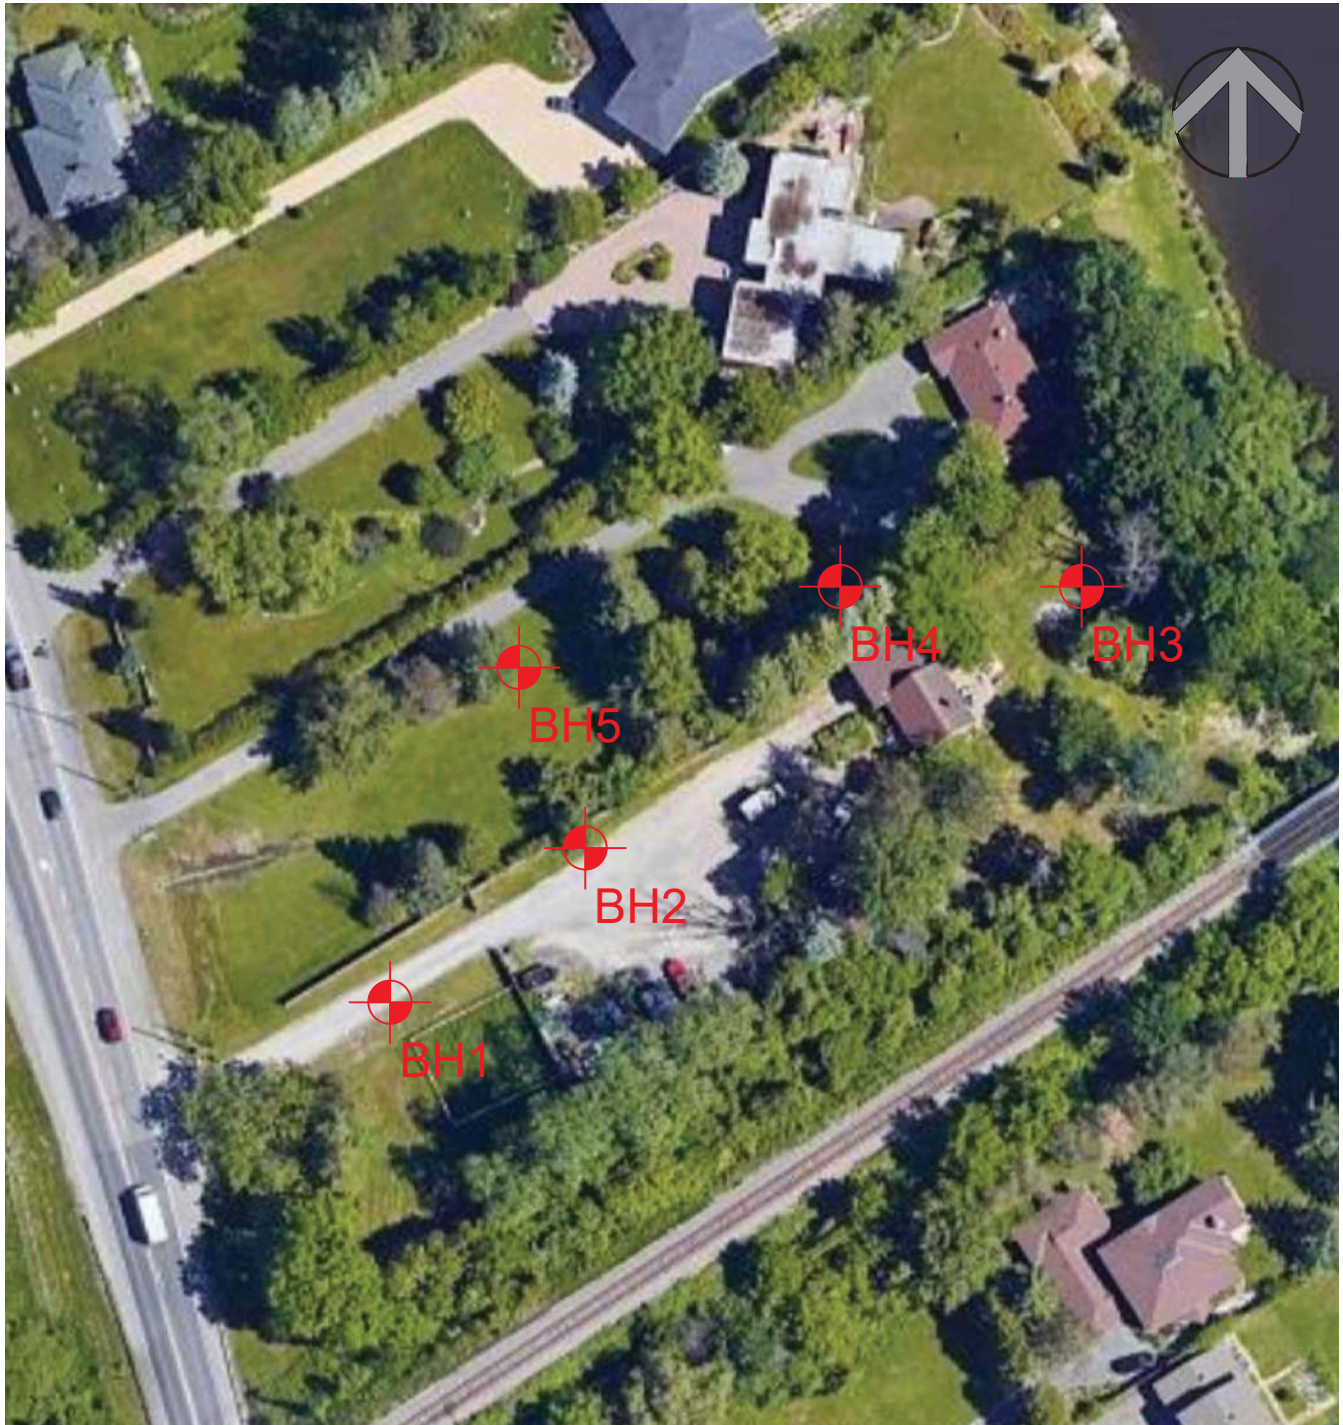
**FIGURE 2**

The fieldwork for this investigation was carried out on November 28, 2022. Prior to the fieldwork, the site was cleared for the presence of any underground services and utilities. A total of five (5) boreholes were drilled onsite to get a general representation of the site's underlying soil conditions, and labelled BH1 through BH5. The approximate locations of the boreholes are shown in Figure 2 included in **Appendix A**.

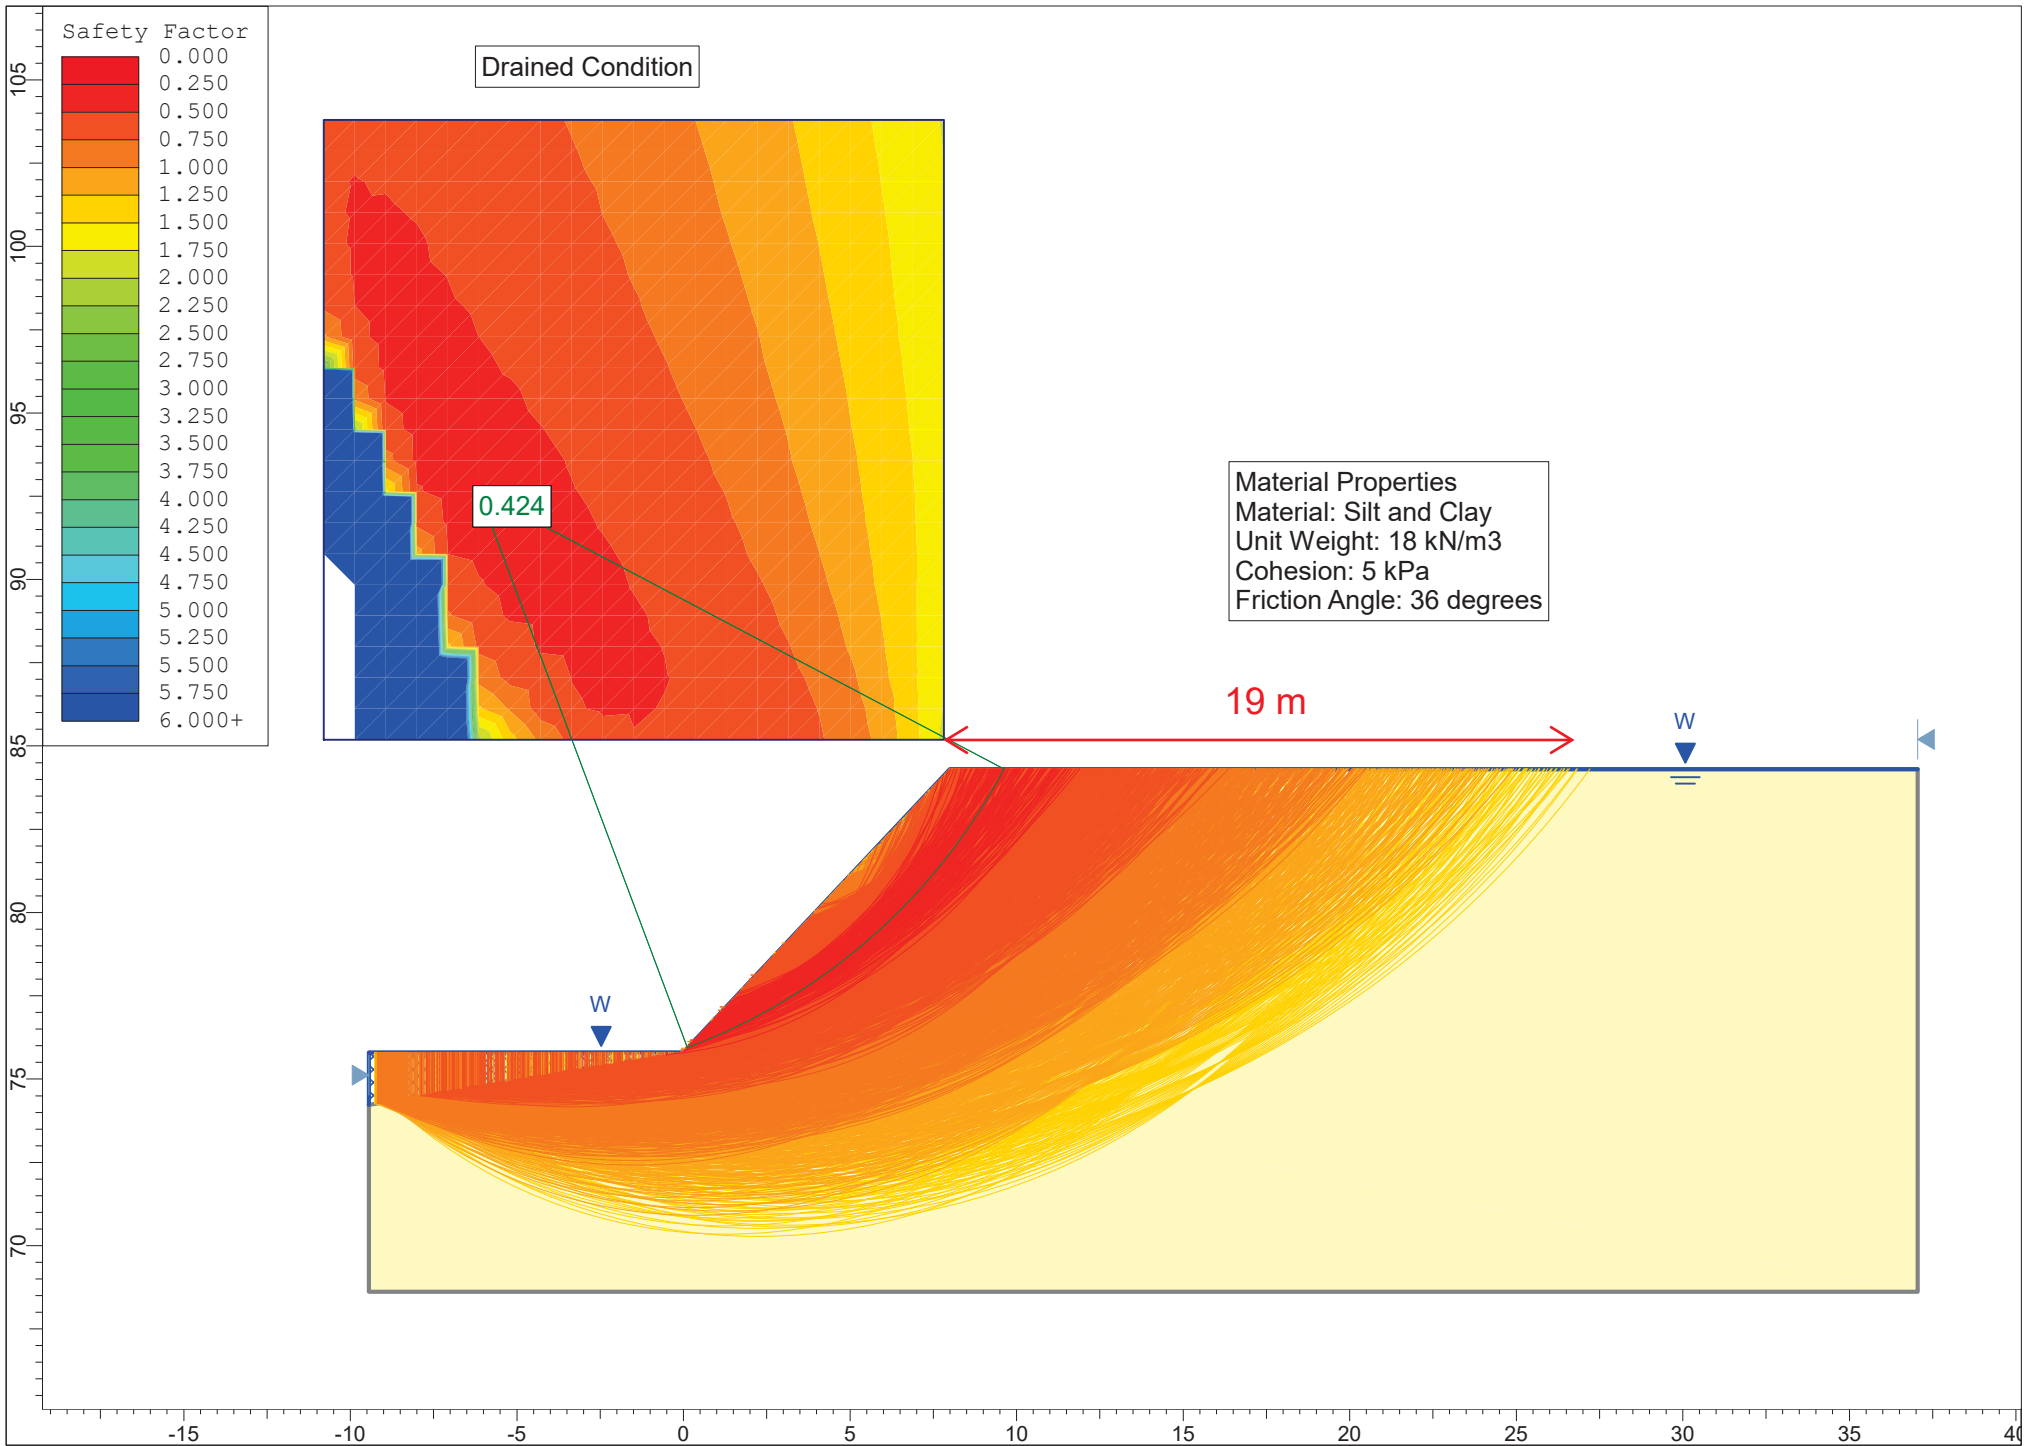
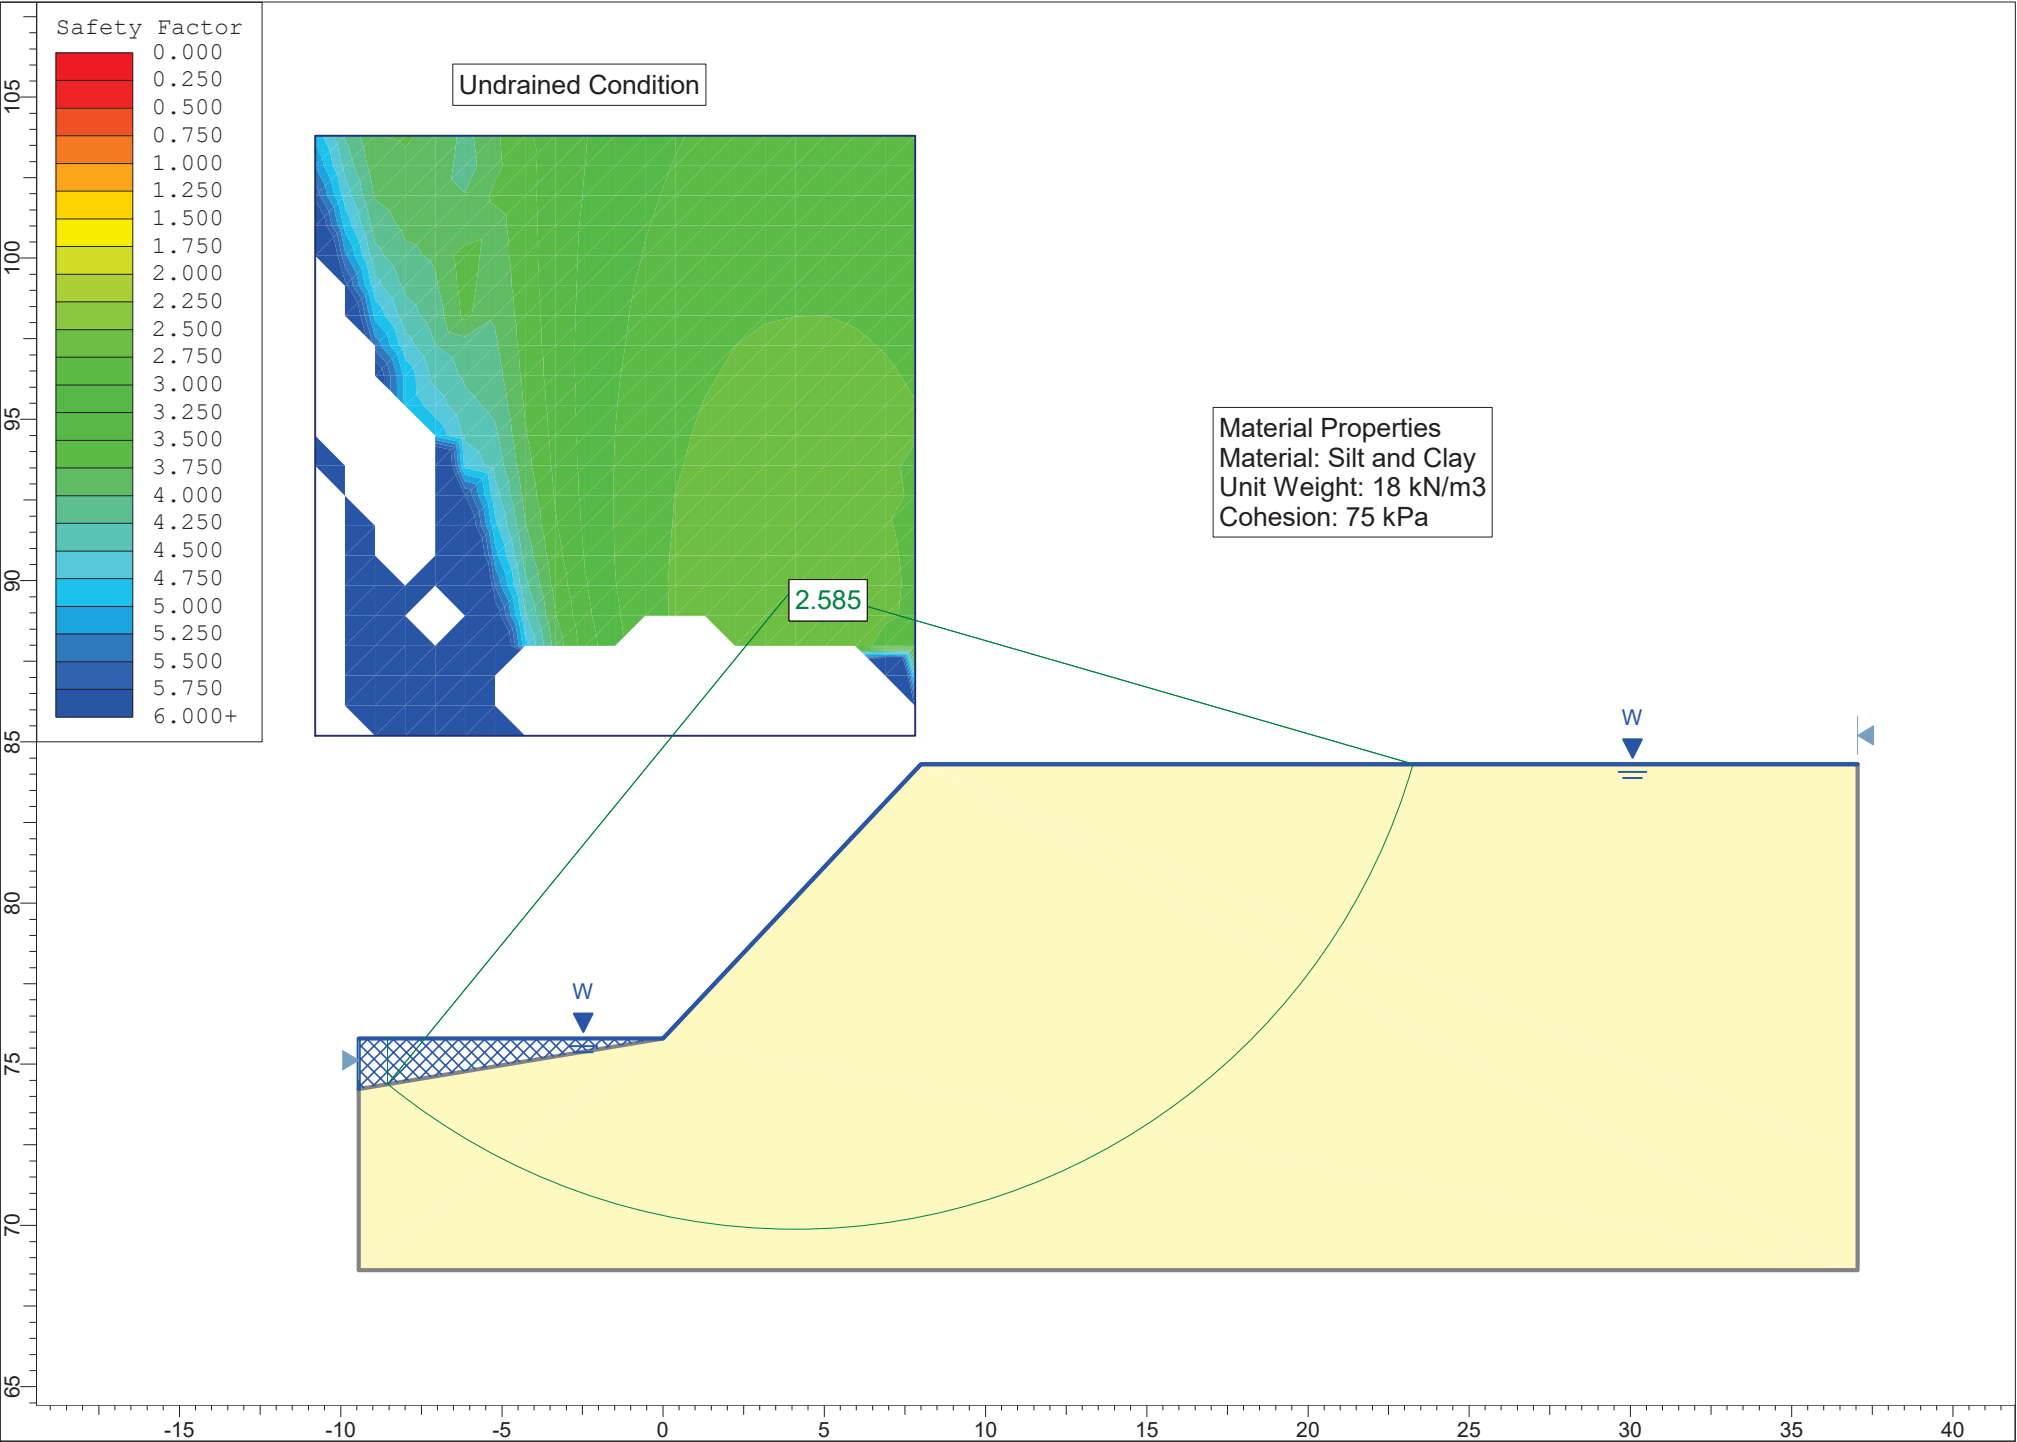
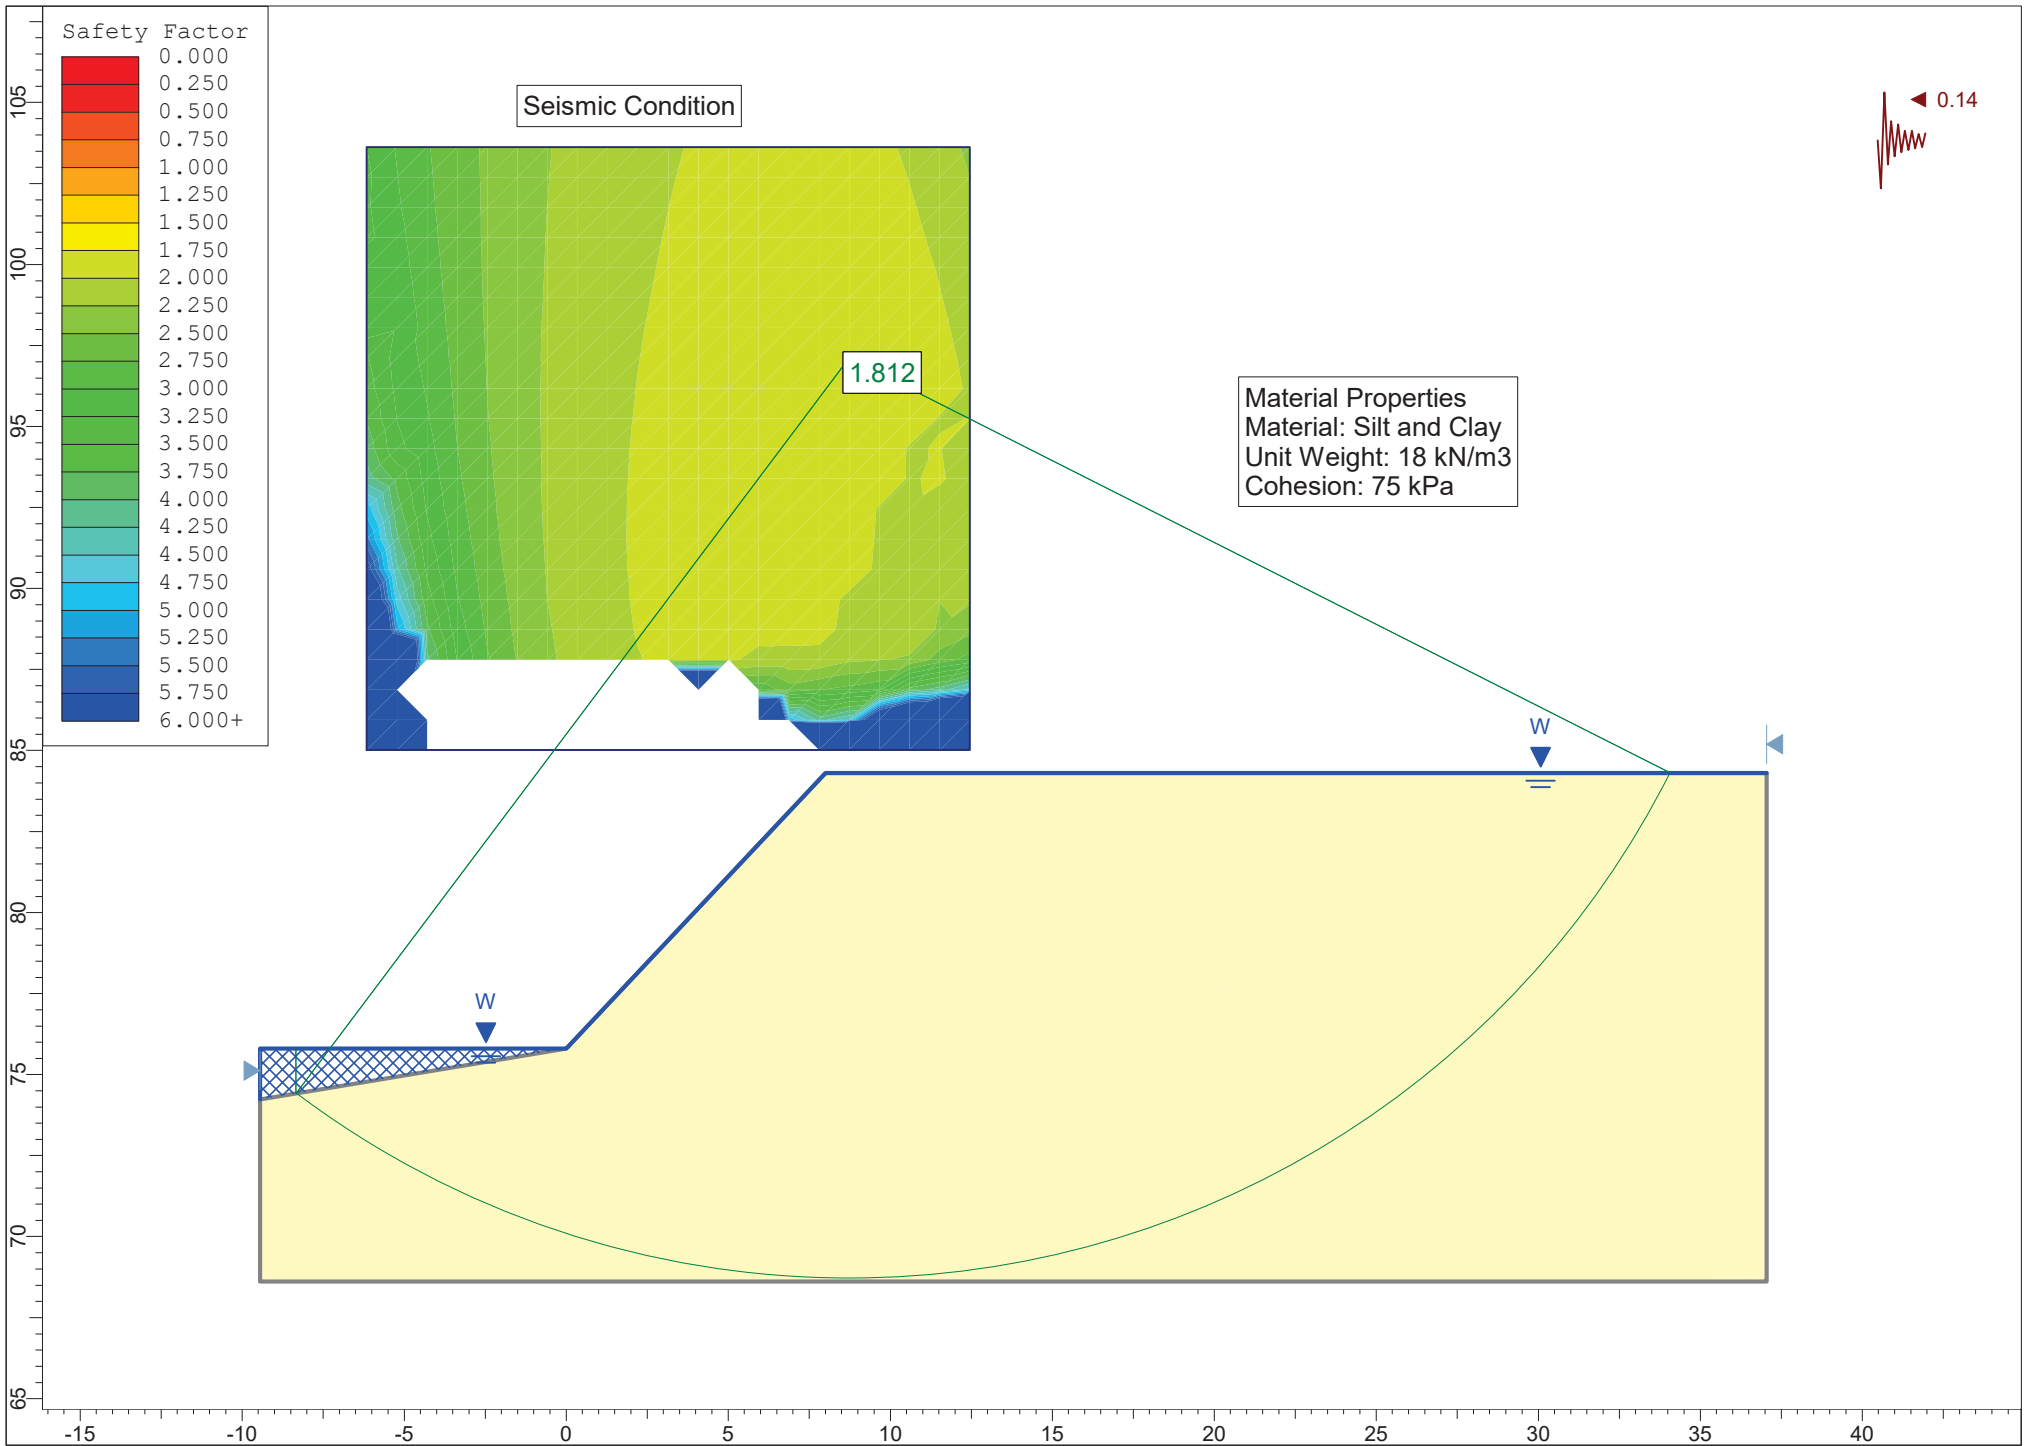
**APPENDIX E**  
**Slope Stability Modelling Results**

The slope modelling program, Slide 5.0 (Rocscience), was used to implement the Bishop simplified method of slices. A slope profile, considered to be the steepest onsite (worst case scenario) was selected and modeled to check the conditions of the slope. The slope was analyzed under both the undrained (short term failure) and drained (long term failure) conditions.

Drained Condition	Undrained Condition	Seismic
Factor of Safety	0.42	2.59	1.81
<b>Min. Required</b>	<b>1.50</b>	<b>1.50</b>	<b>1.10</b>

**These results indicate that the slope is unstable in the drained (long-term) condition. A setback for any permanent structure(s) (dwellings, decks, sheds, gazebos, pools, etc.) from the top of the slope is required to ensure that in the event of a slope failure, the structure(s) will be unharmed. The model was filtered to illustrate the failure surface with a FOS below 1.50.**

The Stable Slope Allowance is the area where a factor of safety is less than 1.50 against overall rotational failure. As indicated in the attached model, **a 19.0 m setback is required for Stable Slope Allowance.**
