# **Phase II – Environmental Site Assessment**

Tunney's Pasture (Block 9)

Ottawa, Ontario

Report: PE6039-2

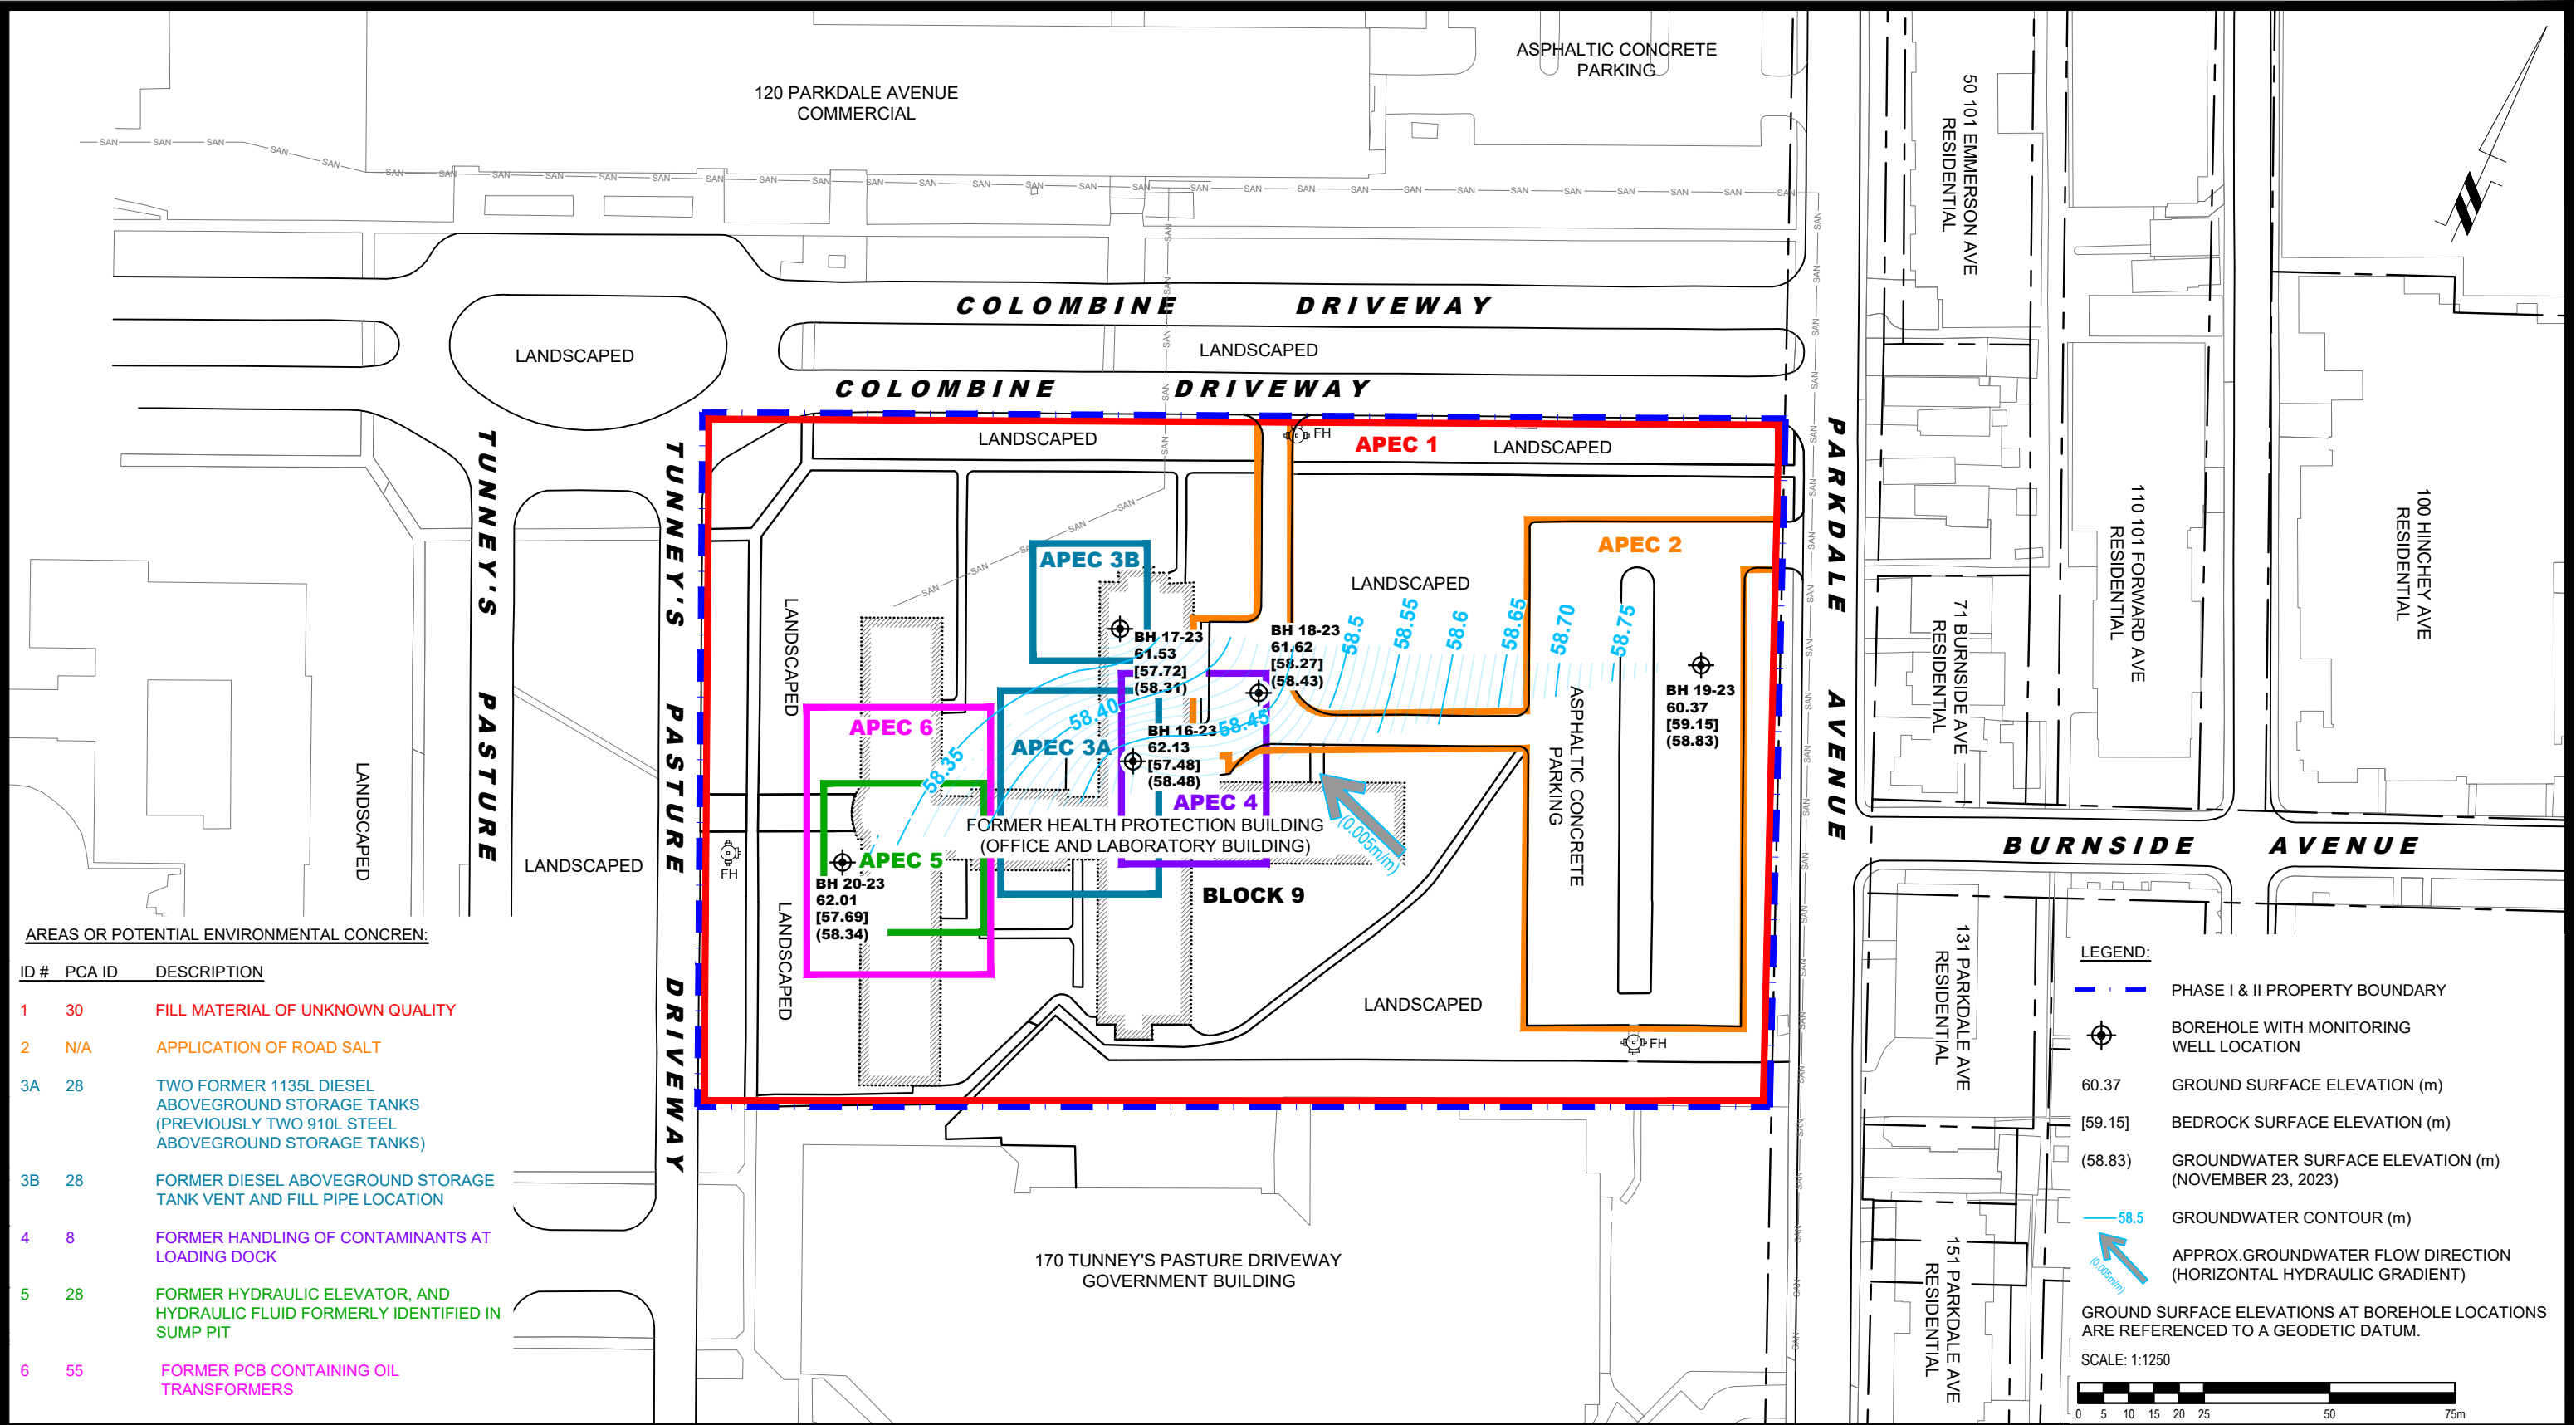
Dwg. No.: PE6039-3

Using the groundwater elevations recorded during the sampling event, groundwater contour mapping was completed as part of this assessment. According to the mapped contour data, illustrated on Drawing PE6039-3 – Test Hole Location Plan in the appendix, the groundwater flow on the subject site was calculated to be in a northwesterly direction. A horizontal hydraulic gradient of approximately 0.005 m/m was also calculated as part of this assessment. It should be noted that groundwater levels are expected to fluctuate throughout the year with seasonal variations.

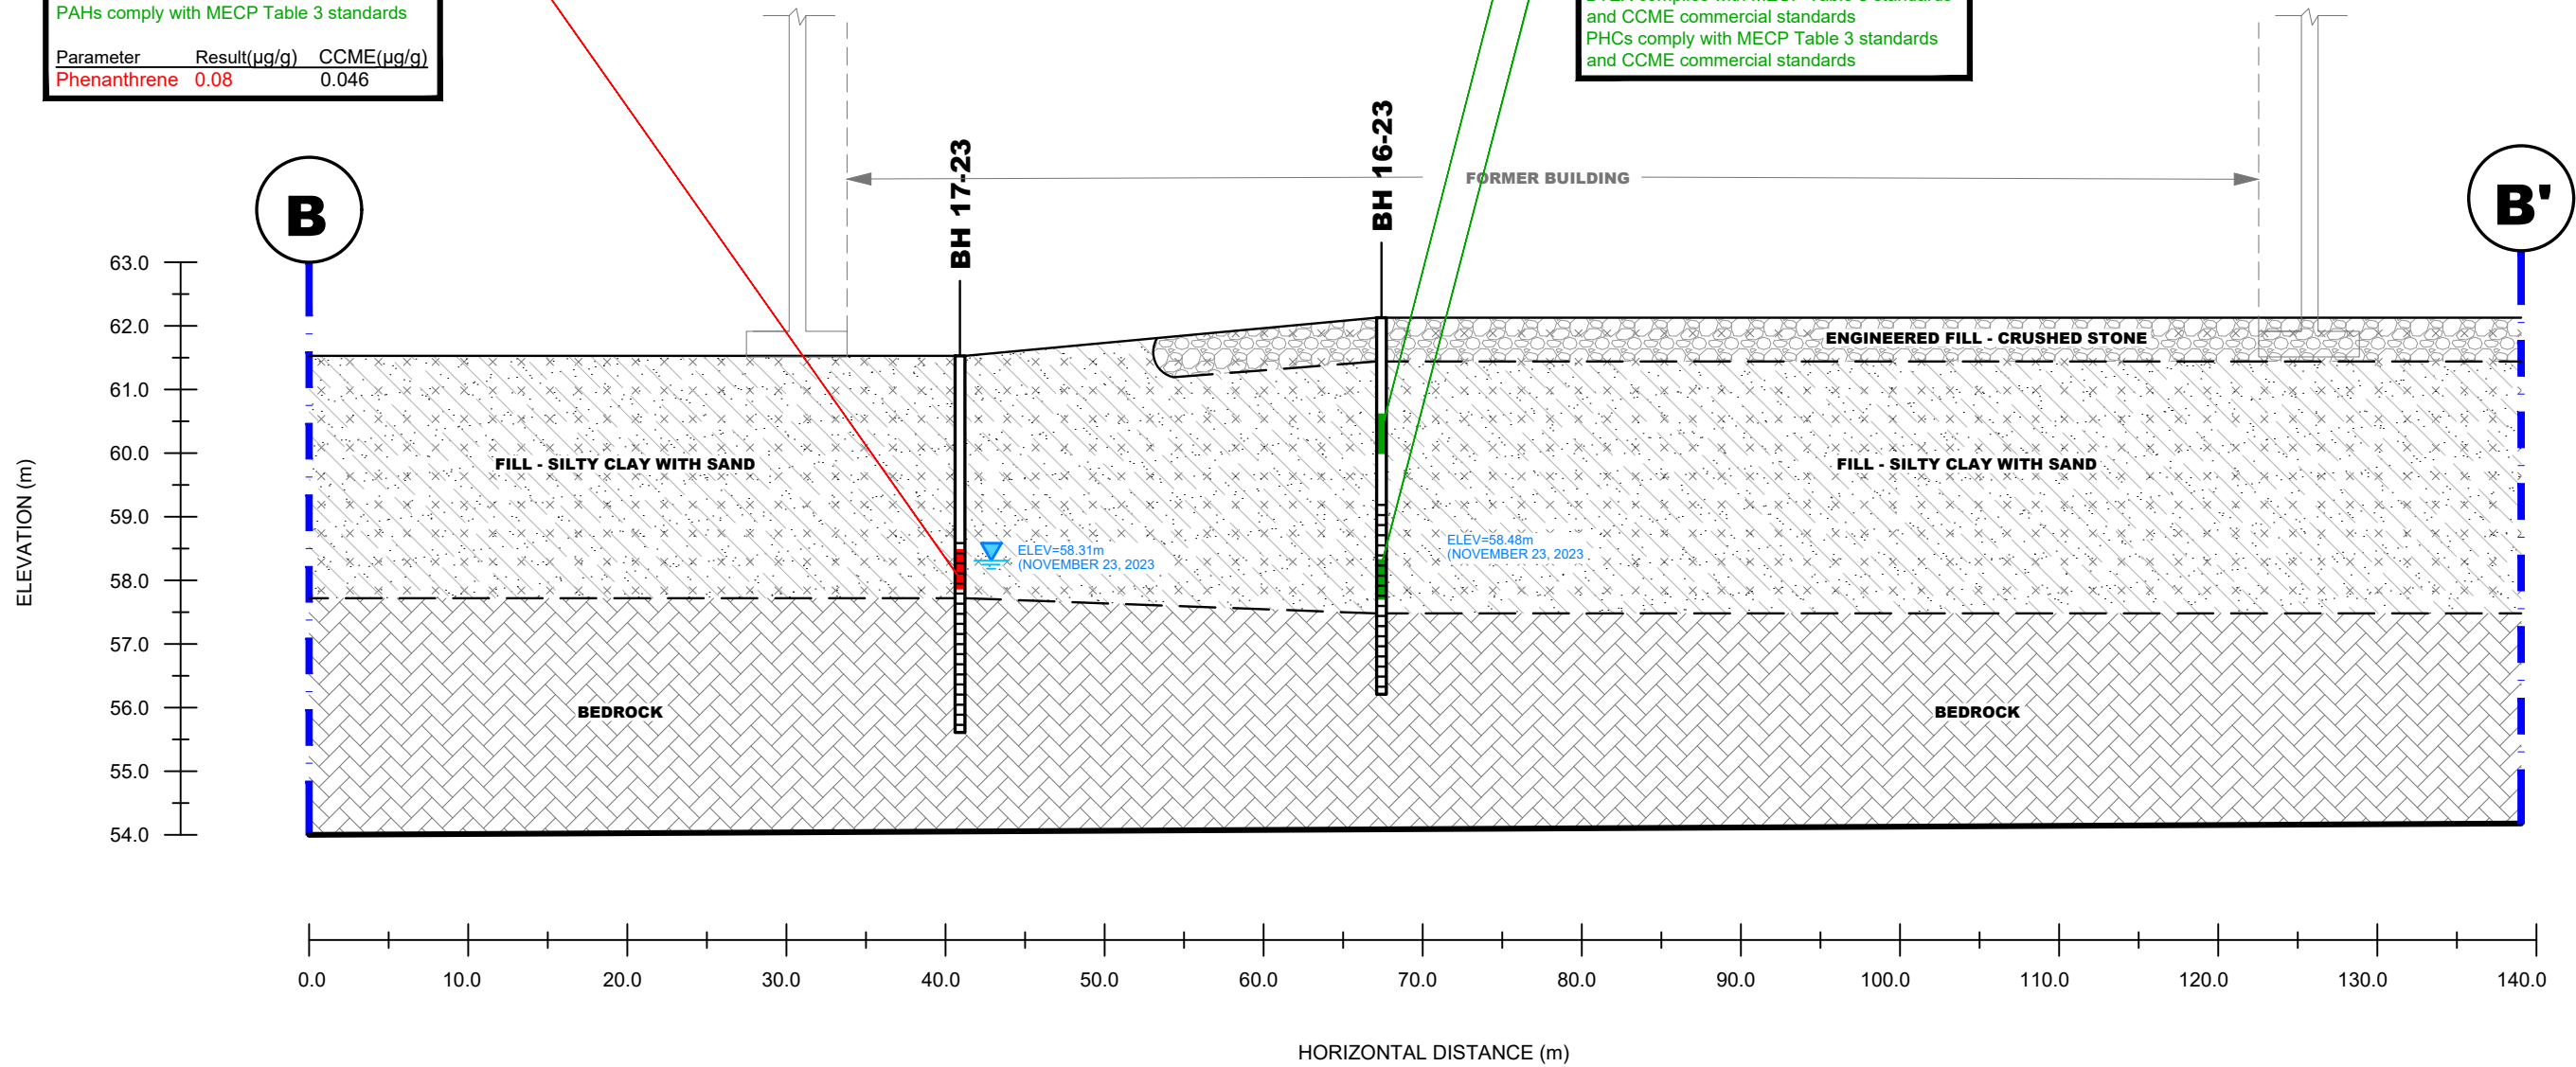
| | | | | TUNNEY'S PASTURE - BLOCK 9 | | Checked by: | JA | Dwg. No.: | PE6039-4B |

SOIL RESULT COMPLIES WITH THE MECP TABLE 3 STANDARDS

SOIL RESULT EXCEEDS THE MECP TABLE 3 STANDARDS
