# **Phase II – Environmental Site Assessment**

Tunney's Pasture (Blocks 1 & 2)  
Ottawa, Ontario

Prepared for Arcadis IBI Group

Report: PE6034-2  
March 22, 2024

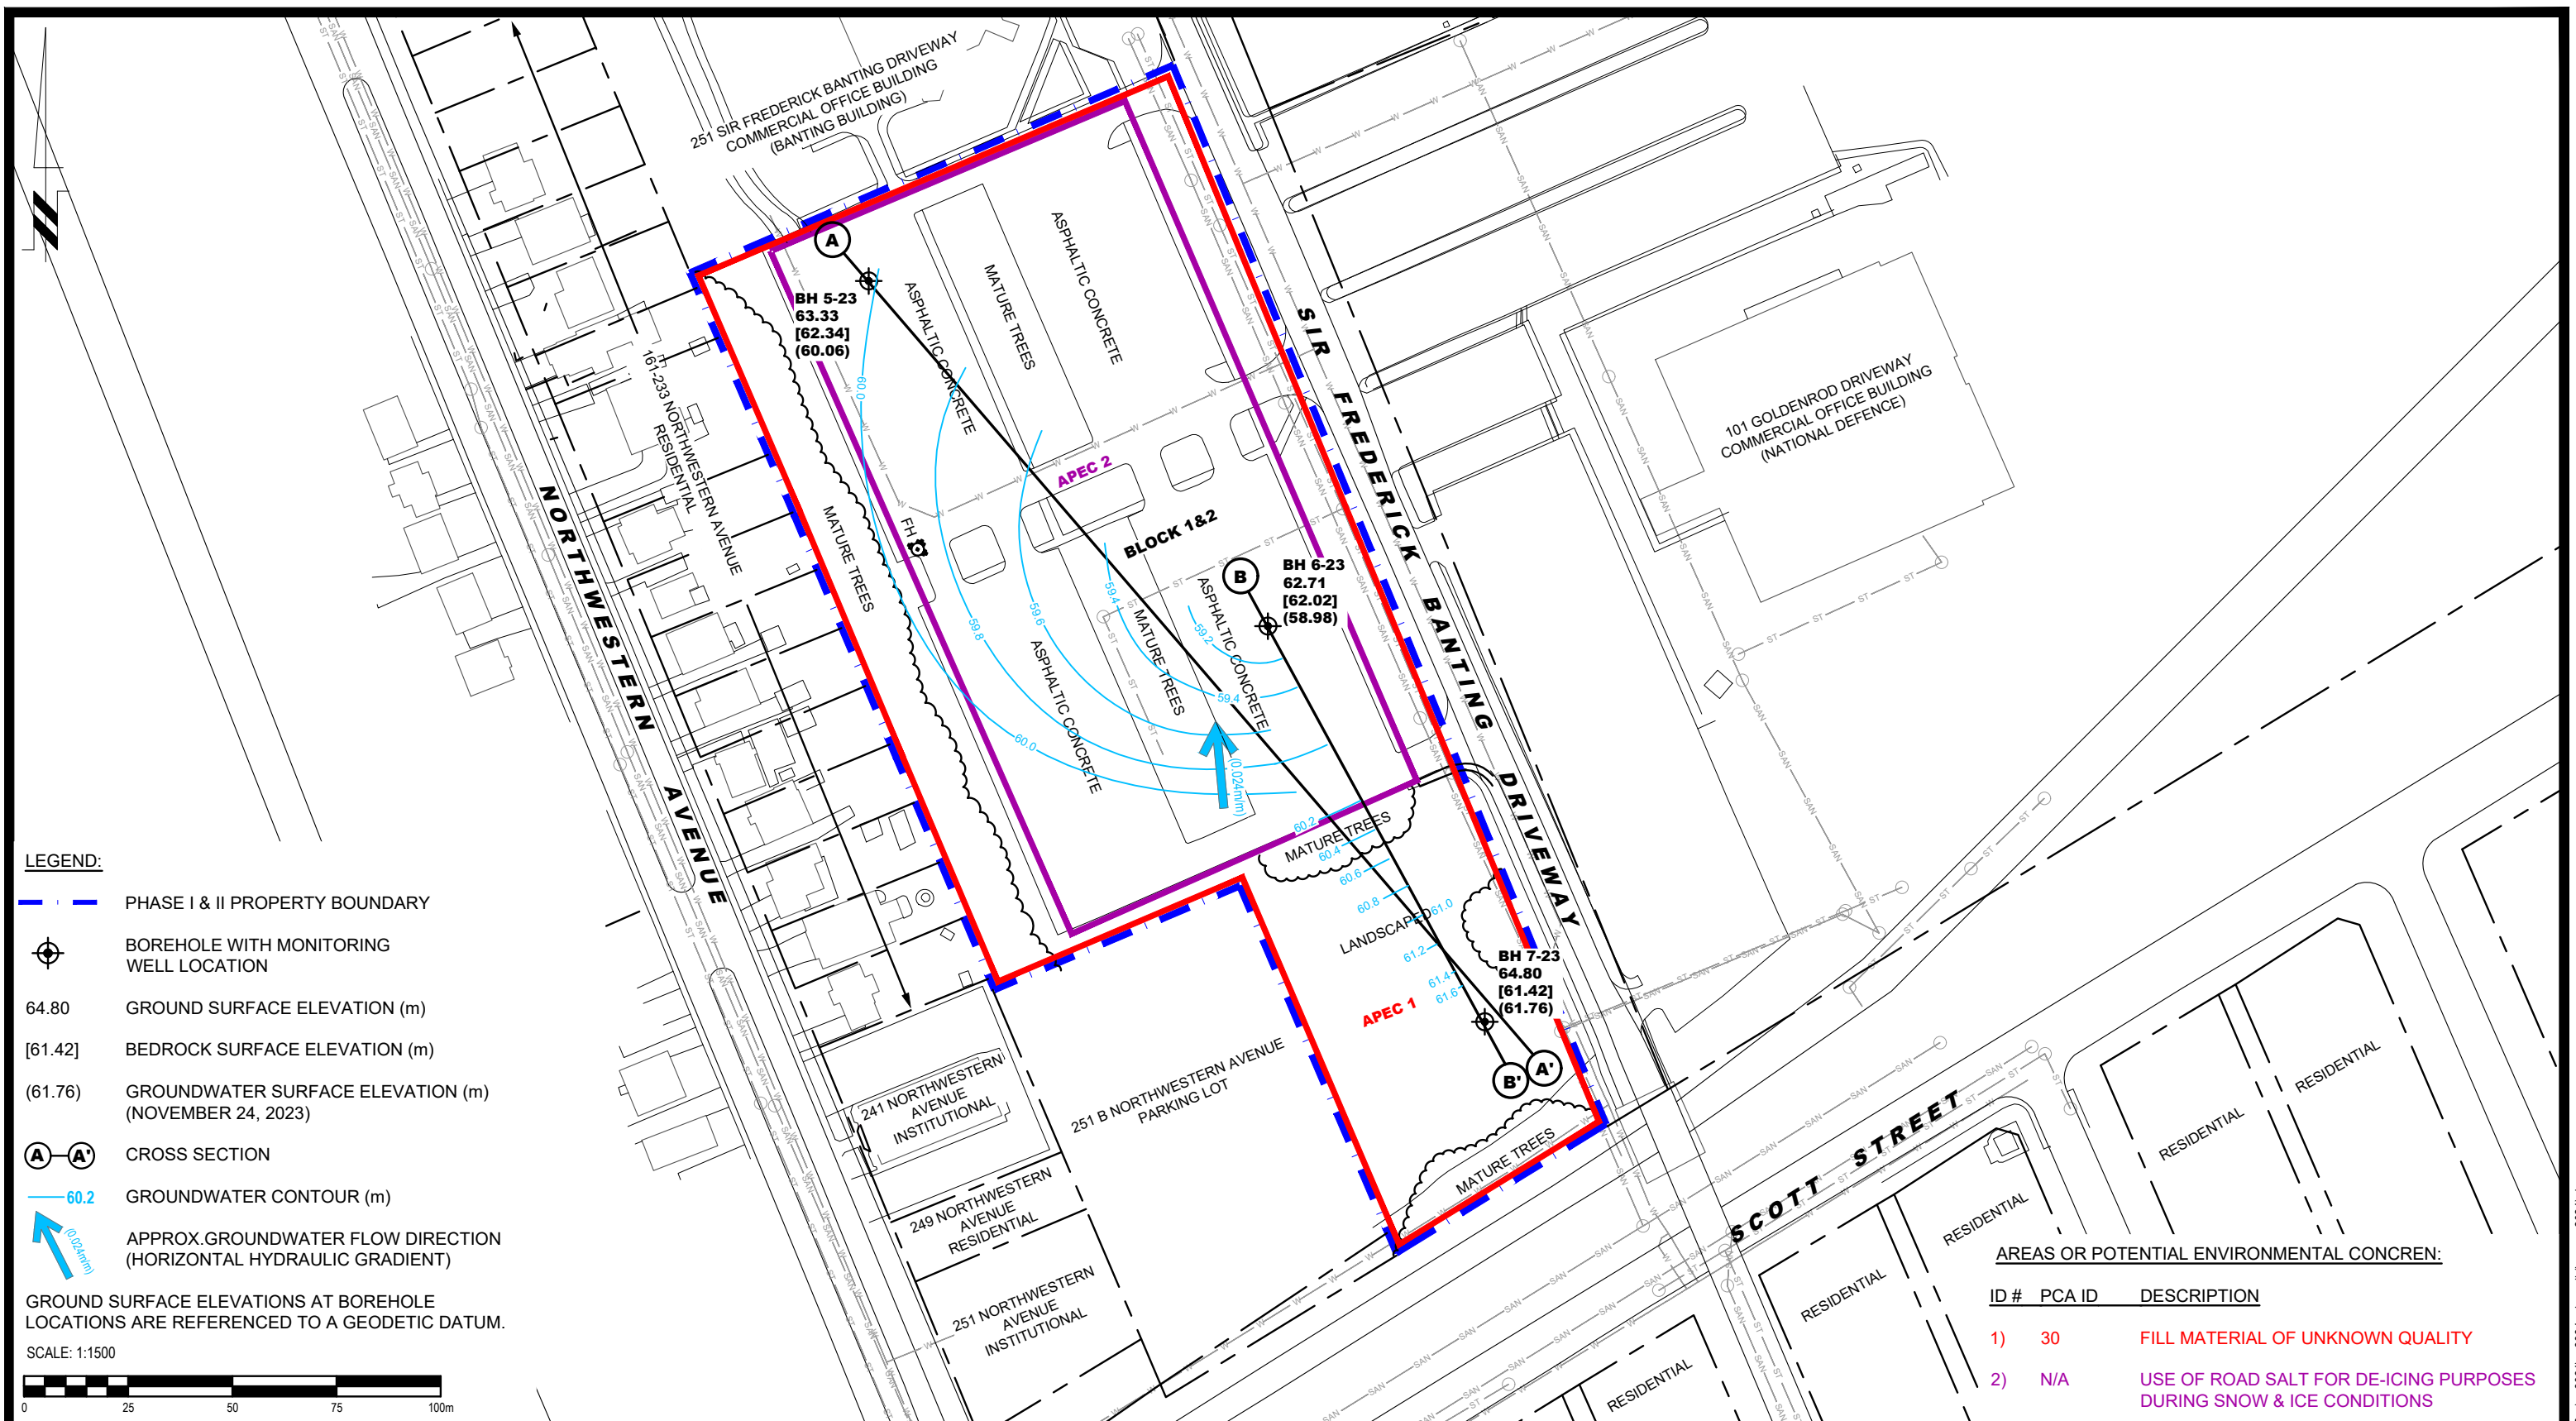
Using the groundwater elevations recorded during the sampling event, groundwater contour mapping was completed as part of this assessment. According to the mapped contour data, illustrated on Drawing PE6034-3 – Test Hole Location Plan in the appendix, the groundwater flow on the subject site was calculated to be in a northerly direction. A horizontal hydraulic gradient of approximately 0.024 m/m was also calculated as part of this assessment. It should be noted that groundwater levels are expected to fluctuate throughout the year with seasonal variations.

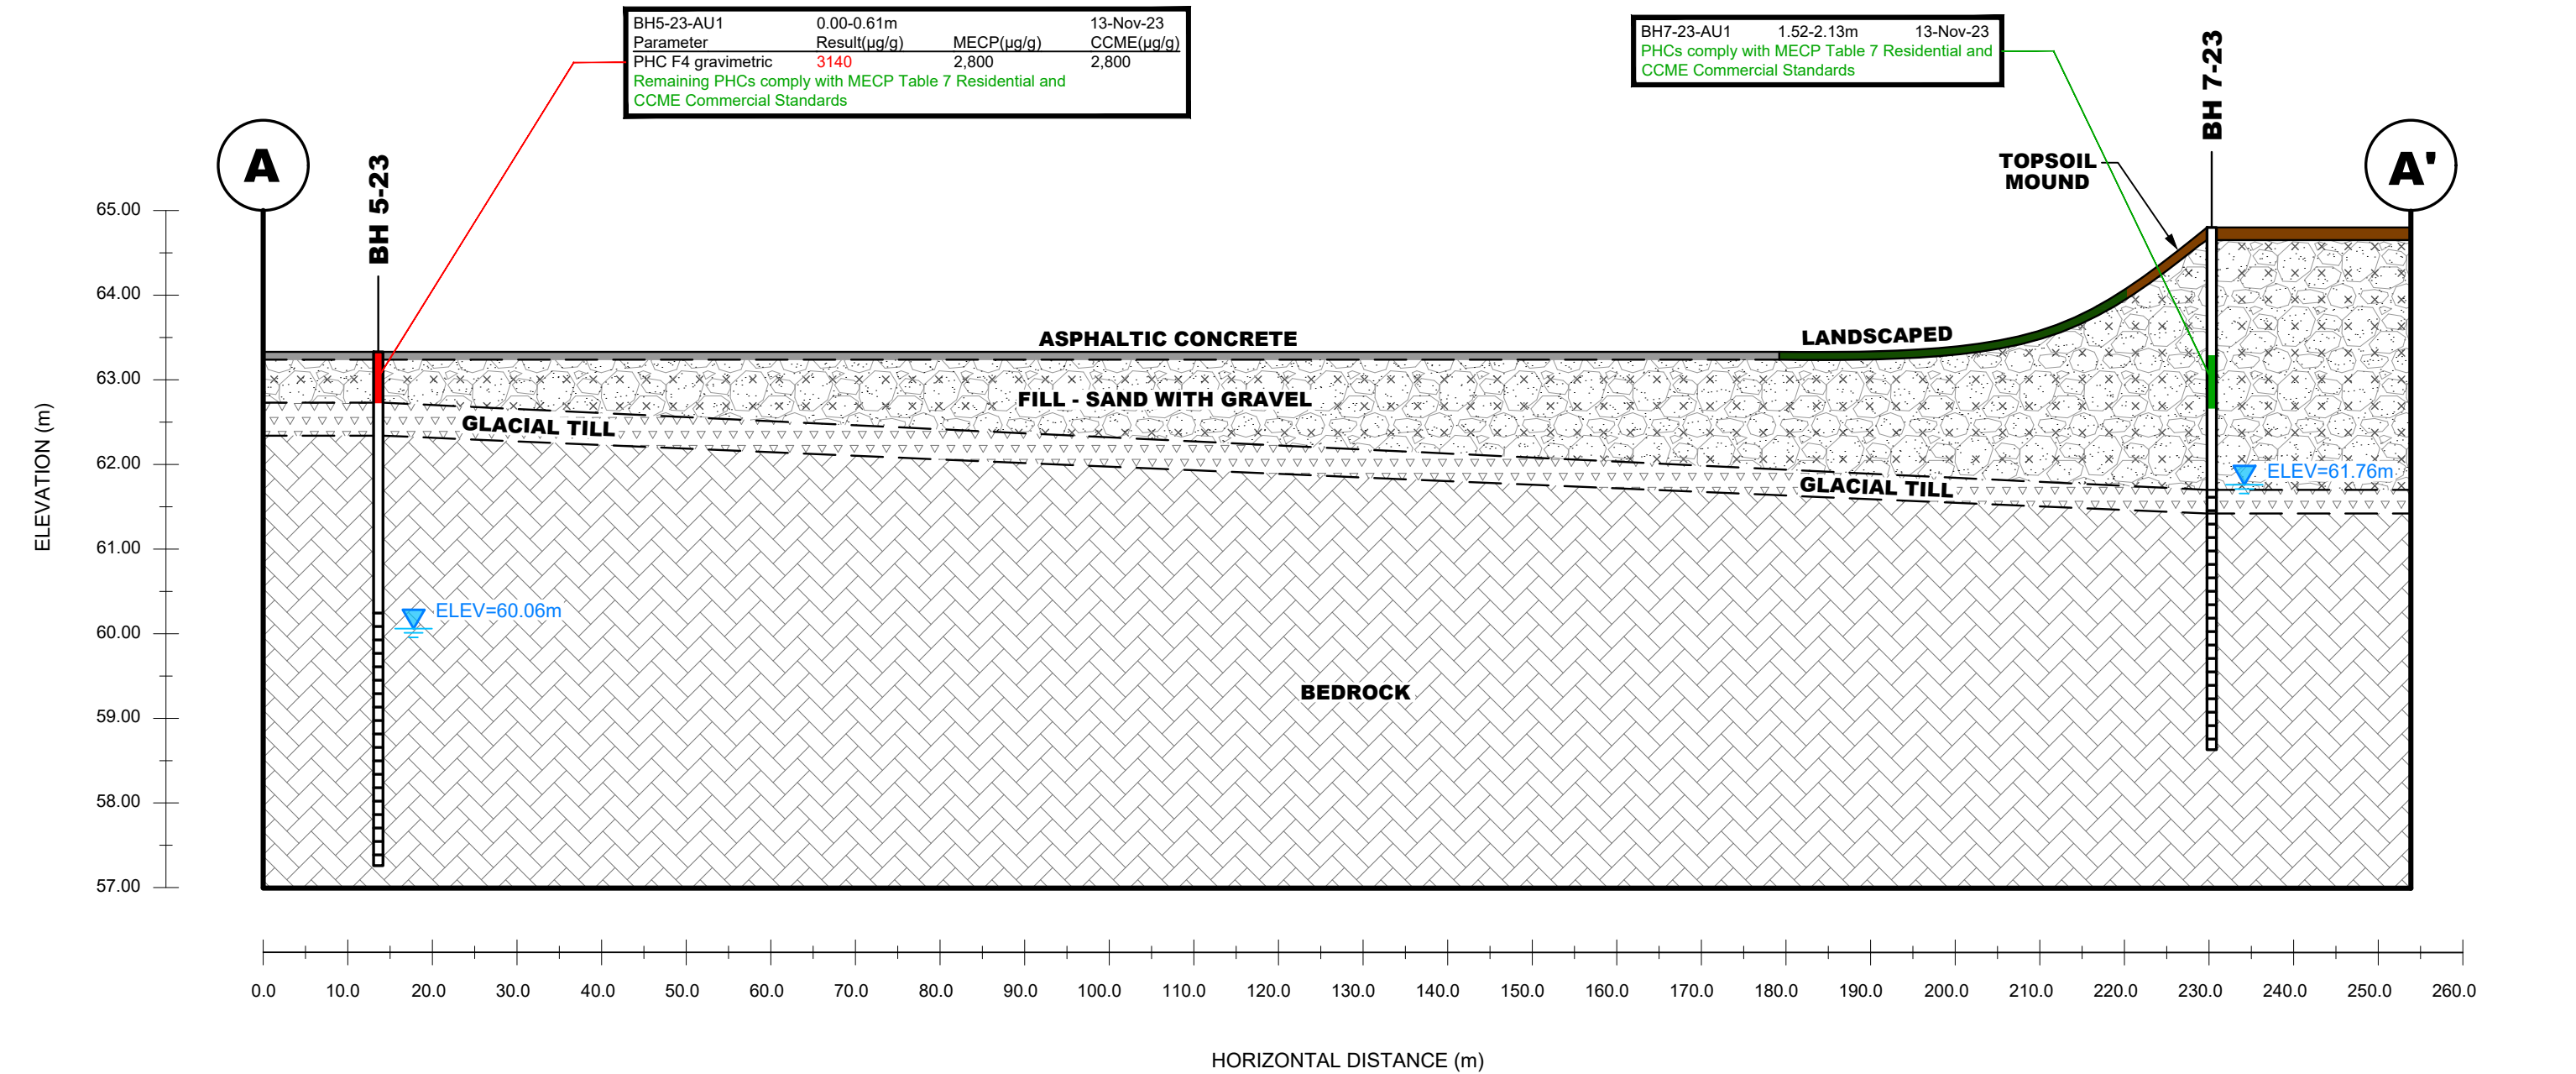
| Checked by: | NS | Dwg. No.: | PE6034-4A |

The fill material present beneath the surficial asphalt at BH5-23 is impacted above provincial MECP standards with heavier fractions of petroleum hydrocarbons (PHC F<sub>4</sub> gravimetric). Given the shallow soil conditions, this sample may have been influenced by the presence of asphalt inclusions in the sample.

SOIL RESULT COMPLIES WITH THE MECP TABLE 7  
RESIDENTIAL AND CCME COMMERCIAL STANDARDS

SOIL RESULT EXCEEDS THE MECP TABLE 7  
RESIDENTIAL AND CCME COMMERCIAL STANDARDS

Based on the findings of this assessment, the shallow fill material present beneath the surficial asphalt at BH5-23 is contaminated with heavier fractions of petroleum hydrocarbons (PHC F<sub>4</sub> gravimetric). Given the low-mobility of these contaminants, it is expected that the contamination is confined to the fill material within a localized area around BH5-23. It should be noted that this contamination only exceeds the provincial MECP Table 7 Standards, and not the federal CCME Standards.

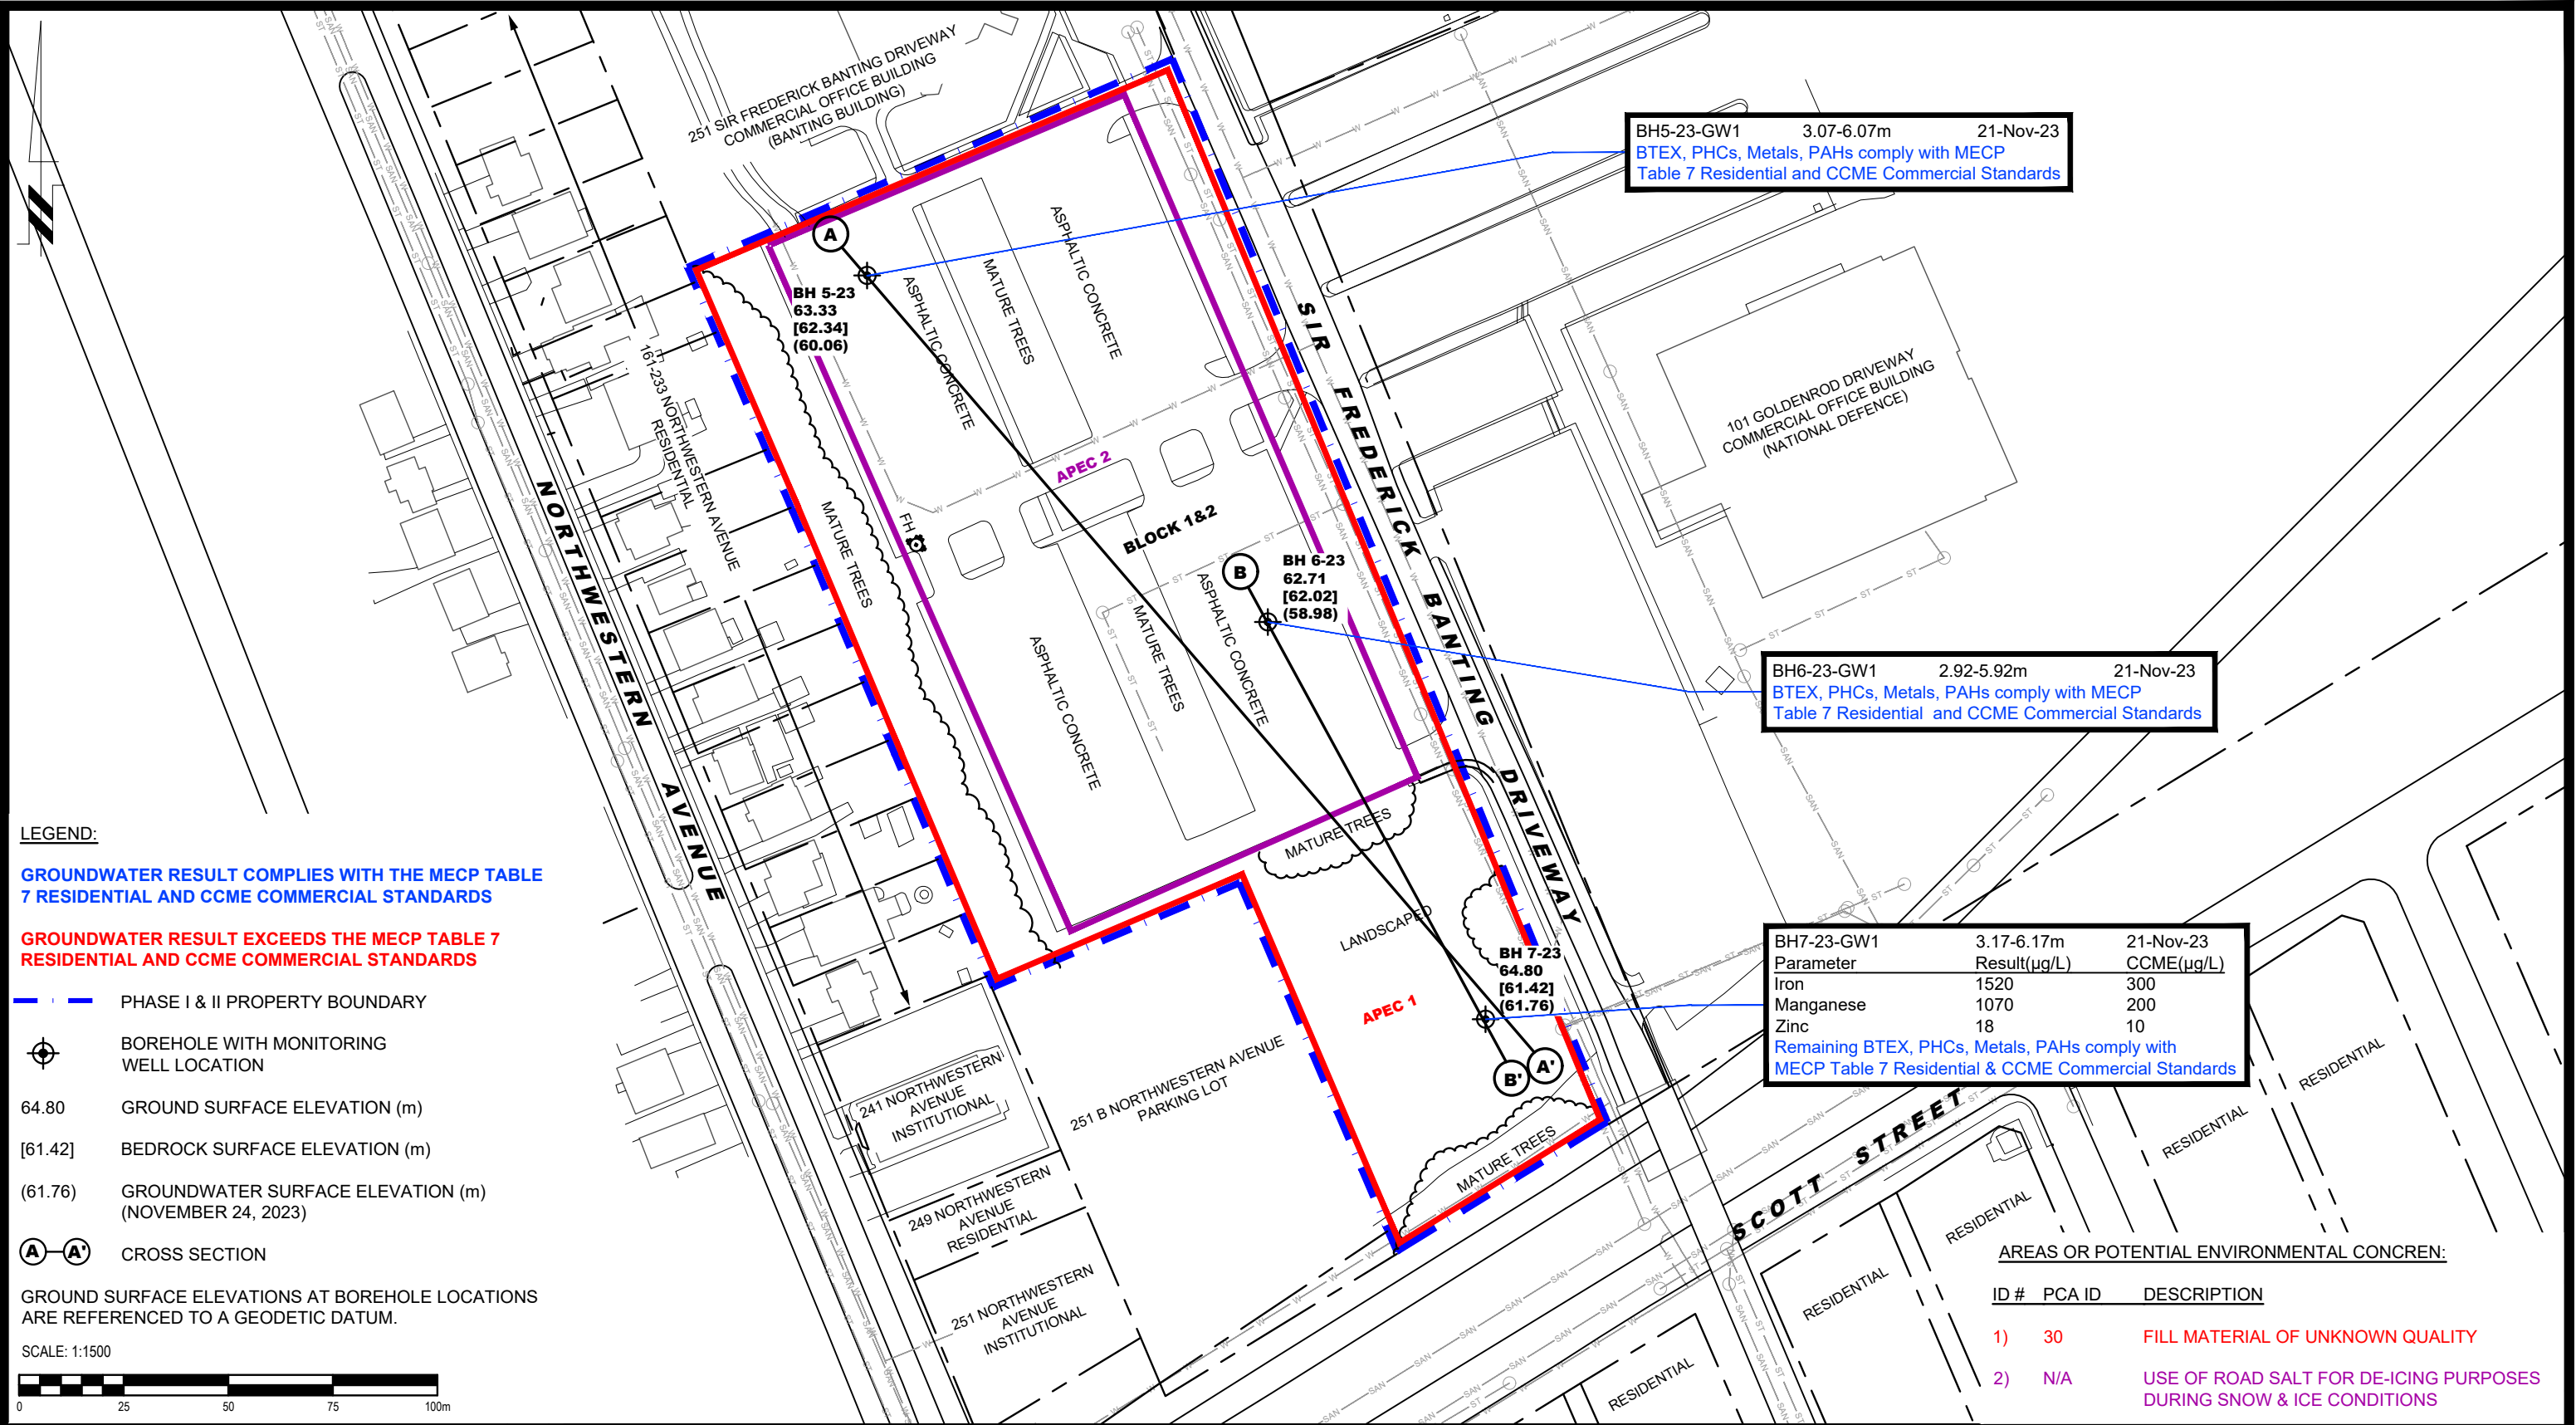
| Checked by: | NS | Dwg. No.: | PE6034-6 |

All groundwater samples were found to comply with both MECP Table 7 Residential Standards and CCME Commercial Standards, with the exception of iron, manganese, and zinc identified in BH7-23, which exceeded the CCME standards. No exceedances in the soil samples were identified for these parameters, and therefore it is considered possible that these parameters are naturally elevated, or they are elevated due to the presence of sediment. The presence of these metals is not considered to pose an environmental risk to the current use of the property.

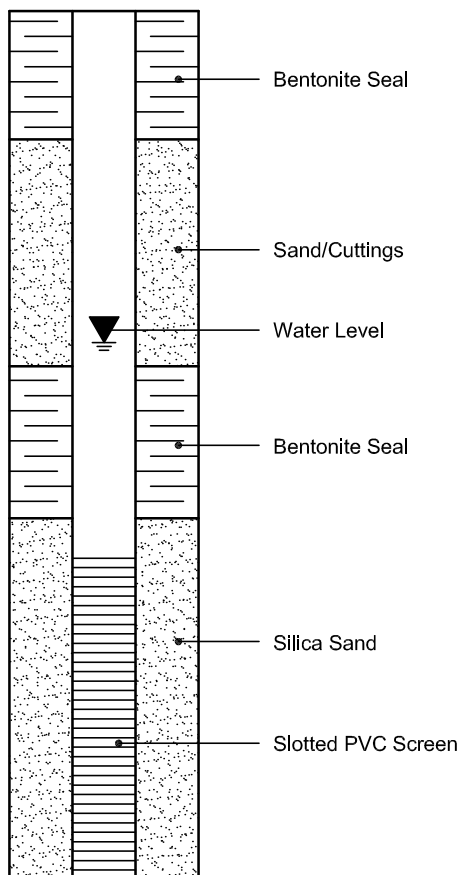
#### MONITORING WELL CONSTRUCTION

Upon completion, the groundwater monitoring wells were developed using a dedicated inertial lift pump, with a minimum of three well volumes being removed from the wells at the time of installation. The wells were developed until the appearance of the water was noted to have stabilized. In addition, the ground surface elevations of each borehole were subsequently surveyed with respect to a known geodetic elevation.
