McKINLEY
ENVIRONMENTAL
SOLUTIONS

April 23rd, 2020

RE: Woodlot S-23 Large Tree Inventory – Minto Communities and Valecraft Homes Kanata North
Developments (Revised)

APPENDIX A – TREE PHOTOS

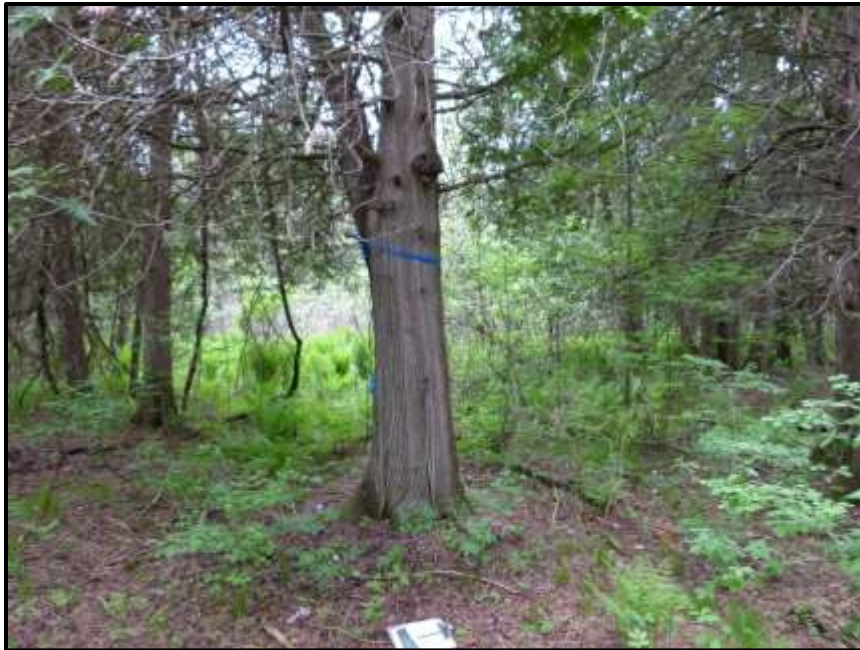
Photograph 9: Tree #10 – White Cedar in good condition (May 27th, 2019).

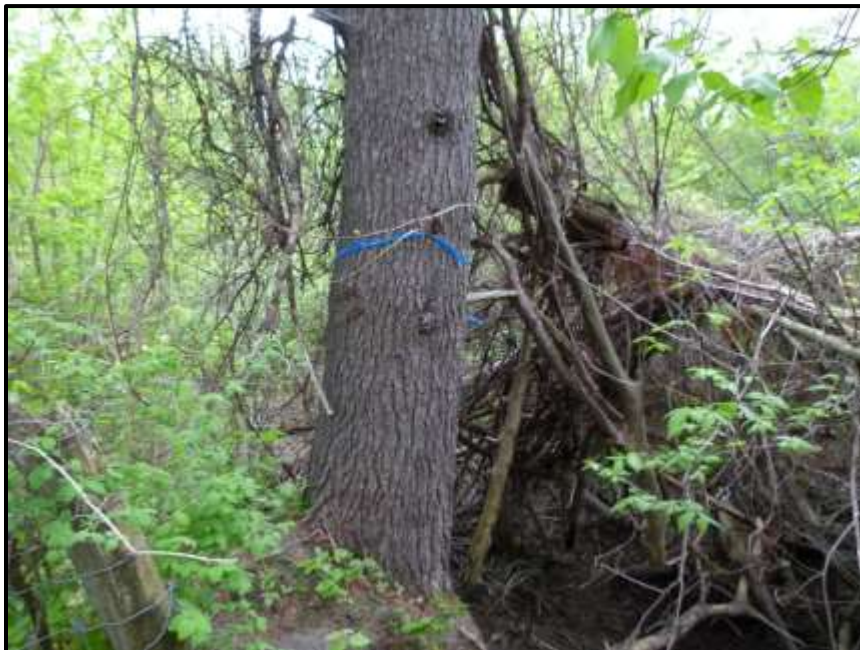
Photograph 16: Tree #17 - White Pine in good condition (May 27th, 2019).

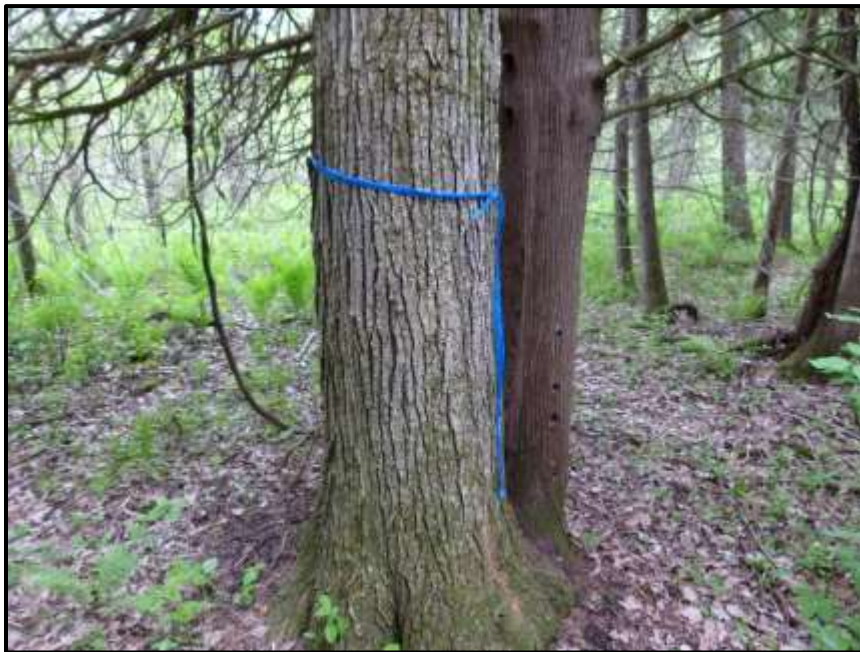
Photograph 20: Tree #21 – Bur Oak in good condition (May 27th, 2019).

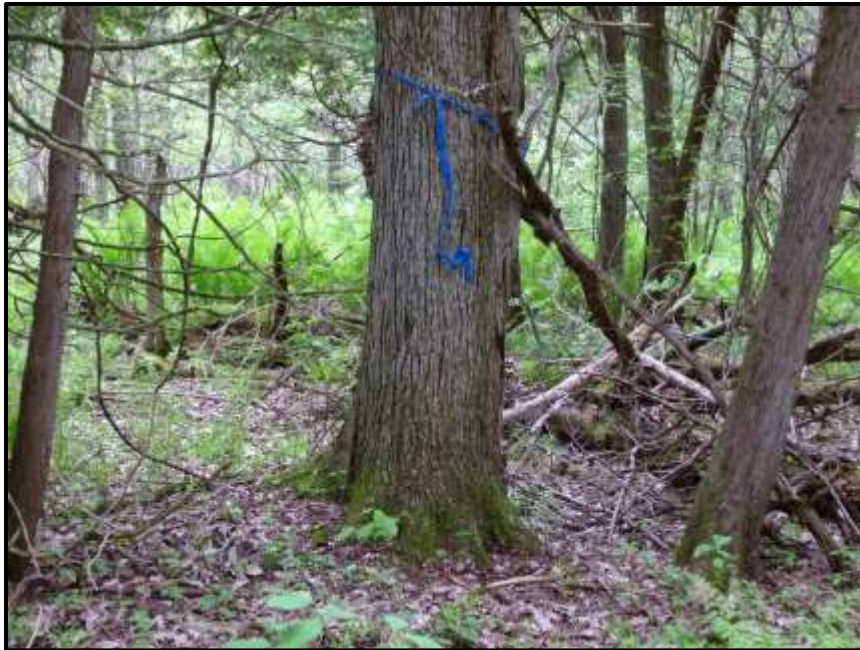
Photograph 21: Tree #22 – Bur Oak in good condition (May 27th, 2019).

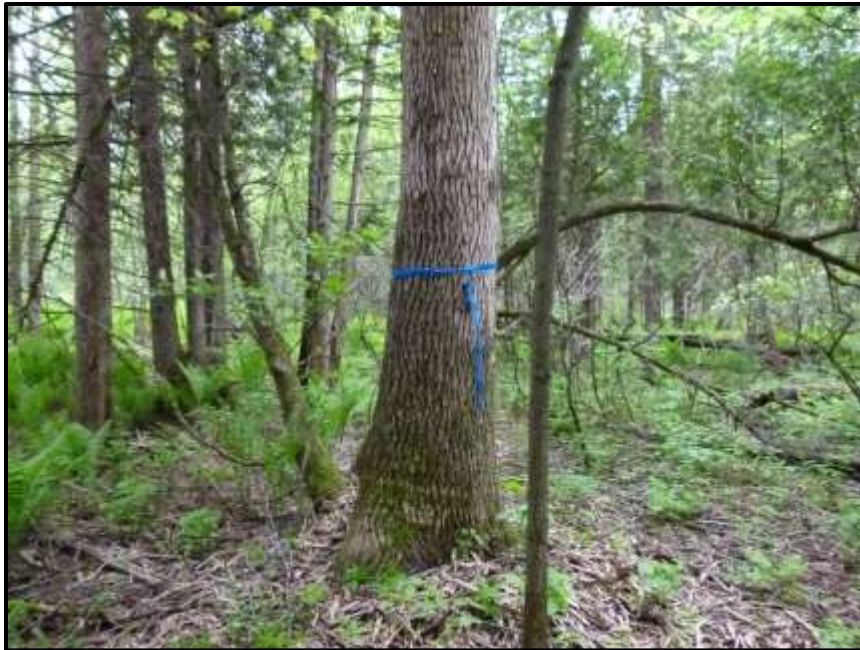
Photograph 25: Tree #26 – dead White Ash (May 27th, 2019).

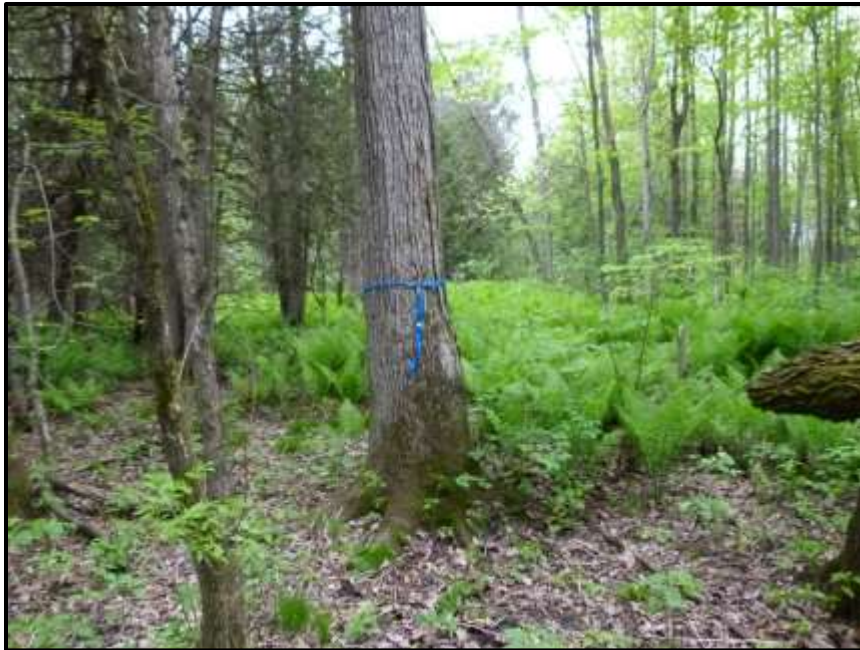
Photograph 27: Tree #28 – Bur Oak in good condition (May 27th, 2019).

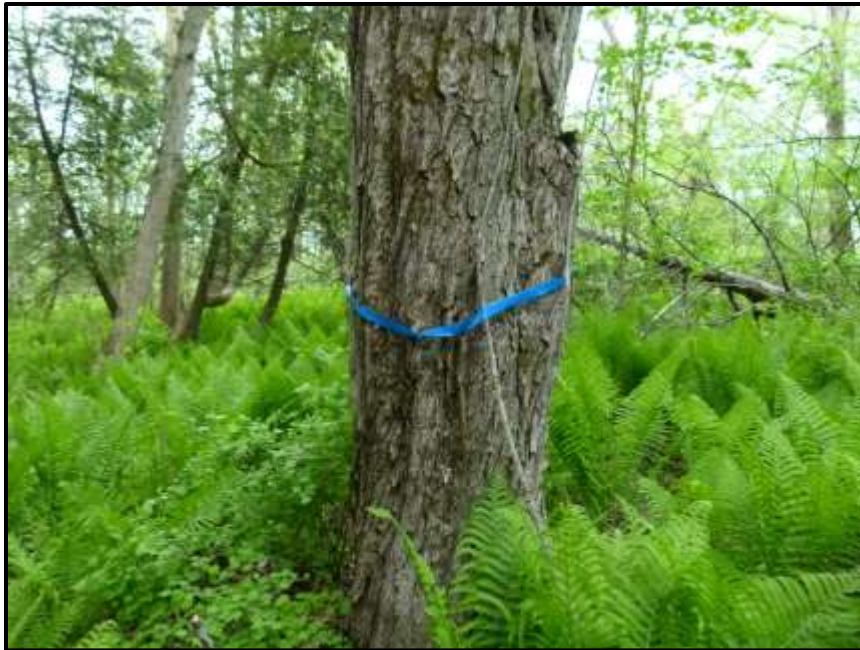
Photograph 29: Tree #30 – Sugar Maple in good condition (May 27th, 2019).

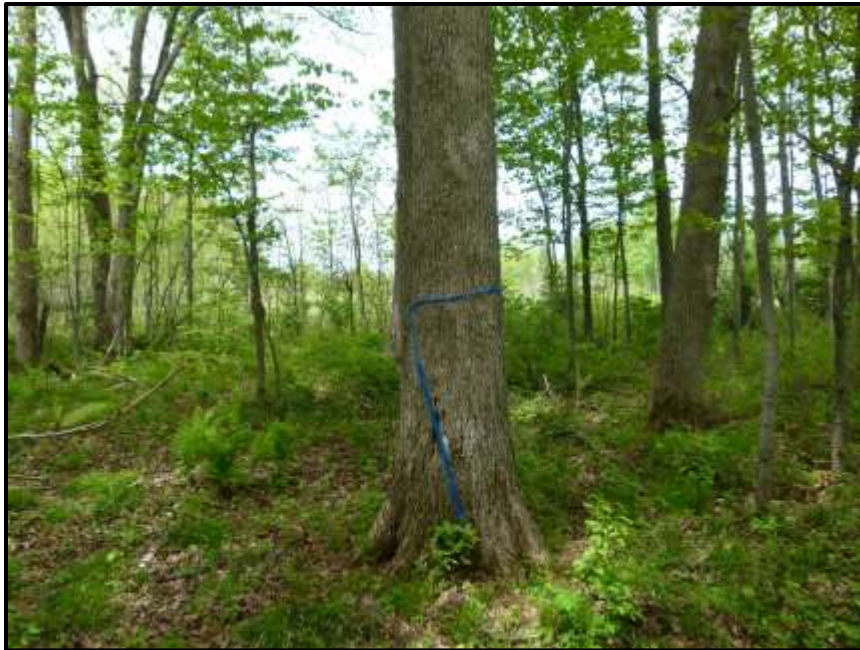
Photograph 35: Tree #36 – Bur Oak in good condition (May 27th, 2019).

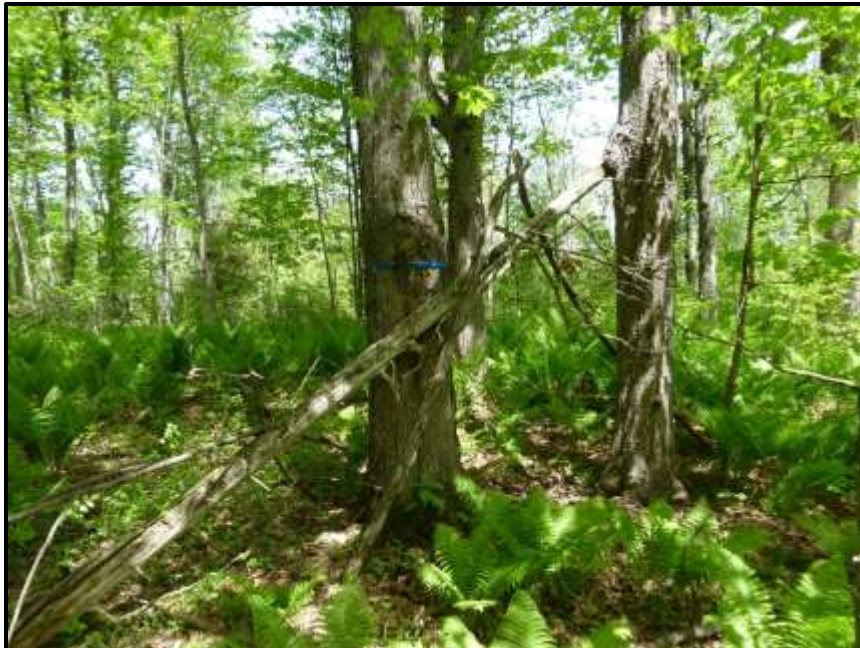
Photograph 40: Tree #41 – Sugar Maple in good condition (May 27th, 2019).

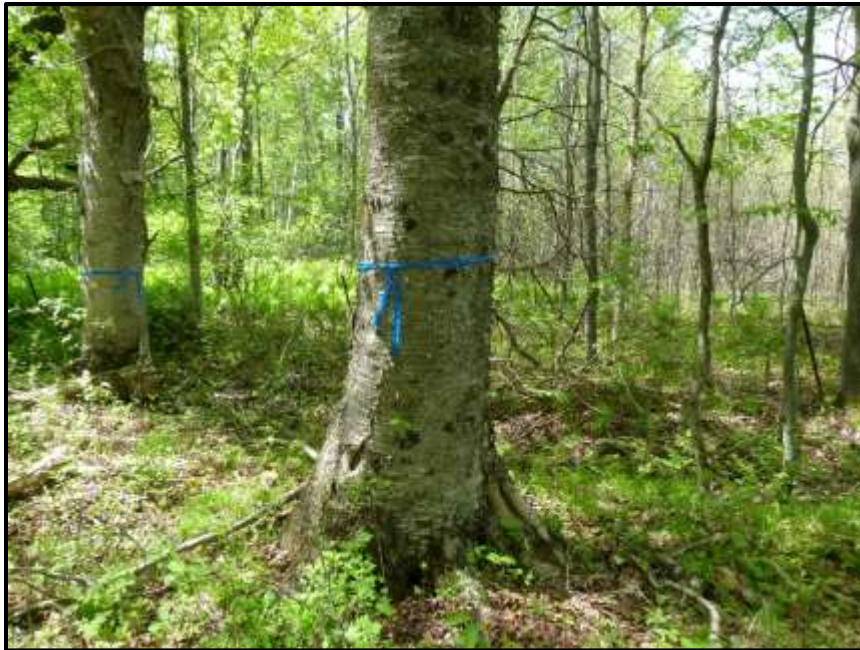
Photograph 43: Tree #44 – Yellow Birch in good condition (May 27th, 2019).

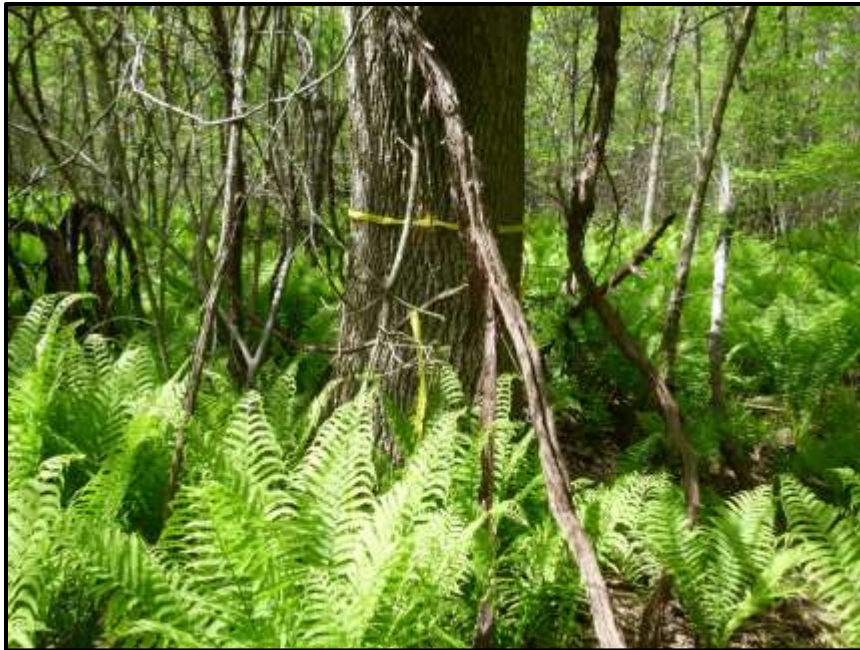
Photograph 53: Tree #54 – dead White Ash (May 30th, 2019).

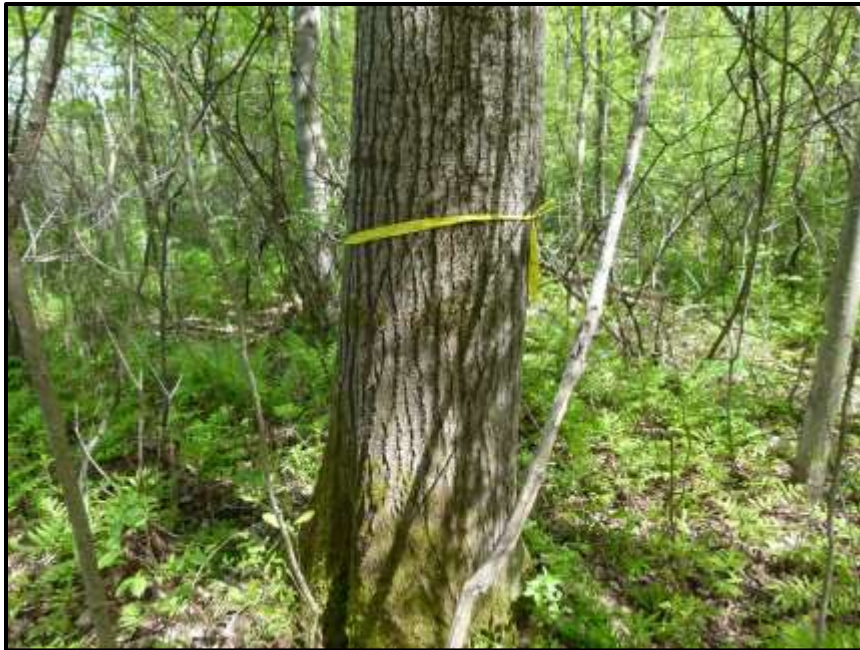
Photograph 59: Tree #60 – Trembling Aspen in good condition (May 30th, 2019).

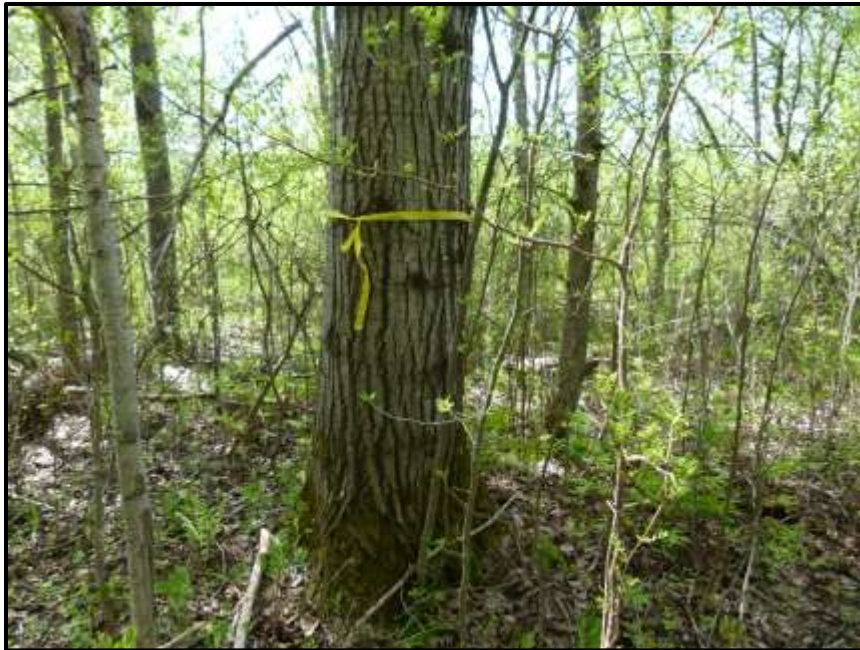
Photograph 61: Tree #62 – Trembling Aspen in good condition (May 30th, 2019).

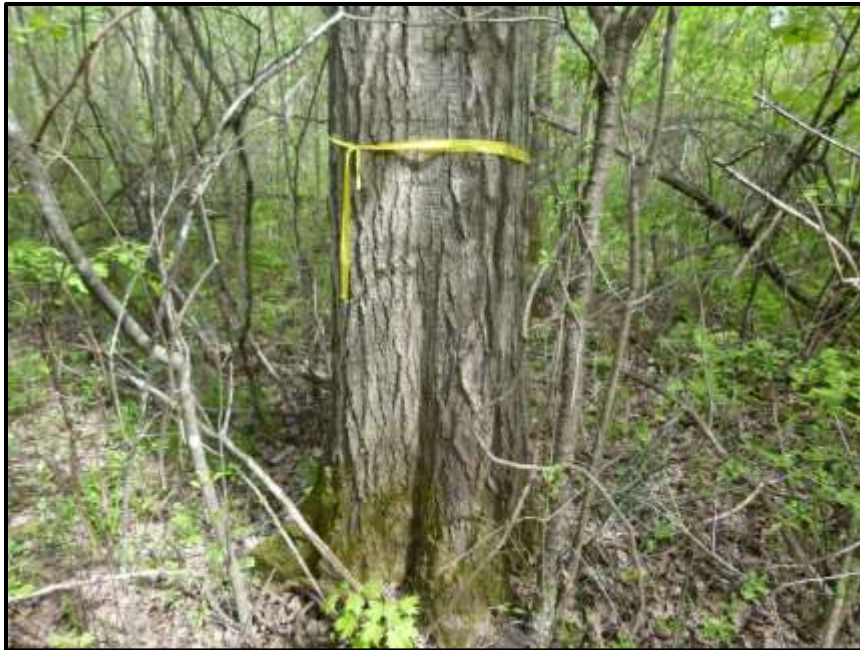
Photograph 63: Tree #64 – Trembling Aspen in good condition (May 30th, 2019).

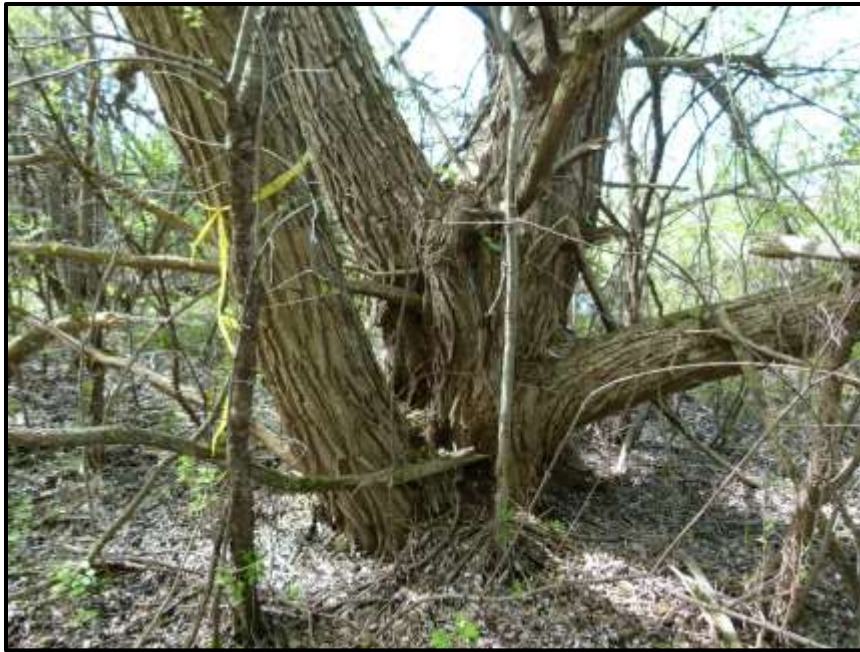
Photograph 65: Tree #66 – Crack Willow in good condition (May 30th, 2019).

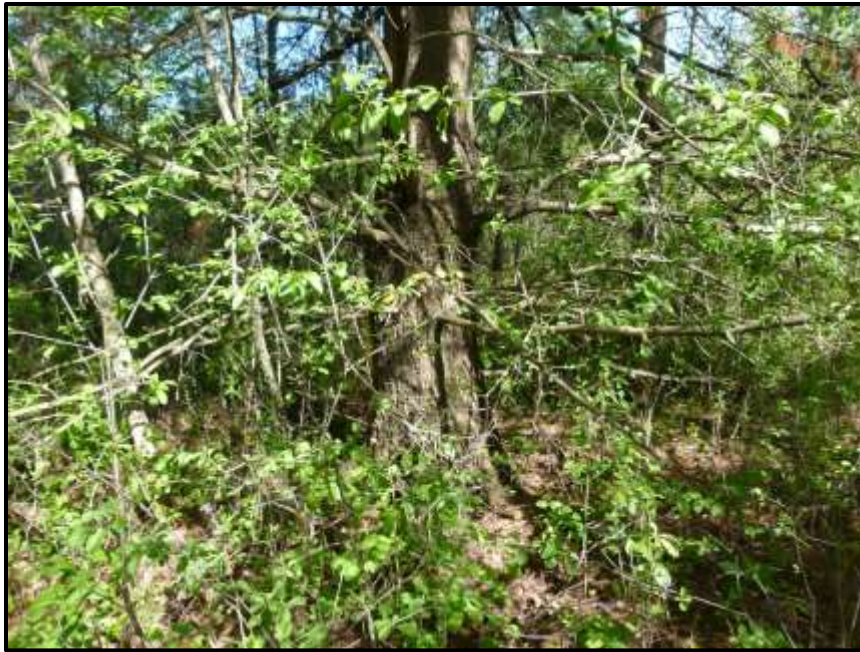
Photograph 67: Tree #68 – White Pine in good condition (May 30th, 2019).

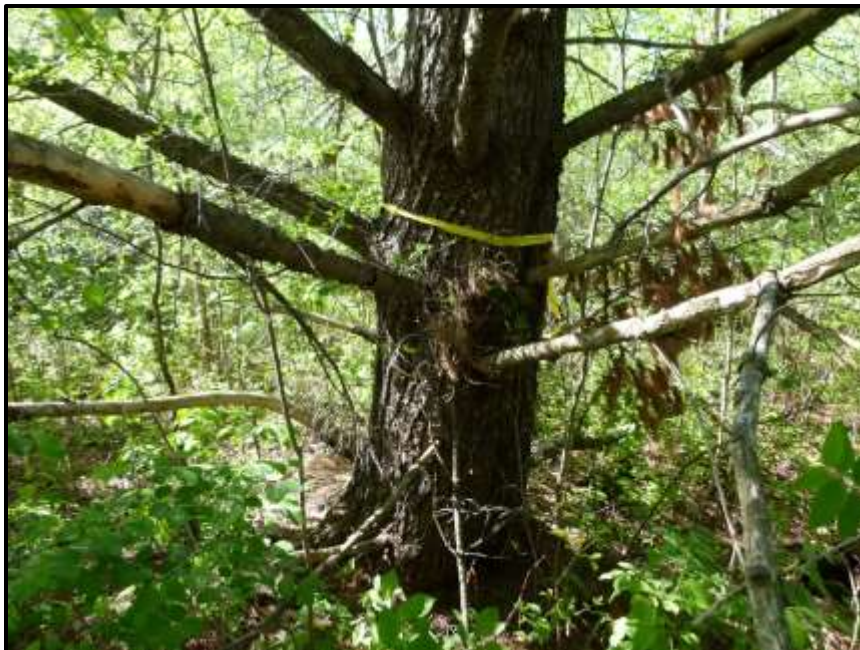
Photograph 68: Tree #69 – White Pine in good condition (May 30th, 2019).

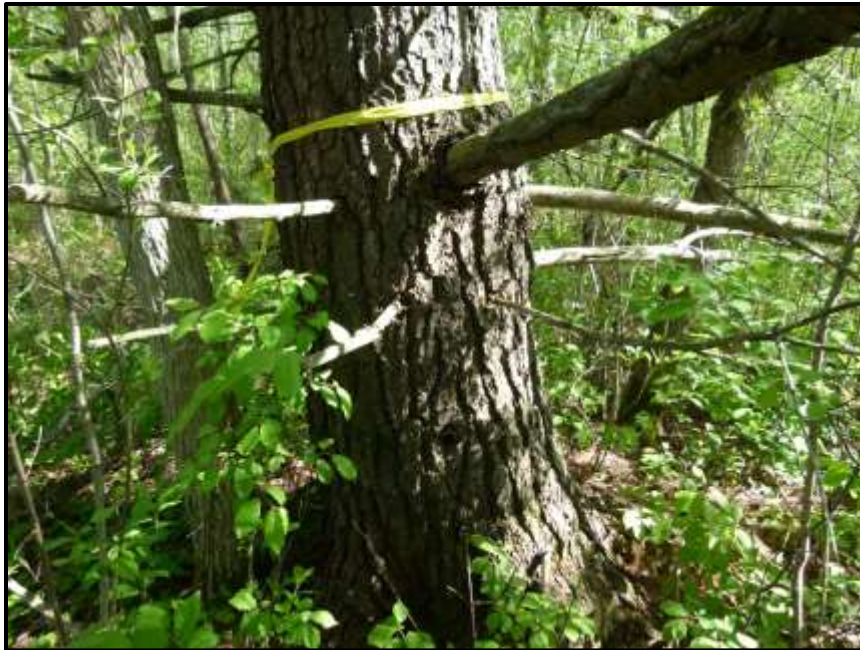
Photograph 69: Tree #70 – White Pine in good condition (May 30th, 2019).
