Landslide Hazard Assessment

Proposed Residential Development

Old Montreal Road
Ottawa, Ontario

Report PG5201-2 Revision 5 dated December 20, 2024

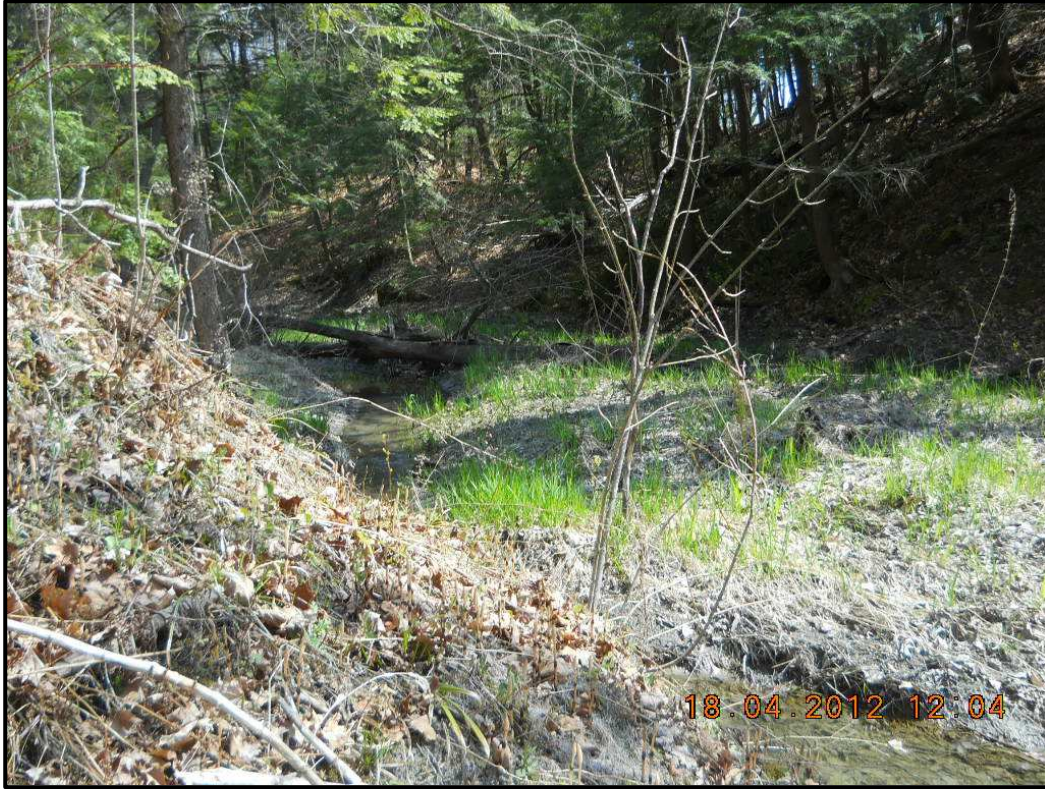
Photo 1A: Photo taken on April 18, 2012 from the north bank of the valley corridor wall along the South Tributary looking east (upstream) near Section I.

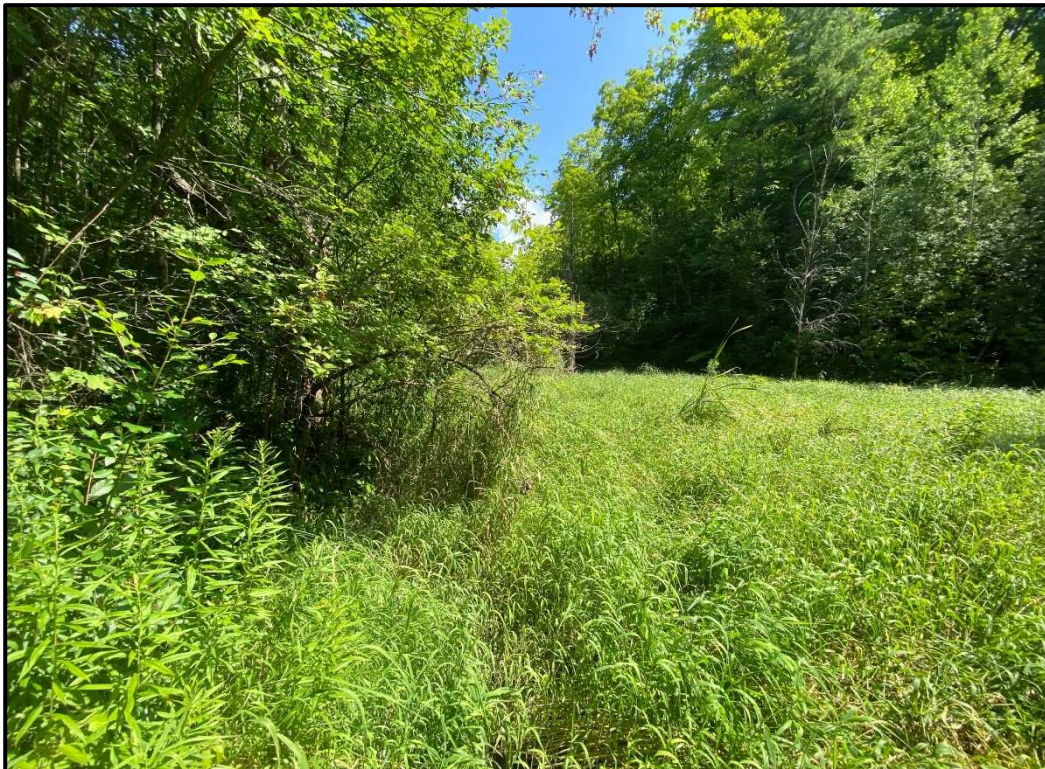
Photo 1B: Photo taken on July 19, 2023 from the north bank of the valley corridor wall along the South Tributary looking east (upstream) near Section I.

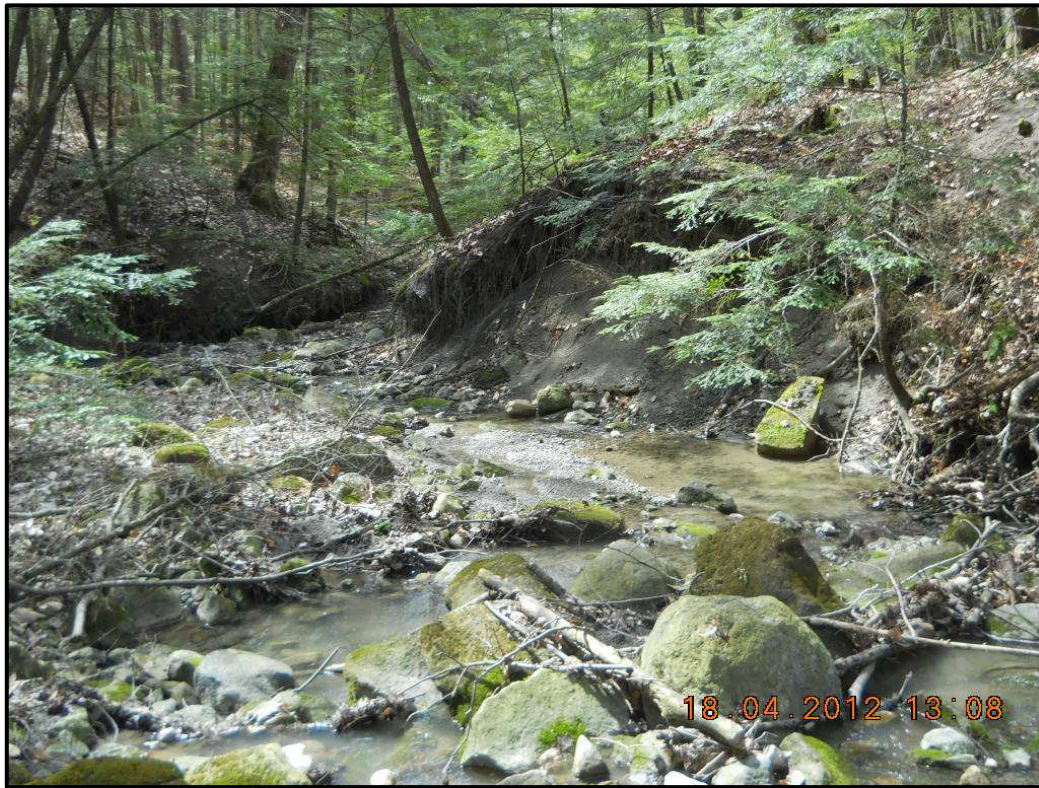
Photo 3: Photo taken on April 18, 2012 from the north bank of the valley corridor wall along the South Tributary looking west (downstream) at Section G.

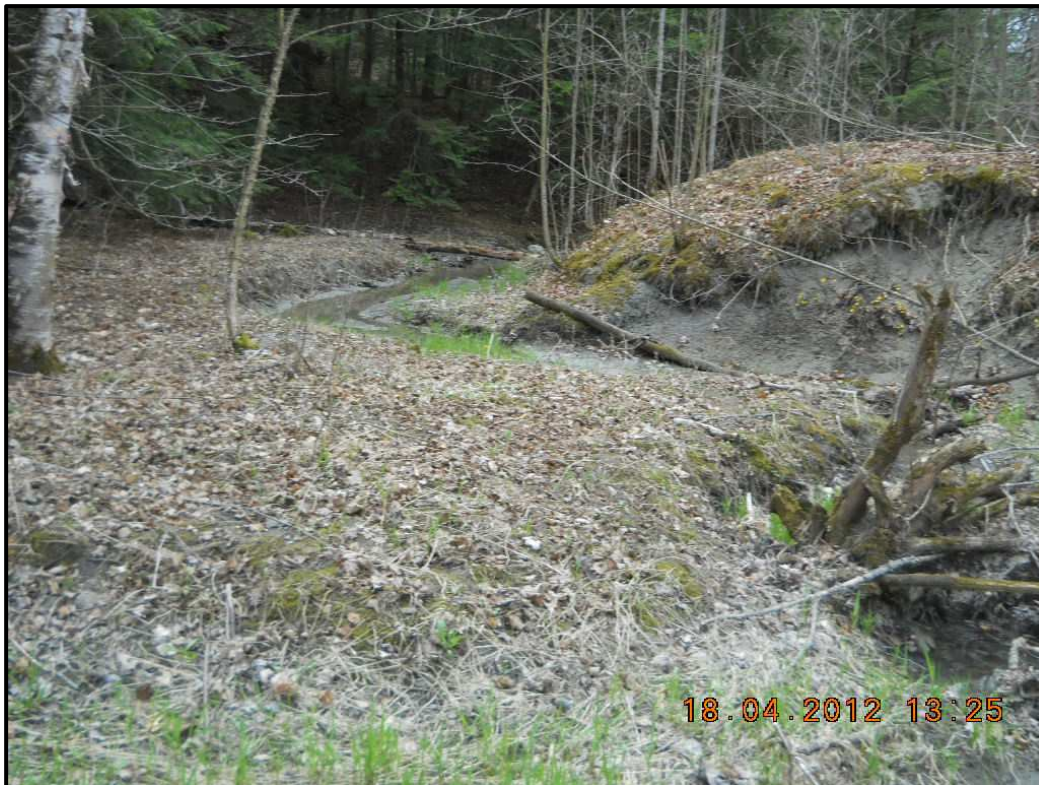
Photo 4: Photo taken on April 18, 2012 from the south bank of the South Tributary looking west (downstream) near Section F.

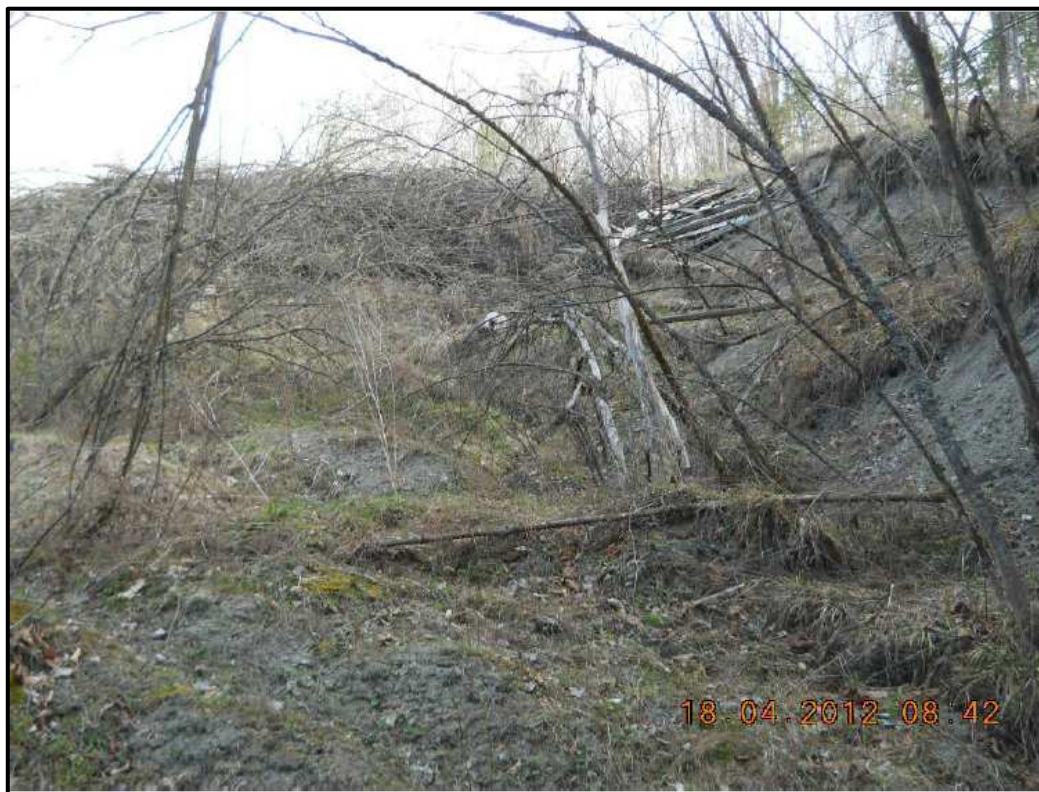
Photo 5: Photo taken on April 18, 2012 of the east bank of the valley corridor along Mid-Branch 1, north of Section J.

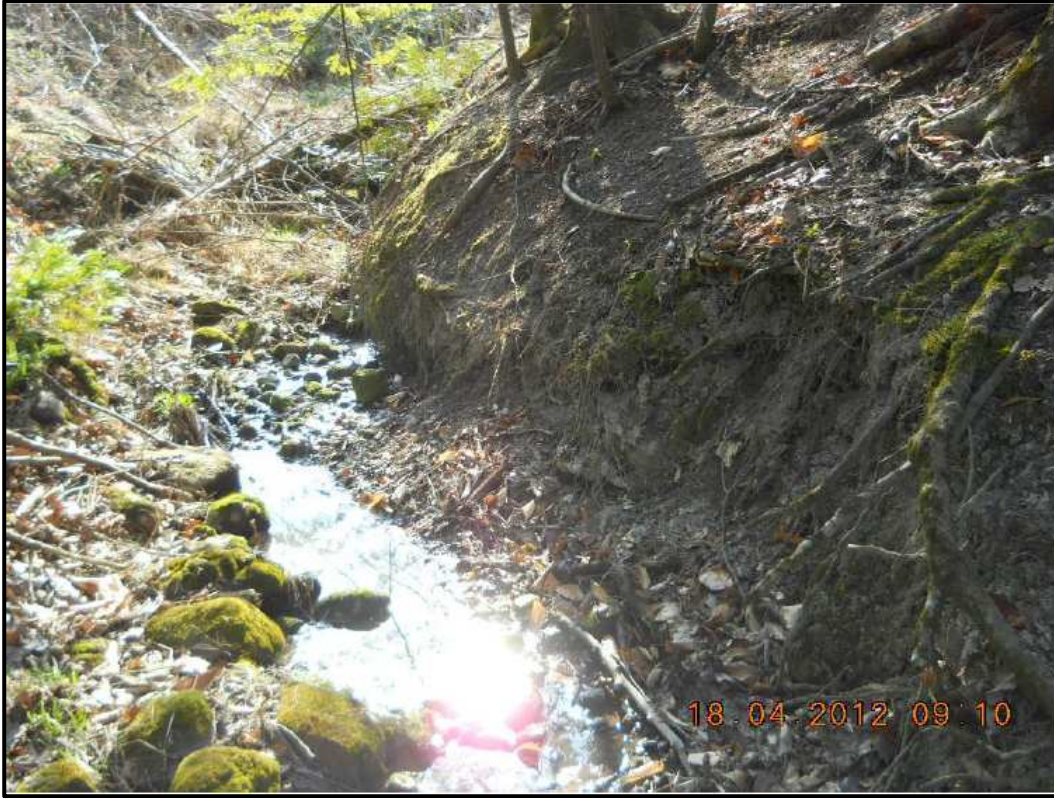
Photo 6A: Photo taken on April 18, 2012 along the watercourse along Mid-Branch 1 looking east (upstream) near Section N.

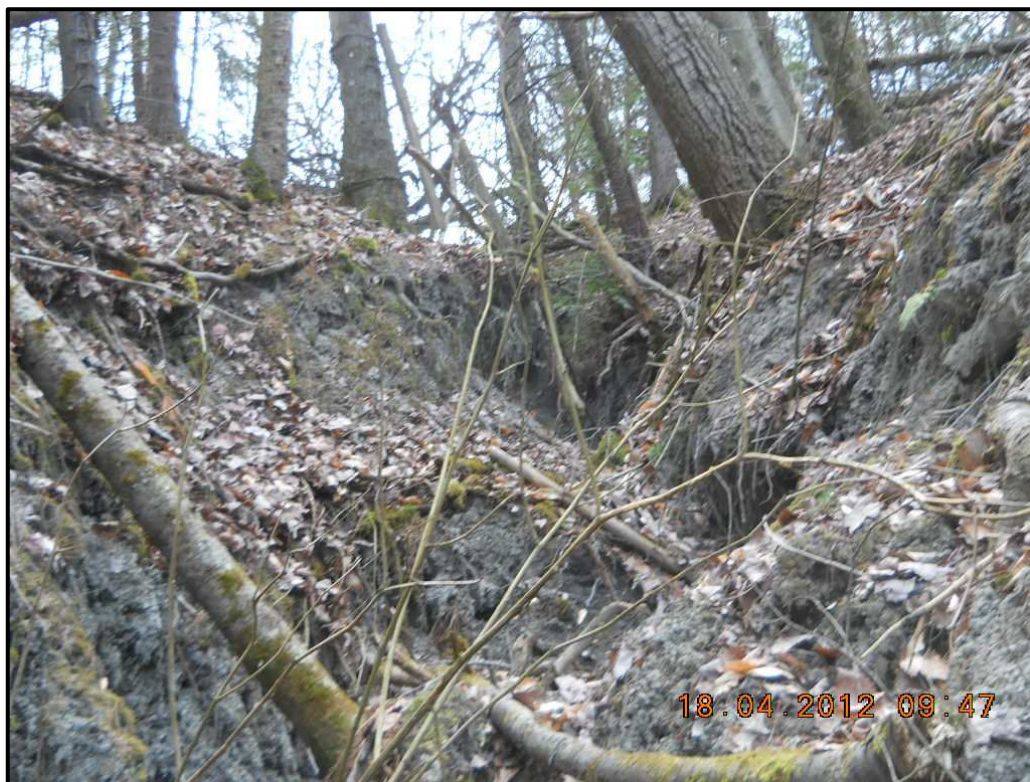
Photo 7A: Photo taken on April 18, 2012 of the drainage ravine near Section K.

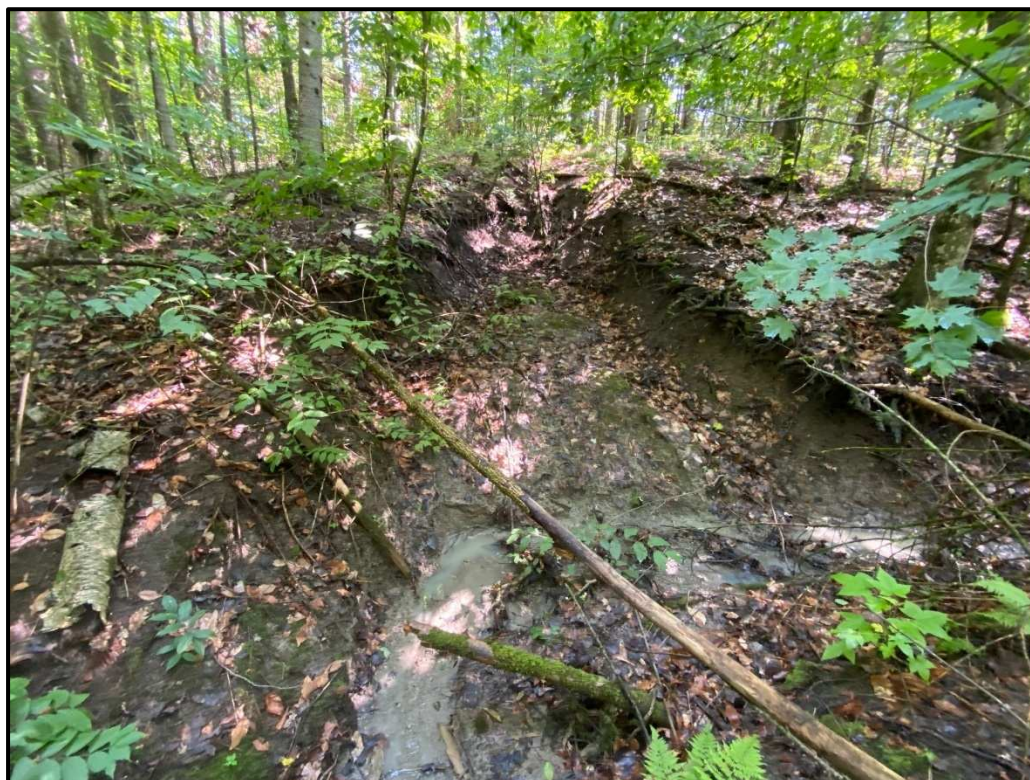
Photo 7B: Photo taken on July 19, 2023 of the drainage ravine near Section K.

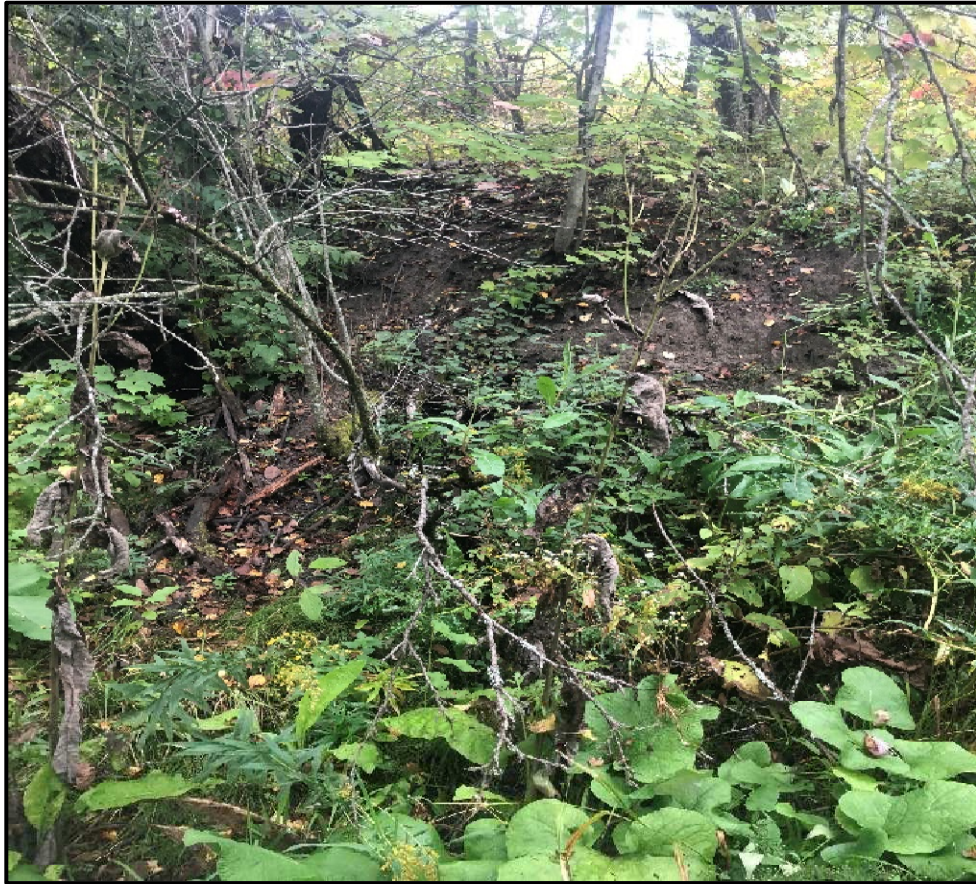
Photo 8A: Photo taken on September 10, 2020 of the north slope face, looking northwest.

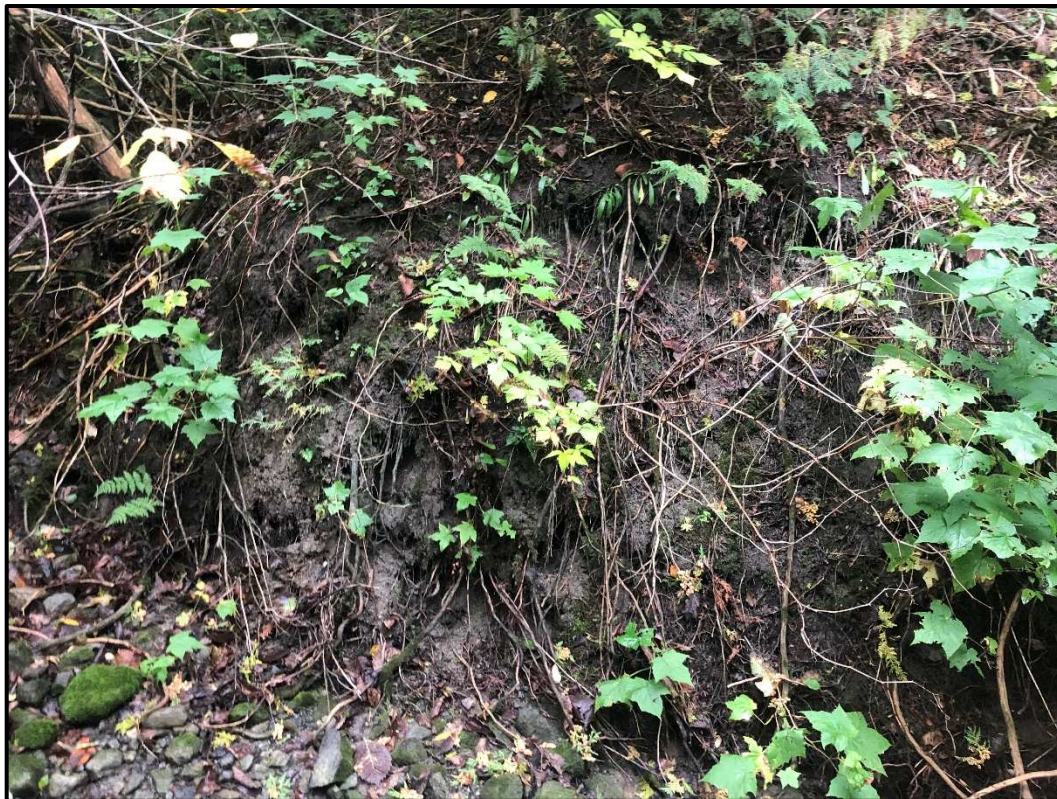
Photo 9A: Photo taken on September 10, 2020 of the north slope face, looking northwest.

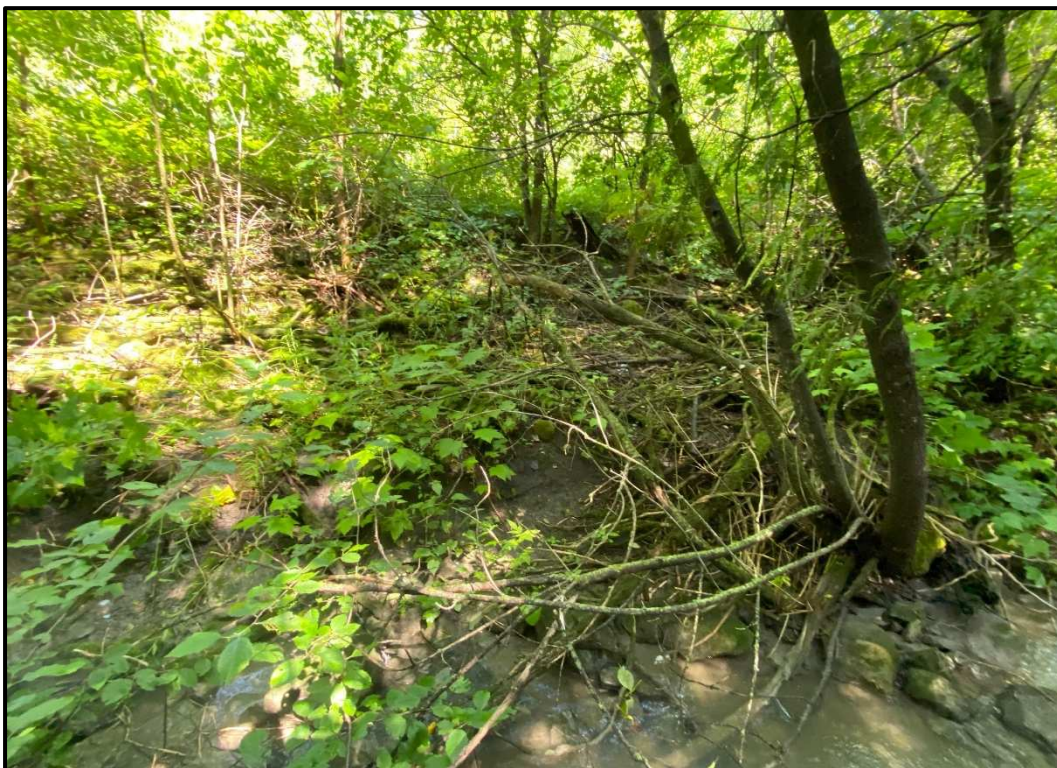
Photo 9B: Photo taken on July 19, 2023 of the north slope face, looking northwest.

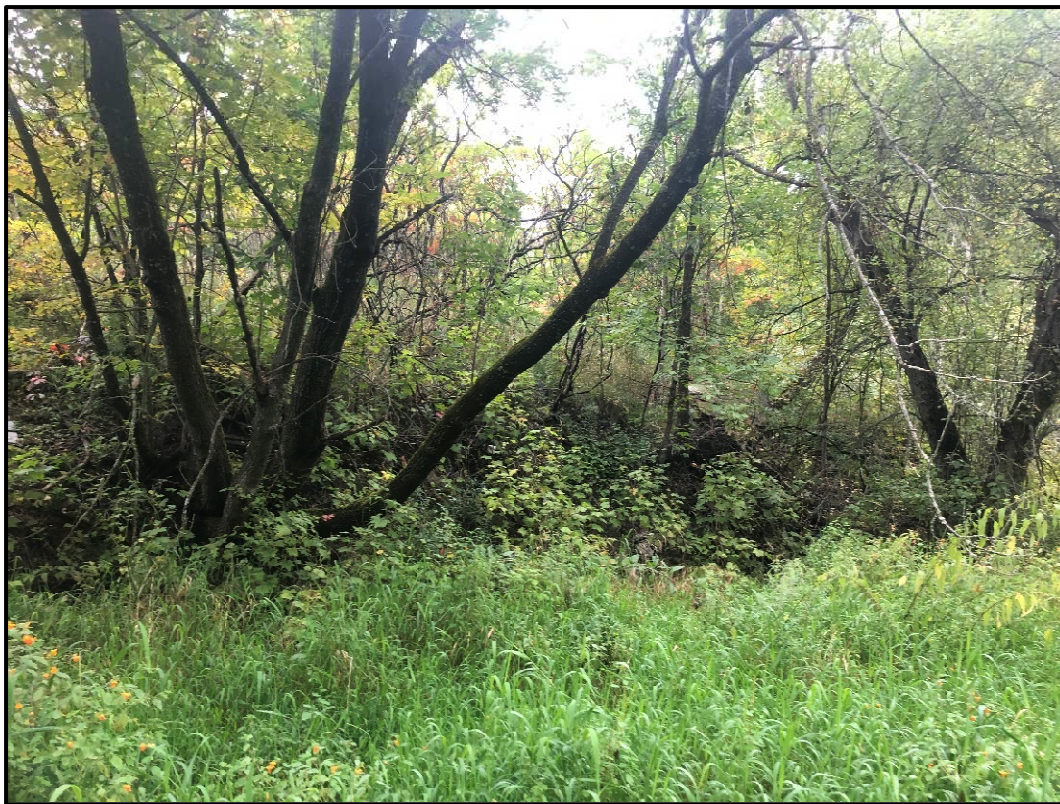
Photo 10A: Photo taken on September 10, 2020 of the north slope face, looking north.

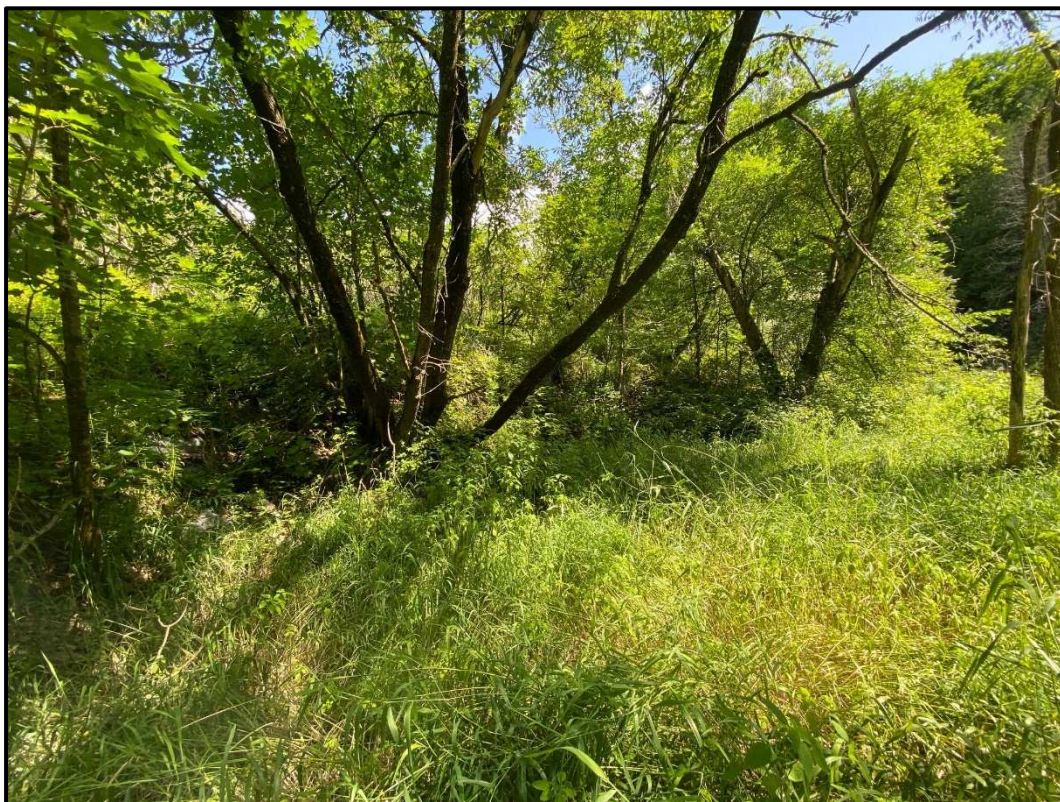
Photo 10B: Photo taken on July 19, 2023 of the north slope face, looking north.

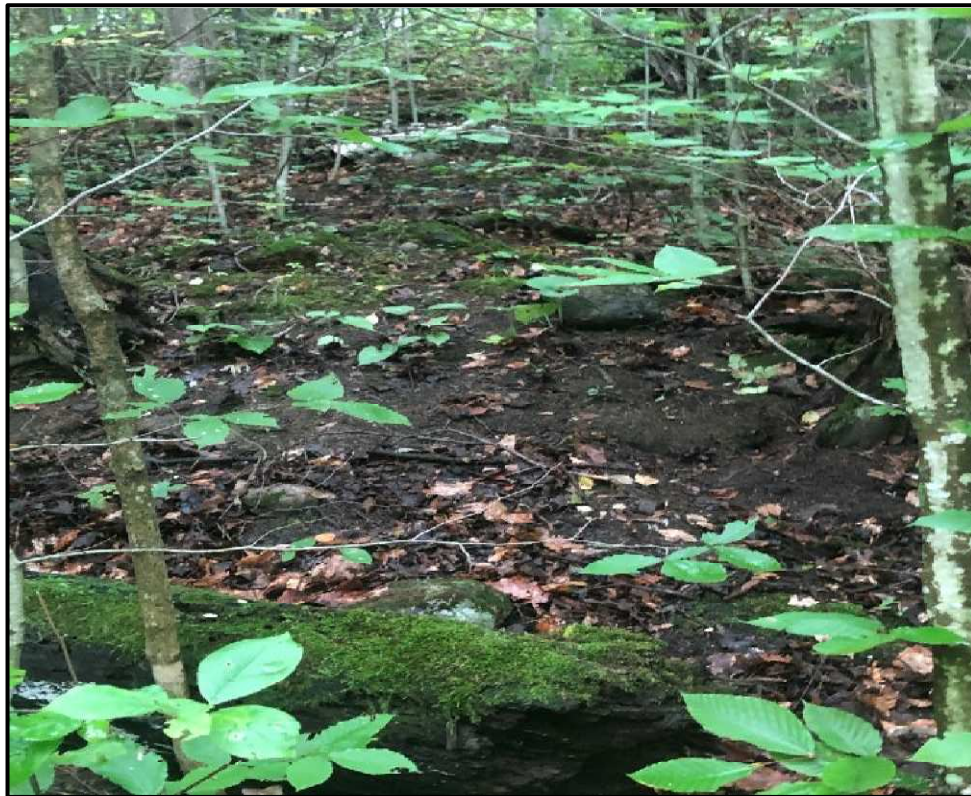
Photo 11A: Photo taken on September 10, 2020 of the south slope face looking southeast near Section O

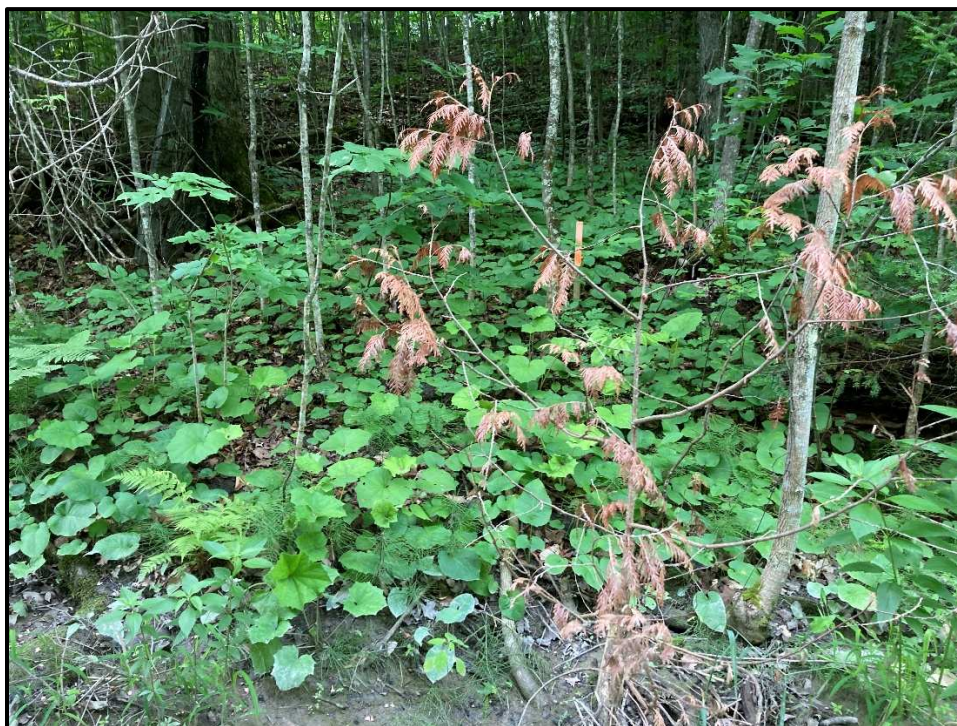
Photo 11B: Photo taken on July 14, 2023 of the south slope face, looking southeast near Section O

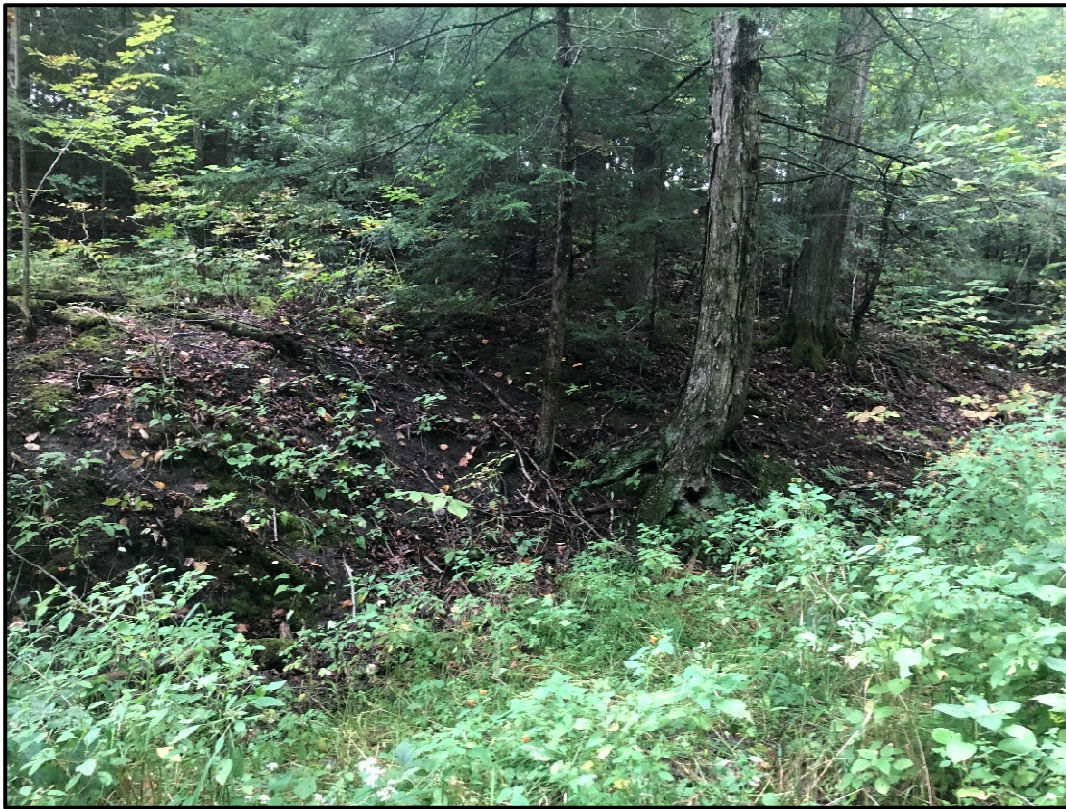
Photo 12A: Photo taken on September 10, 2020 of the north slope face, looking northwest.

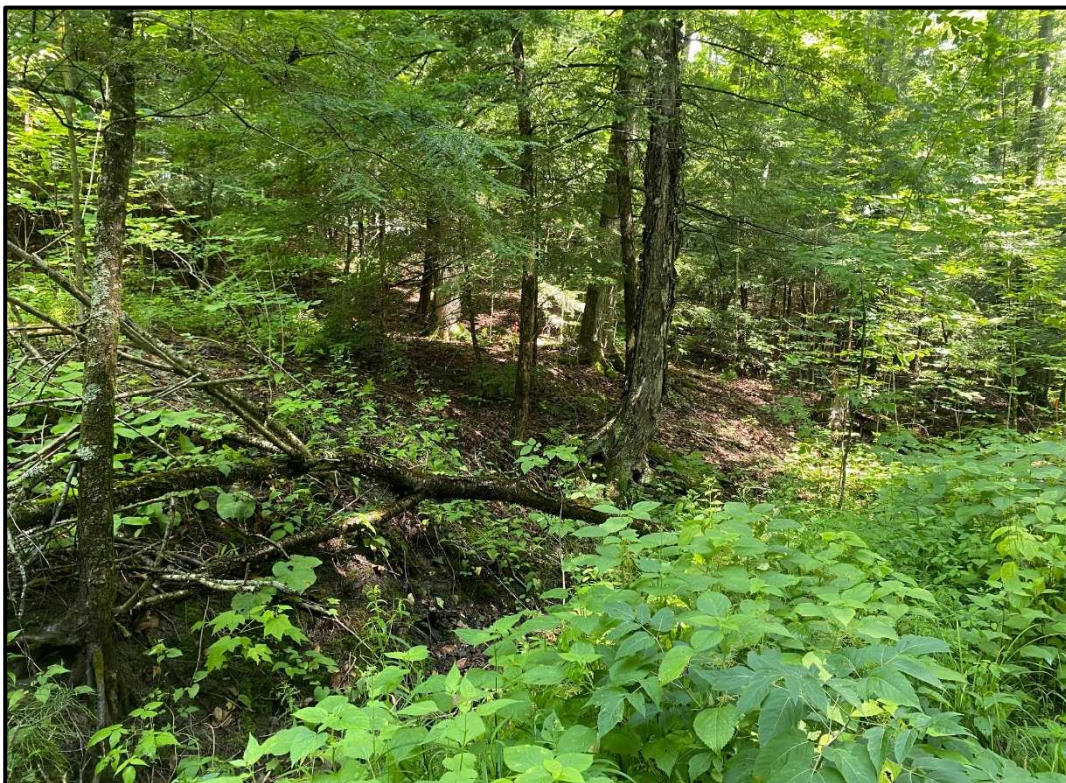
Photo 12B: Photo taken on July 19, 2023 of the north slope face, looking northwest.

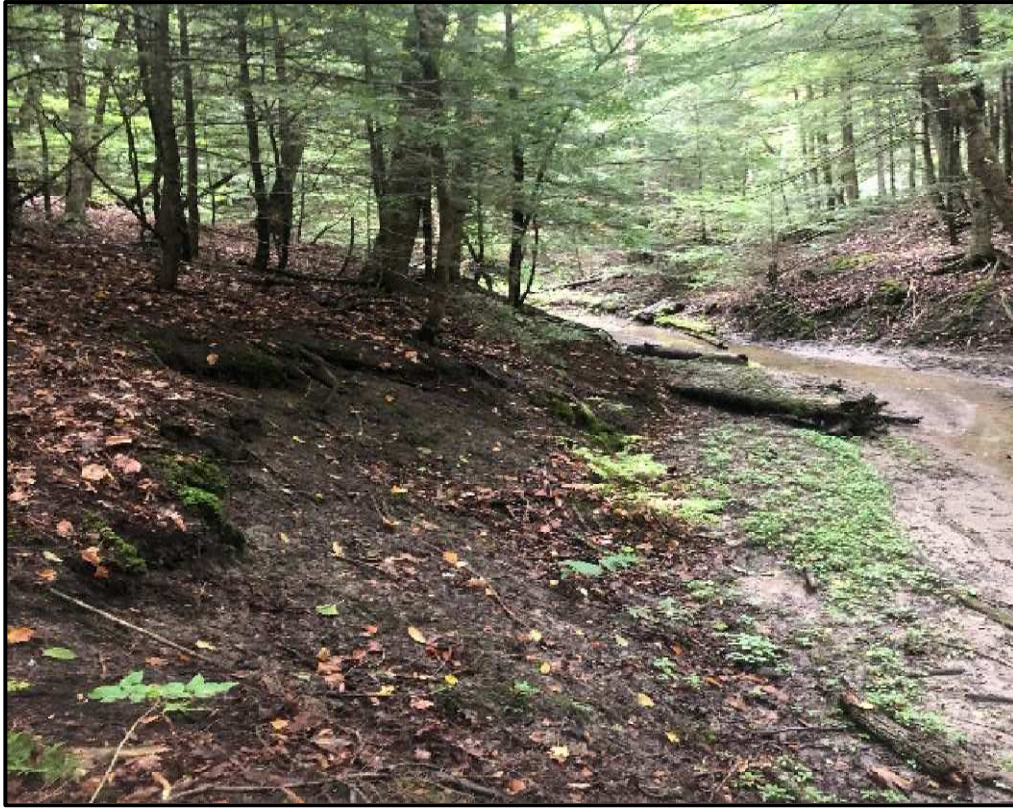
Photo 13A: Photo taken on September 10, 2020 of the north slope face, looking east (upstream) near Section H.

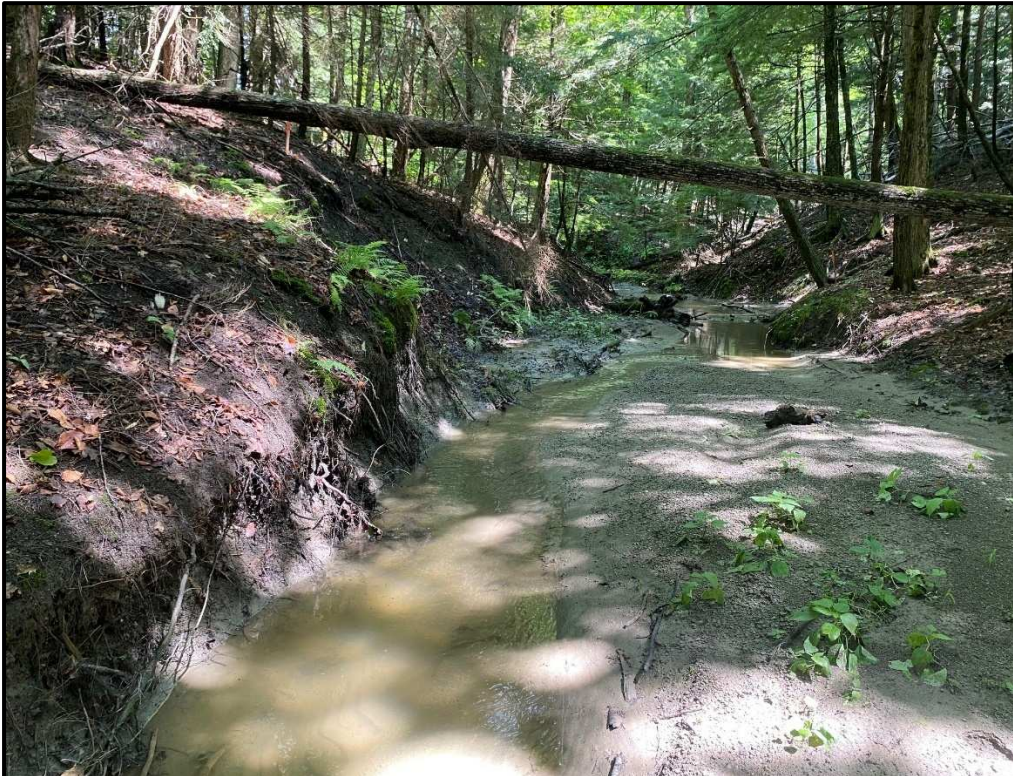
Photo 13B: Photo taken on July 19, 2023 of the north slope face, looking east (upstream) near Section H.

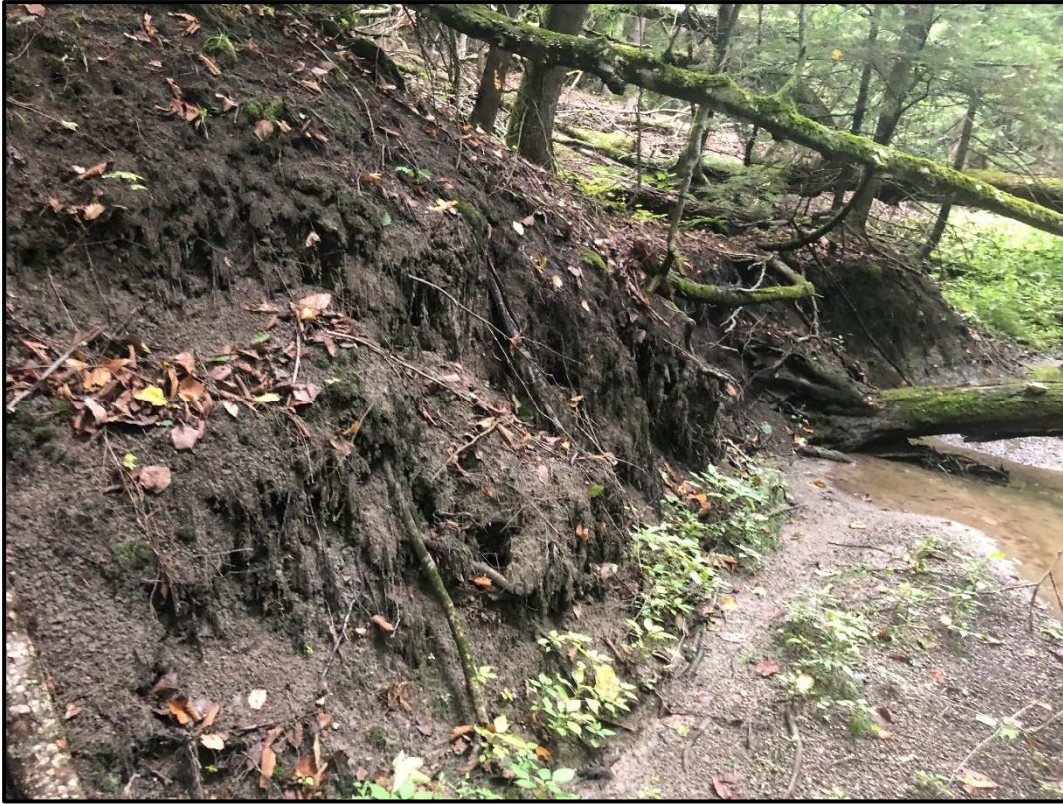
Photo 14A: Photo taken on September 10, 2020 of the north slope face, looking northwest near Section CC.

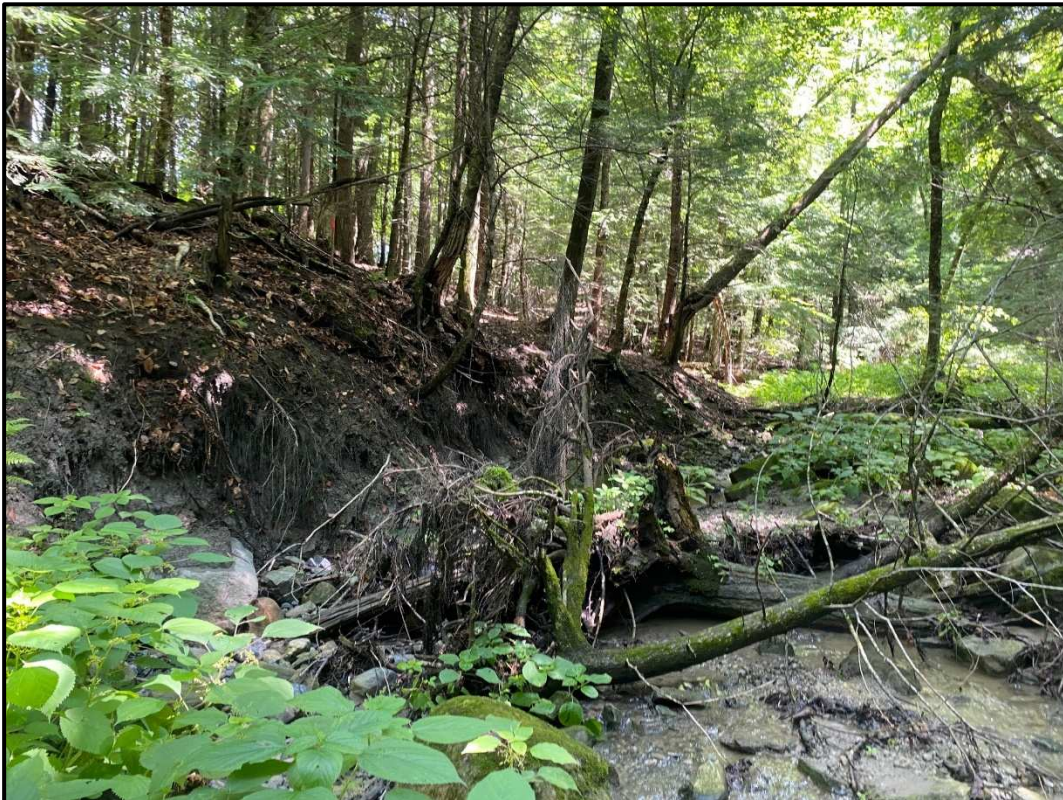
Photo 14B: Photo taken on July 19, 2023 of the north slope face, looking northeast near Section CC.

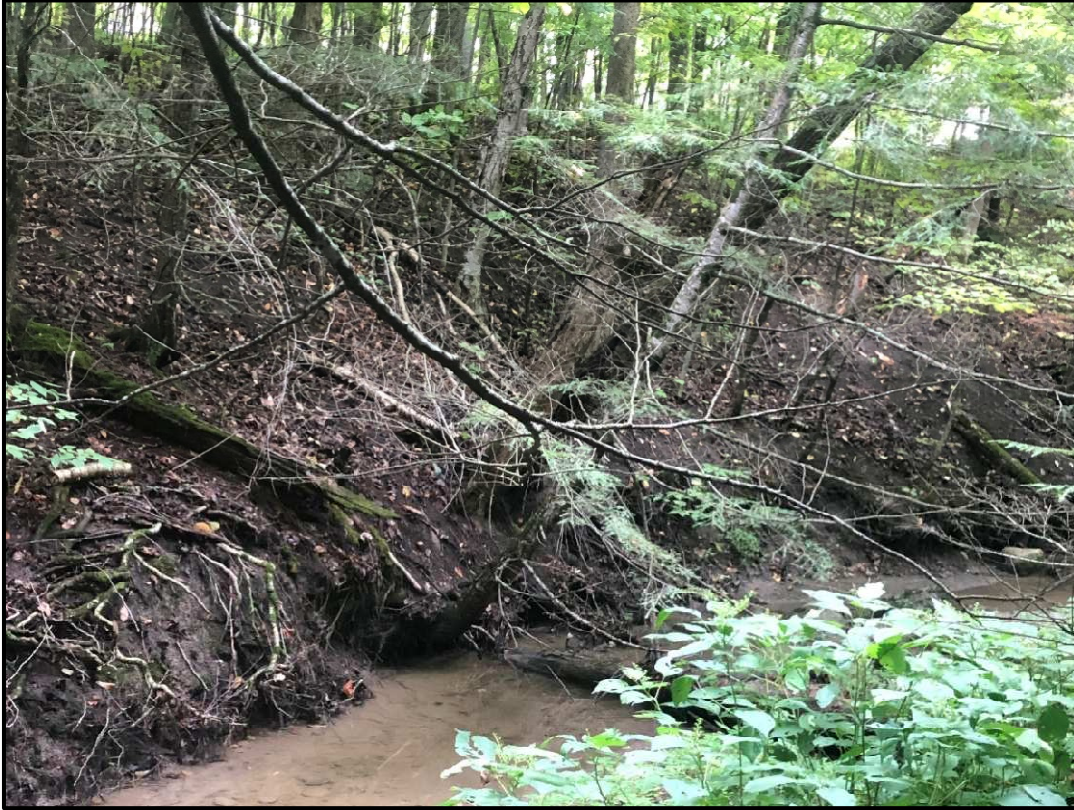
Photo 15A: Photo taken on September 10, 2020 of the north slope face, looking northwest near sections G and II

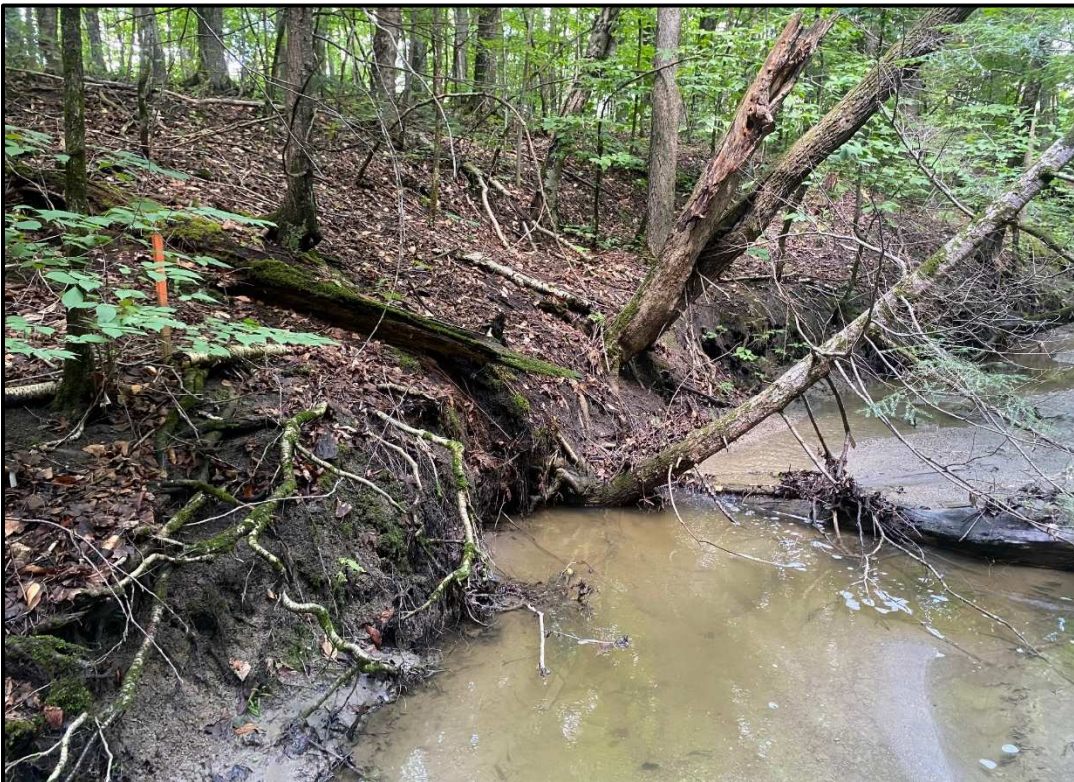
Photo 15B: Photo taken on July 19, 2023 of the north slope face, looking northwest near sections G and II

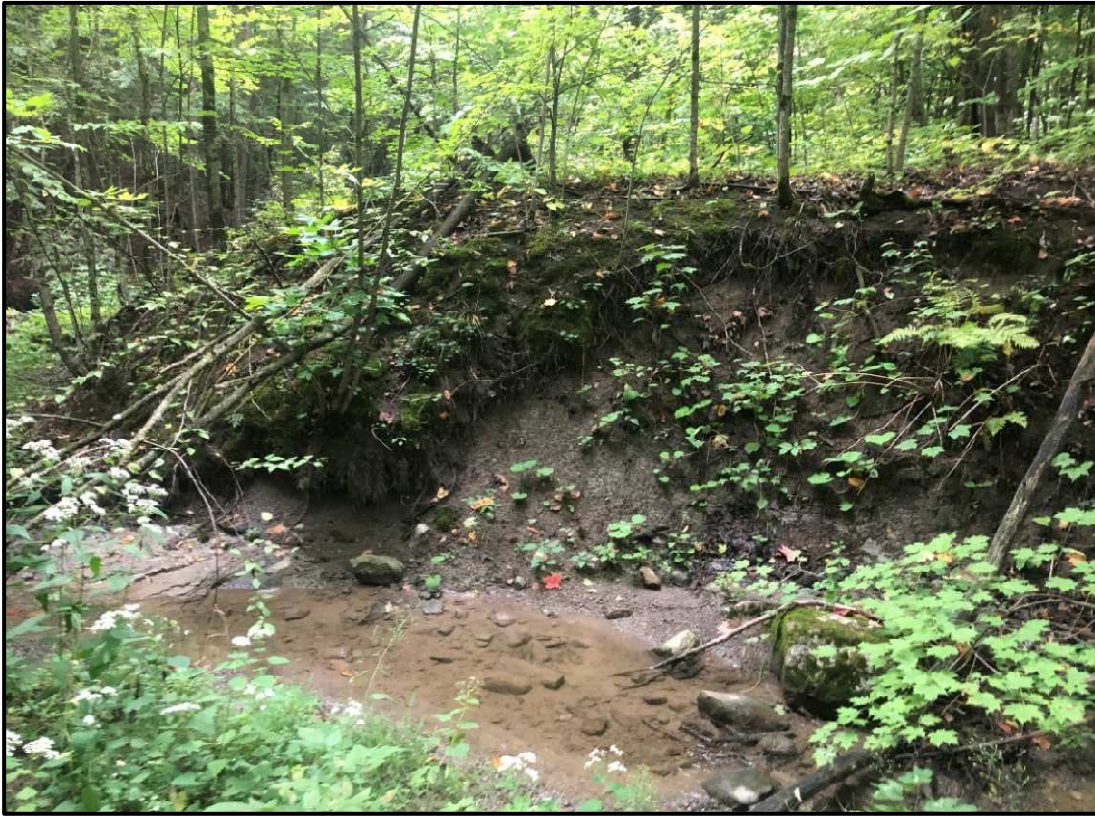
Photo 16A: Photo taken on September 10, 2020 of the south slope face near section HH.

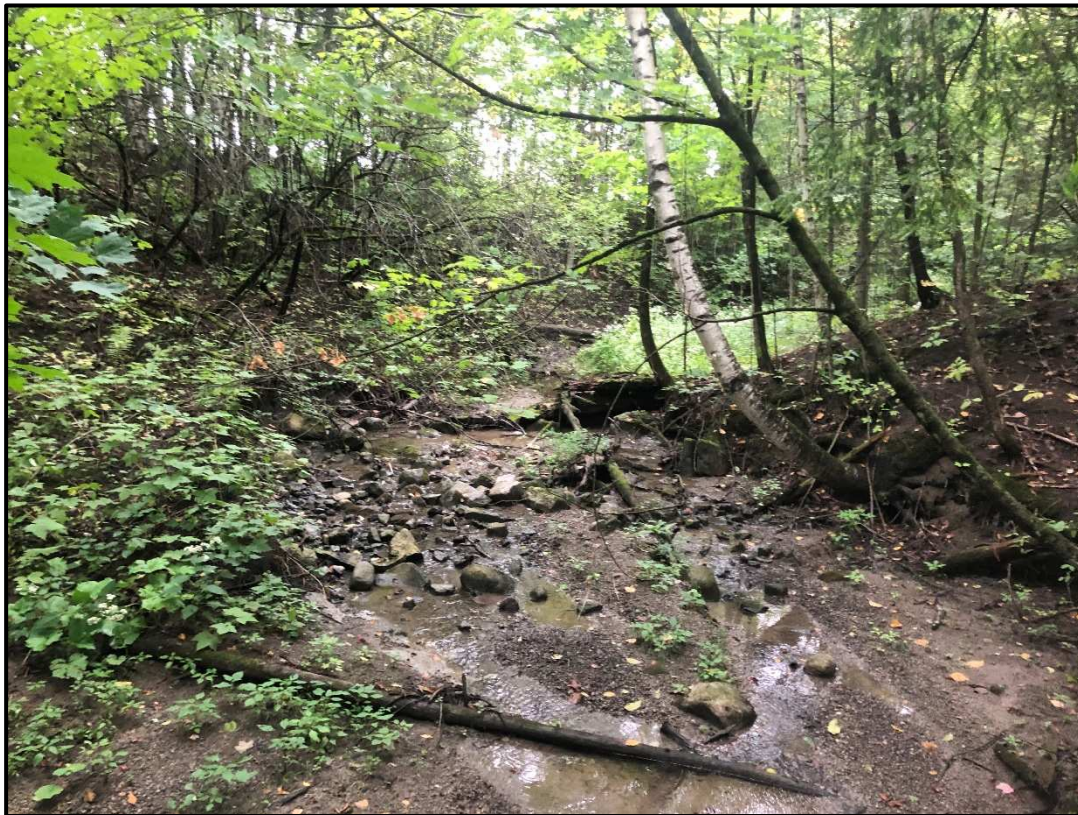
Photo 17A: Photo taken on September 10, 2020 along the watercourse, looking east (upstream).

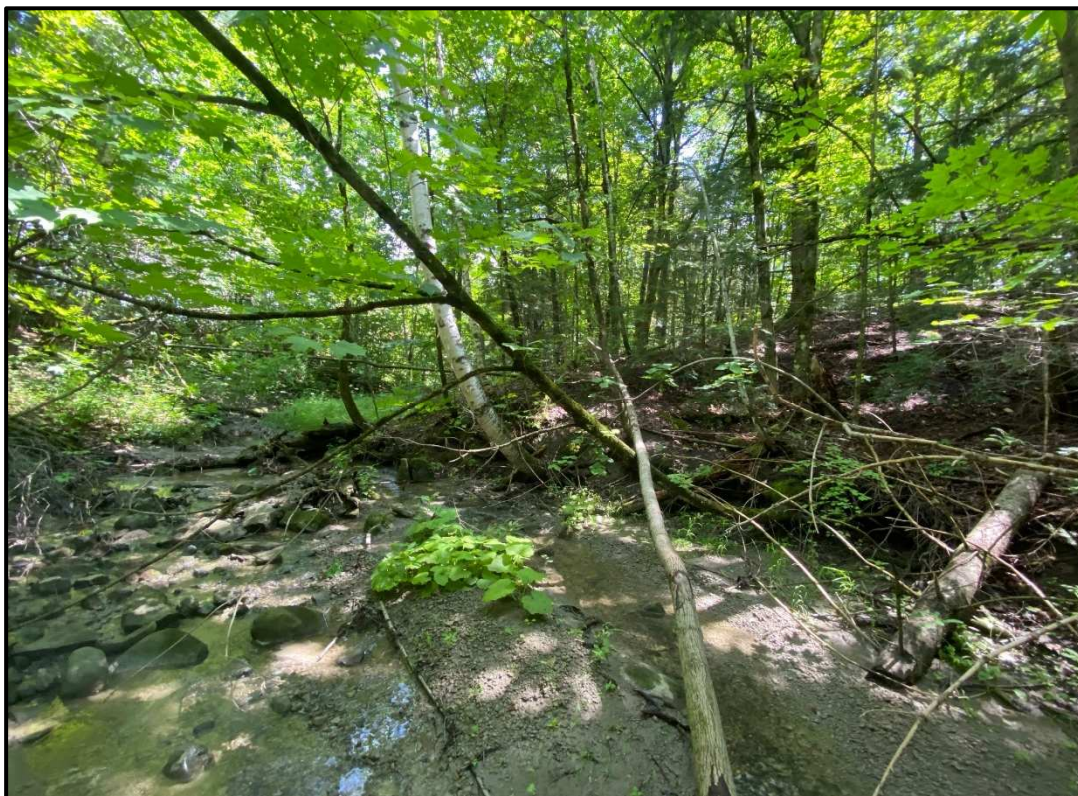
Photo 17B: Photo taken on July 19, 2023 along the watercourse, looking east (upstream).

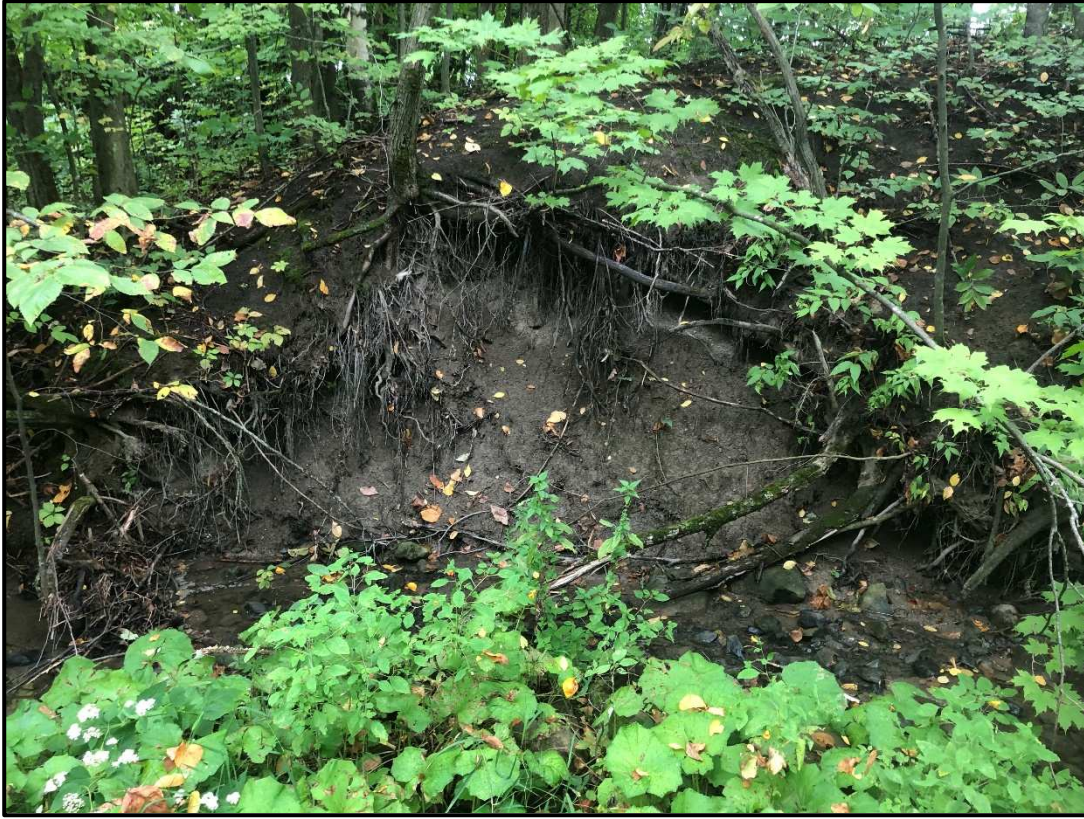
Photo 18A: Photo taken on September 10, 2020 of the north slope face, looking north at section GG.
